# Willamina Elementary School

Yamh\_sch07A

## FEMA 154 Rapid Visual Screening Score Card

Rapid Visual Screening - Senate Bill #2 - Seismic Needs Assessment  
Oregon Department of Geology and Mineral Industries

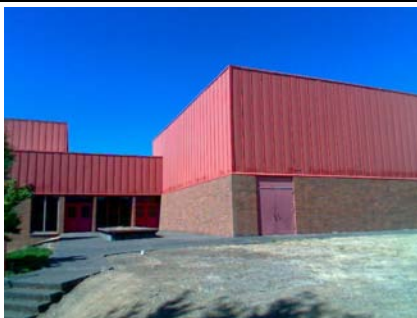
E Vertical Irregularity Primary

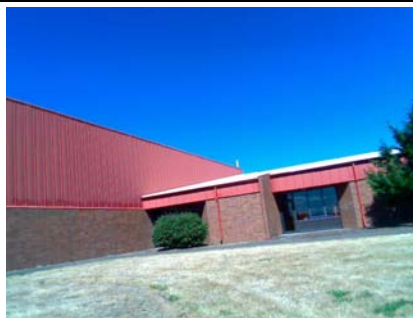
E Vertical Irregularity Secondary

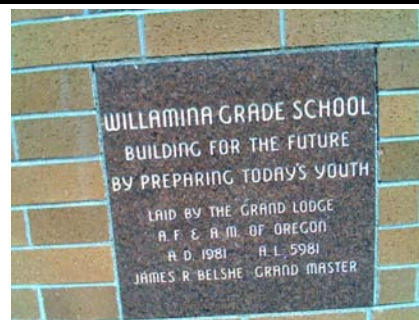
SE Field Verified Year Built  
1981
