Willamina High School

Willamina SD 30J

Yamh_sch09A

Rapid Visual Screening - Senate Bill #2 - Seismic Needs Assessment
Oregon Department of Geology and Mineral Industries

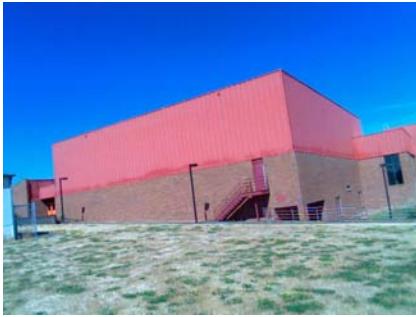
NE General Site		NE Vertical Irregularity Secondary

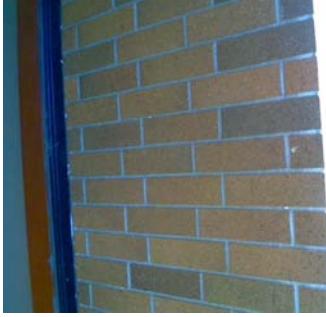
NE Primary Structural Type		NE Vertical Irregularity Secondary

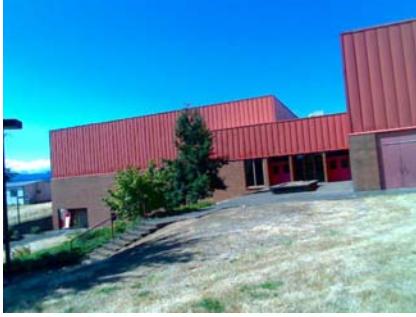
N Vertical Irregularity Primary
