# Patton Middle School

Yamh\_sch14A

## FEMA 154 Rapid Visual Screening Score Card

Rapid Visual Screening - Senate Bill #2 - Seismic Needs Assessment  
Oregon Department of Geology and Mineral Industries

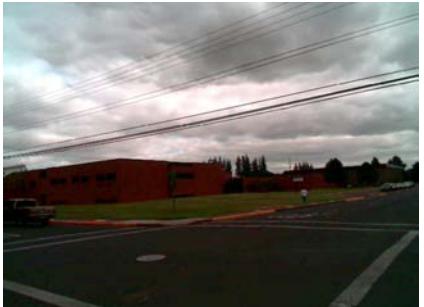
SW General Site	NW General Site	NW Pounding Potential

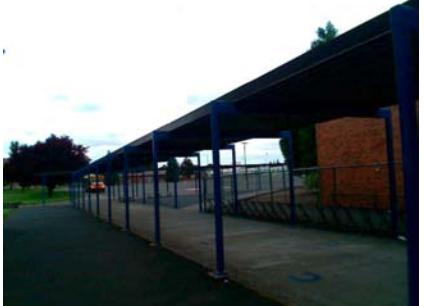
S Falling Hazard	W Falling Hazard	N Elevation View

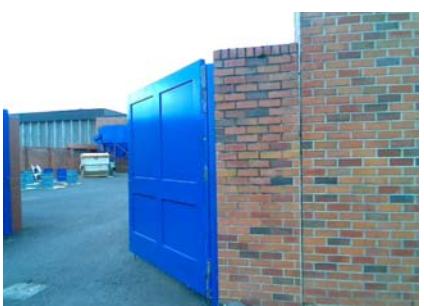
NE Elevation View	N Falling Hazard Wall disconnected at gap.	N Plan Irregularity Primary

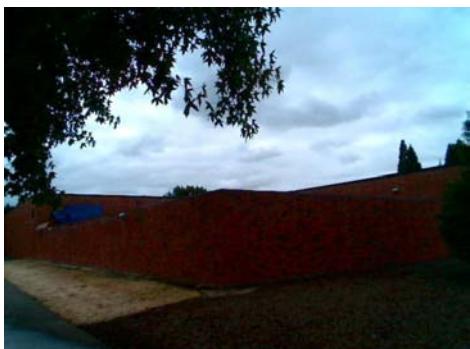
NE Elevation View  
Wall around mech/loading dock area.

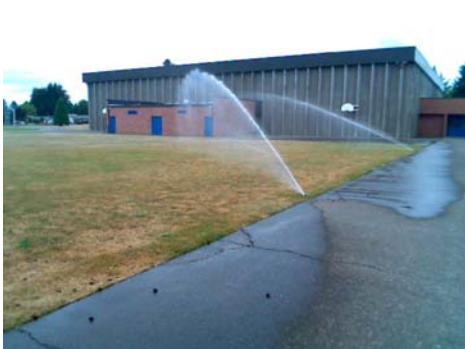
NW Elevation View  
locker room on bldg C same type as bldg A

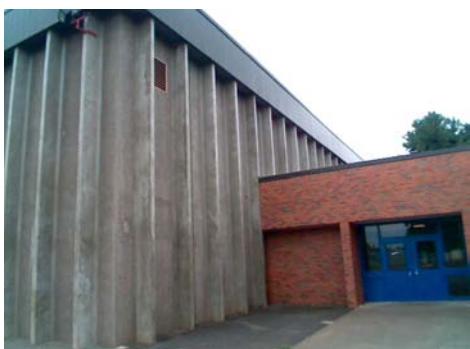
NW Plan Irregularity Secondary

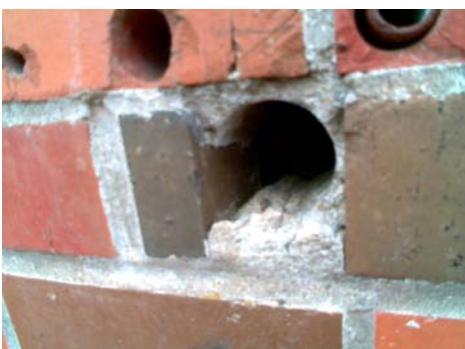
N Primary Structural Type  
Possible cavity wall, behind first layer of brick some concrete  
can be seen inside the hole

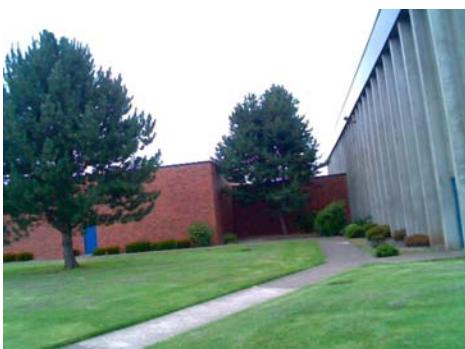
SW Vertical Irregularity Primary

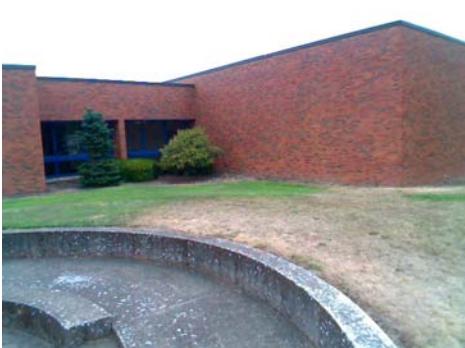
SW Plan Irregularity Primary

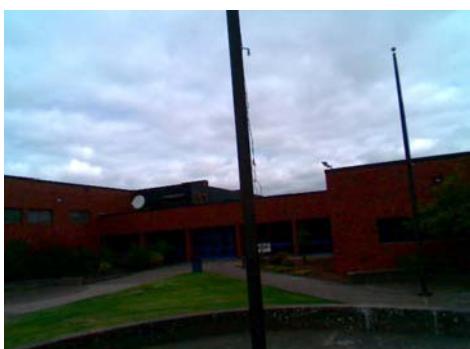
SE Plan Irregularity Primary

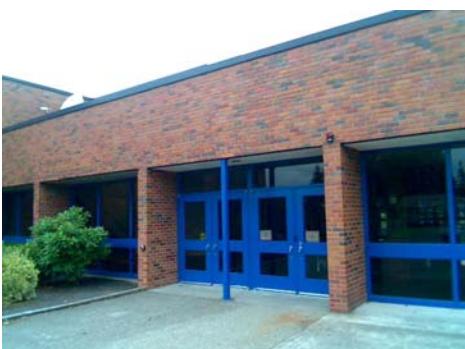
S Falling Hazard

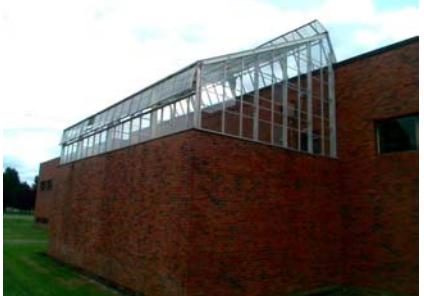
S Elevation View	SW Elevation View	SW Pounding Potential

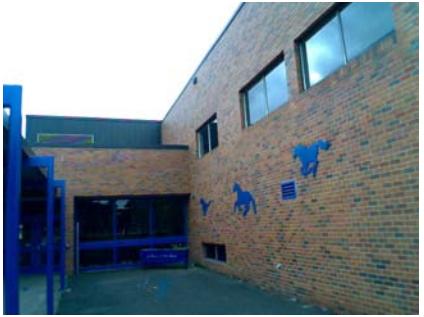
N Plan Irregularity Secondary

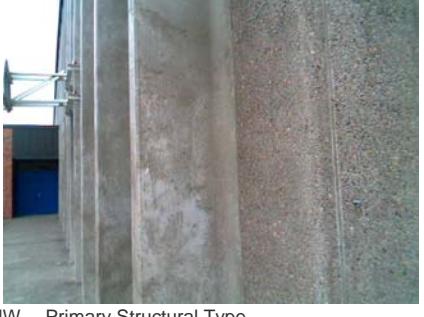
NW Primary Structural Type Caulked edge. Picture is of corner of bldg.

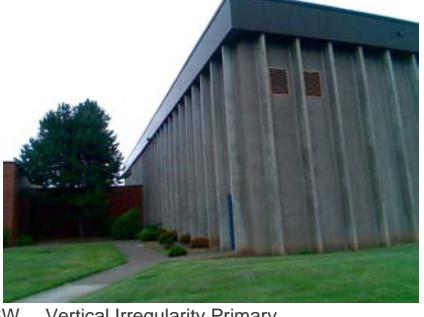
SW Vertical Irregularity Primary
