# Dayton Jr High School

Yamh\_sch19A

## FEMA 154 Rapid Visual Screening Score Card

Rapid Visual Screening - Senate Bill #2 - Seismic Needs Assessment  
Oregon Department of Geology and Mineral Industries

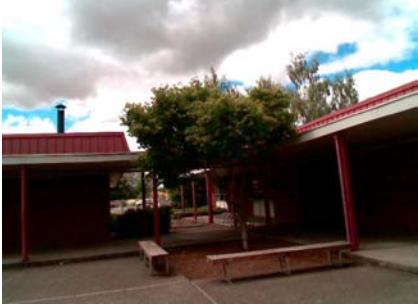
NE Pounding Potential walkway connects both bldgs
