Dayton Grade School

Yamh_sch30A

FEMA 154 Rapid Visual Screening Score Card

Rapid Visual Screening - Senate Bill #2 - Seismic Needs Assessment
Oregon Department of Geology and Mineral Industries

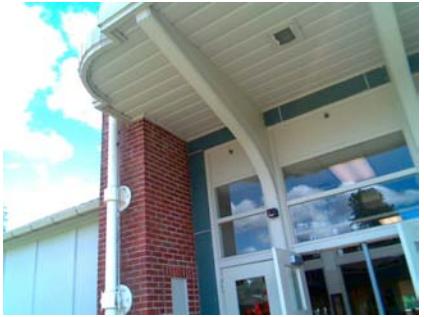
W Primary Structural Type	W Elevation View	W Field Verified Year Built 1951

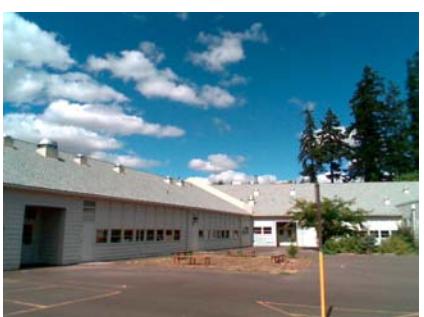
SW Plan Irregularity Primary	E Poor Condition	W Elevation View
