Amity Middle School

Yamh_sch32A

FEMA 154 Rapid Visual Screening Score Card

Rapid Visual Screening - Senate Bill #2 - Seismic Needs Assessment
Oregon Department of Geology and Mineral Industries

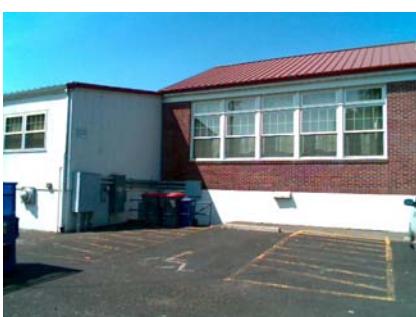
| Plan Irregularities Reentrant Corners:Other (Adjacent Build/Entity) Reentrant Corners: L Shaped None | | Vertical Irregularities Steps in Elevation View: Single Change None None | |

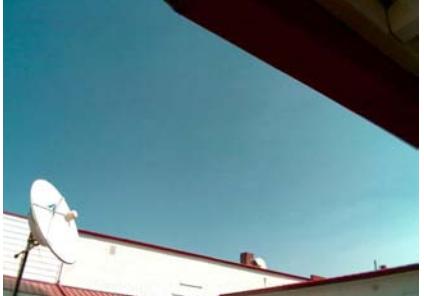
| Falling Hazards Unreinforced Chimneys Other: General None | | Poor Conditions None None None | |

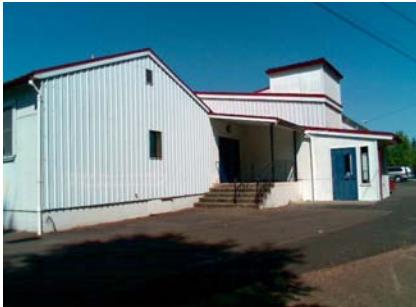
| Reentrant Corners: Other | | Steps in Elevation View: 2 to 3 Changes | |

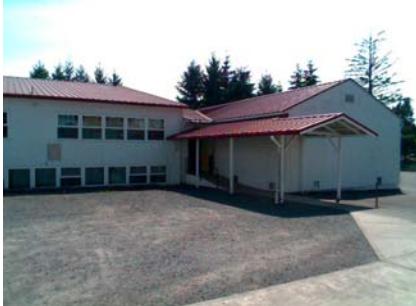
| Reentrant Corners: Other (Adjacent Build/Entity) | | None | |
