Item G, Attachment 2

Public Comments on Biglow Canyon Windfarm RFA4 and Proposed Order

When Wind Towers Fall Apart

Portland General Electric's (PGE) Biglow Canyon

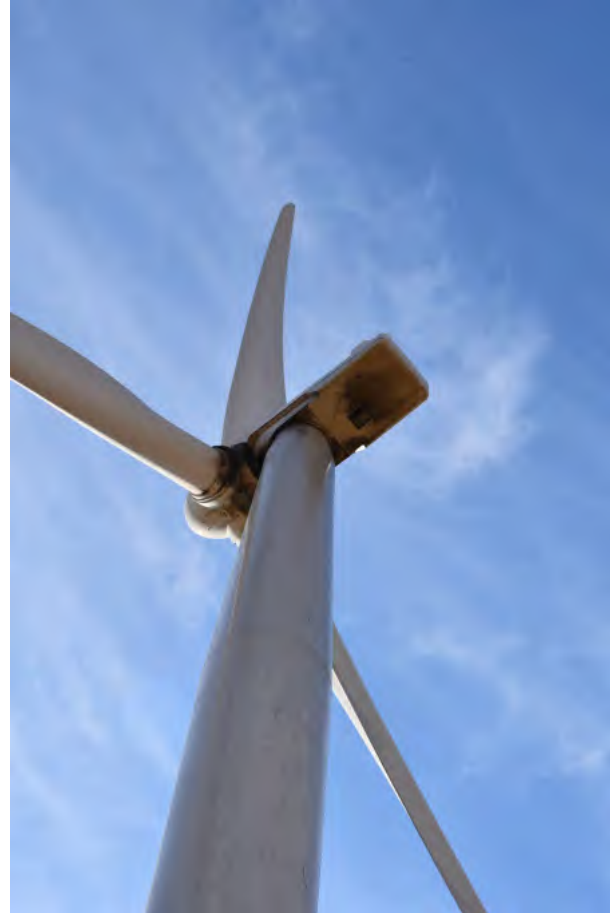
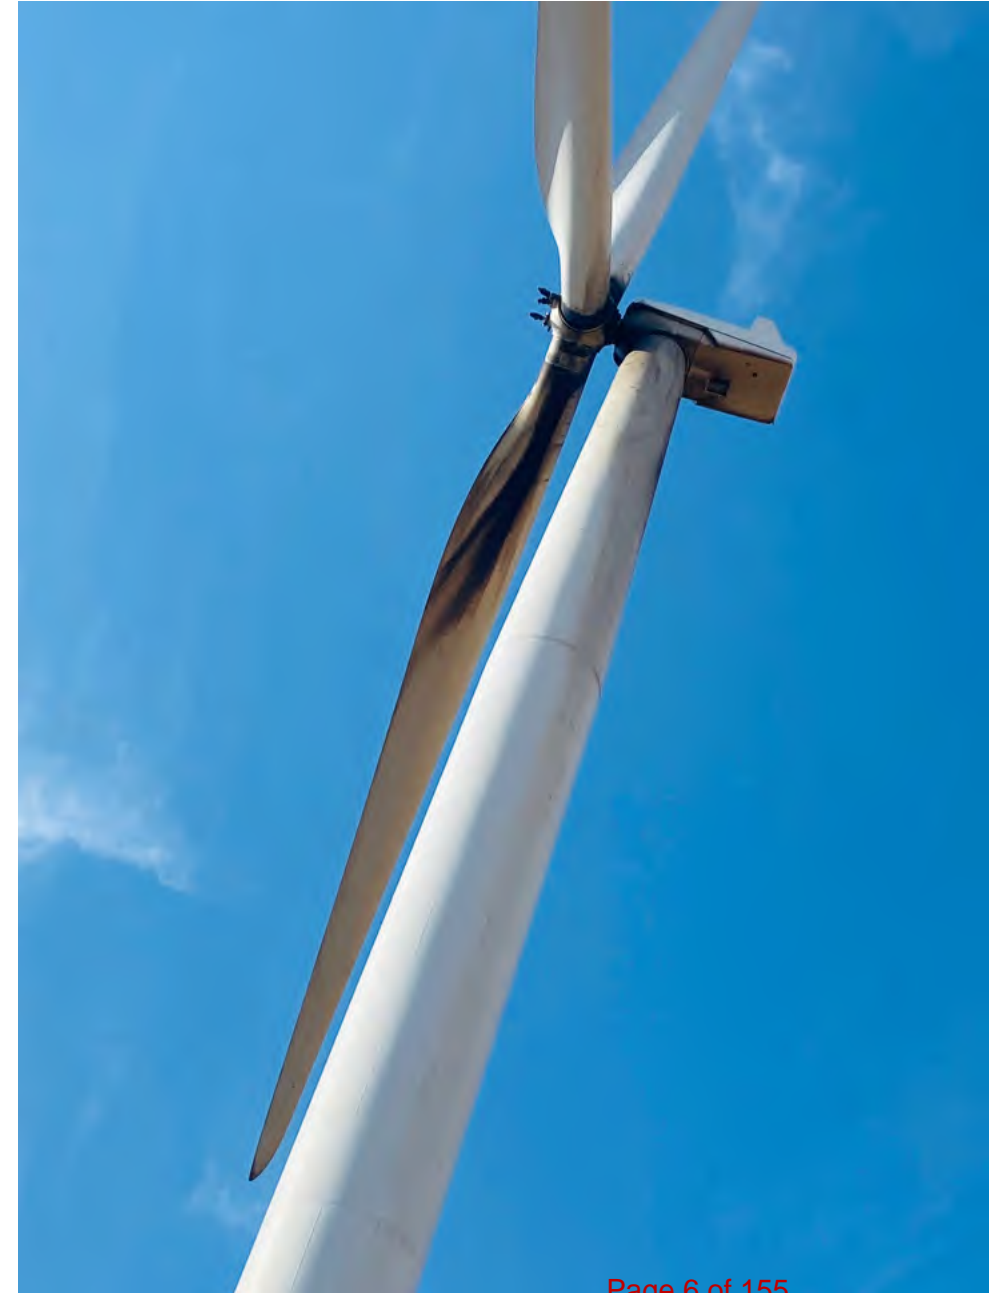
PGE says they have vegetable oil in all their transformers, and that it is safe. That's a bait and switch. The transformers are at the bottom of the towers. This is a blade pitch motor leak and it is definitely hydraulic oil.

There are 76
Vestas in this
project, and over
half of them are
leaky, oily
messes.

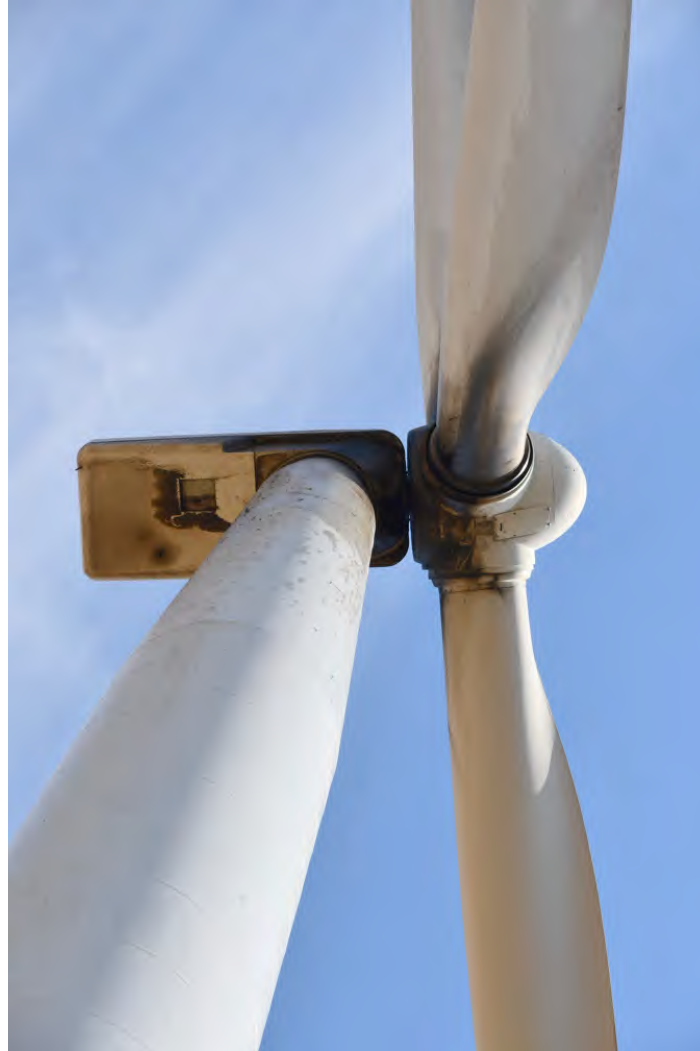
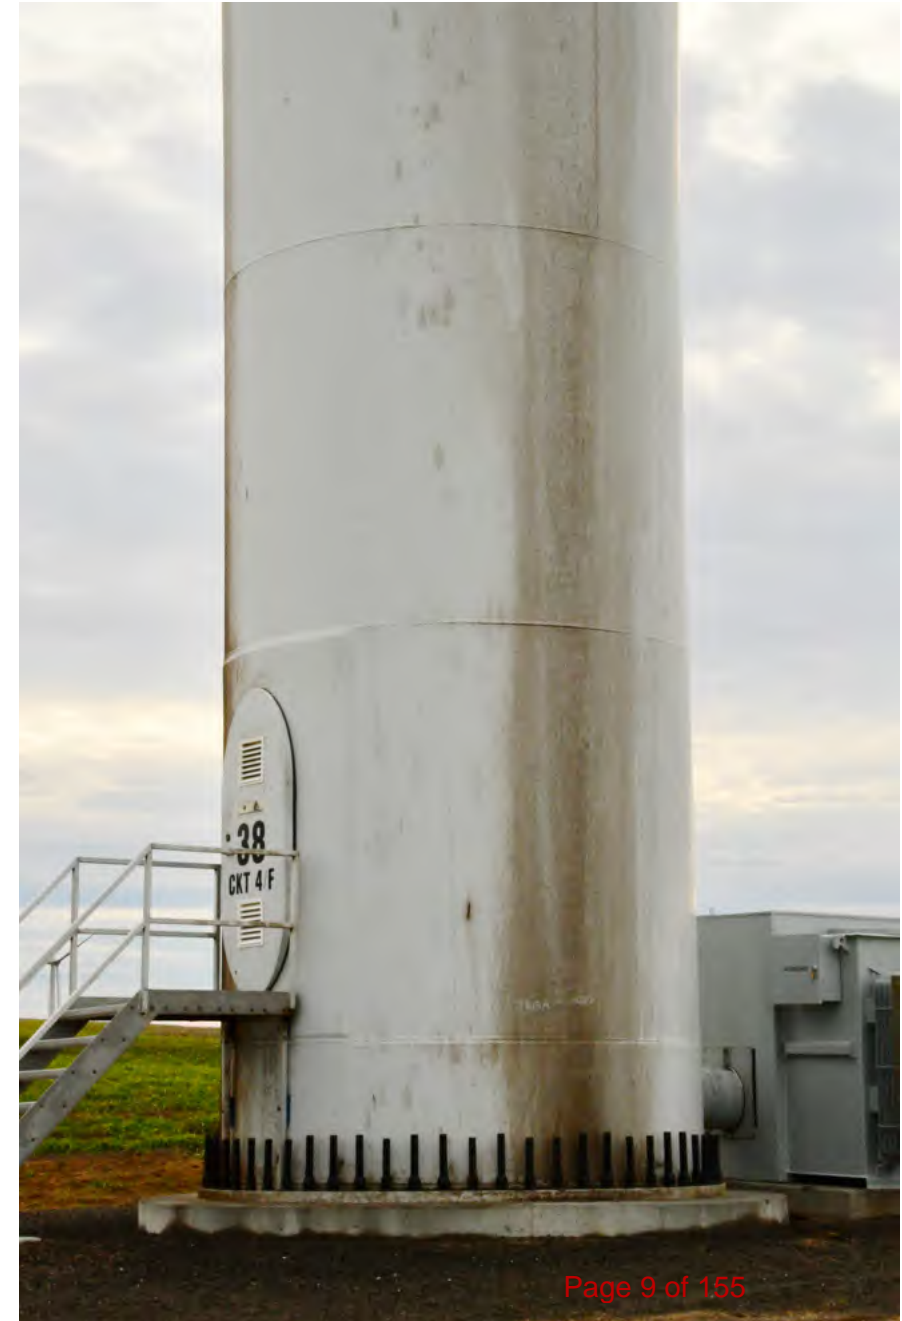
Oil at the bases
leaking onto the
ground....

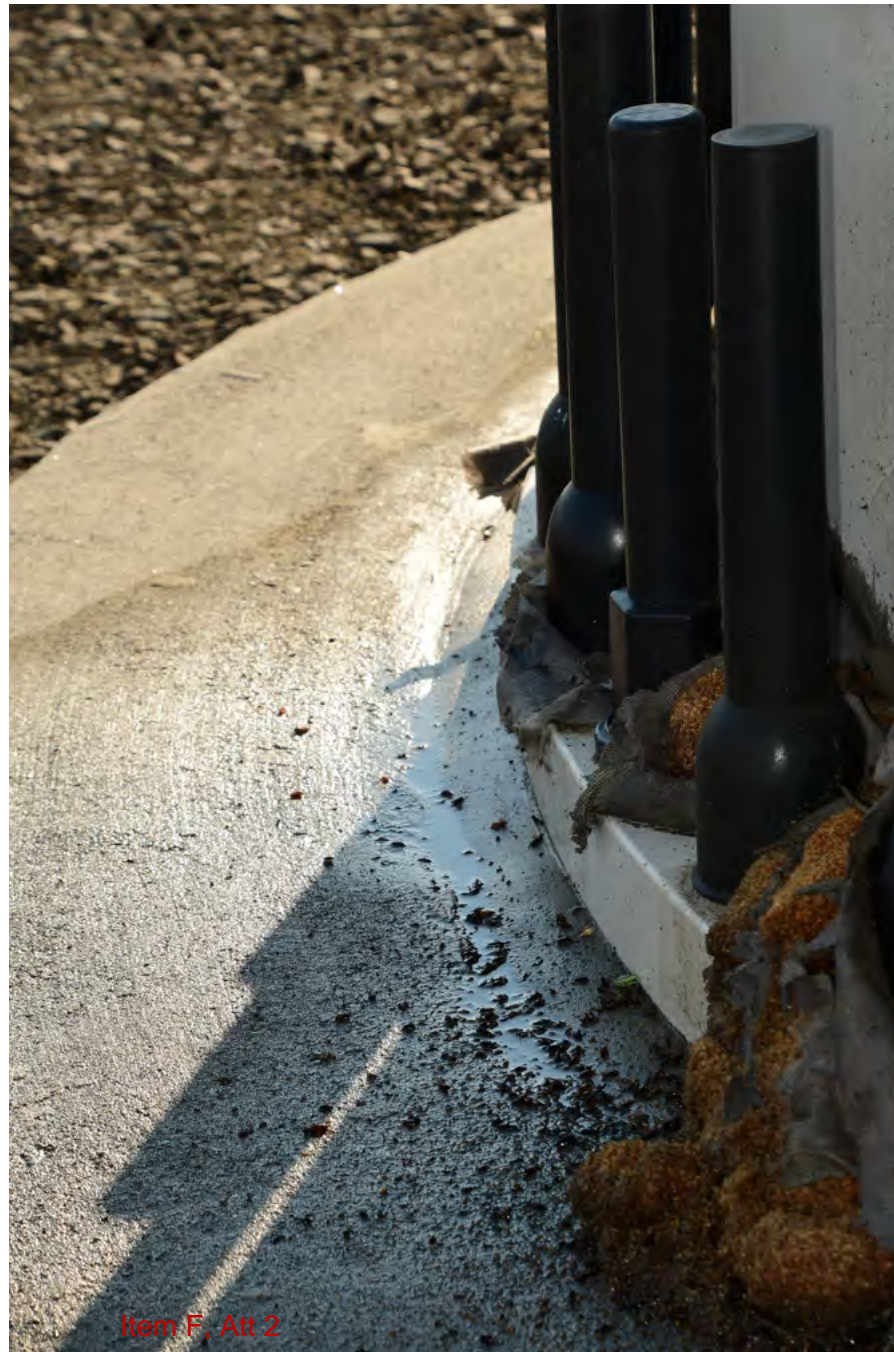
Oily rags show just how dirty it is up there.

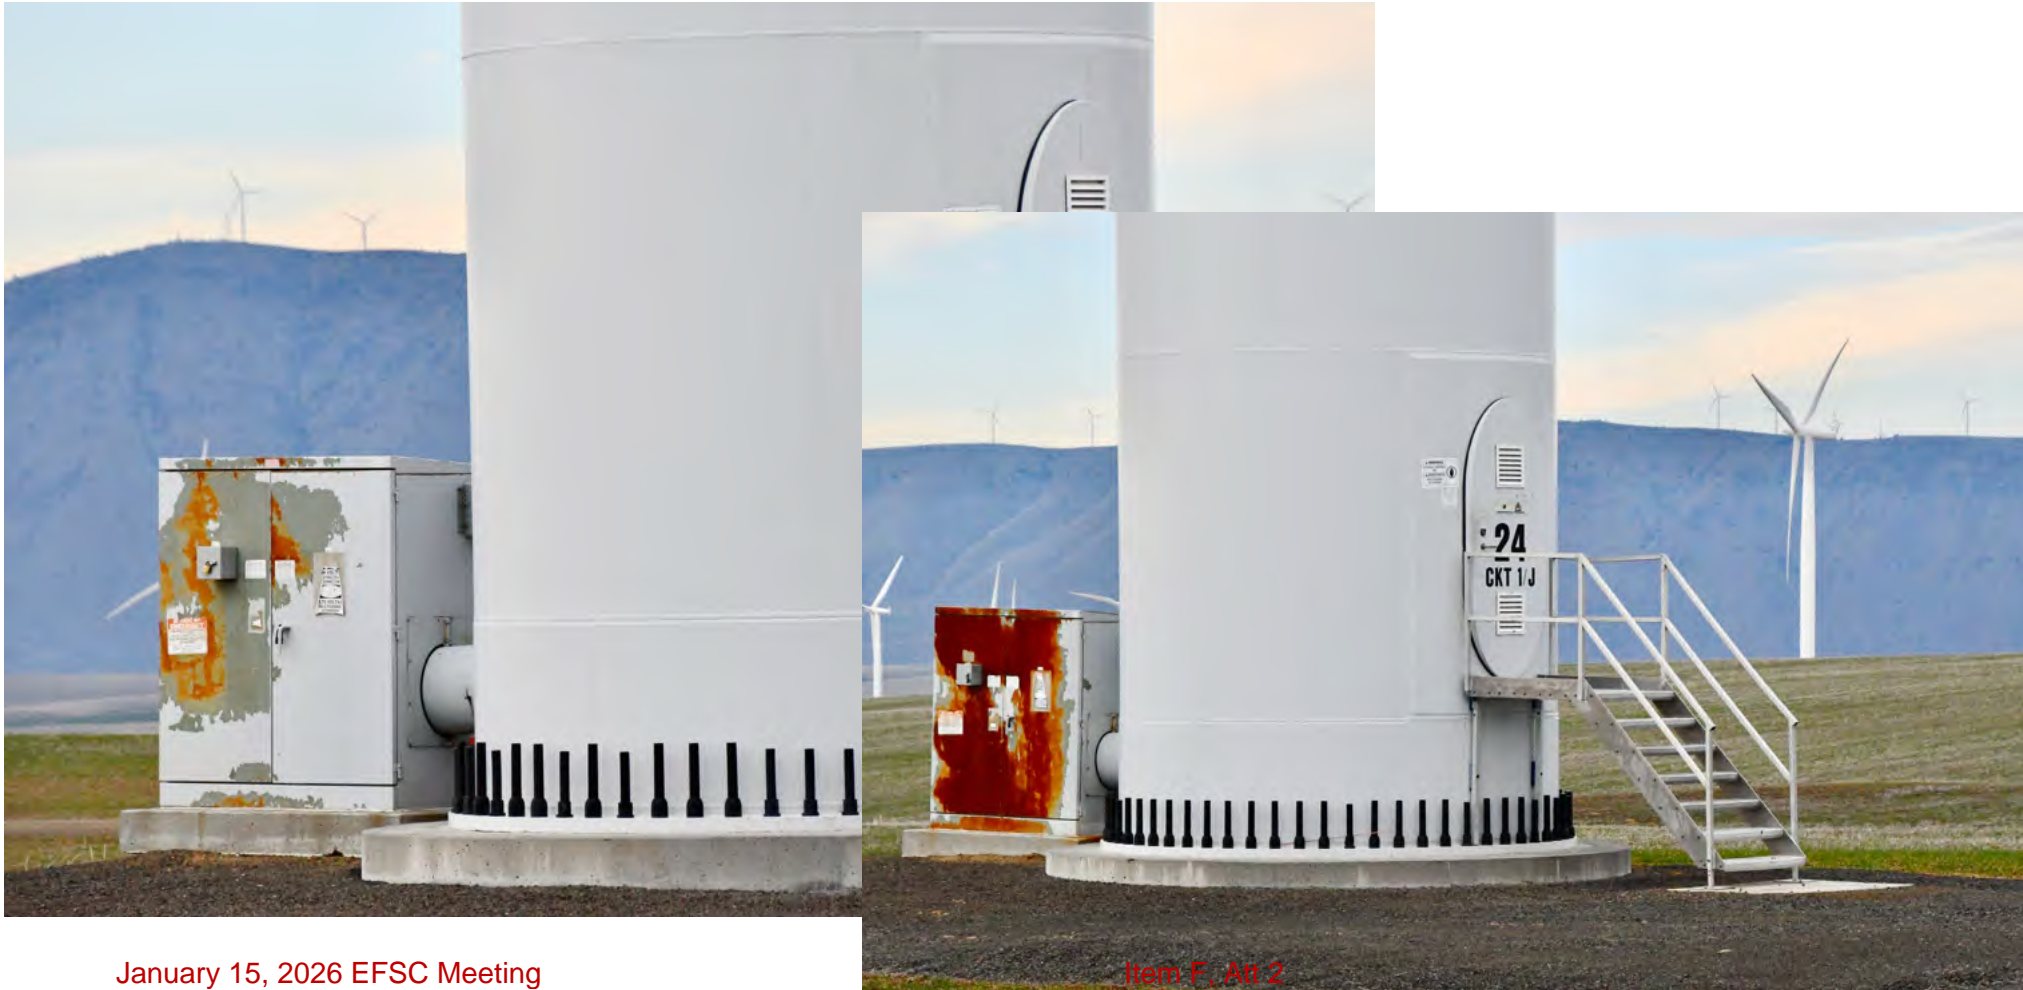
This is one of the "vegetable oil" transformers.
Vegetable oil still has a flashpoint...!

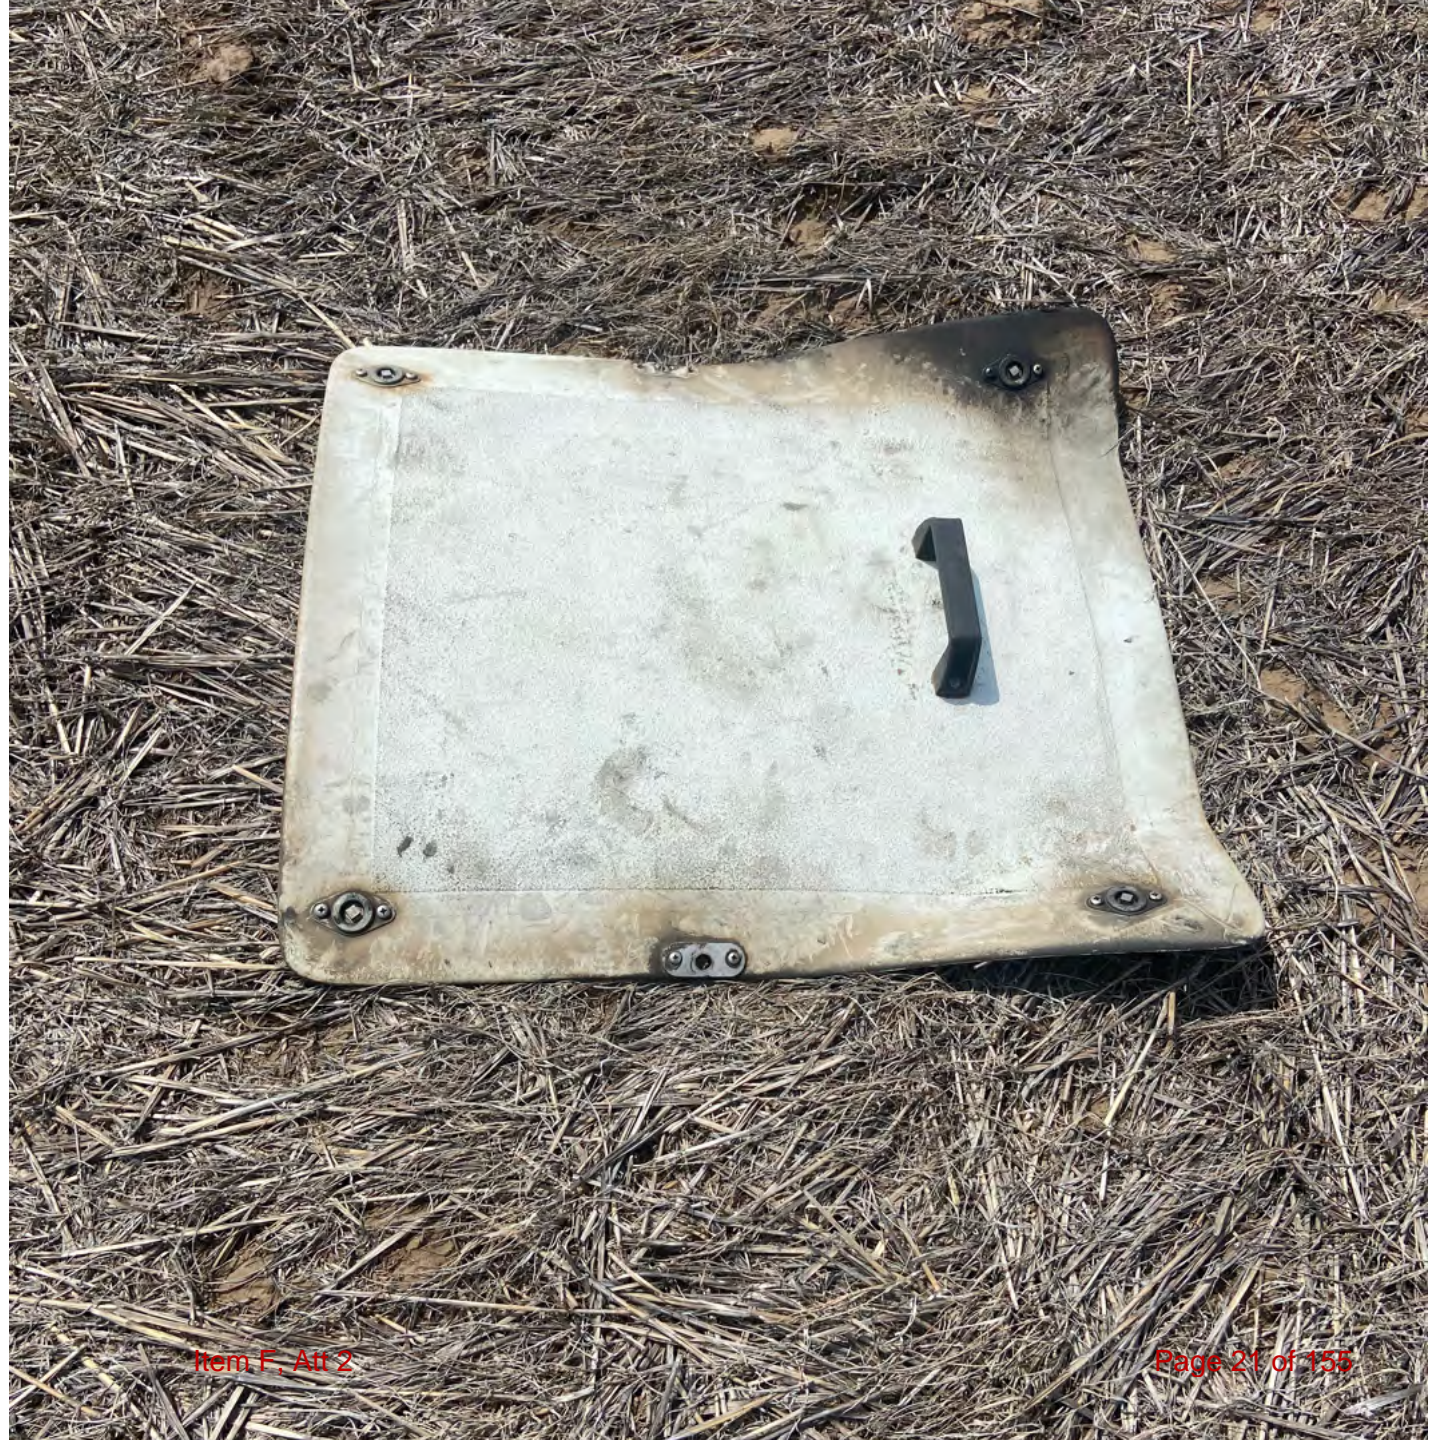
This one is missing a door. In fact, a lot of these towers are missing hatch doors, and the guys find them in our fields "all the time."

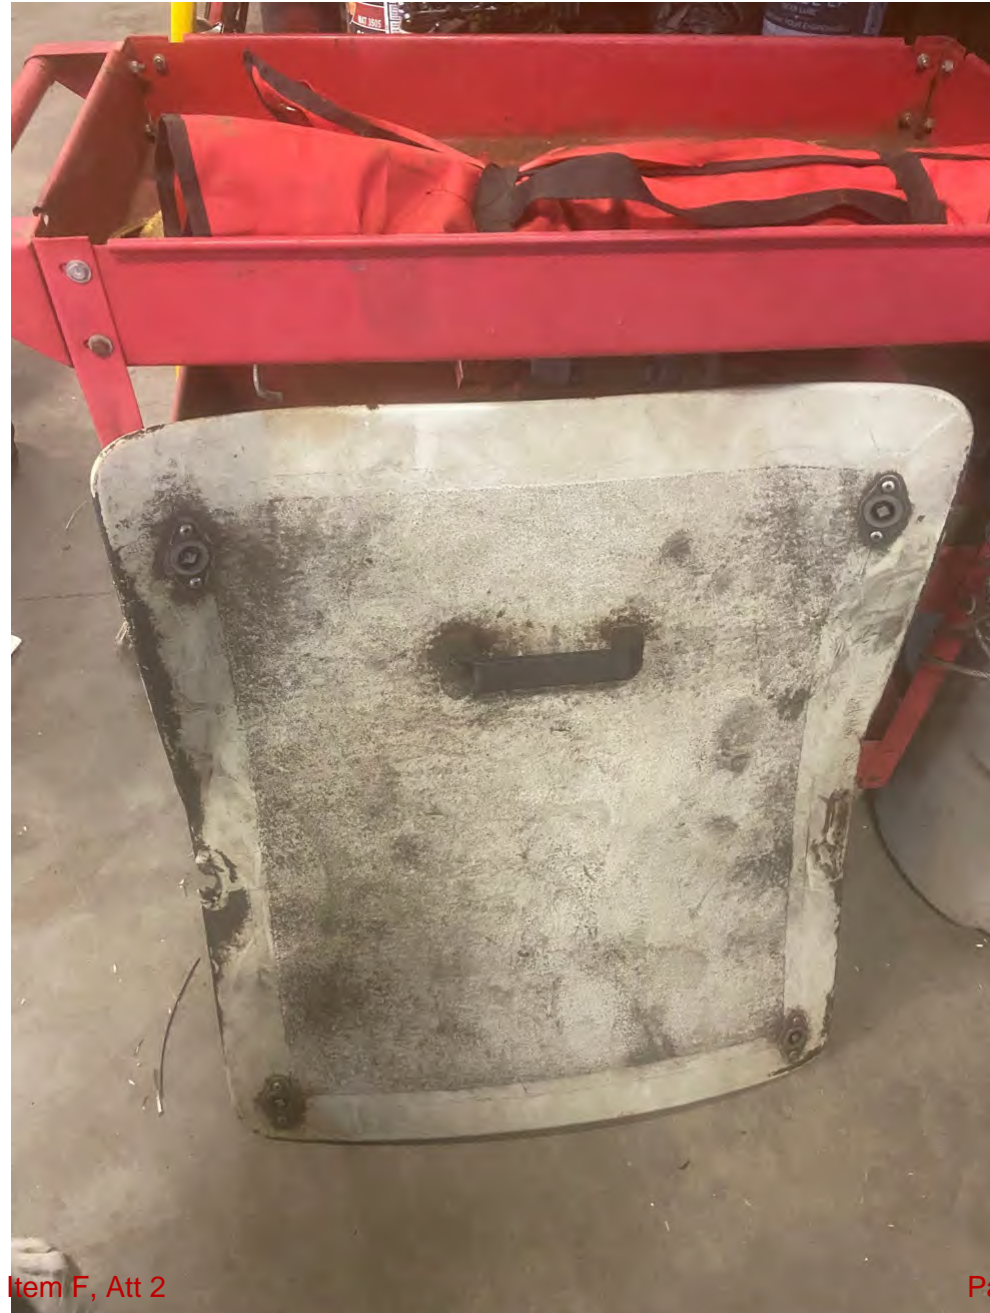
See the hole? You can see where it broke away.

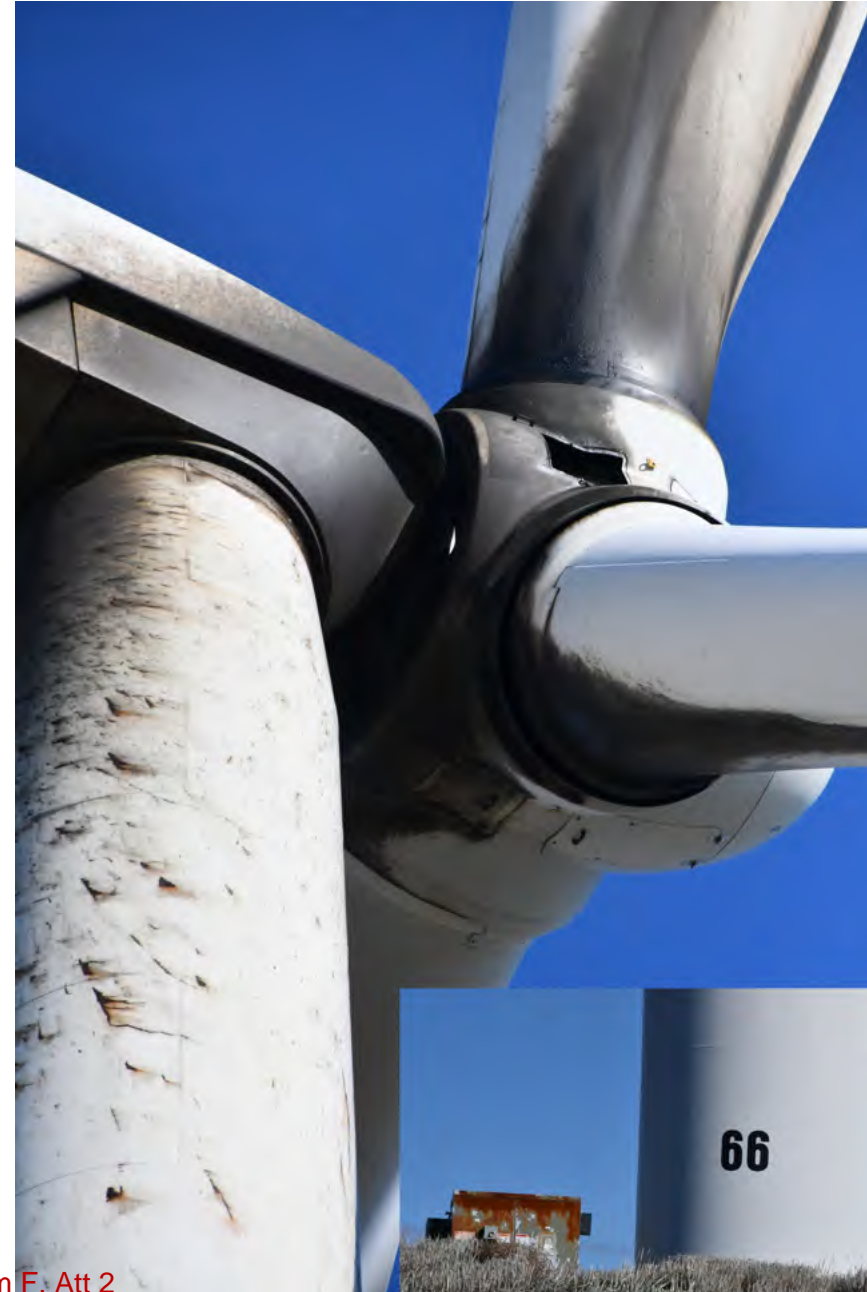
This is what they actually look like in the ones that haven't been cleaned lately.

The trouble is, without fixing the problem, they keep leaking and within a couple weeks they are disgusting again.

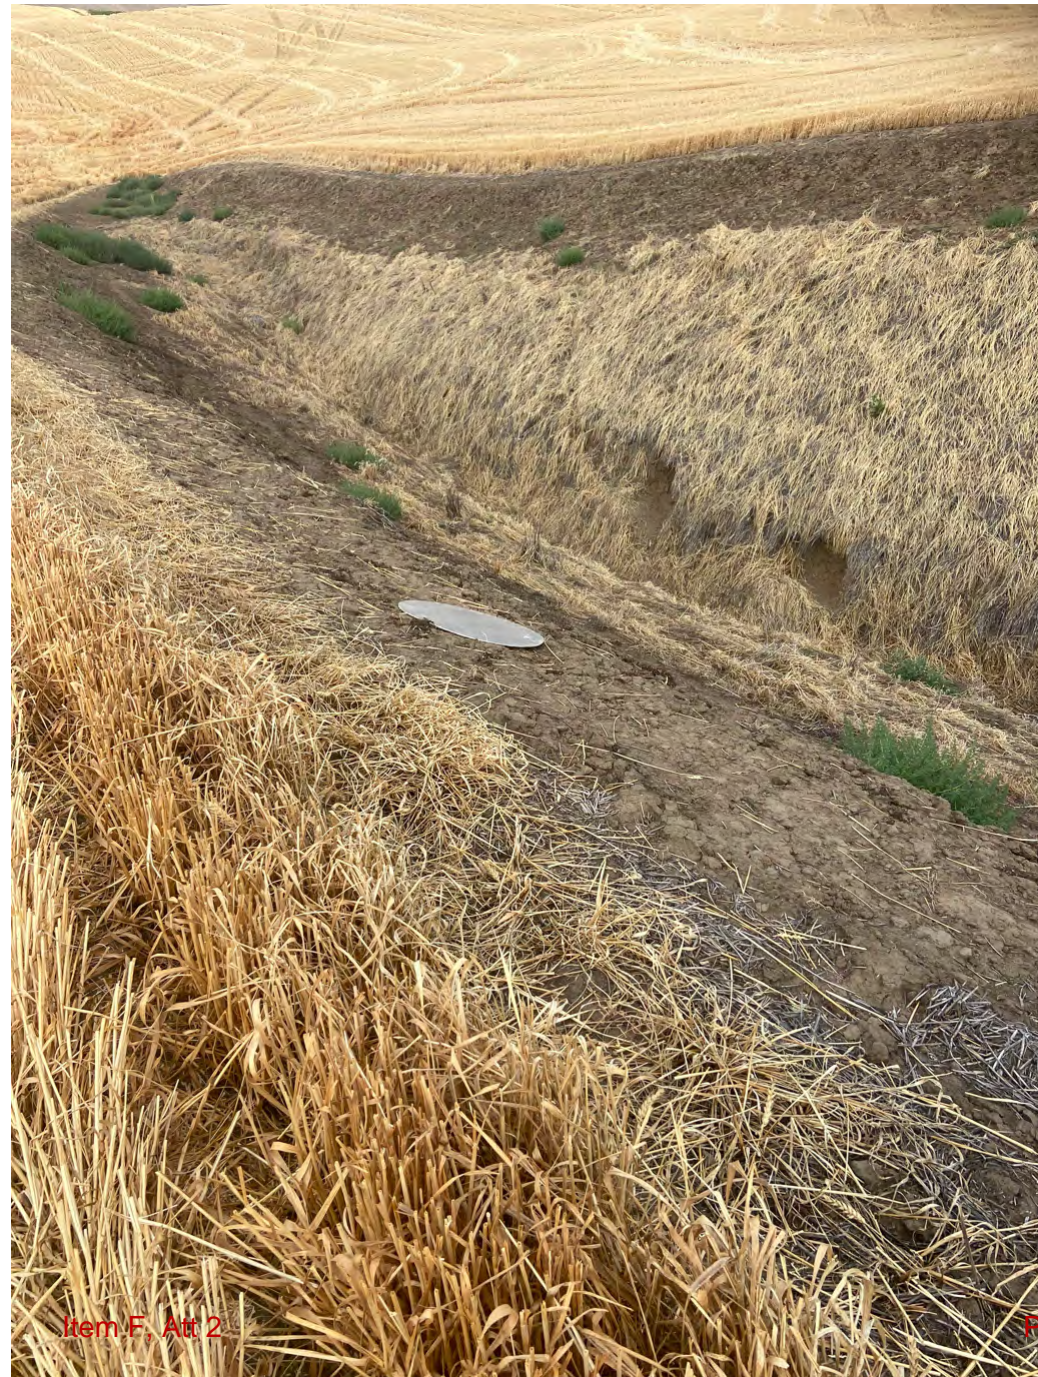
A year ago, April 2021, part of a nose cone fell off. PGE took the rest of the nose cone down and left it.

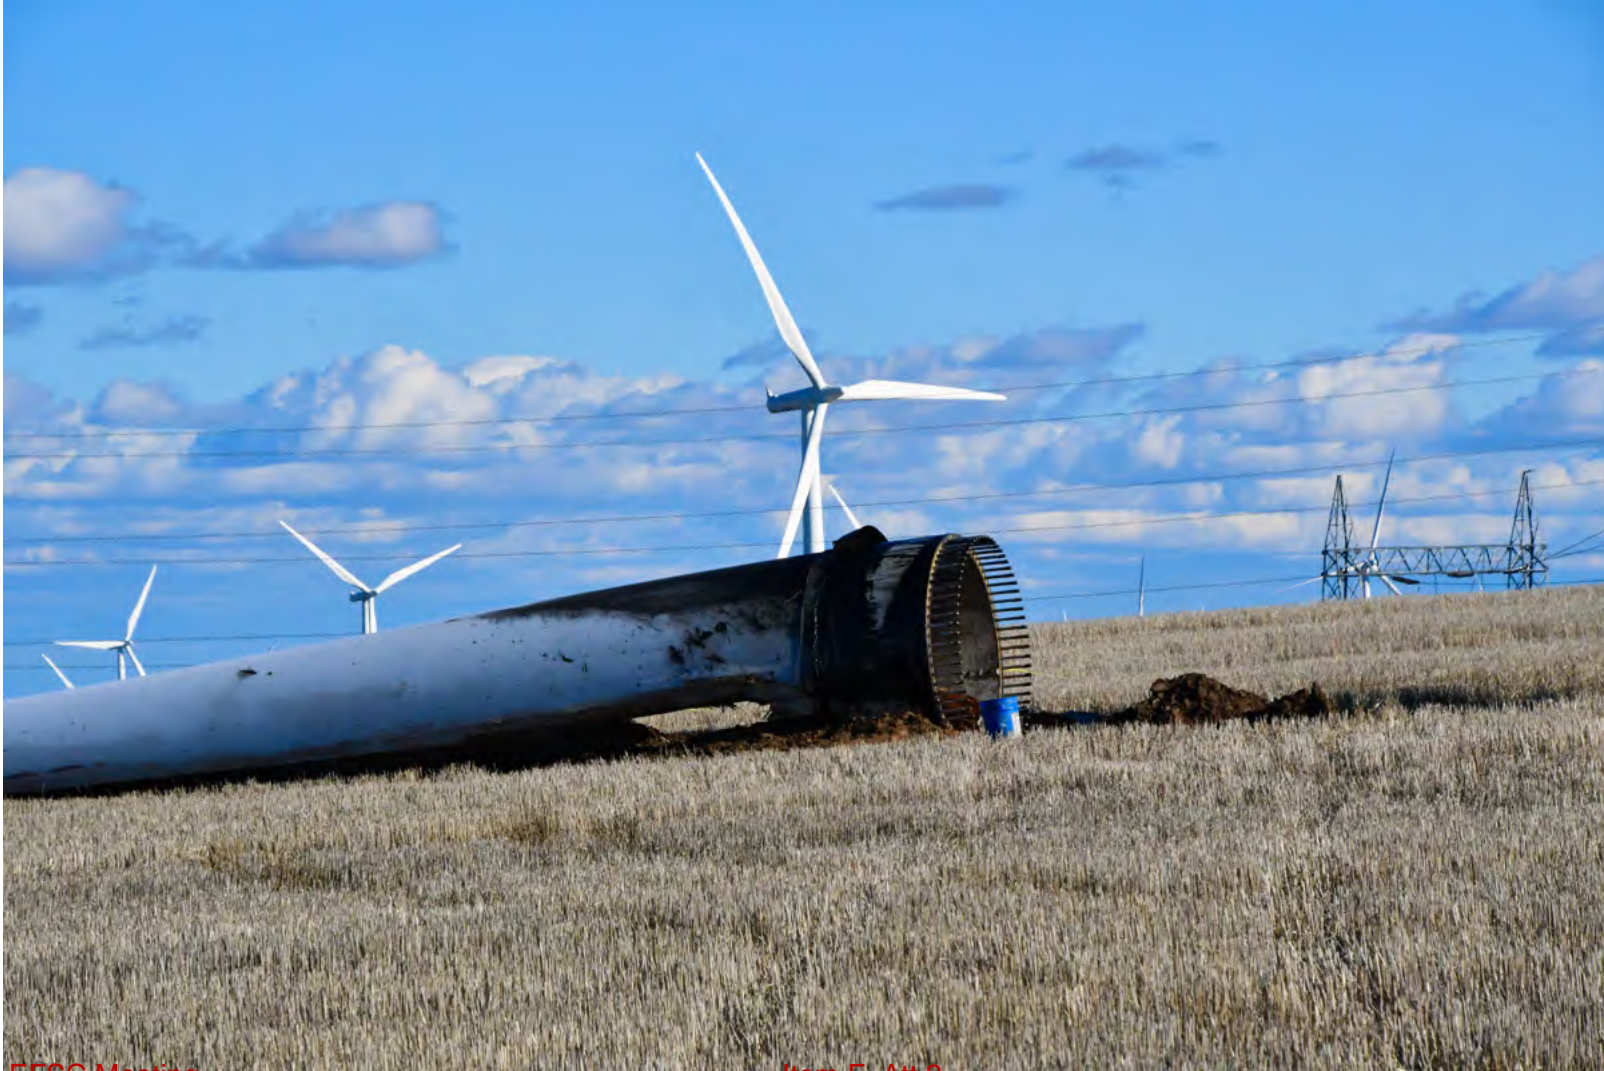
A blade falls off.
That is our house
in the
background.

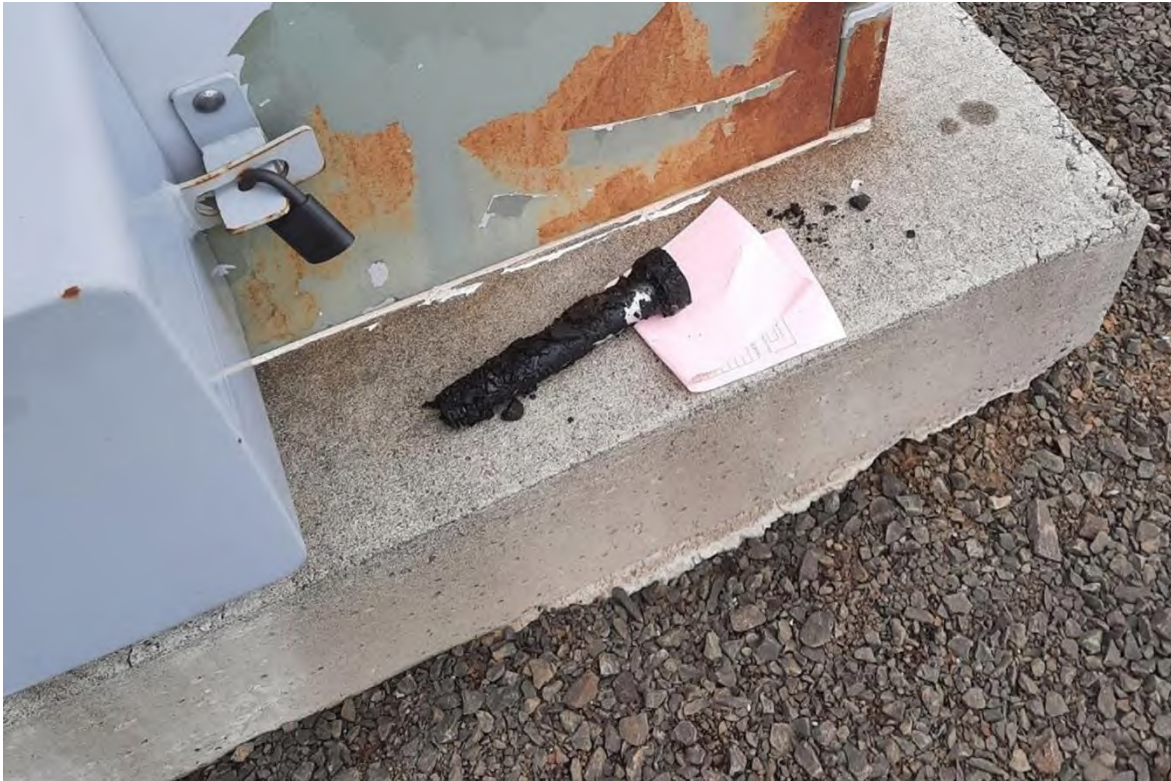
A broken blade bolt found under a wind turbine at Biglow Canyon wind farm by a worker delivering fertilizer in late January. A day or two later, the turbine threw an eight-ton blade into a nearby field. (Courtesy Kevin Massie)

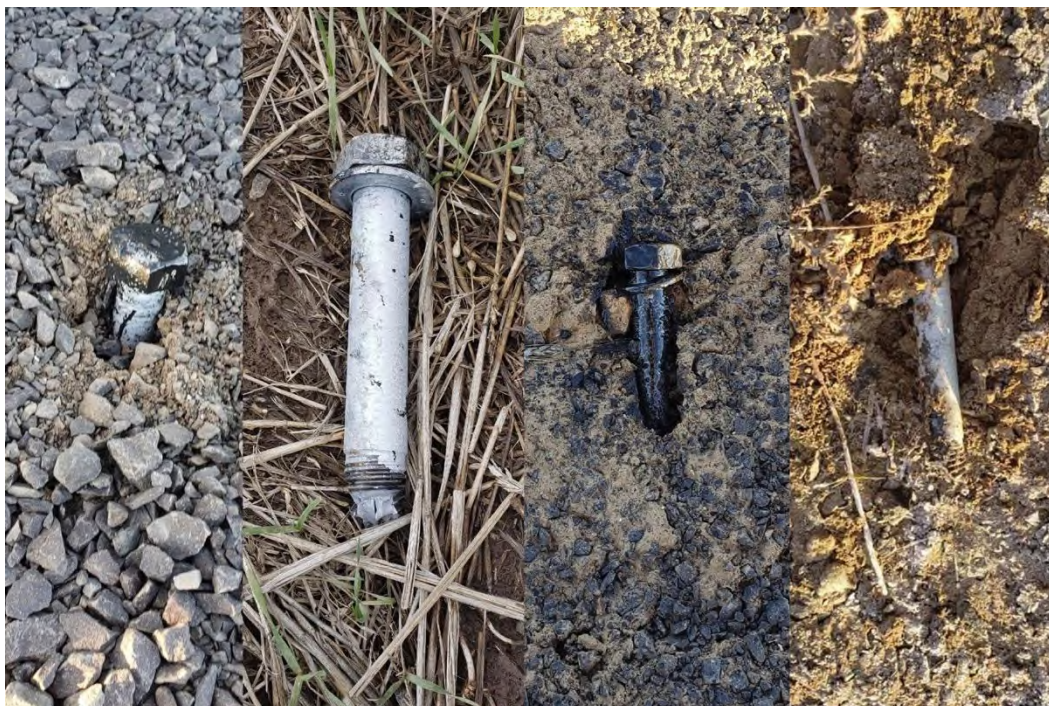
Broken blade bolts were scattered around turbine 71 at Portland General Electric’s Biglow Canyon wind farm after the turbine threw a blade in the early hours of Feb. 1. Hours before the blade throw, a driver delivering fertilizer became stuck in close proximity to the turbine and had to be towed out. (Courtesy Kevin Massie)

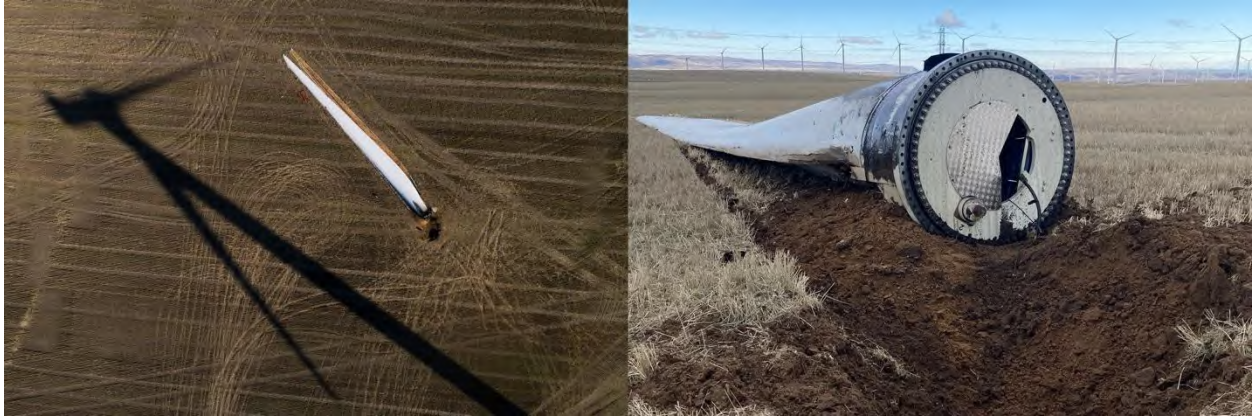
On Feb 1, turbine 71 at Portland General Electric's Biglow Canyon wind farm threw an eight-ton blade 100 yards into a nearby field, plowing a deep furrow in the ground where it landed. (Left, Dave Killen, right courtesy Kathryn McCullough)

Seven months into that review, PGE told The Oregonian/OregonLive that preliminary results suggest the connection between the turbine blade and its hub was “not well clamped,” a problem likely caused by “bolts becoming loose and experiencing fatigue damage over time.”

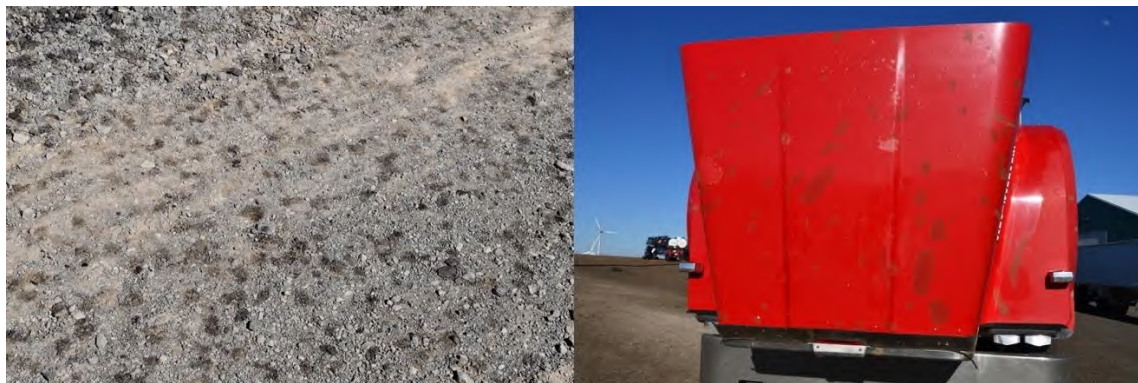
Kevin McCullough parked his truck near one of Biglow Canyon’s Vestas wind turbines for about 30 minutes during wheat harvest in early August. When he returned, he said it was spattered in oil leaking from the top of the turbine. At right, oil spots on the ground nearby the same turbine. Landowners worry that regular leaks of oil and lubricants from Vestas turbines, which PGE says is a fixable problem if it chooses to make the investment, could be contaminating their cropland.
(Courtesy Kathryn McCullough)

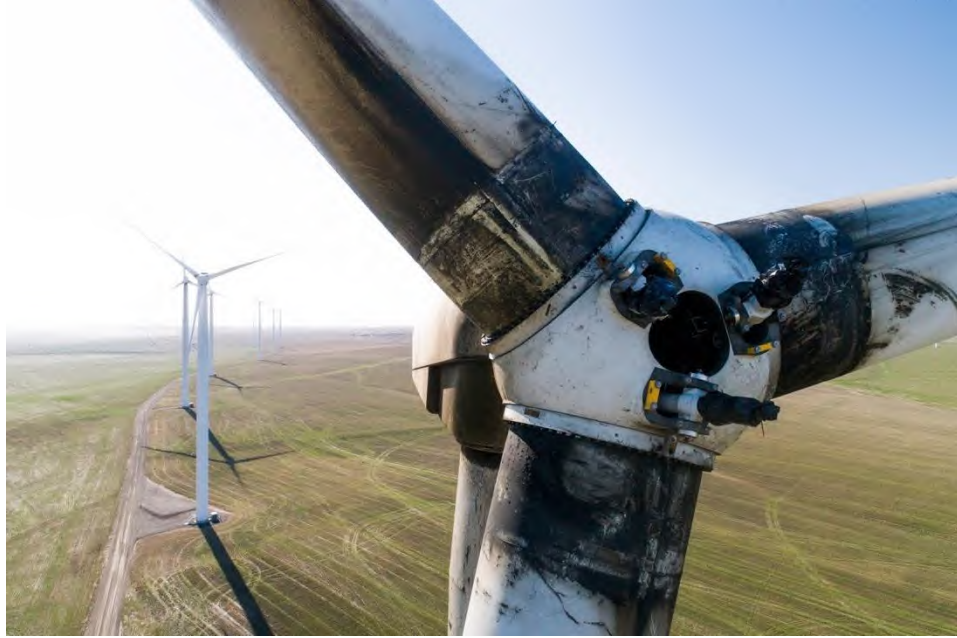
A metal frame and pieces of fiberglass fell from the spinner cone of this Vestas turbine into a field below at Biglow Canyon wind farm in April 2021. PGE didn't report the incident to regulators until this summer. Wind technicians later lowered the turbine's nose cone and spinner frame onto the turbine pad, where the pieces remained for a year. The nose cone blew into a nearby gully, and remained there earlier this month.

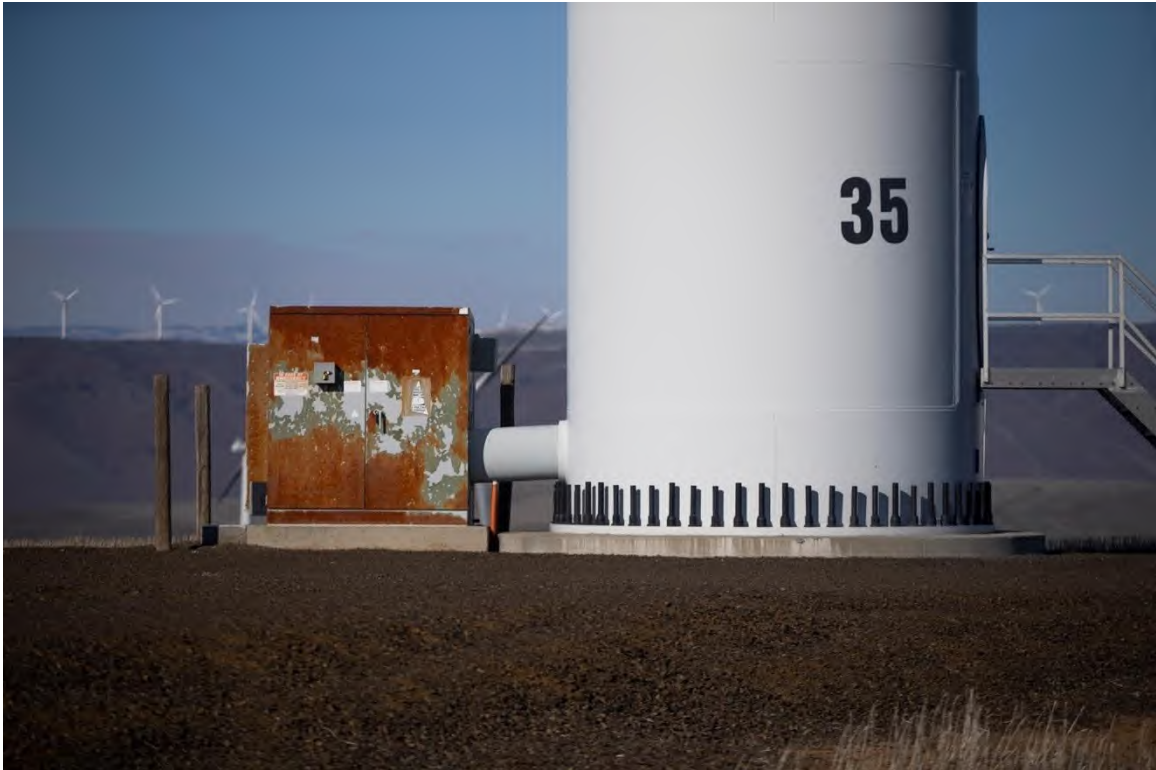
PGE has experienced 10 transformer failures at Biglow Canyon that have collectively leaked 3,000 gallons of mineral oil to the ground surrounding turbines and caused two fires. Pictured above, pad-mount transformers sit in cabinets below each turbine at Biglow Canyon.

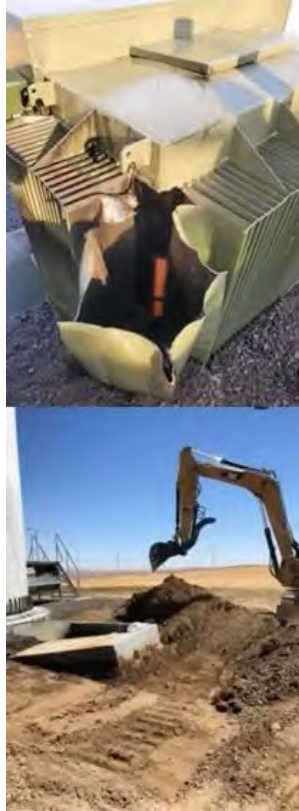
Screen shots of a ruptured transformer and the required cleanup of a transformer oil spill from a presentation that PGE made to state regulators in January about transformer problems at the wind farm.

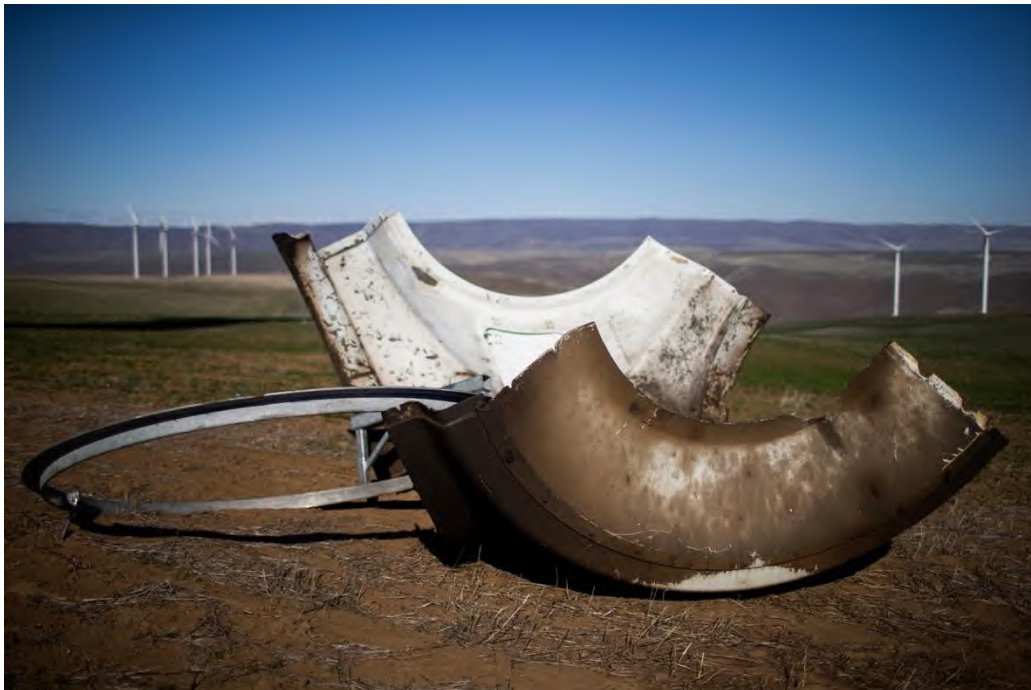
Pieces from a damaged Vestas V82 wind turbine at Biglow Canyon. PGE told regulators a metal frame and pieces of fiberglass fell off the turbine in April 2021. Wind technicians later lowered the turbine’s nose cone and spinner frame to the ground, where they were left for a year.

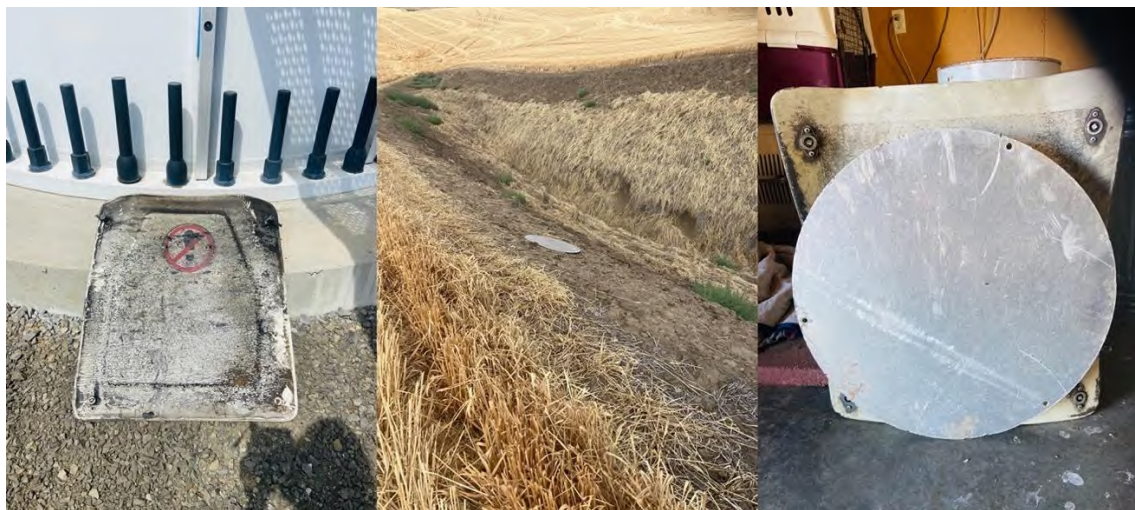
Landowners say they find hatch doors (left) from the Vestas turbines at Biglow Canyon and metal disks (center) from the Siemens turbines that break off and fall into their fields from a height of about 265 feet. State regulators say even small objects falling from that height can reach speeds of nearly 90 mph and could endanger anyone below. (Courtesy Kathryn McCullough)

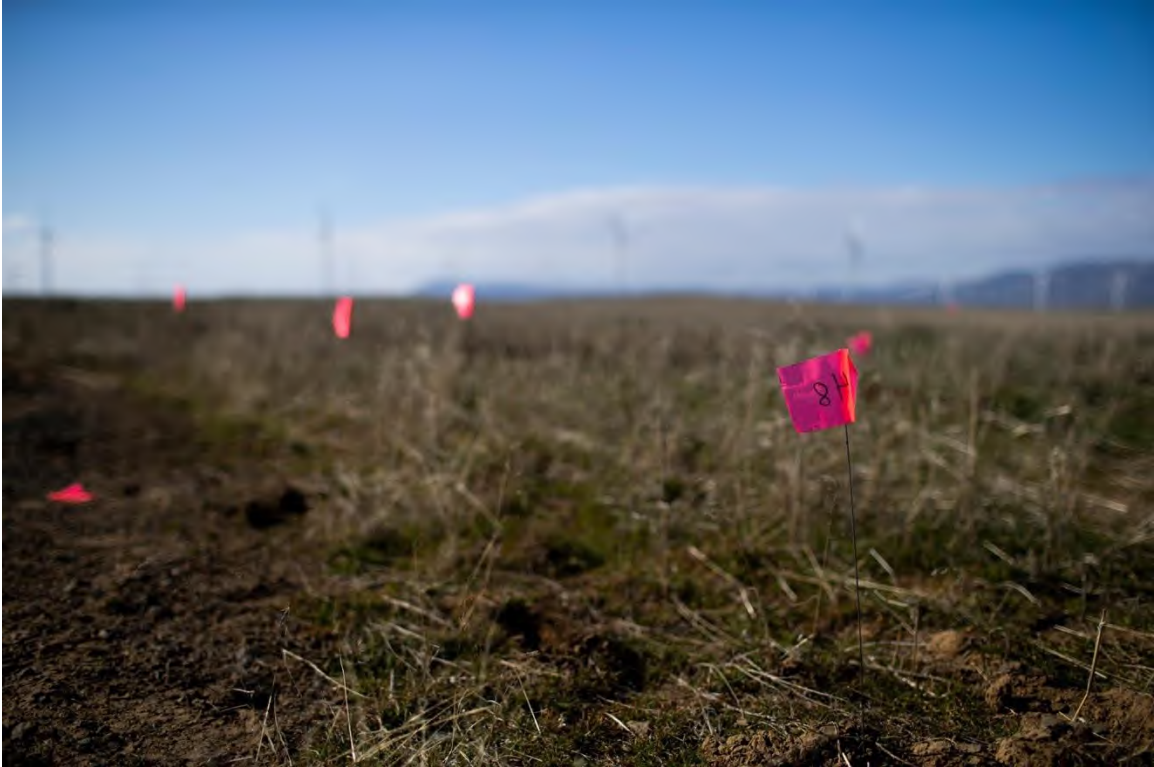
Flags marking debris in a wheat field after a Vestas V82 wind turbine at Biglow Canyon threw one of its eight-ton blades the length of a football field on Feb. 1.

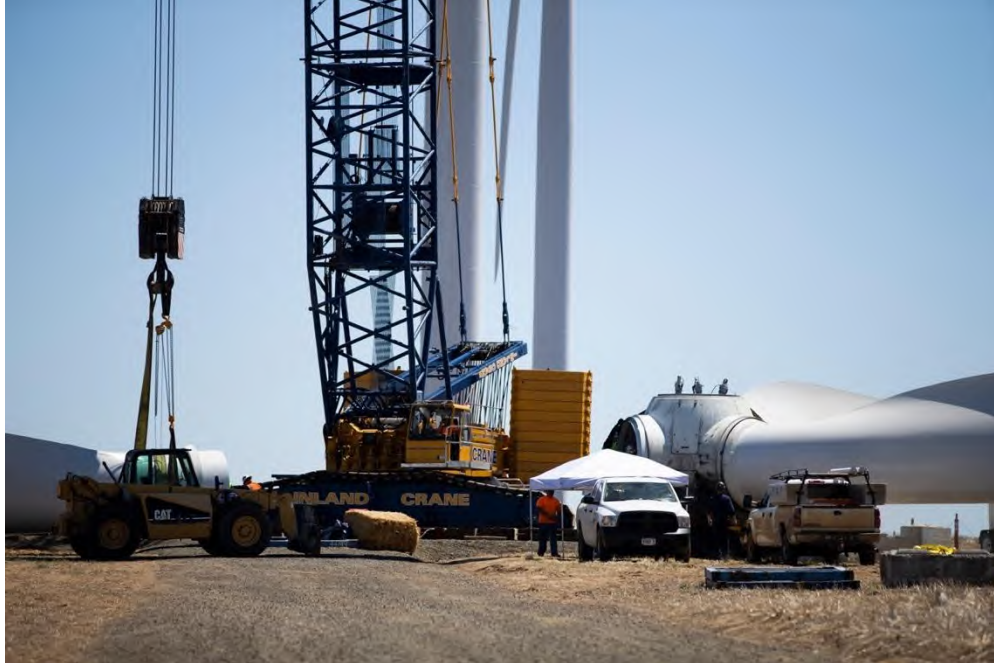
Workers replacing the blades on a Vestas V82 wind turbine at Portland General Electric's Biglow Canyon wind farm in late June. The turbine threw one of its blades into a wheat field on Feb. 1. PGE blamed "a loss of clamping force."
