Item G, Attachment 2

Public Comments on Biglow Canyon Windfarm RFA4 and Proposed Order

When Wind Towers Fall Apart

Portland General Electric's (PGE) Biglow Canyon

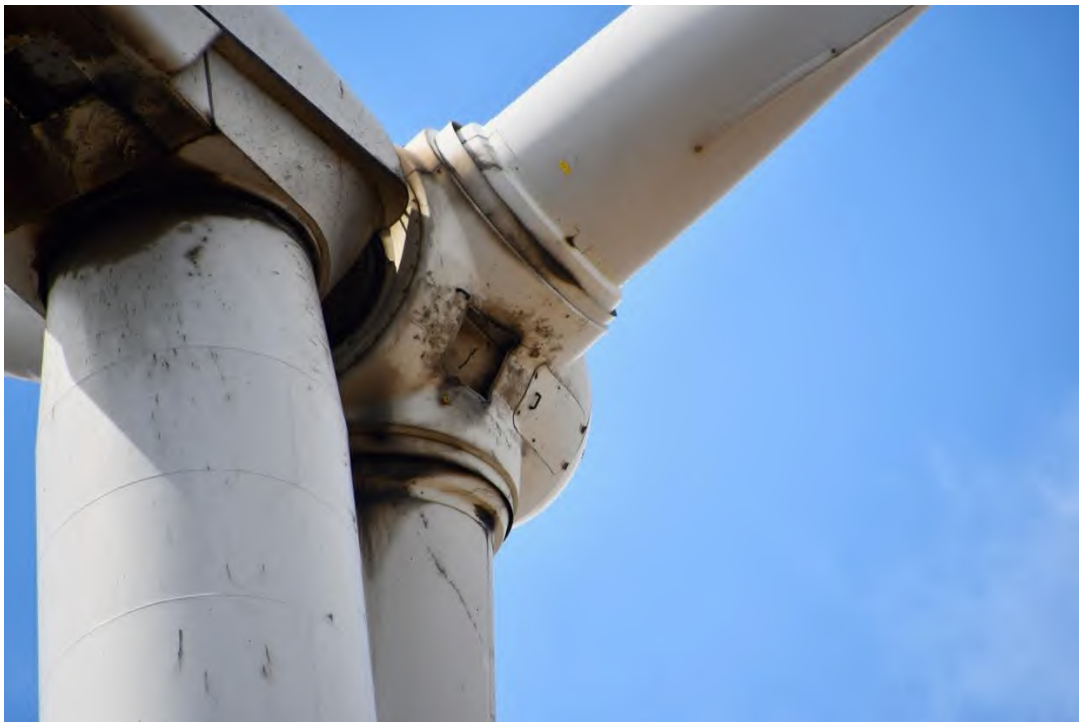
A Vestas V82 turbine, missing a hatch door, at PGE's Biglow Canyon wind farm this summer. Farmers say the hatches fall into their fields from a height of 265 feet. (Courtesy Kathryn McCullough)
