# Dieback and mortality of ponderosa and lodgepole pines associated with herbicide applications along roads on the Deschutes National Forest

Brent Oblinger<sup>1</sup> & Andris Eglitis<sup>2</sup>

Plant Pathologist<sup>1</sup> & Entomologist<sup>2</sup>, USDA Forest Service, Forest Health Protection, Central OR Forest Insect & Disease Service Center

## Cottonwood Rd between Hwy 97 and town of Sunriver

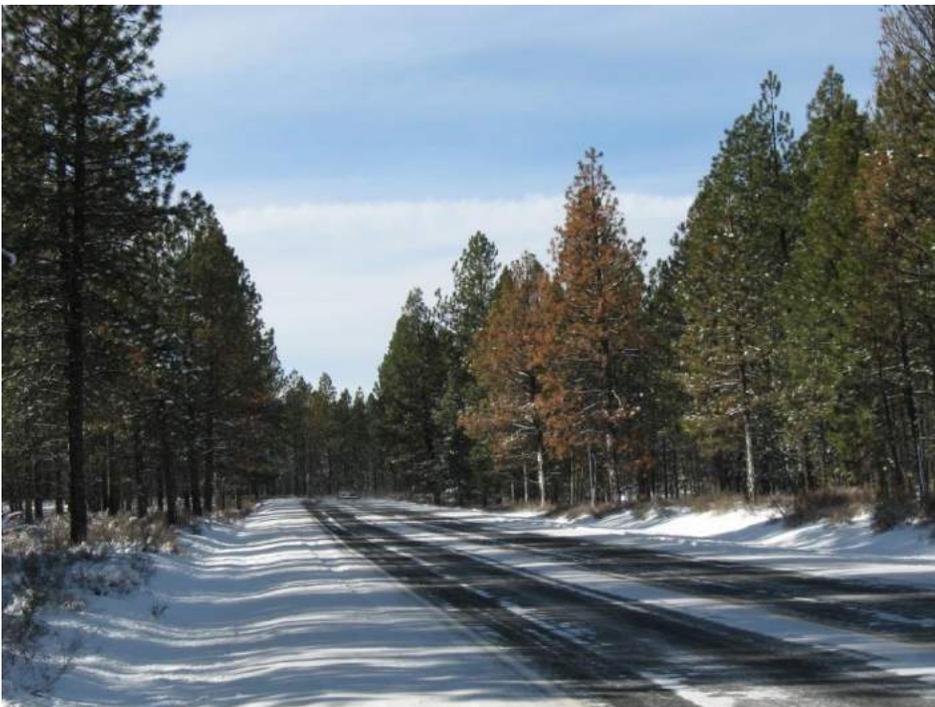
Tree mortality levels were low at the end of 2013. Only several ponderosa pines (less than five overall) had crowns with 0-5% live crown left and they were all immediately adjacent to the road (Figures 1-2). Bark beetles, other insects and biotic diseases did not appear to be affecting these trees at that time. We were informed that the synthetic auxin (growth regulator type) herbicide Perspective<sup>®</sup> (aminocyclopyrachlor) was applied by the county road department in the right-of-way along the road for vegetation management (e.g., invasive plant control). According to District staff, at least one application occurred in October of 2012 but other applications may have occurred. Other scattered pines had various levels of dieback and were limited to the roadside closest to the right-of-way (Figure 3). At that time, it did not appear to be of great concern since the vast majority of trees along the road still appeared healthy (Figure 3). However, if additional trees were killed, they would become a danger to people using the road and have negative impacts on aesthetics. In late 2013, we recommended monitoring the damage to see if dieback and tree mortality increased, and offered to help with monitoring. Information about the risk of tree damage due to herbicides containing the active ingredient aminocyclopyrachlor (including Perspective<sup>®</sup> and Imprelis) was provided to District staff including the Botanist and Roads Manager (Steve Bigby).

**Figure 1. Several ponderosa pines with very little live crown left along the Cottonwood Rd in December of 2013.**

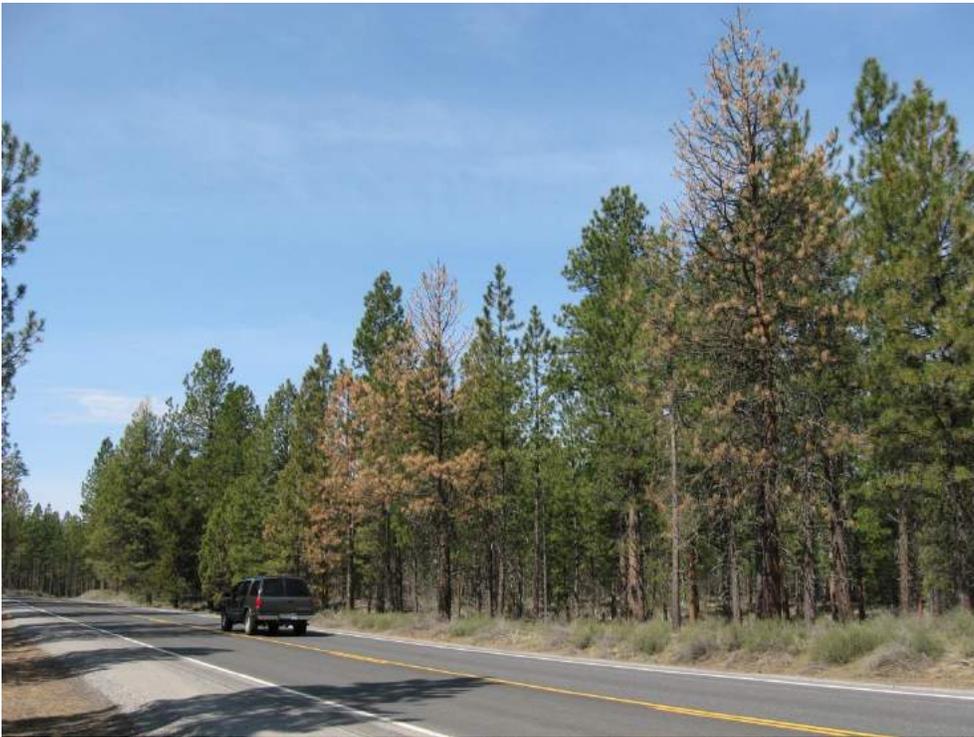
**Figure 2. Roadside ponderosa pines in April of 2015 at same location in Figure 1.**

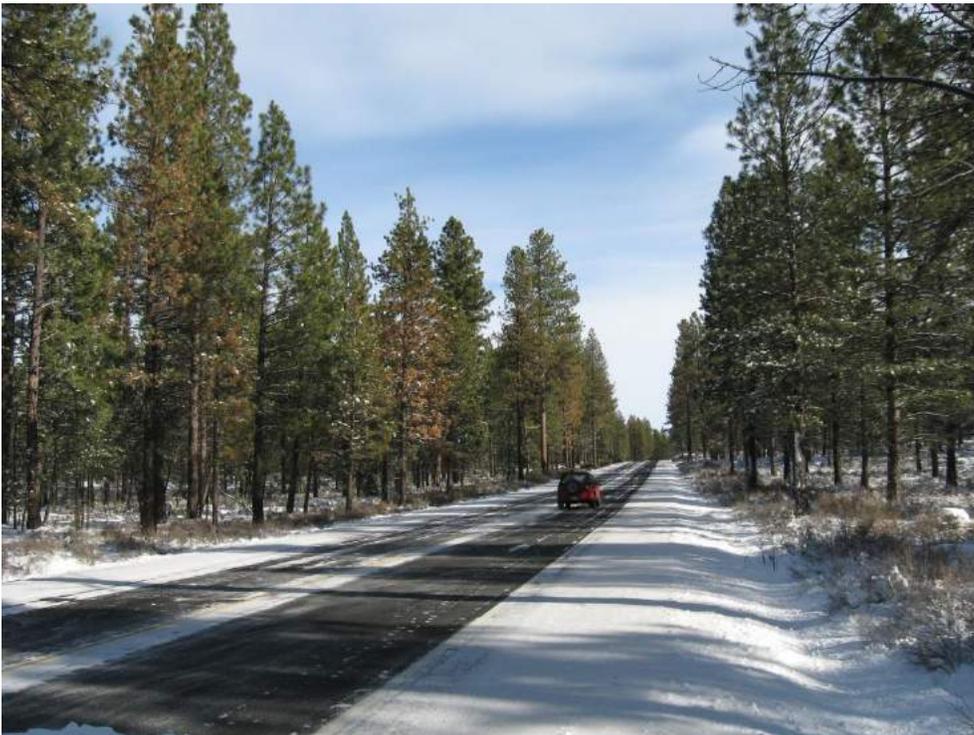
**Figure 3. Scattered ponderosa pines with dieback along the Cottonwood Rd in December of 2013.**

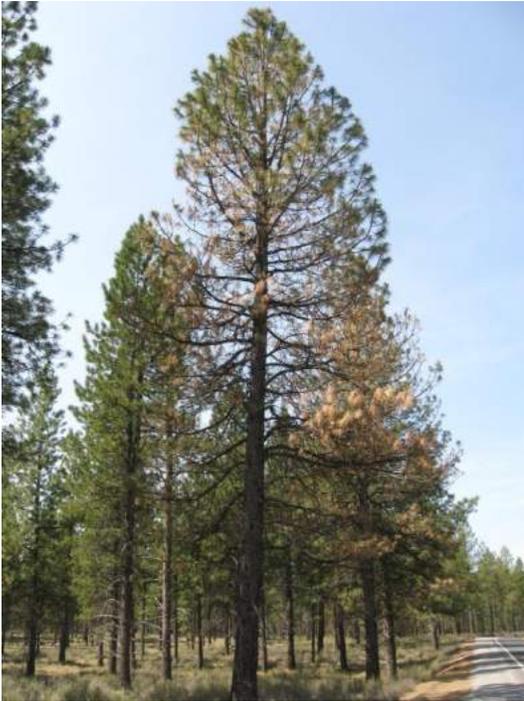
In April of 2015, sites were re-visited by Forest Health Protection staff. Dieback (Figures 4-6) and mortality (Figures 7-8) was observed along the same 1.9 mile stretch of this road. After approximately one year and four months, additional trees had died and 10 recently killed trees were recorded compared to around three before. Killed pines were sapling to sawtimber sized and all were growing adjacent to the right-of-way. A few pole to sawtimber sized trees appeared to be recently attacked by bark beetles that were killed. Dieback also appeared to have increased or remained at the same levels on individual trees. Dieback was scattered along this road segment and but not all roadside trees had crown damage in 2015. However, all recently killed trees and those with the most severe dieback were still confined to locations adjacent to the right-of-way and not farther from the road. Symptomatic shoots were collected from young trees and from mature trees using pole pruners.

**Figure 4. Dieback on ponderosa pine along the Cottonwood Rd in April of 2015.**

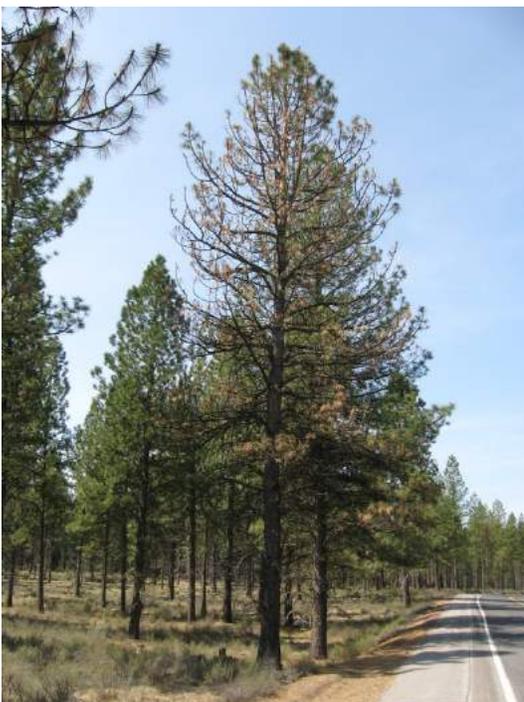
**Figure 5. Severe dieback on ponderosa pine along the Cottonwood Rd in April of 2015.**

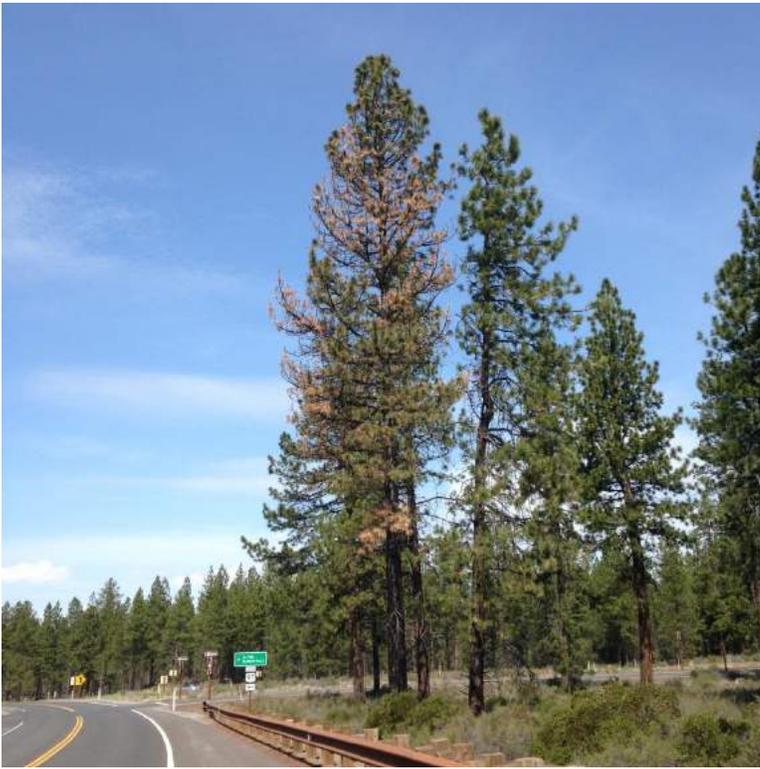
**Figure 6. Dieback on ponderosa pine near the Cottonwood Rd Exit and HWY 97 in April of 2015.**

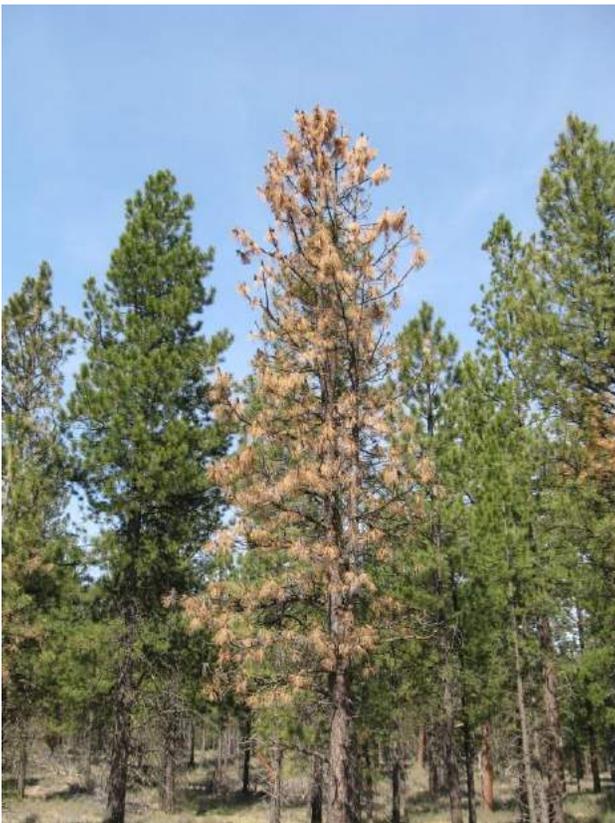
**Figure 7. Recently killed ponderosa pine along the Cottonwood Rd in April of 2015.**

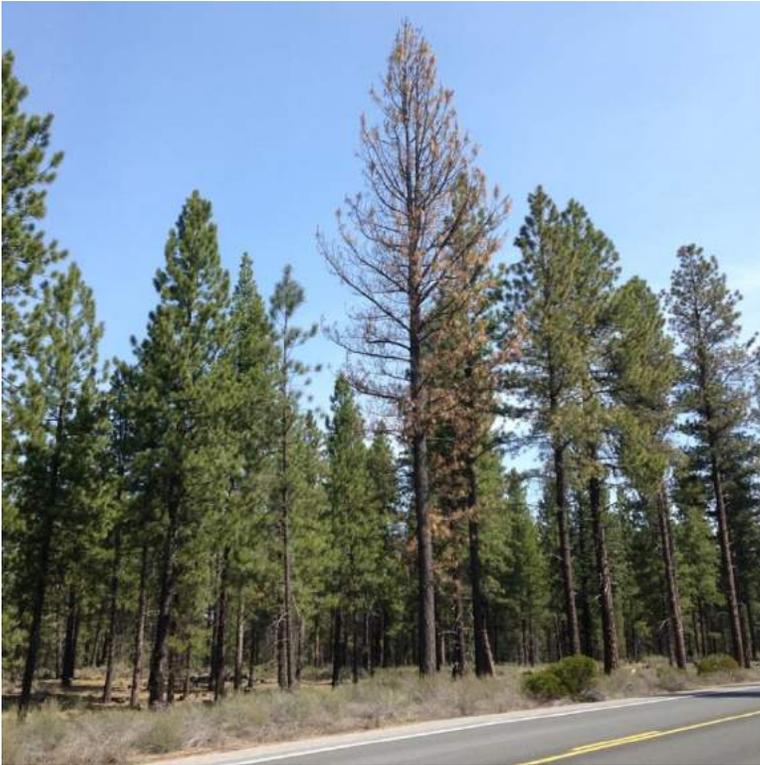
**Figure 8. Recently killed ponderosa pine along the Cottonwood Rd in April of 2015.**

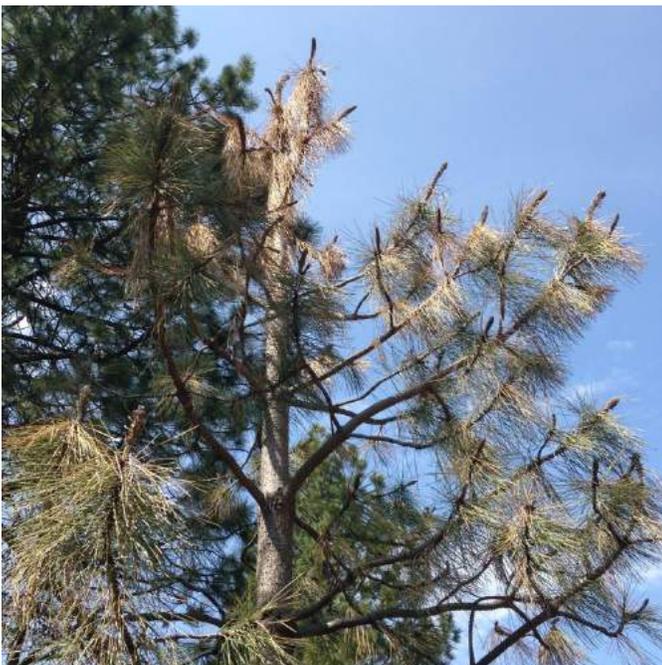
Also in April of 2015, symptoms of off-target herbicide injury were observed on recently killed trees and trees with dieback along this road segment. Crown symptoms did not appear to be characteristic of damage by de-icing salts (typically confined to foliage and does not result in stem dieback). Symptoms of herbicide injury included characteristic curling or twisting (epinasty) of shoots and tips of branches that are typical of damage caused by growth regulator type (synthetic auxin) herbicides (Freucht 1988). Curling of shoots was observed much more frequently on younger trees (on ponderosa pine and lodgepole pine) than older, less vigorously growing trees (Figures 9-13). Shoot blight did not appear to be caused by insects such as shoot borers or fungal pathogens such as *Diplodia* spp.

**Figure 9. Dieback and curling of shoots on pole sized ponderosa pine along the Cottonwood Rd in April of 2015.**

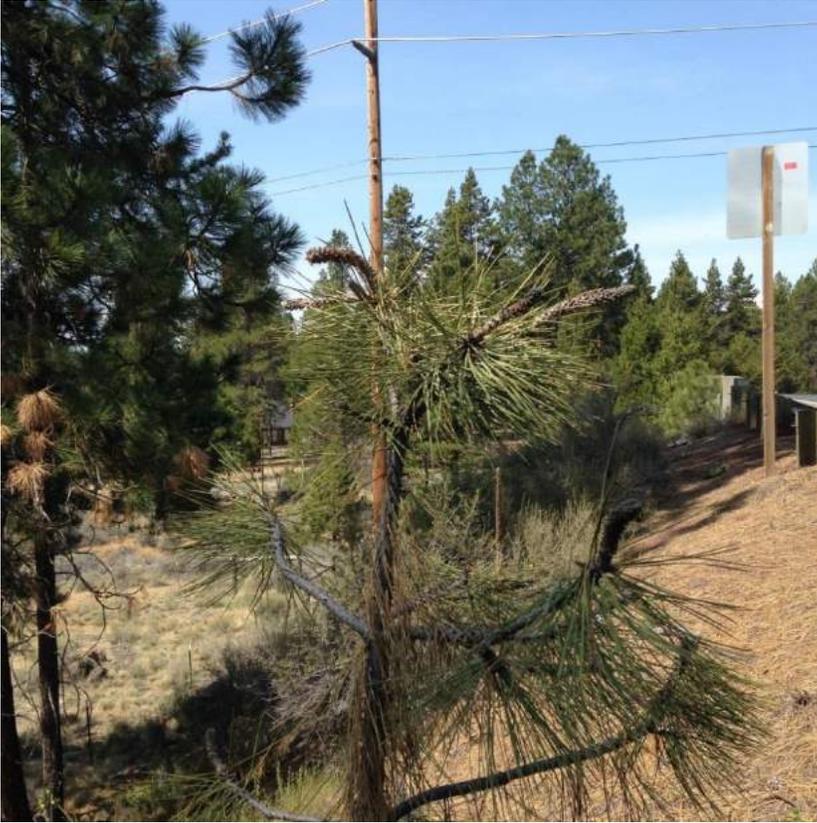
**Figure 10. Dieback and curling of shoots on ponderosa pine sapling along the Cottonwood Rd in April of 2015.**

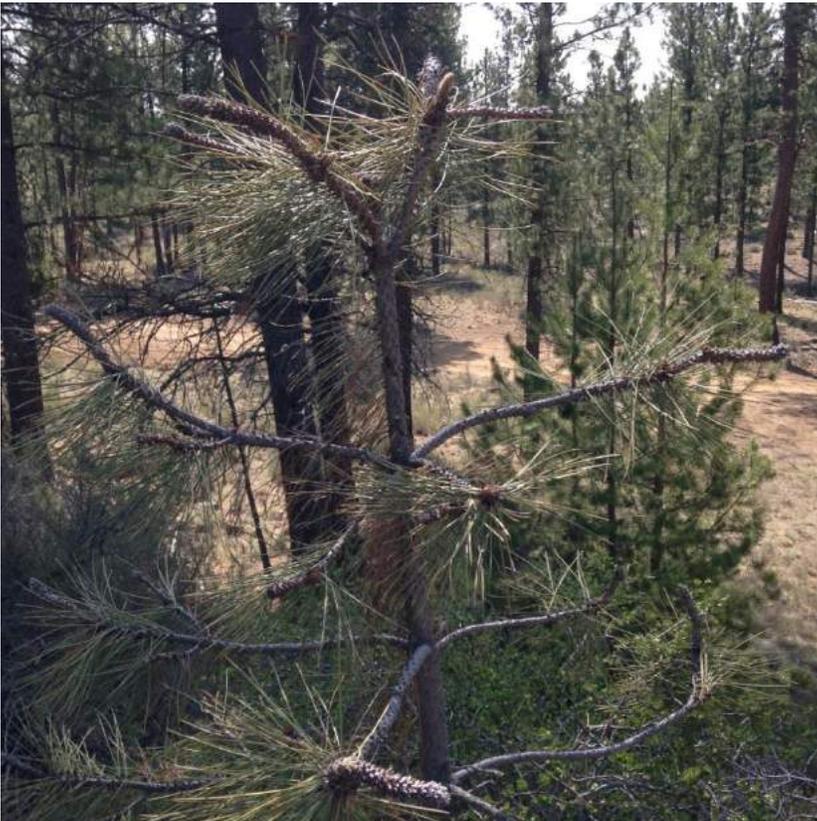
**Figure 11. Dieback and curling of shoots on ponderosa pine sapling along the Cottonwood Rd in April of 2015.**

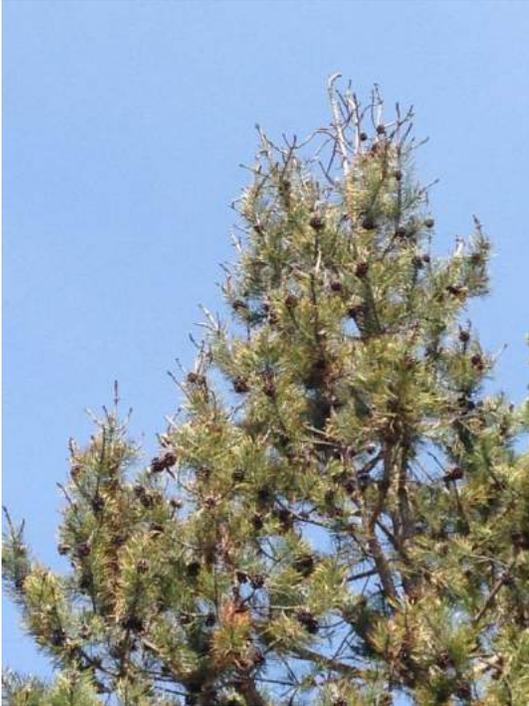
**Figure 12. Dieback and curling of shoots on pole sized lodgepole pine along the Cottonwood Rd near Sunriver in April of 2015.**

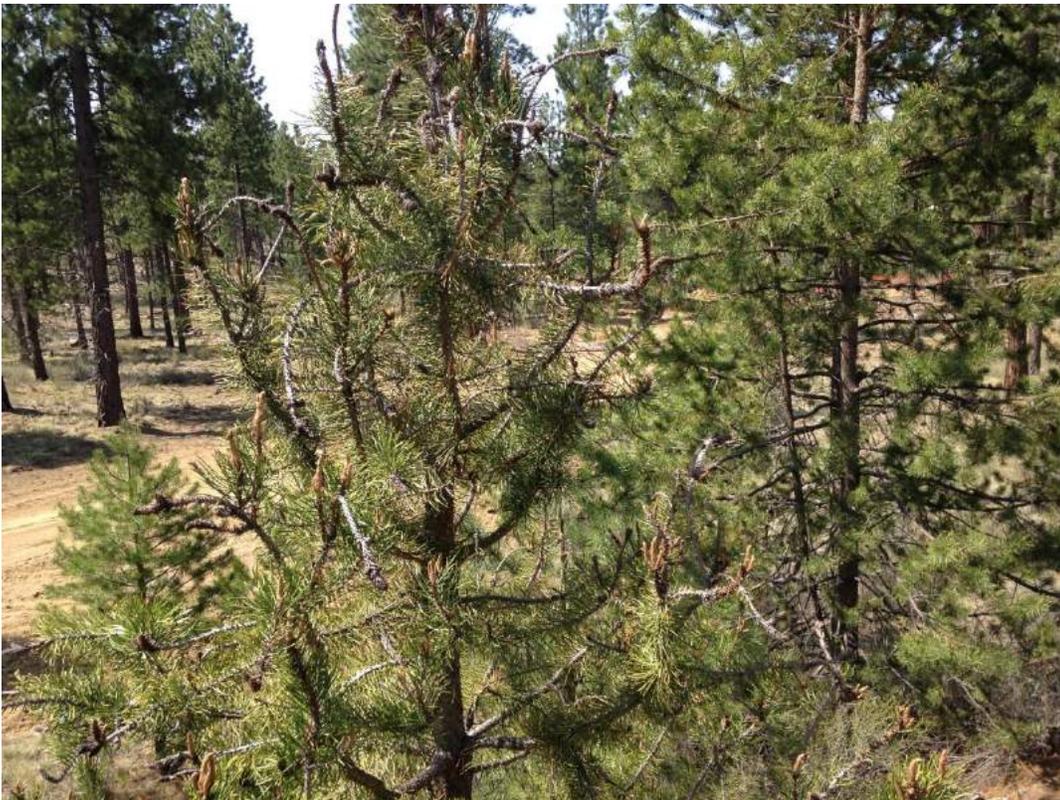
**Figure 13. Dieback and curling of shoots on lodgepole pine sapling along the Cottonwood Rd in April of 2015.**

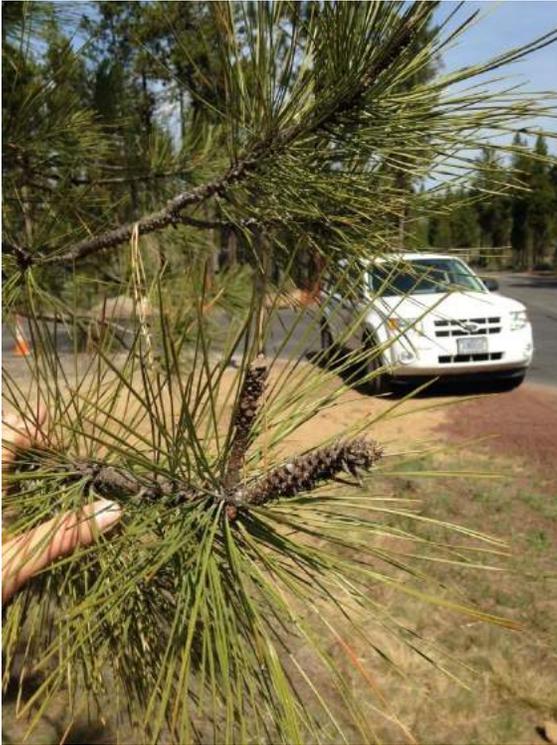
Also on conifers affected by growth regulator type herbicides, affected new growth can turn brown and die, which was commonly observed on pines adjacent to the right-of-way where shoots were dying from the tip back (Figures 14-15).

**Figure 14. Dieback of shoots on ponderosa pine along the Cottonwood Rd near Sunriver in April of 2015.**

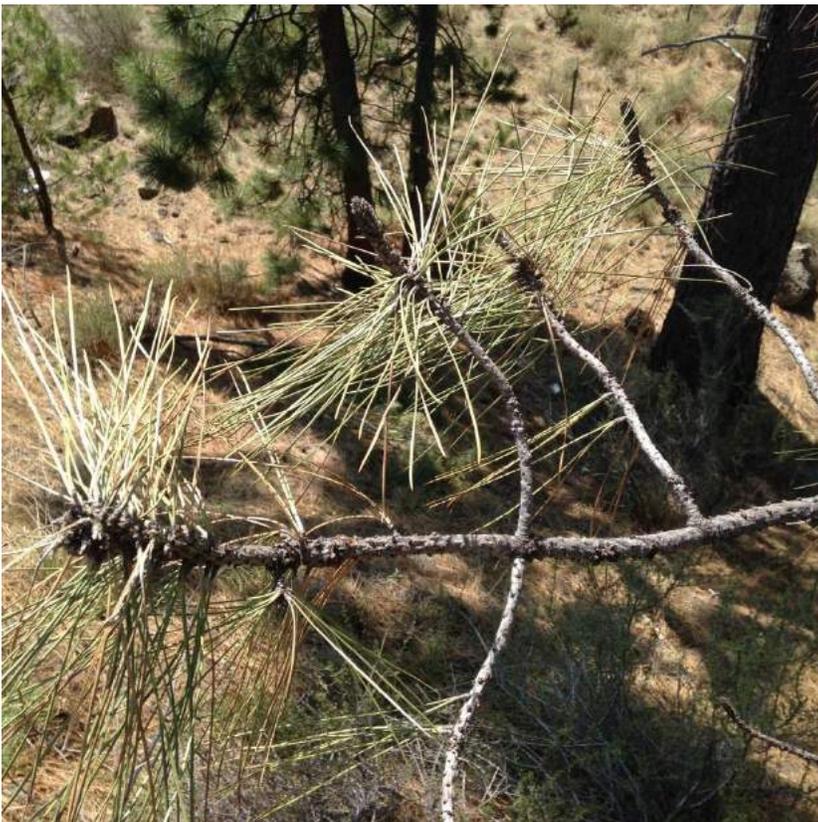
**Figure 15. Dieback of shoots on ponderosa pine along the Cottonwood Rd near Sunriver in April of 2015.**

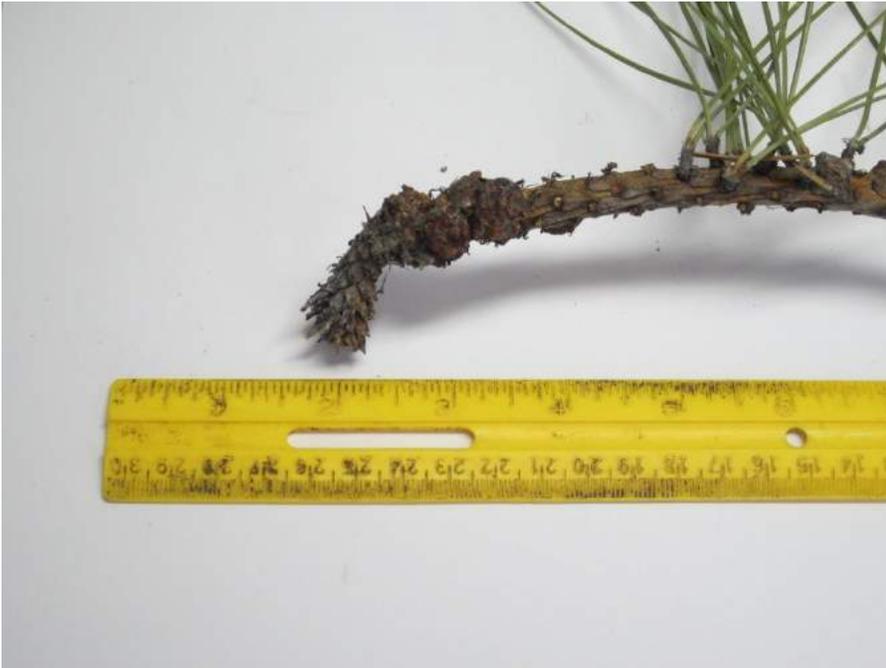
Abnormal swellings on shoots were also commonly observed on young and mature trees with dieback (Figures 16-17). Swellings did not appear to be caused by western gall rust or insects after examining samples back in the lab. Swellings were always toward shoot tips and often immediately distal to killed shoot tips that may have been abnormal callus tissue formed as a result of a response to growth regulator type herbicide damage. In response to growth regulator herbicides, cell proliferation can occur in meristematic tissue of stems and tissue swelling is a common symptom associated with this type of herbicide damage.

**Figure 16. Abnormal swellings and dieback on shoot tip of ponderosa pine collected along the Cottonwood Rd in April of 2015.**

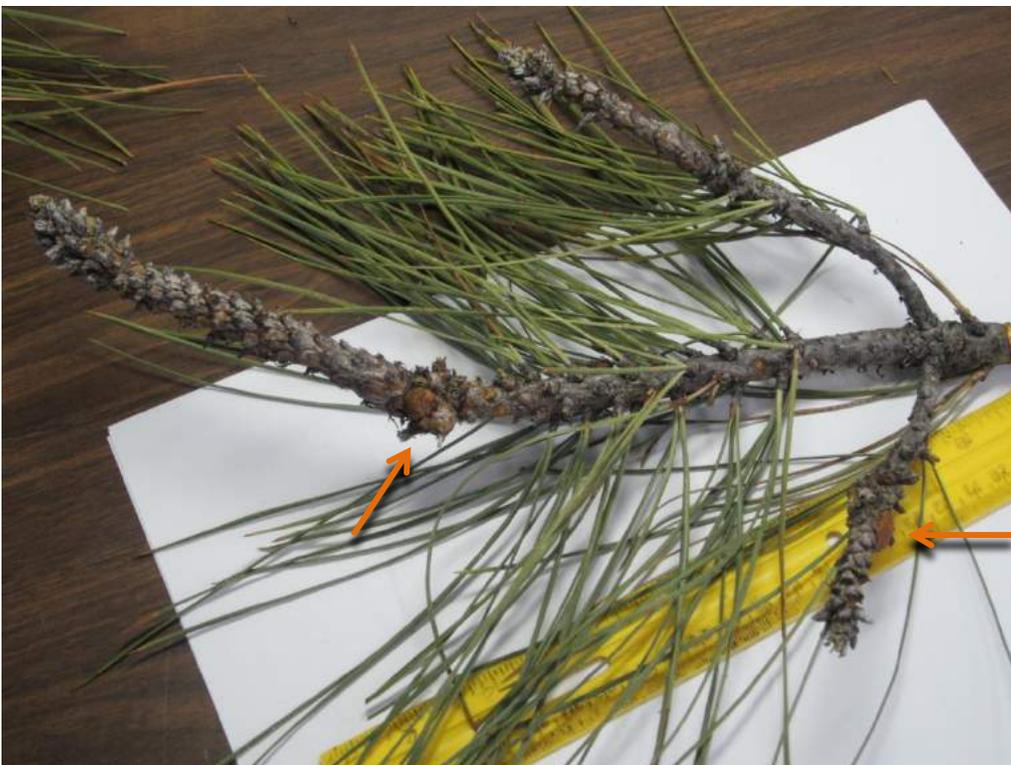
**Figure 17. Abnormal swellings (arrows) and dieback on shoots of ponderosa pine collected along the Cottonwood Rd in April of 2015.**

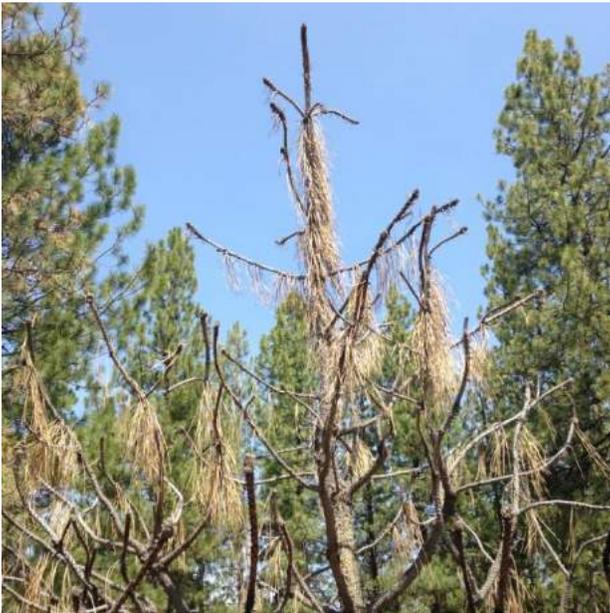
**Figure 18. Curling of shoots and abnormal swellings on shoot tips of recently killed, pole sized ponderosa pine along County Rd 40 in April of 2015.**

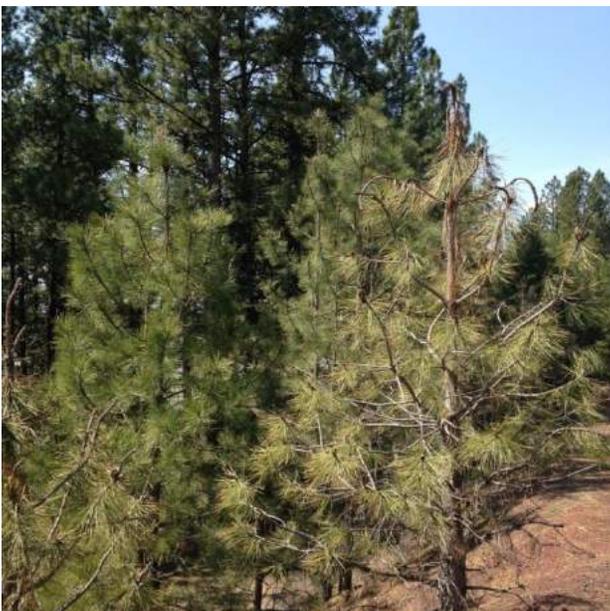
**Figure 19. Curling of shoots on young ponderosa pine closest to right-of-way along County Rd 40 in April of 2015.**

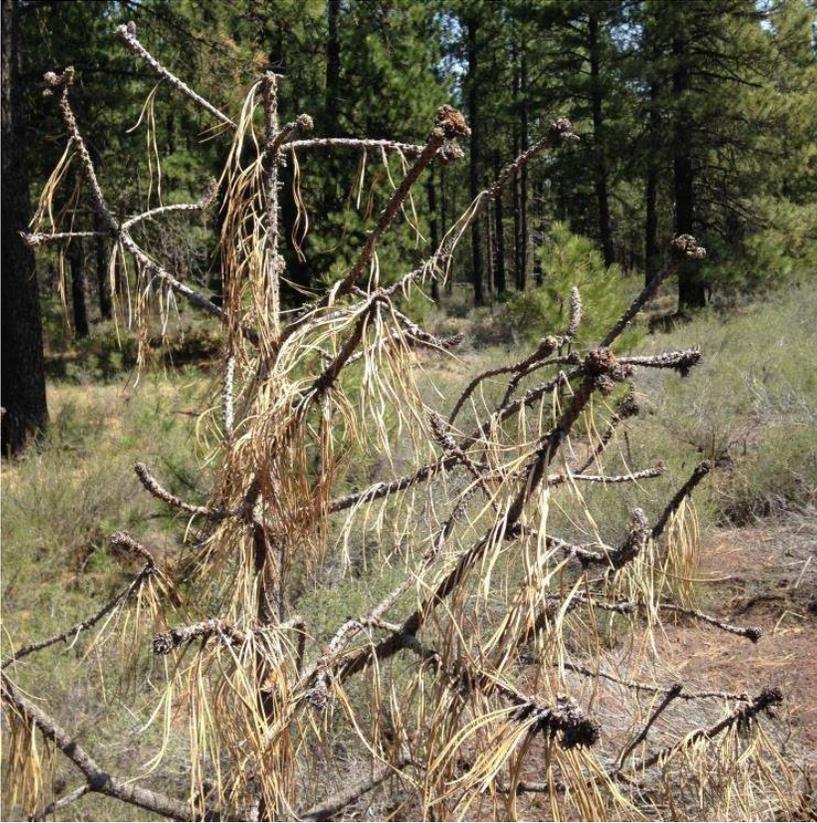
**Figure 20. Abnormal swellings on shoot tips of recently killed, young ponderosa pine along County Rd 40 in April of 2015.**

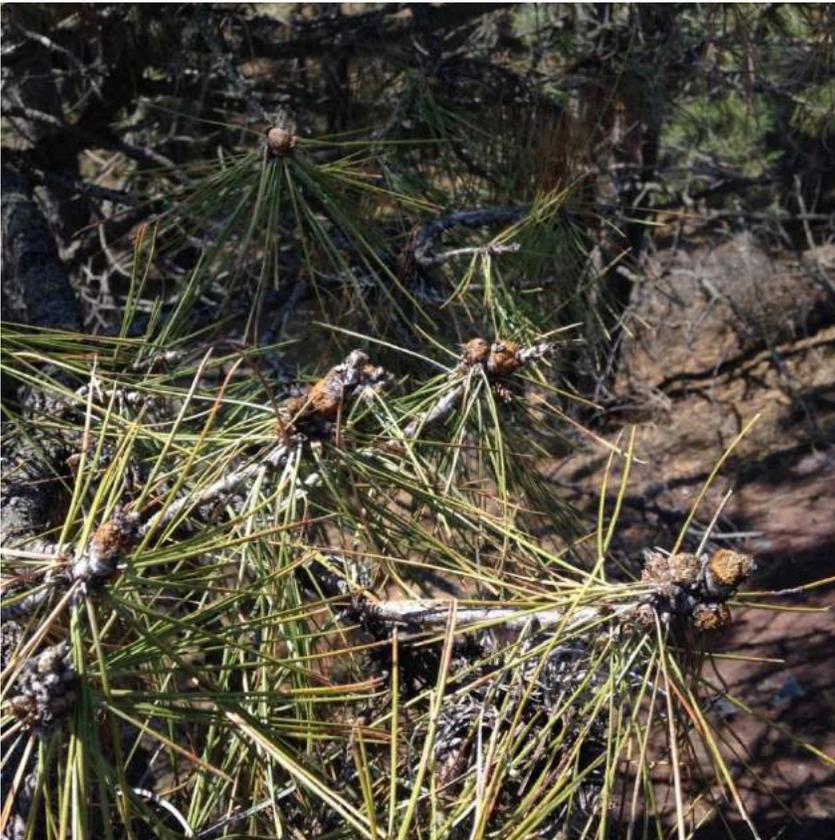
**Figure 21. Abnormal swellings and dieback on shoot tips of pole sized ponderosa pine along County Rd 40 in April of 2015.**

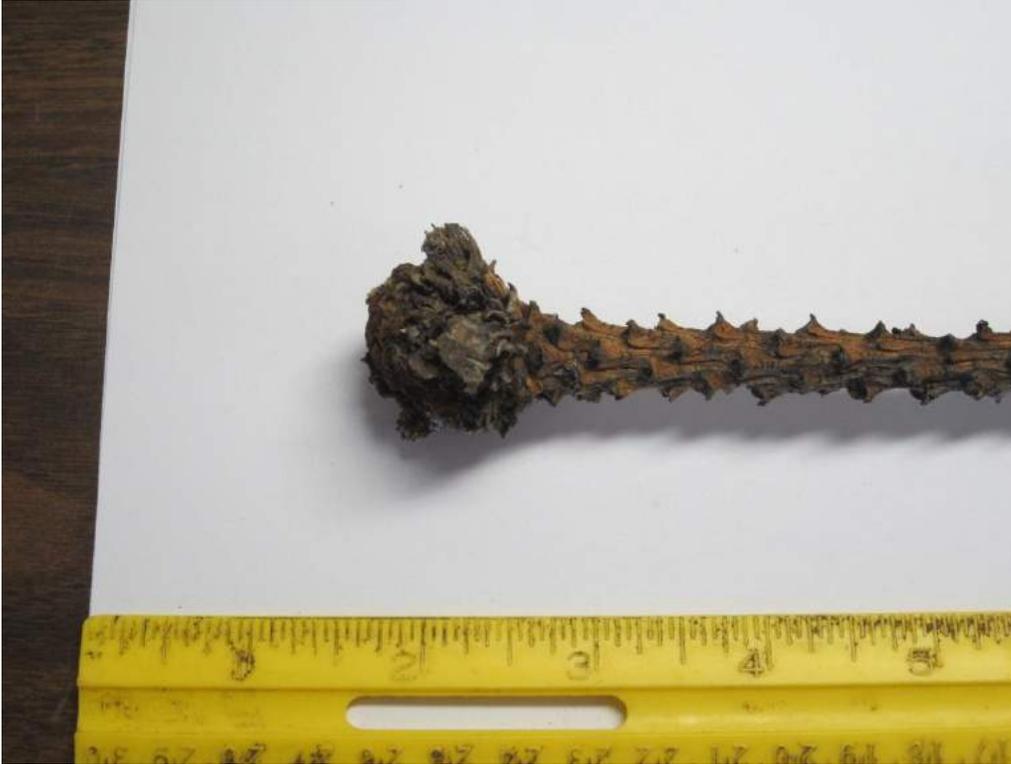
**Figure 22. Abnormal swelling on shoot tip of recently killed, young ponderosa pine collected along County Rd 40 in April of 2015.**

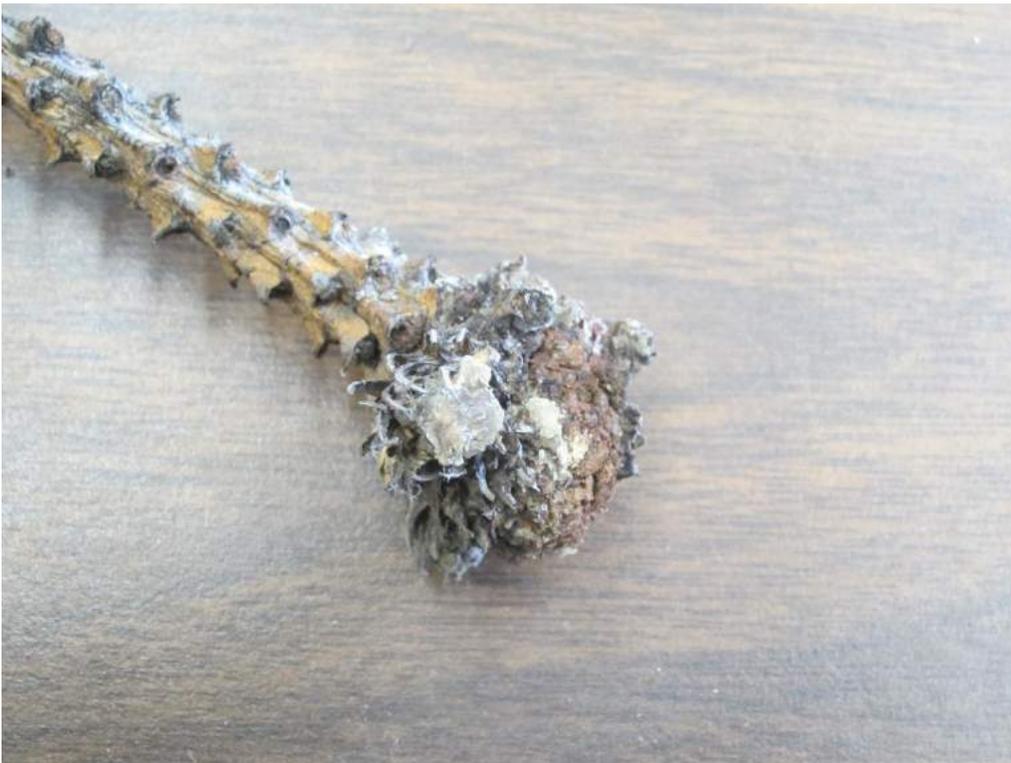
**Figure 23. Abnormal swelling on shoot tip of recently killed, young ponderosa pine collected along County Rd 40 in April of 2015.**

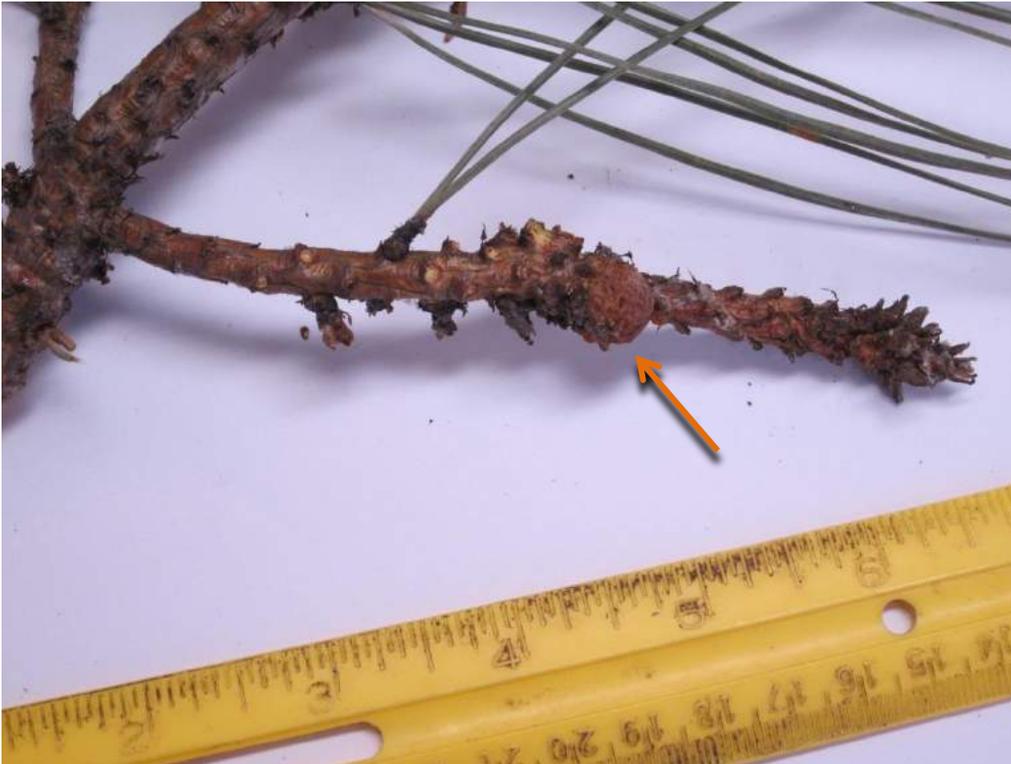
**Figure 24. Abnormal swelling (arrow) and dieback on shoot tip of mature ponderosa pine collected along County Rd 40 in April of 2015.**

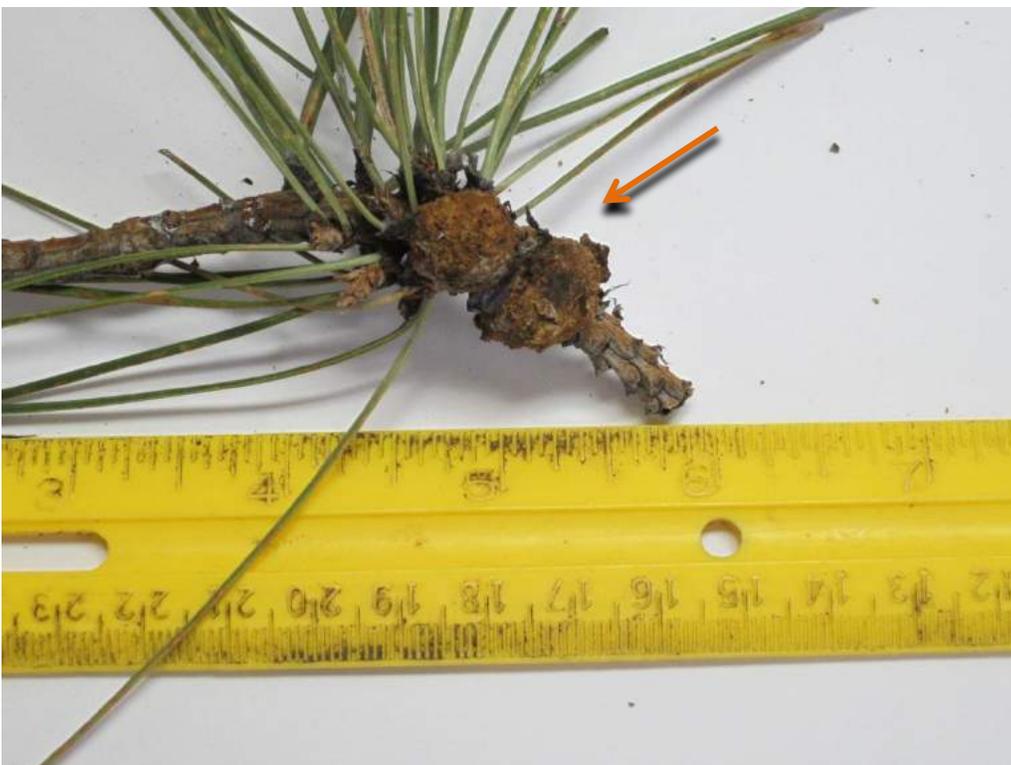
**Figure 25. Abnormal swellings (arrow) and dieback on shoot tip of ponderosa pine collected along County Rd 40 in April of 2015.**

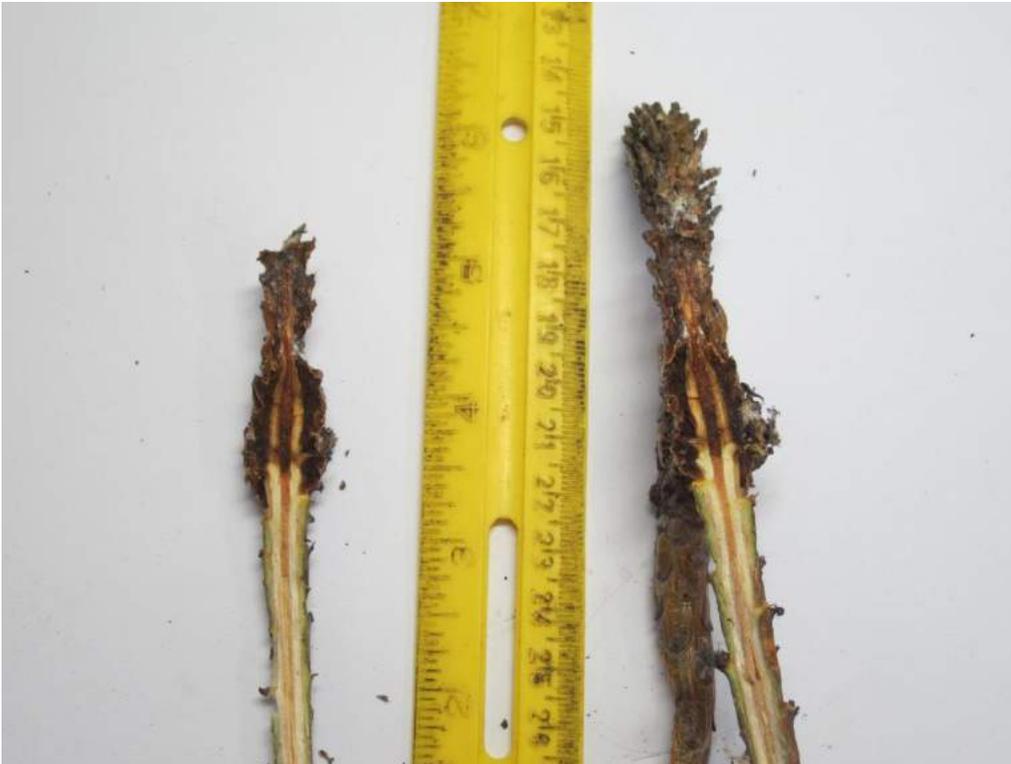
**Figure 25. Cross sections of abnormal swellings on shoot tip of pine with dieback collected along County Rd 40 in April of 2015.**

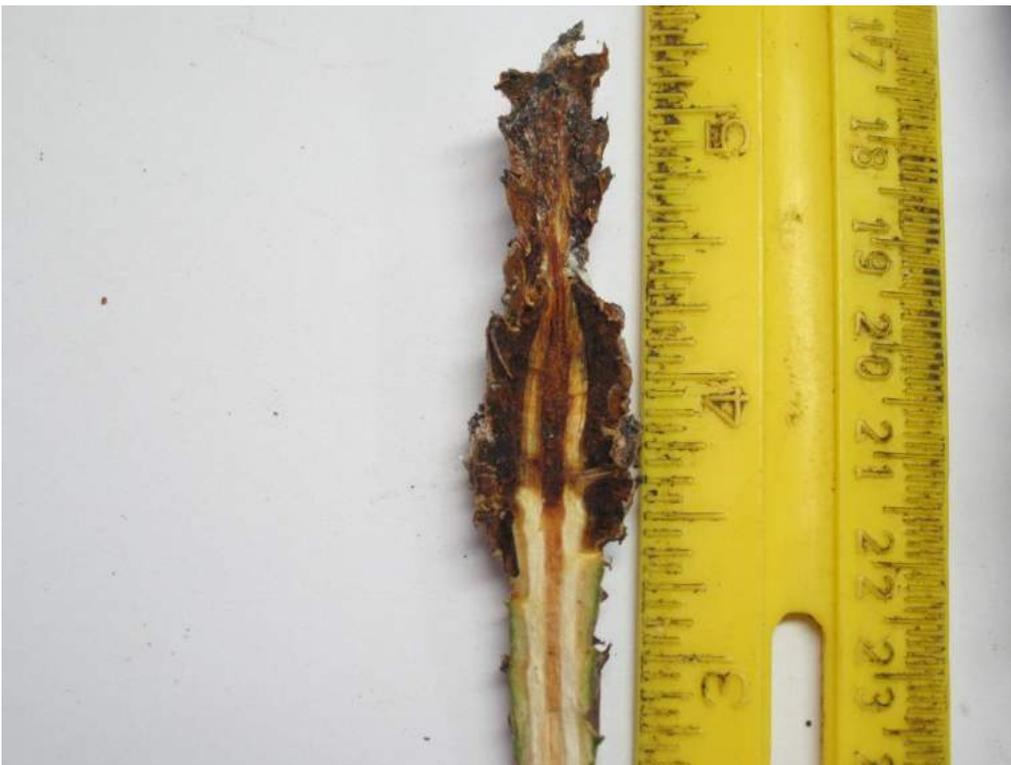
**Figure 26. Cross section of abnormal swelling on shoot tip of pine with dieback collected along County Rd 40 in April of 2015.**

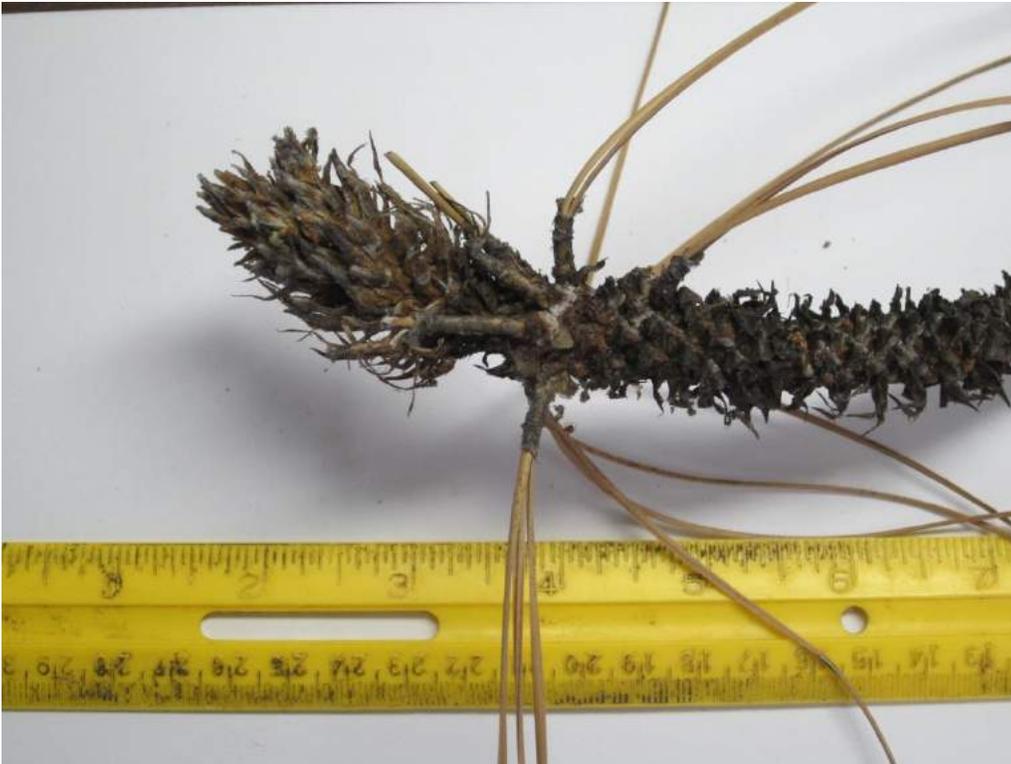
**Figure 27. Abnormal swelling on shoot tip of mature ponderosa pine with dieback collected along County Rd 40 in April of 2015.**

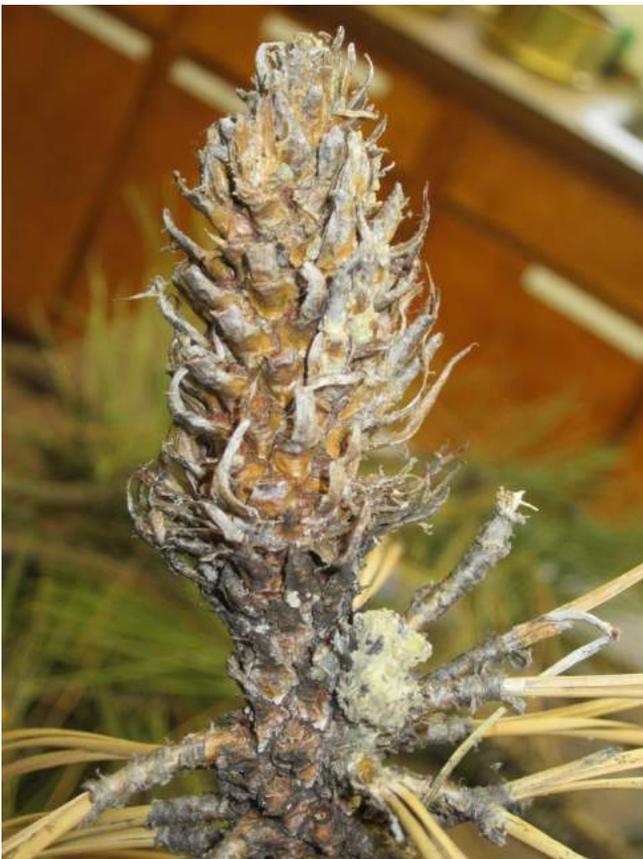
**Figure 28. Abnormal swelling on shoot tip of mature ponderosa pine with dieback collected along County Rd 40 in April of 2015.**

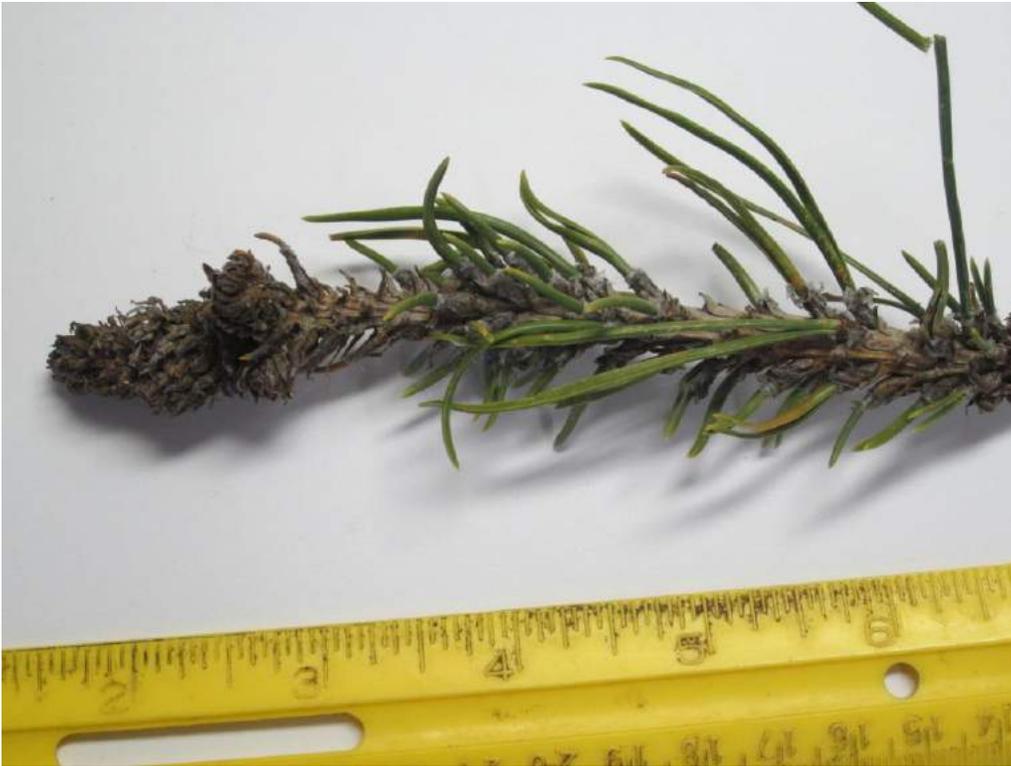
**Figure 29. Abnormal swellings and dieback on shoot tip of young lodgepole pine collected along County Rd 40 in April of 2015.**

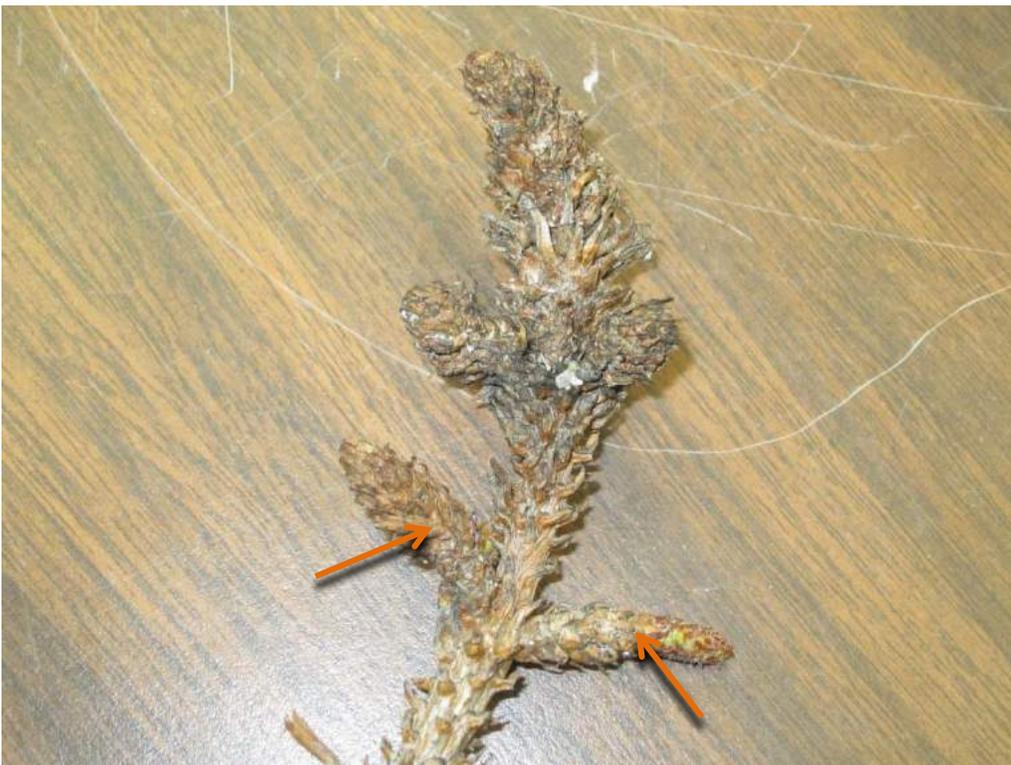
**Figure 30. Abnormal swellings and dieback on shoot tip of lodgepole pine collected along County Rd 40 in April of 2015; note adventitious buds and shoots elongating (arrows) below killed shoot tip.**

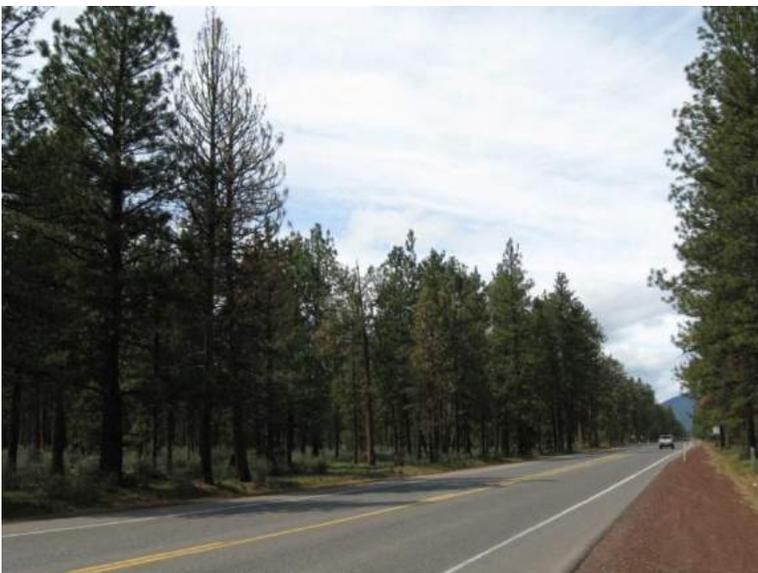
**Figure 31. Recent ponderosa pine mortality along Hwy 20 in April of 2015.**

Identical symptoms described above were also observed on ponderosa pine along the Three Creek Lake Rd just south of the town of Sisters. After meeting with Sisters District staff, we recommended mitigating any danger trees (any killed and especially those dead at intersections) along this heavily used highway, provided information on past reports of damage to trees by herbicides containing aminocyclopyrachlor, shared Dupont's Warning Statement about the risk of damage to trees (including ponderosa pine) by Perspective® and recommended that alternative herbicides be evaluated for use along right-of-ways that are less likely to threaten tree health in areas where valued trees are growing adjacent to roads.
