# Dieback and mortality of ponderosa and lodgepole pines associated with herbicide applications along roads on the Deschutes National Forest

Brent Oblinger<sup>1</sup> & Andris Eglitis<sup>2</sup>

Plant Pathologist<sup>1</sup> & Entomologist<sup>2</sup>, USDA Forest Service, Forest Health Protection, Central OR Forest Insect & Disease Service Center

## Cottonwood Rd between Hwy 97 and town of Sunriver

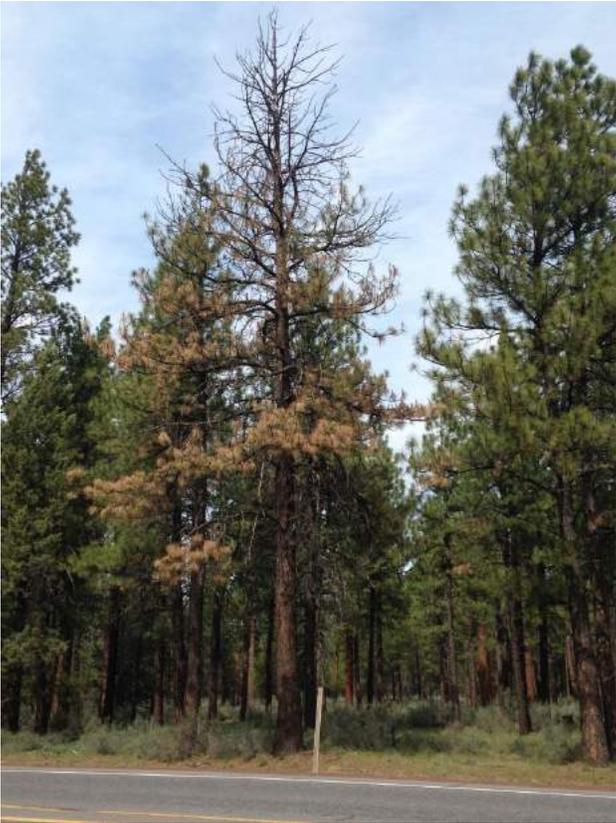
**Figure 32. Ponderosa pine recently killed along Hwy 20 in April of 2015.**

Identical symptoms described above were also observed on ponderosa pine along the Three Creek Lake Rd just south of the town of Sisters. After meeting with Sisters District staff, we recommended mitigating any danger trees (any killed and especially those dead at intersections) along this heavily used highway, provided information on past reports of damage to trees by herbicides containing aminocyclopyrachlor, shared Dupont's Warning Statement about the risk of damage to trees (including ponderosa pine) by Perspective® and recommended that alternative herbicides be evaluated for use along right-of-ways that are less likely to threaten tree health in areas where valued trees are growing adjacent to roads.

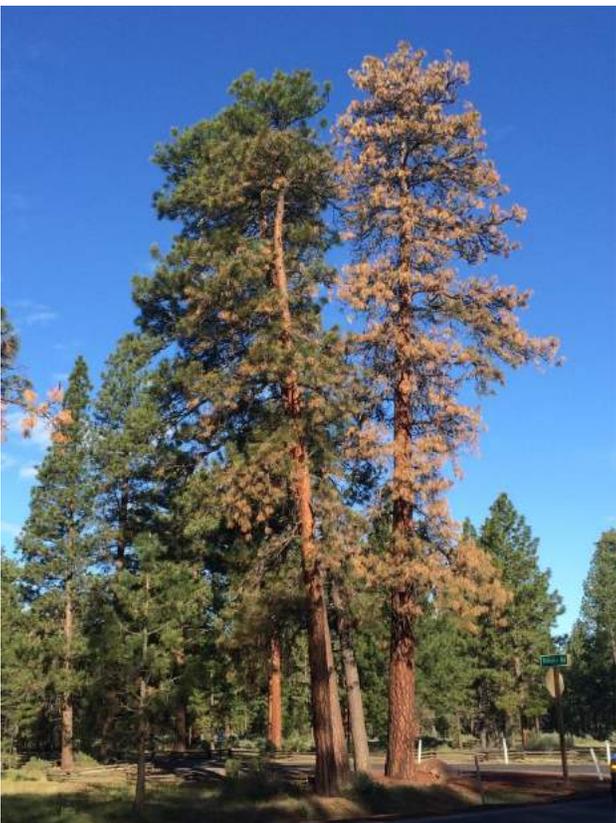
**Figure 33. Mature ponderosa pine recently killed along Hwy 20 at the intersection of the Tollgate Rd (Photo by Jeremy Fields, May of 2015).**

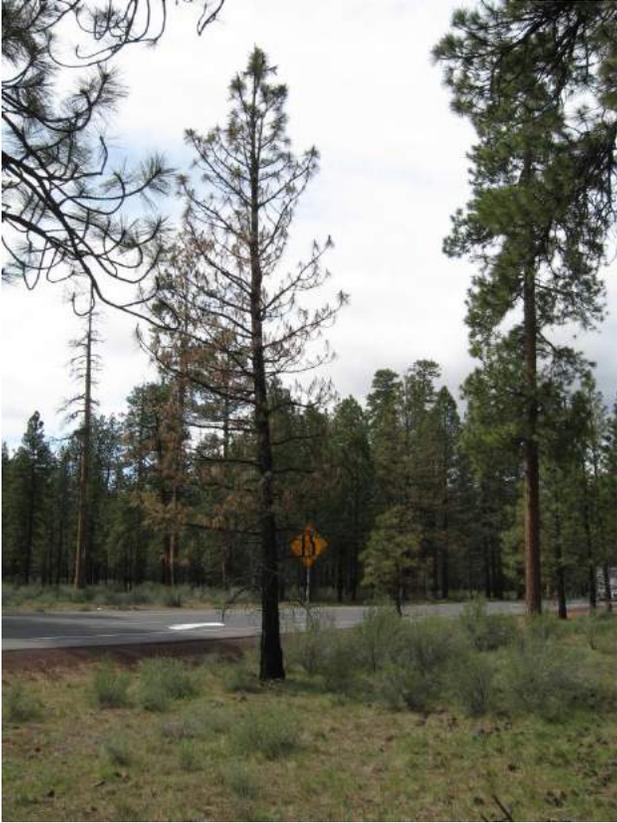
**Figure 34. Ponderosa pine with very little live crown along Hwy 20 near the intersection of NF-500 Rd in April of 2015.**

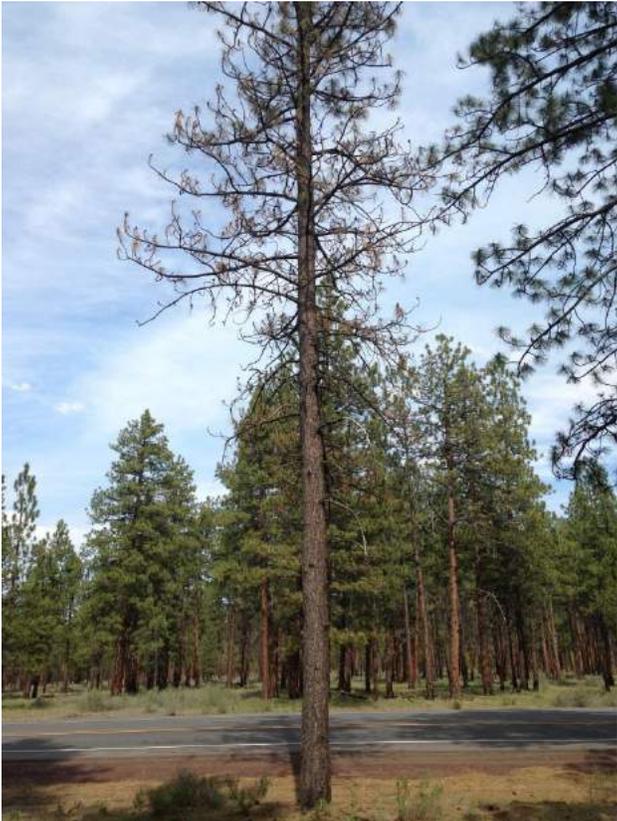
**Figure 35. Ponderosa pine with severe dieback along Hwy 20 in April of 2015.**

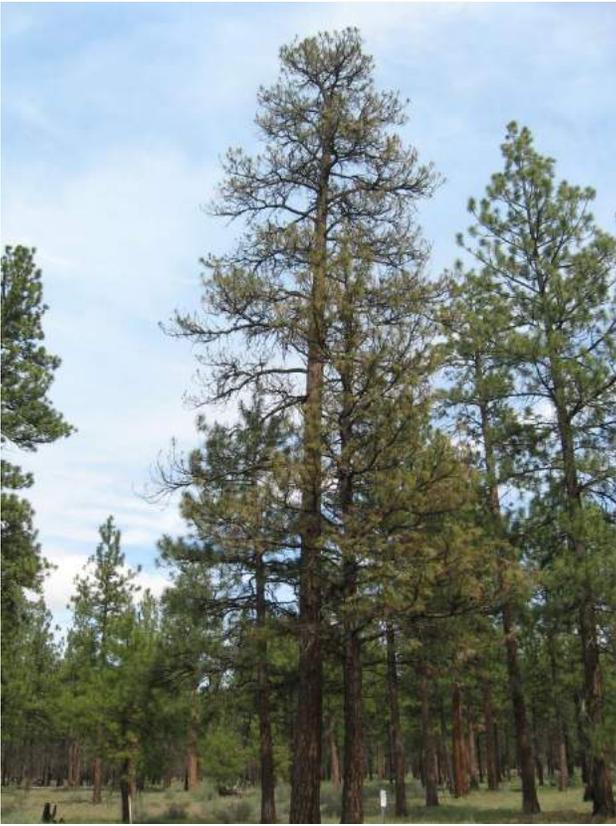
**Figure 36. Mature ponderosa pine with crown thinning and dieback along Hwy 20 in April of 2015.**

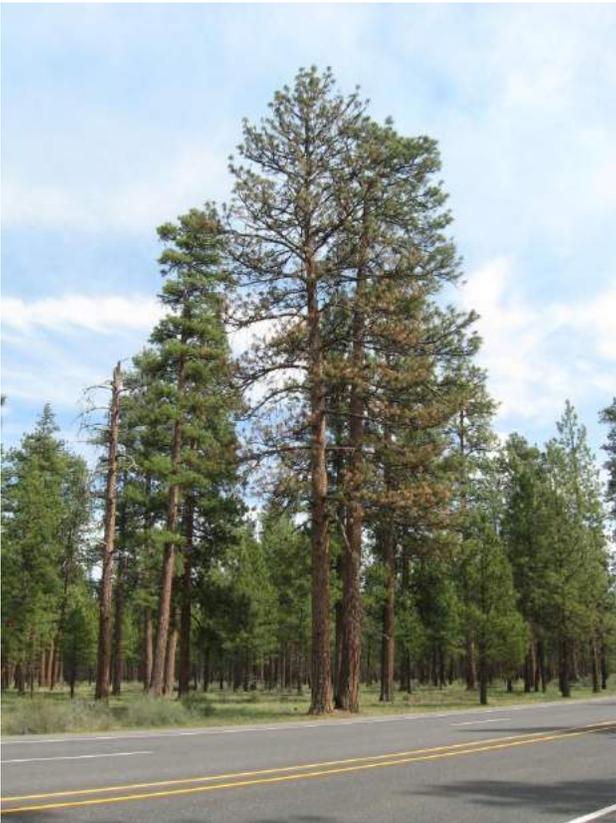
**Figure 37. Mature ponderosa pine with dieback along Hwy 20 in April of 2015.**

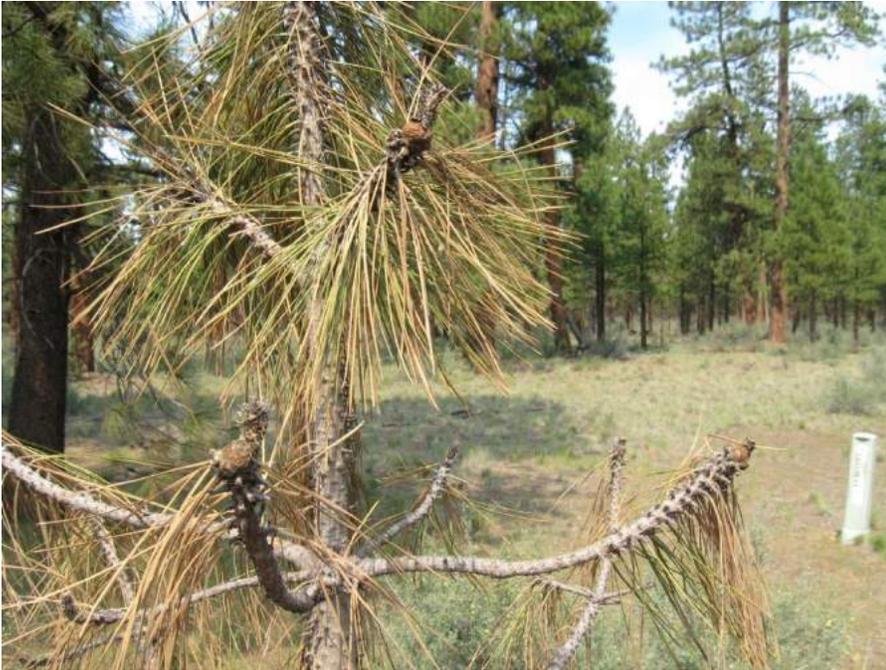
Additional symptoms of herbicide damage consistent with other locations were also observed along Hwy 20. Branches with dieback were collected from young and mature trees and examined back in the lab. Abnormal swellings at shoot tips were found on young and mature ponderosa pine with dieback and those recently killed adjacent to the right-of-way (Figures 38-39).

**Figure 38. Young ponderosa pine with abnormal swellings at shoot tips and severe dieback along Hwy 20 across from the Tollgate Rd intersection in April of 2015.**

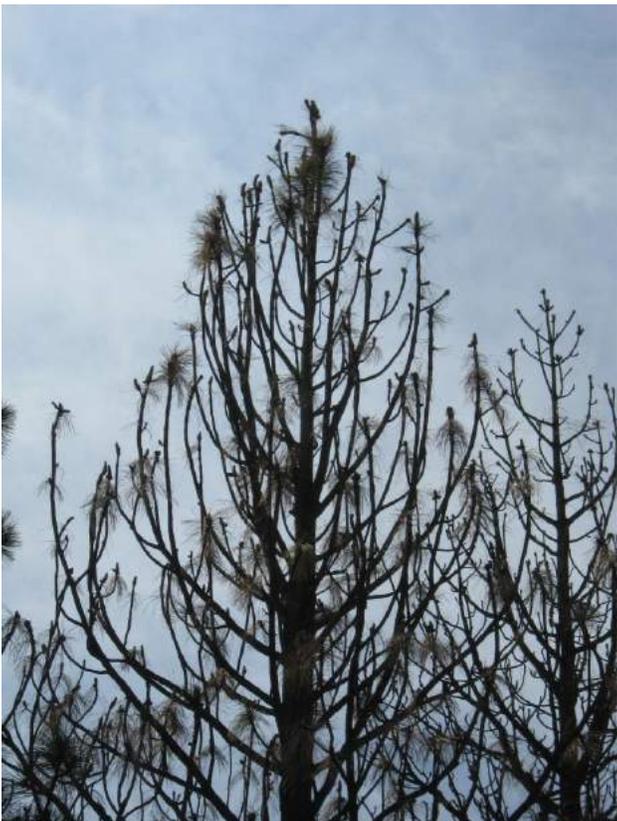
**Figure 39. Tops of recently killed, mature ponderosa pines with abnormal swelling at shoot tips along Hwy 20 in April of 2015.**

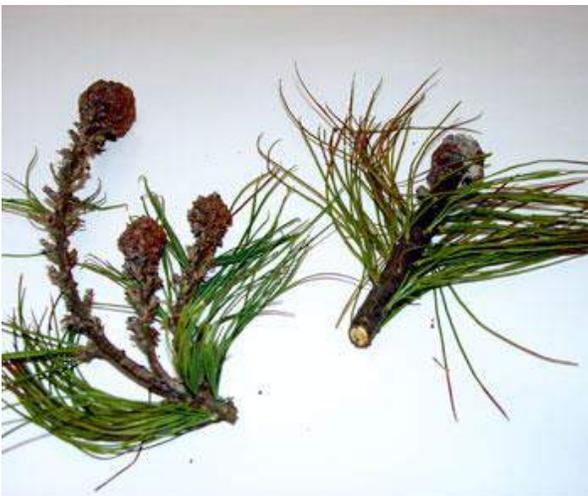
**Figure 40. Abnormal swellings on shoot tips of eastern white pine associated with Imprelis® herbicide injury (Cregg 2013).**
