Small Forestland Investment in Stream Habitat

CFF Meeting
January 14, 2026

Tide Creek Culvert Replacement

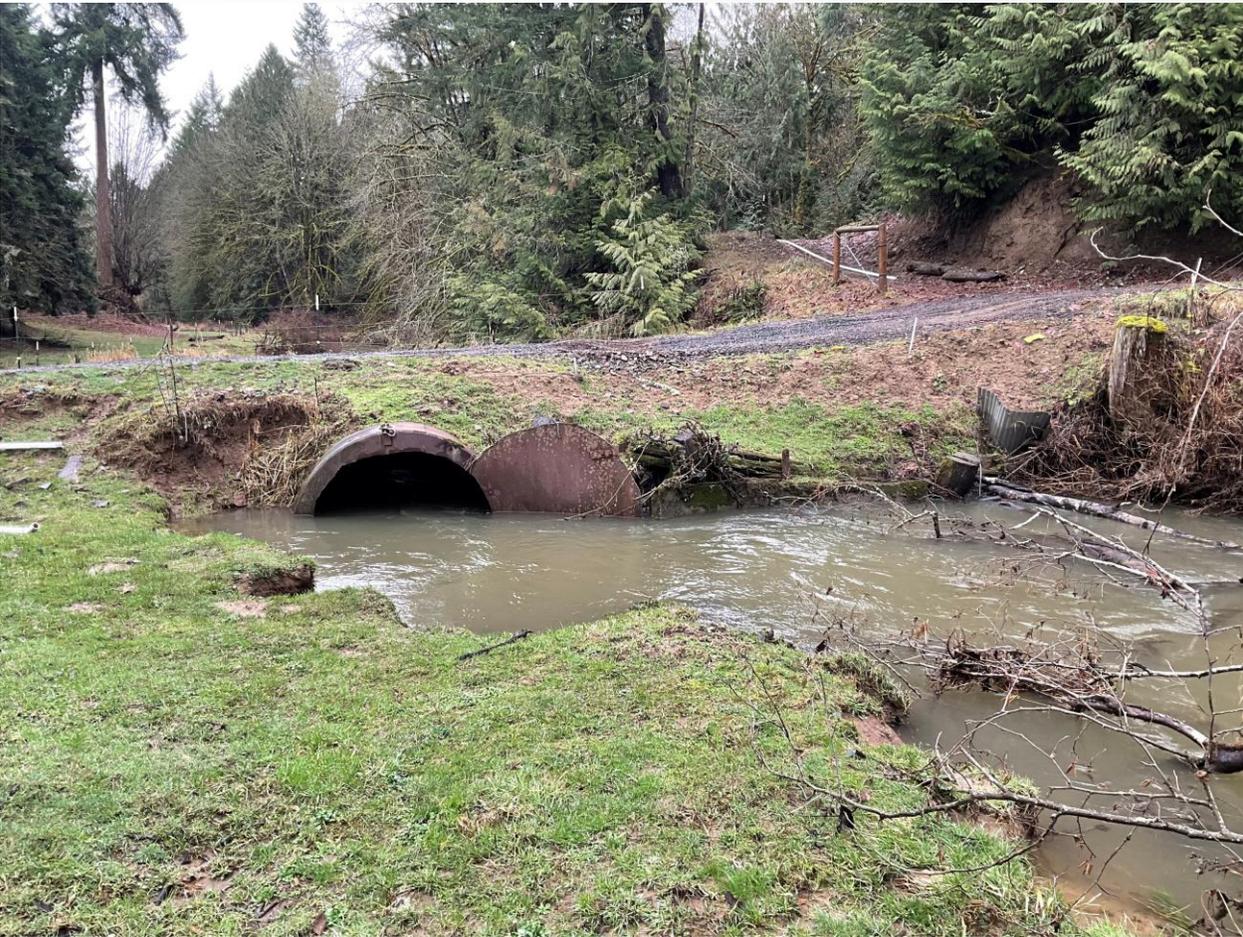
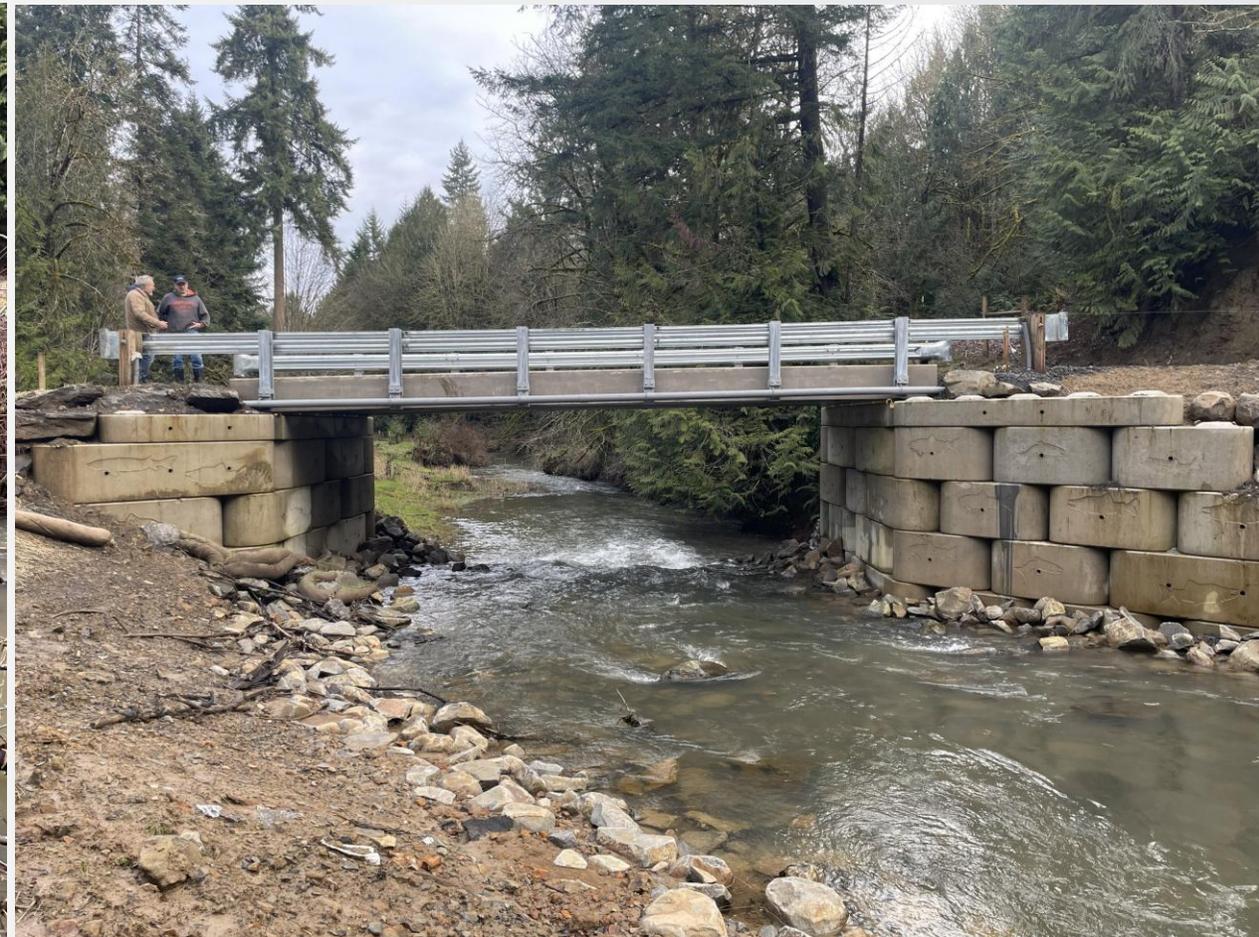
Crossing inlet before and after.

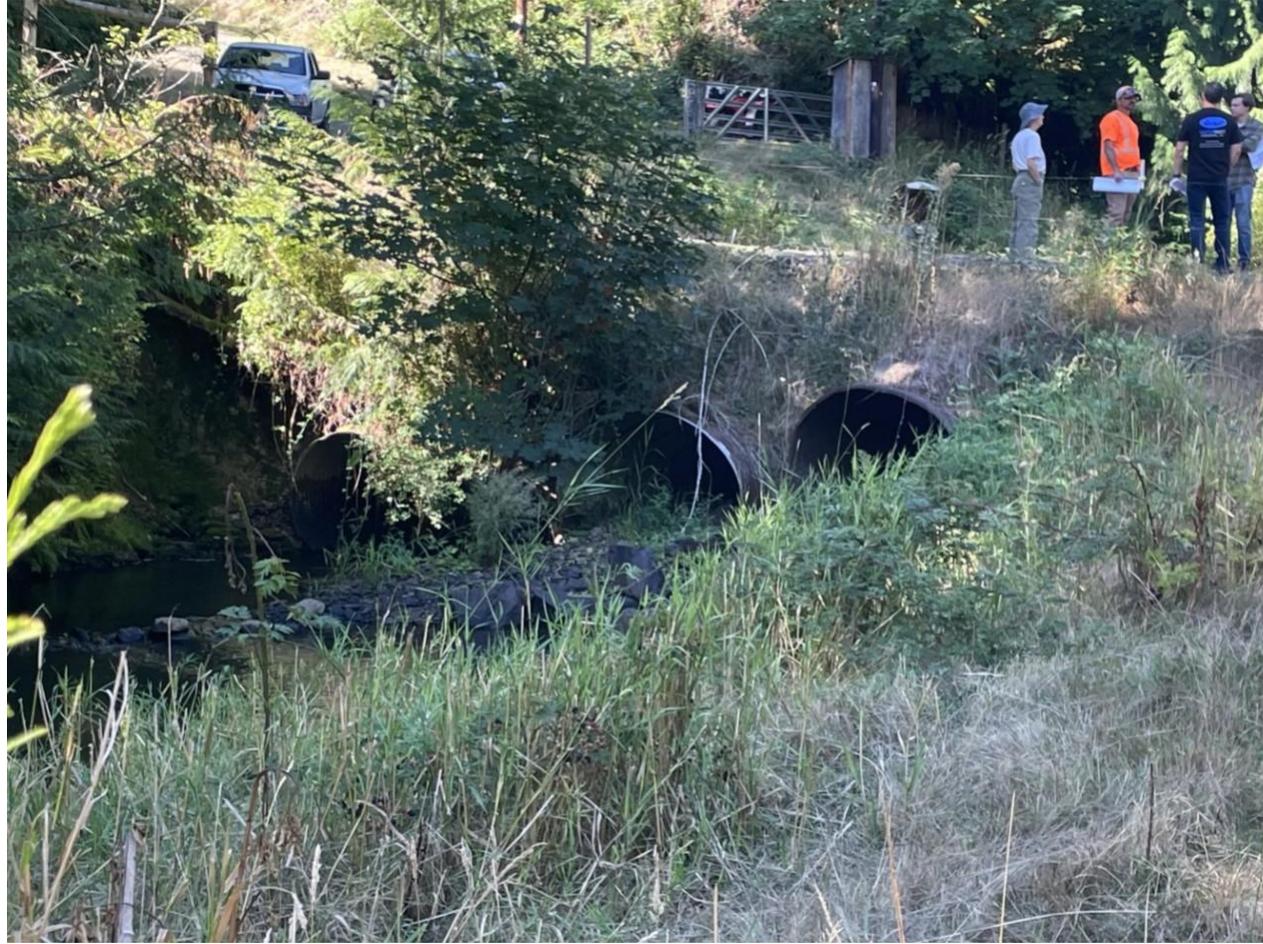
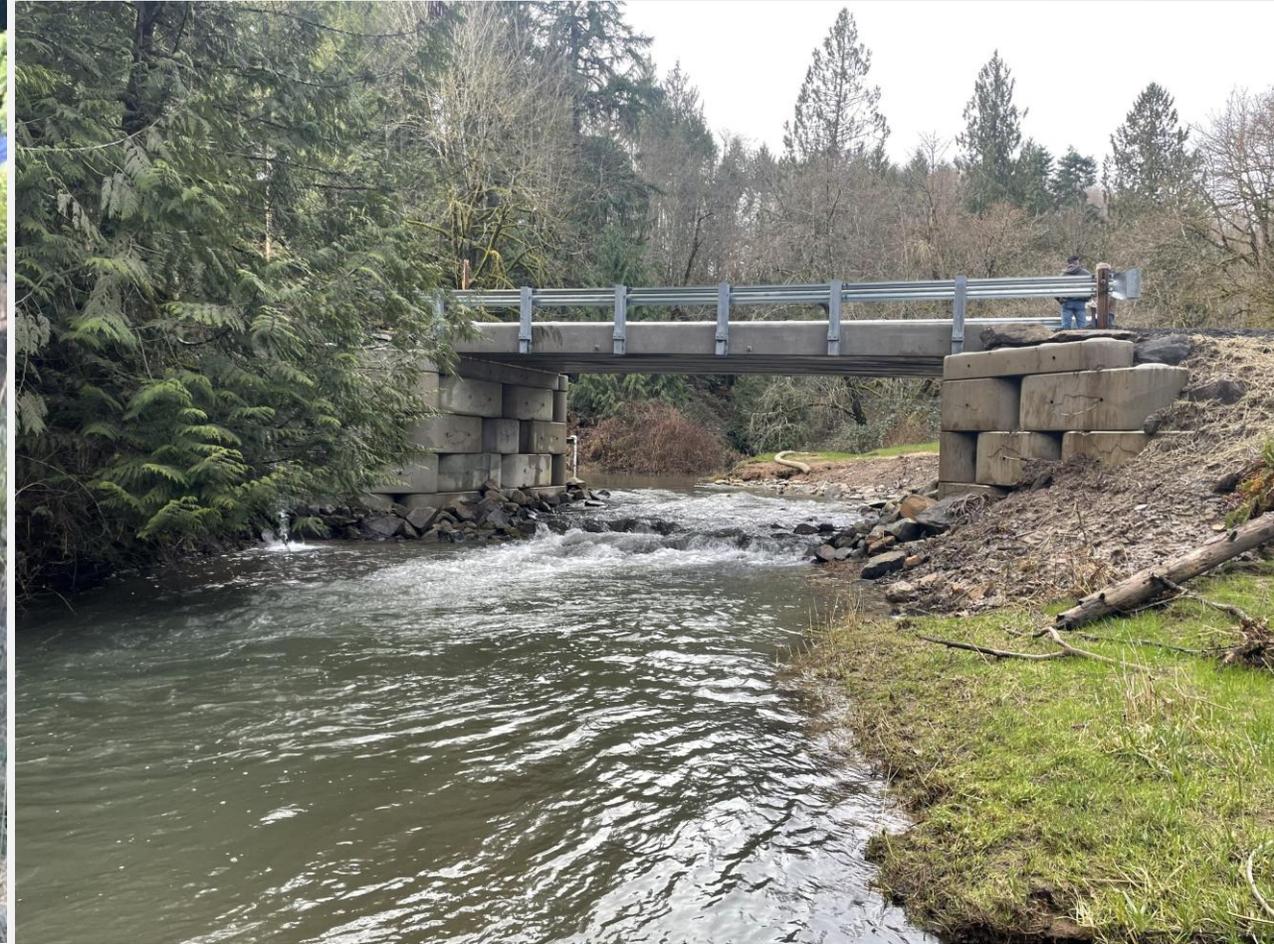
Crossing outlet before and after.
