Culvert Repair Programmatic Agreement 2020 Annual Report

**Oregon Department of Fish and Wildlife | Oregon Department of Transportation
January 2022**

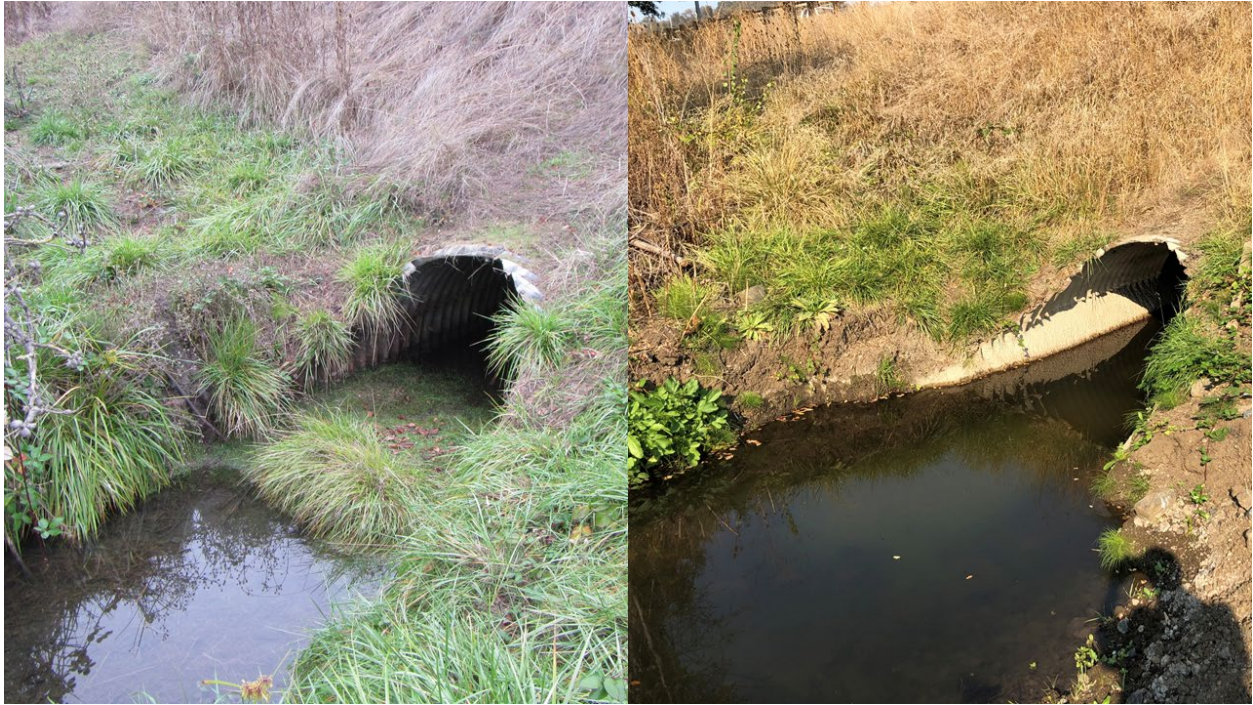
Figure 5: Unnamed Tributary to Roberts Creek Before and After

The culvert's structural condition was deteriorating due to barrel and invert damage, and in need of repair. The active channel width at the site was estimated at 12 feet. Hydraulic calculations determined that during 5% daily exceedance flows (high fish passage design flow) the culvert had velocities of 4.90 fps, and depth at the outlet was 2-5/8 inches at the 95% daily exceedance flows (low fish passage design flow). This compares to an ODFW fish passage design criteria maximum velocity of 2 fps at high fish passage design flow, and a minimum water depth of 6 inches at low fish passage design flow.

The culvert was repaired with a 6-inch paved invert treatment and staggered fish baffles were placed every 15 feet to decrease velocity and create hydraulic variation. Hydraulic calculations estimated a post-treatment high fish passage design flow velocity of 4.01 fps, and a low fish passage design depth of 3 inches. The reduction in velocity and increase in depth improved access to approximately 0.7 miles of potential habitat for cutthroat trout.

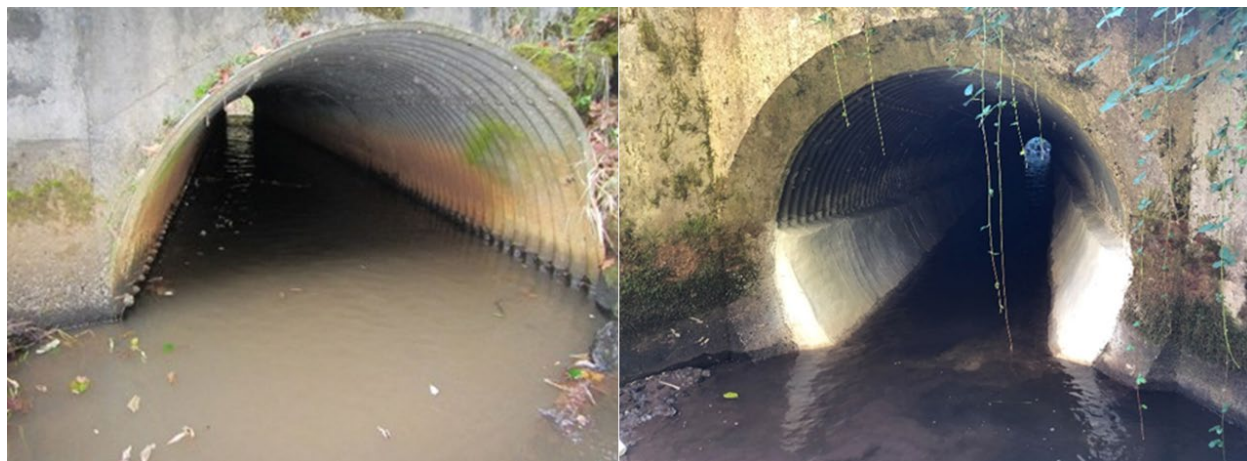
Figure 6: Pass Creek Culvert Repair Before and After

The culvert's structural condition was deteriorating due to distortion, barrel damage, and invert damage, and in need of repair. The active channel width at the site was estimated at 15 feet. The culvert was determined to have shallow depths during periods of low flow, creating a partial fish passage barrier.

The culvert was repaired with a 6-inch paved invert and staggered fish blocks were placed every 5 feet to increase flow depths and create hydraulic shadow. The increased water depth and addition of hydraulic shadow improved access to approximately 1.96 miles of potential habitat for cutthroat trout and steelhead/rainbow trout.

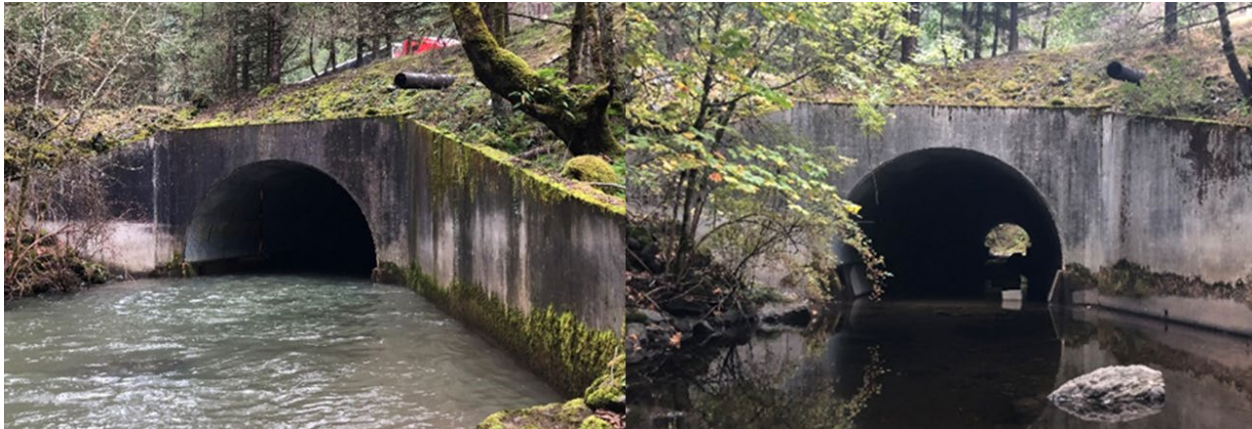
Figure 7: Canyon Creek Culvert Repair Before and After

The culvert's paved bottom was severely deteriorated and had several voids, causing water to flow under the culvert. The active channel width at the site was estimated at 25 feet. Pre and post project hydraulic calculations of velocity and depth were not determined for this culvert. Moderate and high velocities were observed during winter months. To improve fish passage, the project proposed to reduce velocity during moderate and high flows and retain a V-shaped notch in the bottom of the culvert for fish movement during low summer flows.

Concrete repairs were made to the culvert invert and staggered fish blocks were placed every 10 feet on river left inside the culvert to decrease velocity and maintain the existing low flow notch. The decreased velocity and low flow channel improved access to approximately 13.14 miles of habitat for cutthroat trout, federally listed coho salmon, and steelhead/rainbow trout.

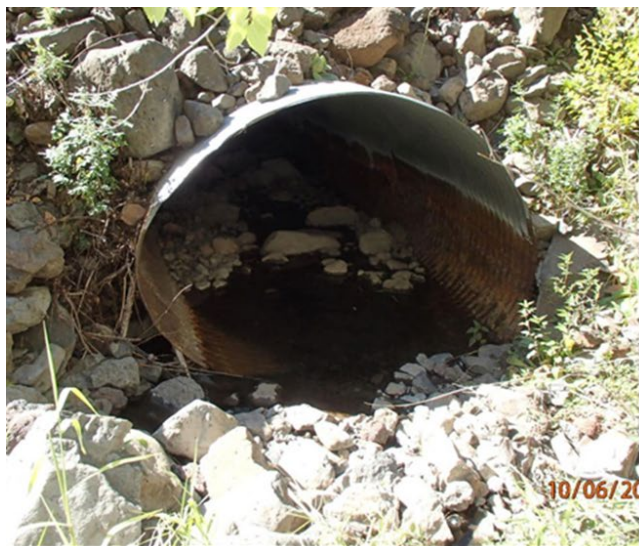
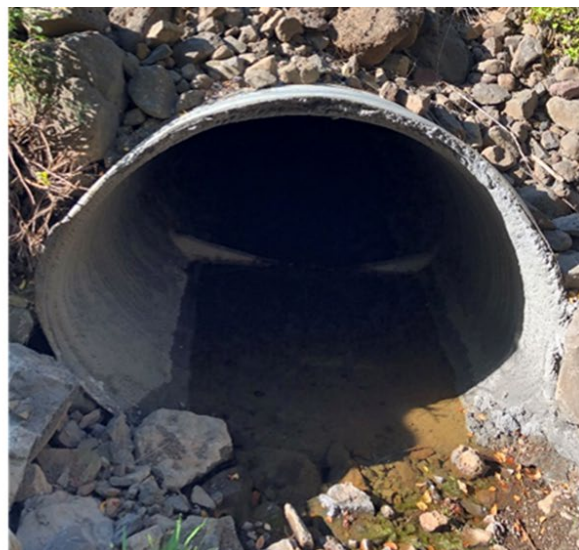
Figure 8: Unnamed Tributary to Wallowa River Culvert Repair Before and After

The culvert was partially filled with larger rock material and its invert was rusted through in multiple spots, resulting in the culvert being impassable during low flow conditions. Hydraulic calculations determined that high fish passage design flow conditions at the culvert had velocities of 4.38 fps and had less than two inches of depth during low fish passage design flow levels.

The rock and gravel material were removed from the culvert and a sprayed on concrete liner was used to repair the invert. Eight-inch-high weirs placed every 12 feet were installed to decrease high flow velocity and increase low flow depths. Hydraulic calculations estimated a post-treatment design high flow velocity of 3.12 fps and design low flow depth exceeding 8

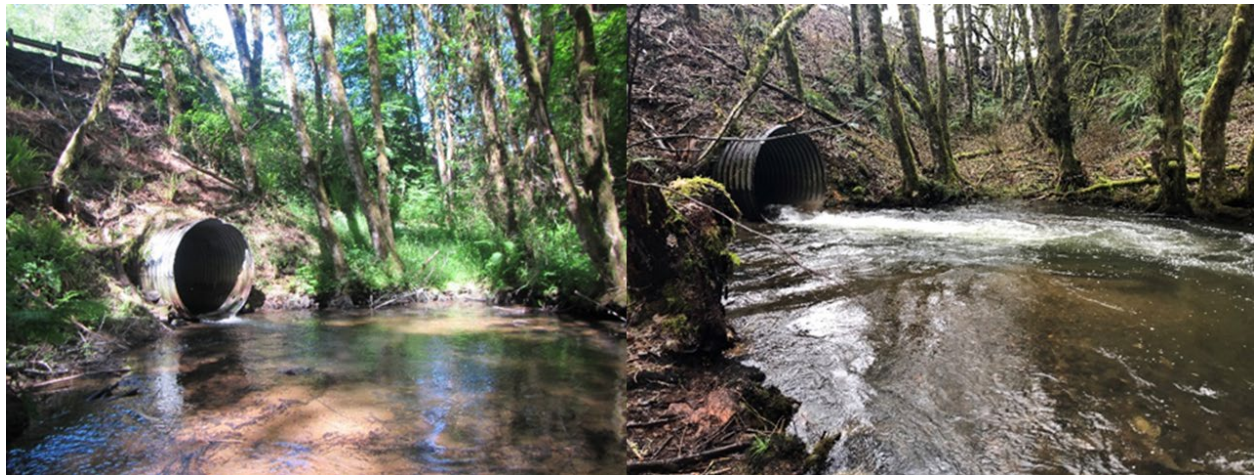
Figure 9: Rock Creek Culvert Repair Before and After

The culvert was in critical condition, with large voids from a rusted invert leading to the piping of water under the culvert. Hydraulic calculations determined that during periods of high fish passage design flows, the culvert had velocities up to 5.77 fps. During periods of low fish passage design flow, models estimated less than three inches of water depth in the culvert. Also, the culvert outlet was perched at low flow, and a trash rack not meeting fish passage design criteria was present upstream of the culvert.

The culvert was repaired with a 6-inch paved invert and six baffles were placed every 25 feet to reduce velocities inside the culvert. An existing riffle was treated with additional boulders at the tail of the outlet pool to create additional roughness and reduce the perch during low flow. Hydraulic calculations estimated a post-treatment velocity of 1.65 fps during high fish passage design flows, and depths of over 2 ½ feet during low fish passage design flow. The decreased velocity, increased depth, and reduced perch improved access to approximately 6.48 miles of habitat for cutthroat trout, federally listed coho salmon, steelhead/rainbow trout, and lamprey.
