Culvert Repair Programmatic Agreement 2022 Annual Report

**Oregon Department of Fish and Wildlife | Oregon Department of Transportation
April 2023**

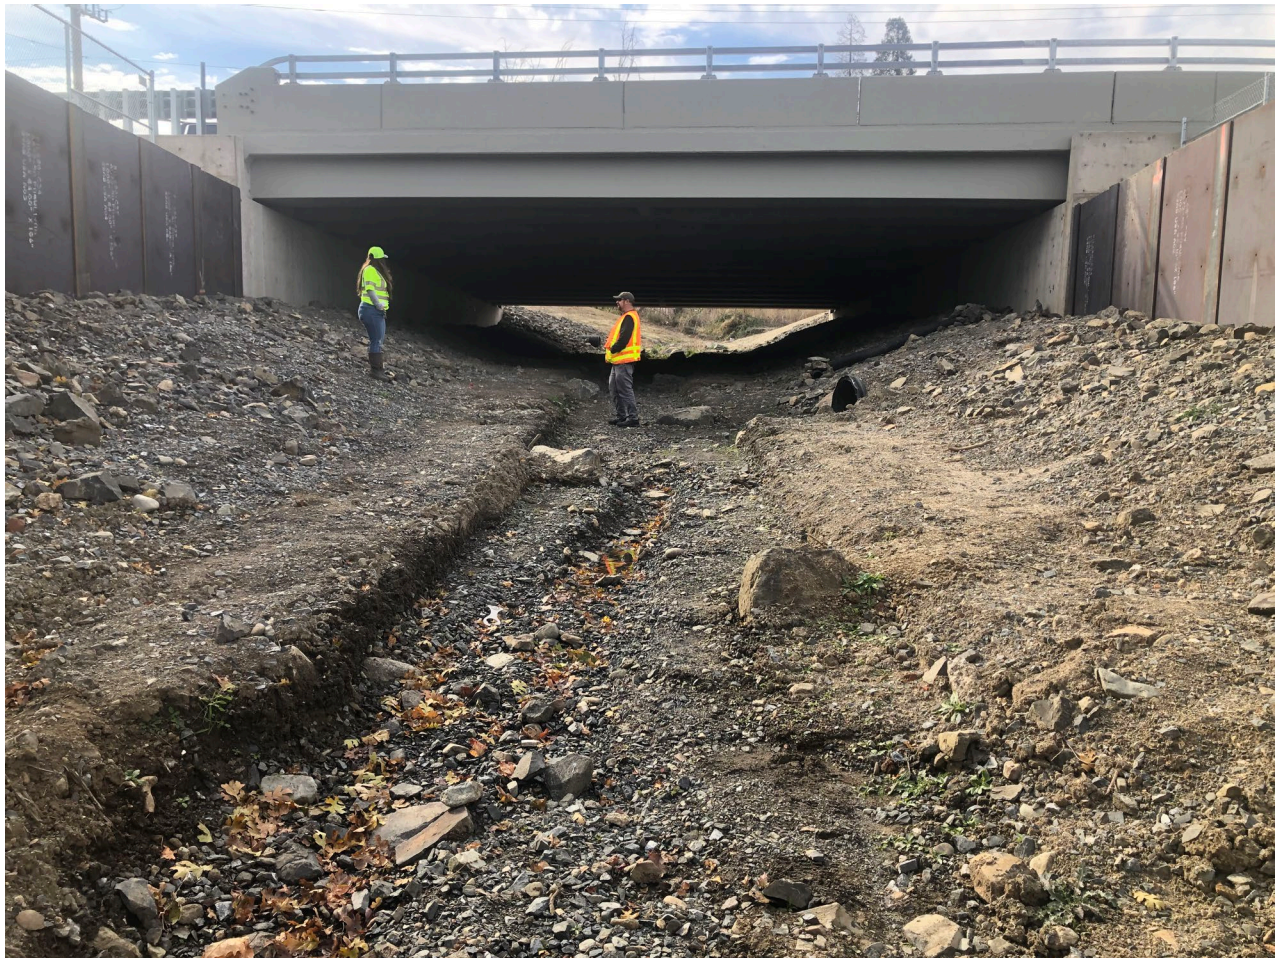
Figure 3: OR 99W Coleman Creek Culvert Replacement Project, Before and After

Description: The top panel of two photos shows Coleman Creek before the replacement. The photo shows the original culvert outlet with large perch, creating a fish passage barrier. The bottom photo is after the culvert replacement, showing a new 46-foot long bridge with the reconstructed stream channel under it.

The OR 99W Coleman Creek Culvert Replacement Project, Figure 3, completed by the ODOT Fish Passage Program, is one example of ODOT's commitment to improving fish passage and supporting the Oregon Plan for Salmon and Watersheds. The project replaced an undersized 4-foot by 6-foot concrete box culvert with a 46-foot-long bridge. The original culvert was undersized for the stream channel, causing channel scour and incision. The culvert also had a large perch at the outlet, which resulted in a significant passage barrier for both adult and juvenile NMF. The Coleman Creek fish passage project opened access to over 4 potential miles of high-quality spawning and rearing habitat for summer and winter steelhead, fall Chinook salmon, cutthroat trout, and lamprey species at a cost of \$5.3 million.

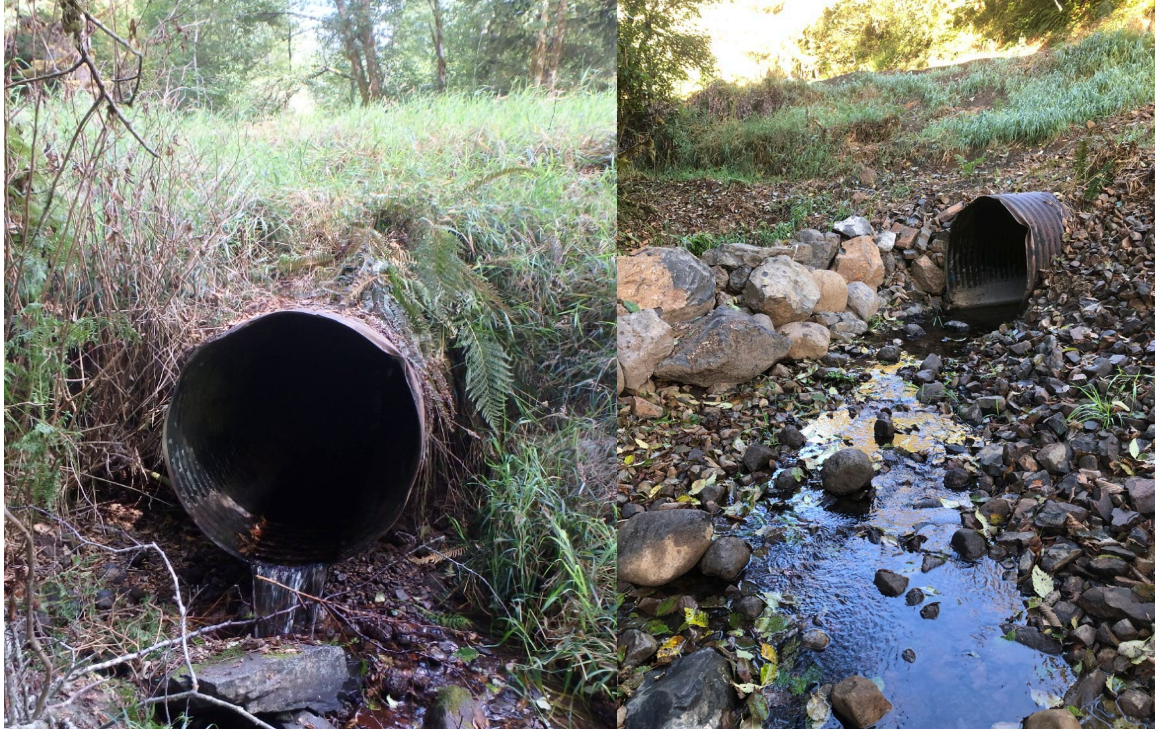
Figure 5: Small Creek Before and After

This culvert conveys Small Creek, a tributary of the Little Nestucca River in Tillamook County, Oregon. Small Creek has an estimated active channel of 10' and the current culvert is 54' long and 4' in diameter. The culvert had an 18" drop on the outlet near the confluence with the Little Nestucca River, causing significant fish passage issues, and was a complete barrier for Pacific lamprey. The culvert showed signs of invert and barrel damage, and was in need of repair.

Description: Two images, the first displays the culvert pre-repair from the outlet end with a perch creating a fish passage barrier. The second shows the culvert post-repair from the outlet end with a roughened riffle backwatering the outlet.

The culvert was repaired by paving the invert to cover the scour and seal the barrel. Fish passage improvements include a roughened riffle to the culvert outlet to eliminate the jump, and rounded cement corner baffles were installed to reduce velocities, and increase the depth in the culvert barrel.

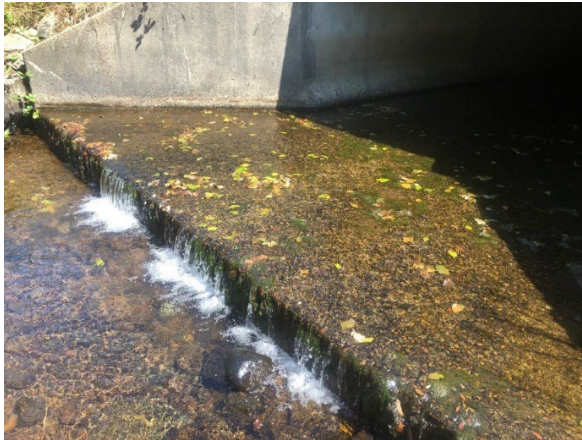
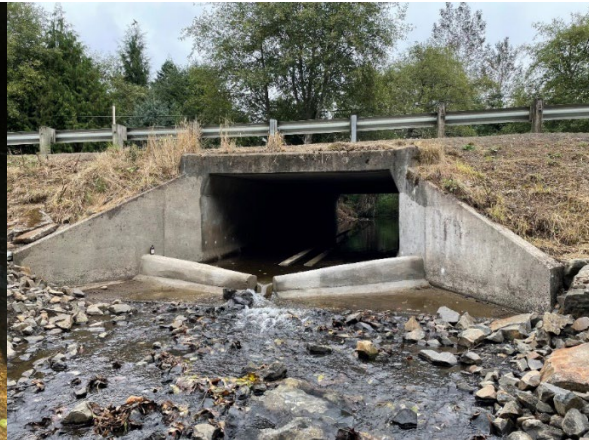
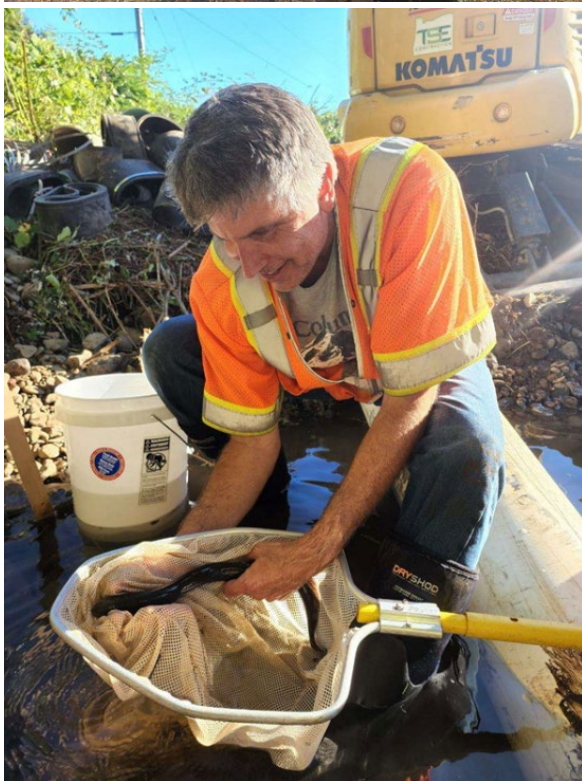
Figure 6: Munson Creek Culvert Repair Before and After

The box culvert had exposed rebar and concrete wear from scour on the invert and was in need of repair. Some small sections of the walls had some erosion as well. The active channel width is estimated to be 17'.

Description: Three images, the first is pre-repair looking at the culvert outlet and Apron. A 12" drop off of the apron can be seen. The second is post-repair looking inside the culvert from the outlet end with a roughened riffle backwatering the outlet, and rounded baffles on each side of a low flow channel. The third image shows Wade Holaday, Senior Major Culvert Maintenance Engineer, with an adult Pacific lamprey collected during fish salvage.

The repair included repaving of the invert of the culvert and covering erosion scour and exposed rebar. To address the perch on the apron, a 70' roughened channel was built up to the culvert outlet, eliminating the jump. Weirs were placed in the culvert to reduce the velocities and increase the depth. The weirs are rounded to allow for lamprey migration. In addition, a low flow channel was created in the barrel to further increase passage depth during low flows. Improved passage here will provide easier access to 4.73 miles of habitat for coast cutthroat trout, Pacific lamprey, winter steelhead, coho and fall Chinook. Prior to construction, the fish salvage captured 18 adult Pacific lamprey from below the culvert apron. These individuals were released upstream, and extended the known distribution of Pacific lamprey in the Tillamook River Watershed.

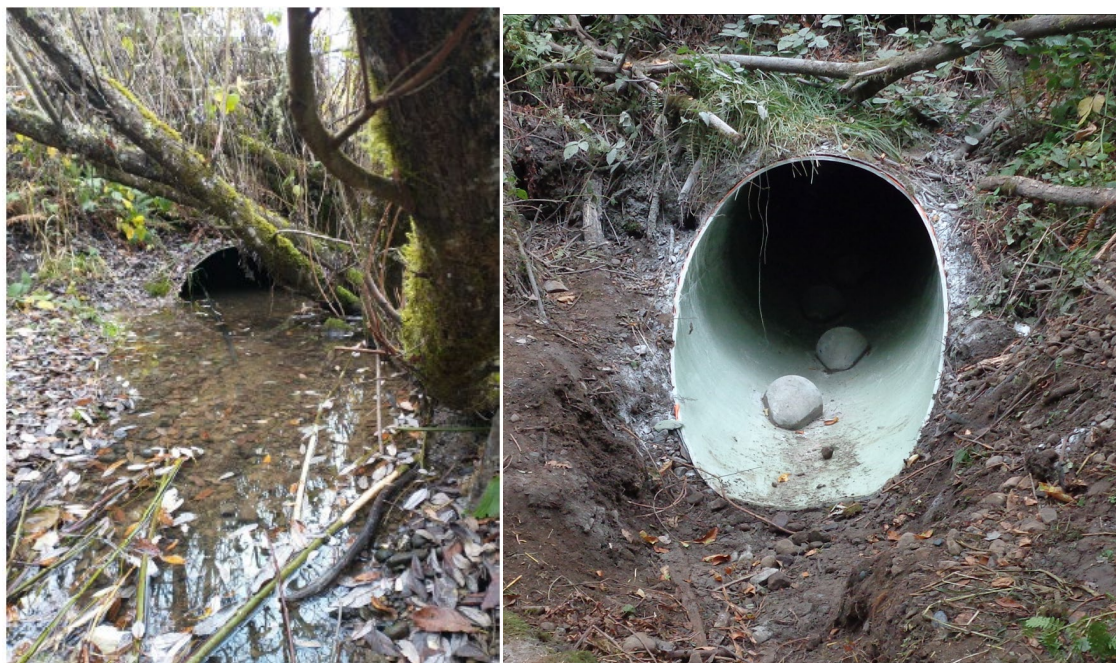
Figure 7: Unnamed Tributary of the South Fork Coquille River Culvert Repair Before and After

The culvert is deteriorating and has vertical and horizontal alignment breaks. The active channel width is estimated at 7' and is a seasonal stream, but provides coastal cutthroat trout habitat when it is flowing. The undersized culvert had velocity issues for fish passage at higher flows.

Description: Two images, the first shows inside the culvert from the outlet end pre-repair with water running through it. The second displays inside the culvert from the outlet end post-repair with fish blocks installed.

The structural condition of the culvert was addressed by installing a CIPP liner. Fish blocks were installed in the culvert to increase depth, increase hydraulic complexity and reduce velocities. The passage improvements will improve passage for coastal cutthroat trout to 0.56 miles of additional habitat upstream of Highway 42.
