# Culvert Repair Programmatic Agreement 2018 Annual Report

Oregon Department of Fish and Wildlife | Oregon Department of Transportation  
January 2021

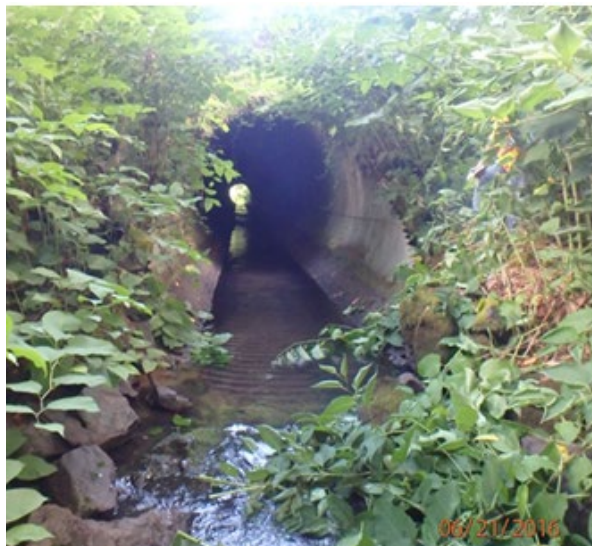
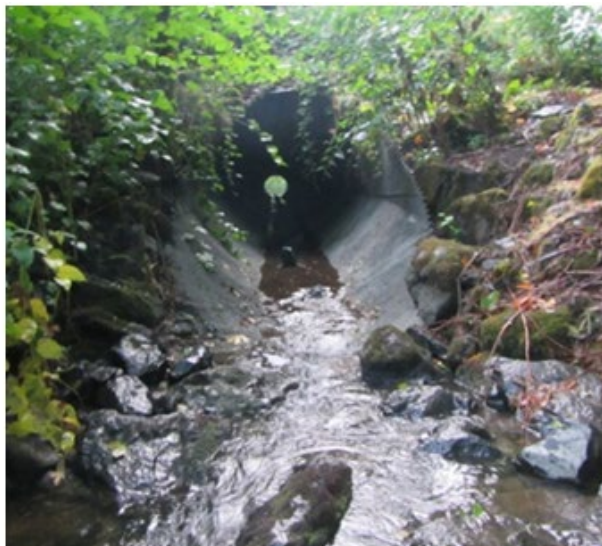
Figure 6: Pass Creek Culvert Repair Before and After

The 12-foot diameter CMP is 284 feet long and drains an area of 5.27 square miles. The culvert's surveyed condition was considered poor due to corrosion and a missing section of the invert. If left untreated, this could become a potential hazard to the traveling public due to water saturating and destabilizing the surrounding soil arch and roadbed, leading to settlement of the culvert that could leave the roadway unsupported.

The stream has an estimated active channel width of 15 feet. Water velocities during high flow conditions and shallow water depths during low flow conditions created a partial barrier for the upstream movement of fish through the culvert. Cutthroat trout, steelhead, rainbow trout, and ESA listed coho salmon were potentially blocked or delayed from accessing the approximately 4.89 miles of upstream habitat due to these conditions.

The culvert was repaired with a 6-inch paved invert treatment. This allowed for the degraded invert condition to be restored, keeping the water inside the barrel. Installing an 18-inch pre-cast concrete fish blocks at 10-foot intervals through the pipe improved fish passage. These blocks slow water velocities during high flow events, increase flow depth during low flow conditions, and create flow complexity within the culvert. The resulting conditions improve fish passage and increase access to the 4.89 miles of upstream habitat.

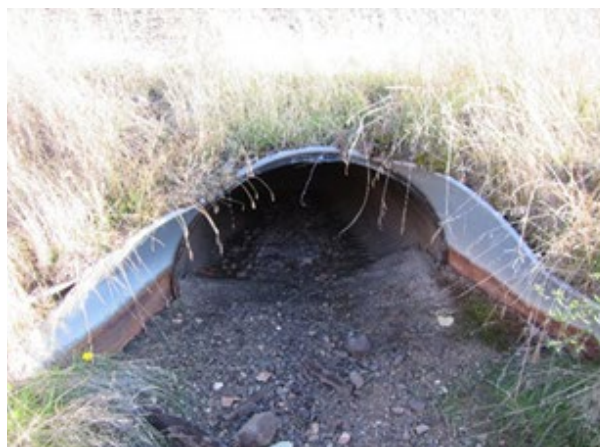
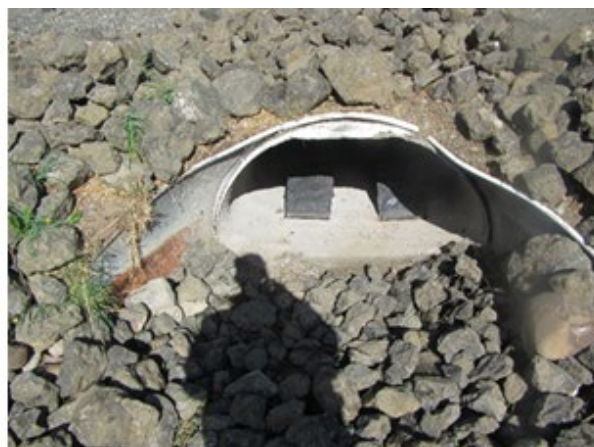
Figure 8: Unnamed Tributary to Cow Creek Culvert Repair Before and After

Description: Two images, the first looks at the end of an arch culvert pre-construction, grass growing along the top, and thin layer of sediment in the bottom. The second image is post-repair, looks at the end of the arch culvert, it is surrounded by rock with baffles installed inside.

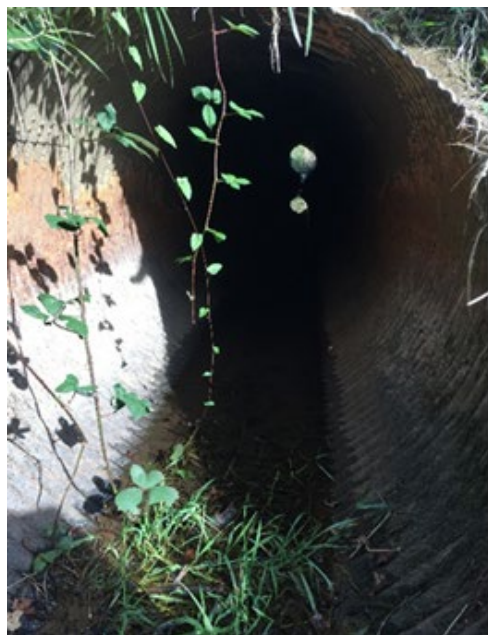
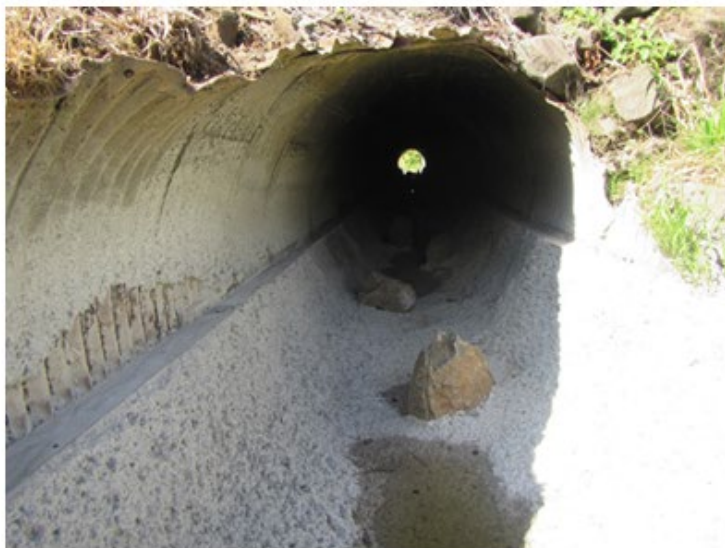
Figure 9: Unnamed Tributary to the Tillamook River Culvert Repair

Description: Two images, the first is the inside of the culvert pre-repair. The second is inside the culvert post-repair. Here we can clearly see concrete on the invert and fish rocks installed.

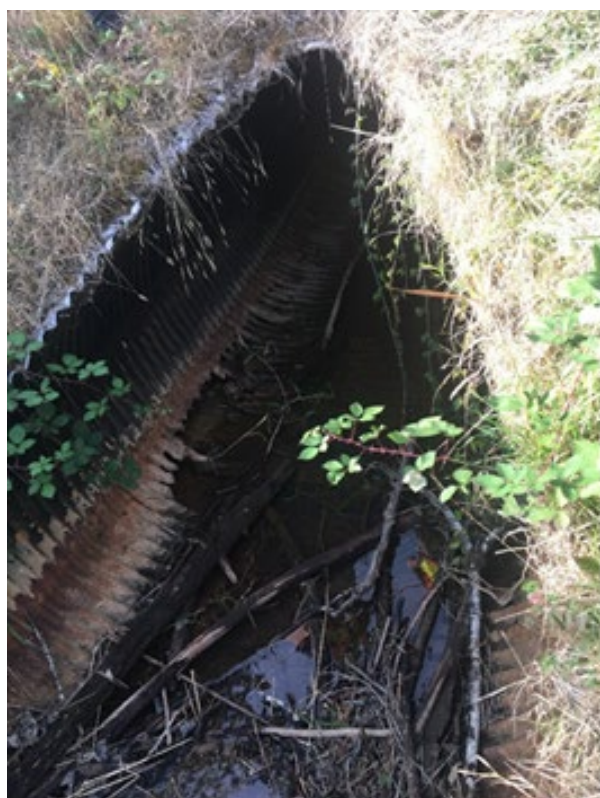
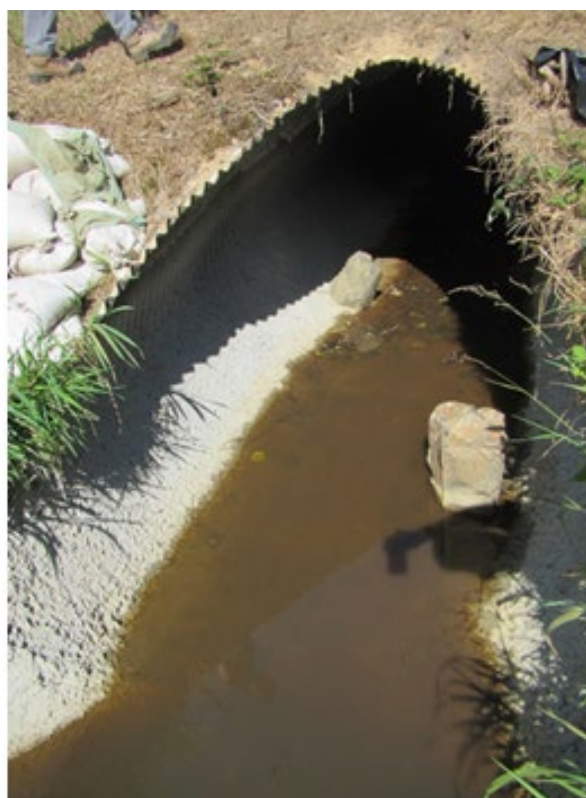
Figure 10: Unnamed Tributary to the Tillamook River Culvert Repair

Description: Two images, the first is looking down at the mitered slope end treatment pre-repair. The second is looking down at the mitered slope end treatment post repair.

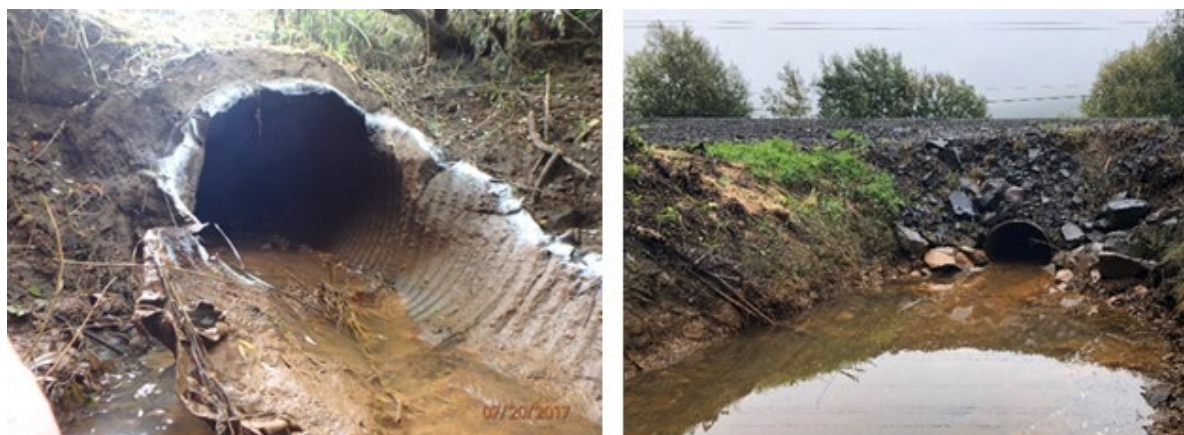
Figure 11: Tandy Creek Culvert Repair

Description: Two photos, the first shows the outlet end of the culvert recently dug out of the mud pre-repair, with water running through it. The second photo shows standing water at the post repaired outlet of the culvert.
