# **Culvert Repair Programmatic Agreement 2019 Annual Report**

Oregon Department of Fish and Wildlife | Oregon Department of Transportation  
August 2021

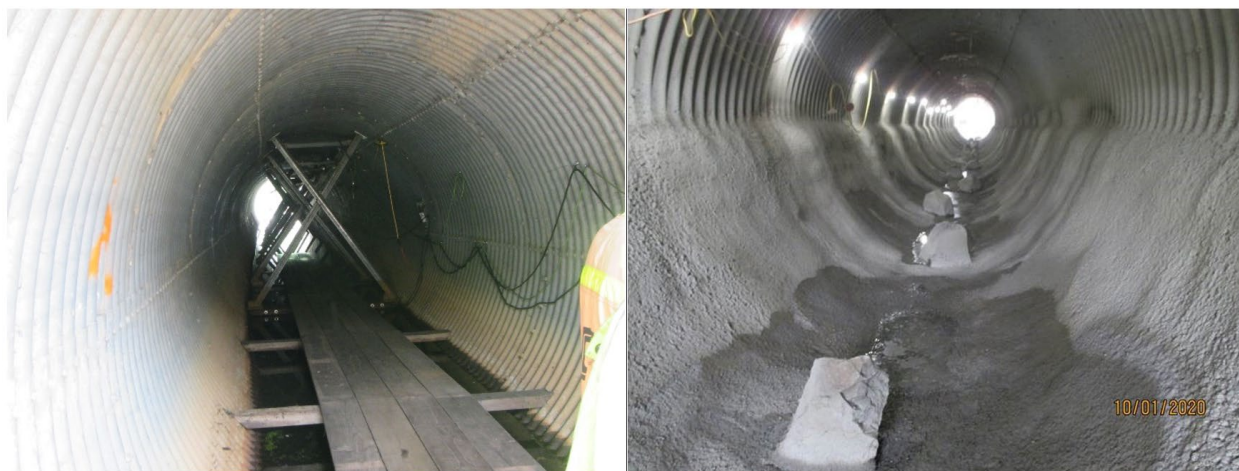
Figure 6: Johnston Creek Culvert Repair, Before and After

The structural conditions of these culverts was critical due to significant corrosion. The culverts were collapsing causing sagging and roadway cracking on the highway. A fatal accident occurred at this location due to a partial roadway collapse over the culverts. Significant repairs to the culverts would trigger Oregon's fish passage rules, and in August of 2018 ODOT declared these culverts an emergency and began the process of planning to address fish passage at this location under the CRPA. Internal cross-bracing to support the culverts was completed in the spring of 2019, with fish passage improvements and further repair work were implemented in 2020.

Hydraulic calculations showed flow conditions at the culvert had velocities over 2 fps and flow depths as low as 4 inches (flows ranging between 5 percent and 95 percent of the daily

The degraded culverts were repaired with an invert pave that sealed and reinforced the failing corrosion and returned structural integrity to the culverts. Fish passage was improved with the addition of fish rocks in lower culvert. The repair work was completed in 2019, and the fish passage improvements were completed in 2020. These fish rocks were placed in the east culvert to decrease the velocities within the culvert and offer ample hydraulic variation for NMF. Post-treatment conditions were estimated to have velocities approximately 2.1fps, down from over 3 fps and flow depths of over 7 inches, thus improving access to the approximate 4.95 miles of upstream habitat.

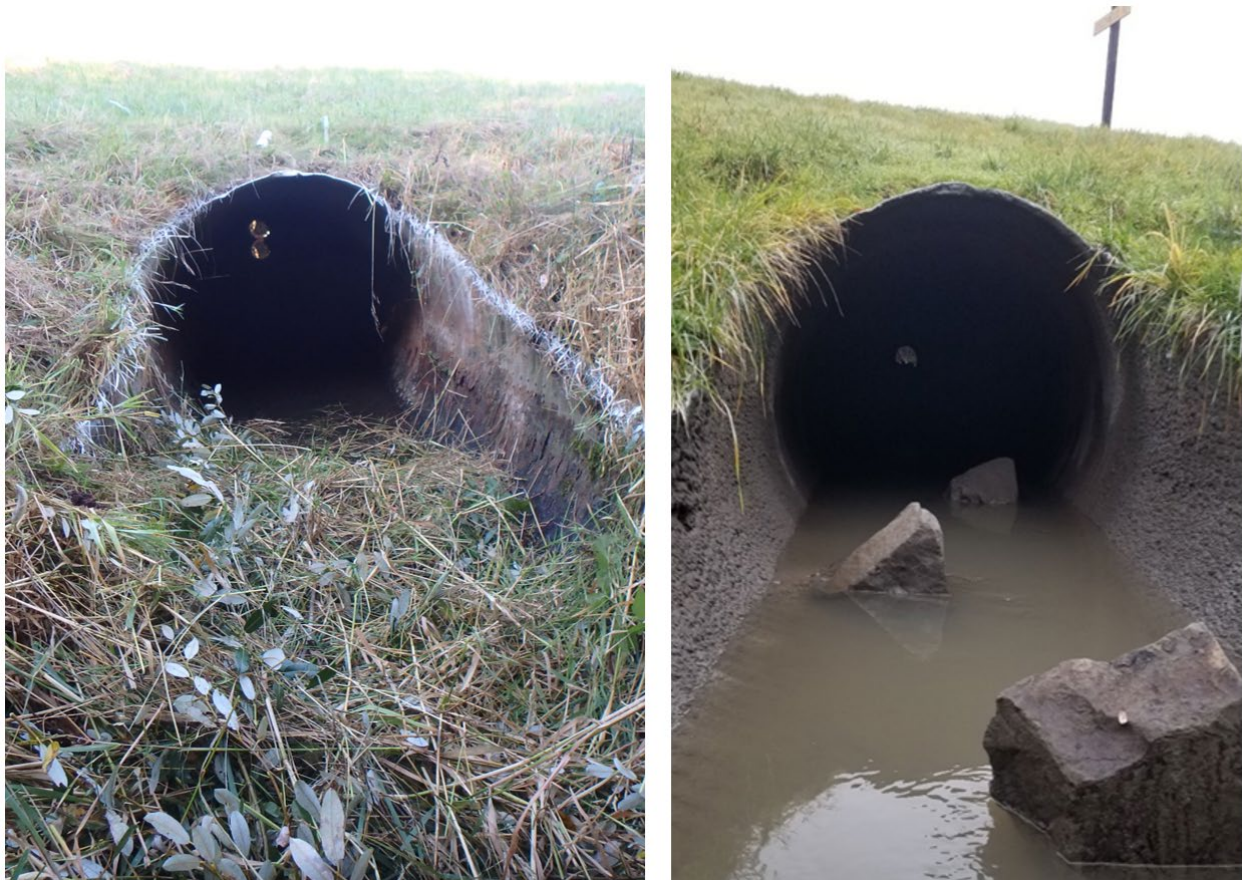
Figure 7: Unnamed Tributary to Mud Slough Culvert Repair, Before and After

Although the culvert was rated in fair condition following initial inspections, subsequent inspection efforts determined that the amount of invert rusting was enough to warrant repair. Degradation of a culvert invert allows water to saturate the soil surrounding the culvert. It also erodes away the soil beneath the culvert and can lead to settling. If left untreated, these issues can lead to the roadway becoming unsupported and unsafe.

The rusting culvert was repaired by a Centrifugally Cast Concrete to amend structural issues caused by rust. Fish passage was improved by the addition of fish rocks to slow water velocity, increase hydraulic diversity, and better facilitate fish passage during high flows. The fish rocks lowered the velocity in the culvert and allowed for variation of hydraulic conditions through the culvert to improve NMF passage conditions to the potential 5.05 miles of habitat upstream.

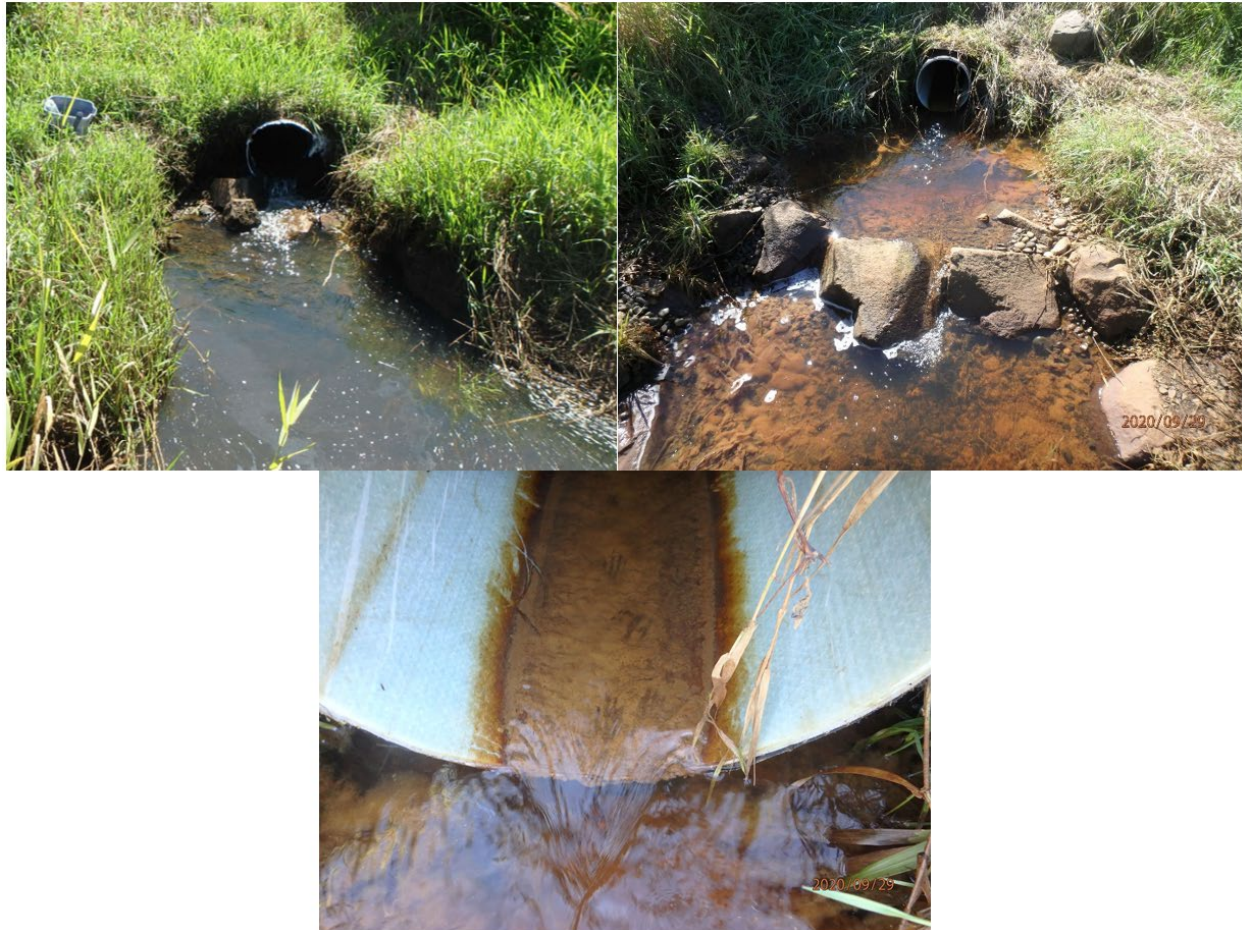
Figure 8: Unnamed Tributary to Westport Slough Culvert Repair, Before and After

The 18 inch diameter CMP is 95 feet long and drains an area of 1.55 acres of habitat and floodplain. The culvert's surveyed condition was considered critical due to corrosion. If left untreated, this could become a potential hazard to the traveling public due to water saturating and destabilizing the surrounding soil arch and roadbed, leading to settlement of the culvert that could leave the roadway unsupported.

Post-construction monitoring at this site determined that the boulder receiving pools did not fully seal and backwater the culvert to the designed plans. Adaptive management in 2020 included resealing the weir with fine material to backwater the culvert to designed condition. The site will continue to be monitored to ensure the weir functions as intended.

Fish passage was improved at the outlet of the culvert by building two boulder receiving pools. The culvert was repaired with a CIPP liner. This allowed for the degraded invert condition to be restored, keeping the water inside the barrel. Installing two downstream u shaped boulder receiving pools improved fish passage. These pools slow velocities during outgoing tides, backwatering the culvert for longer durations, and reducing the perched condition of the culvert at low tide. The resulting conditions improve fish passage and increase access to the 1.55 acres of upstream habitat.

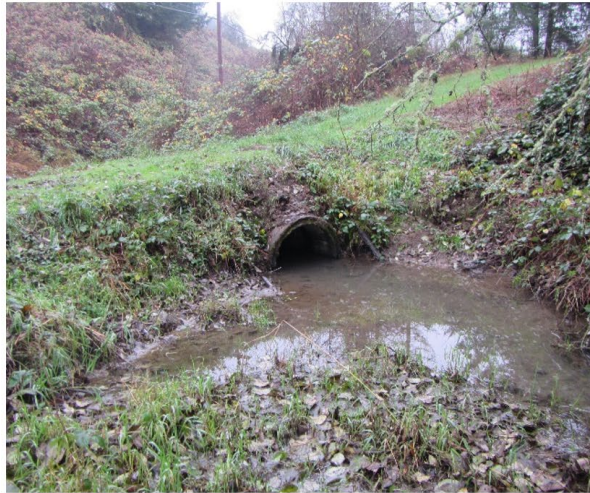
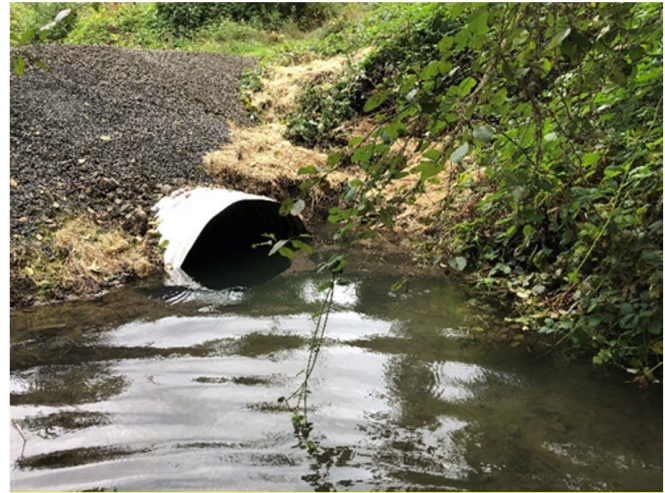
Figure 9: Spring Brook Creek Culvert Repair, Before and After

The culvert drains an area of 0.21 square miles which is heavily influenced by spring fed runoff, there are 0.14 miles of fish habitat for cutthroat trout upstream of the culvert. The culvert is an arch culvert with a box culvert on both ends. The box culvert sections are 3-feet high by 4-feet wide and the entire culvert is 132 feet long. The transitions between the arch and the boxes on each end were not sealed. The culverts surveyed condition is fair. Roadway fill had begun to leak into the culvert. The culvert also fills with sediment and needs to be cleaned yearly. If left untreated this condition is potentially hazardous to the traveling public due to road destabilization which leaves the roadway unsupported.

Conditions at the ODOT culvert under highway 99 were not a barrier to fish passage. However, approximately 30 feet downstream from this culvert is a private road crossing. The culvert on this road crossing was a 3-foot diameter culvert, which was undersized and placed at a stream elevation that was not conducive to fish passage. Conditions at this lower culvert presented a passage barrier to cutthroat trout downstream from the ODOT culvert.

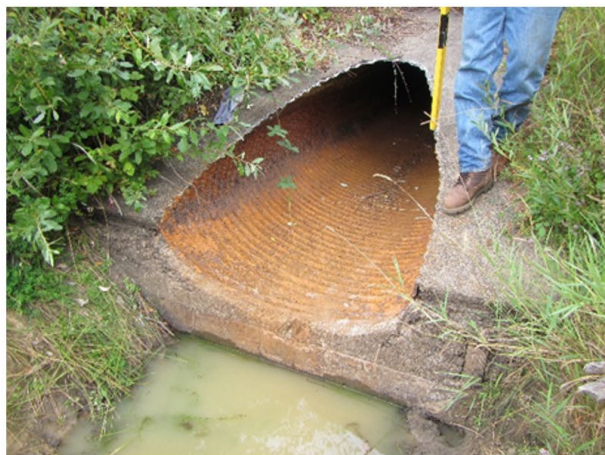
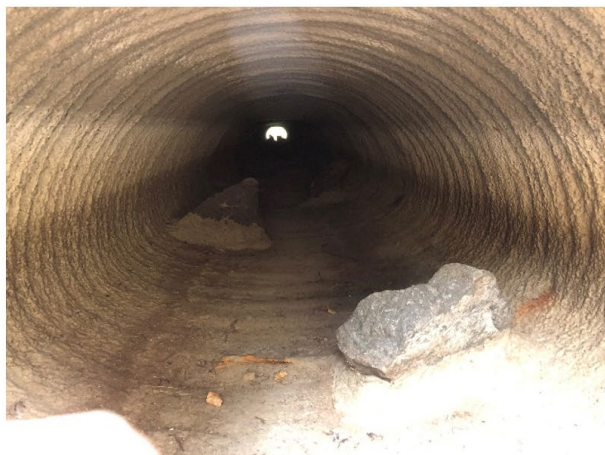
Figure 11: Long Tom River Floodplain Lake Culvert Repair, Before and After

Description: Two images, the first looks at the end of an arch culvert pre-construction, where the culvert invert is showing signs of rust and deterioration. The second image is post-repair, and looks in the end of the arch culvert. The interior of the culvert shows new concrete around the perimeter, and fish rocks placed on the inlet.

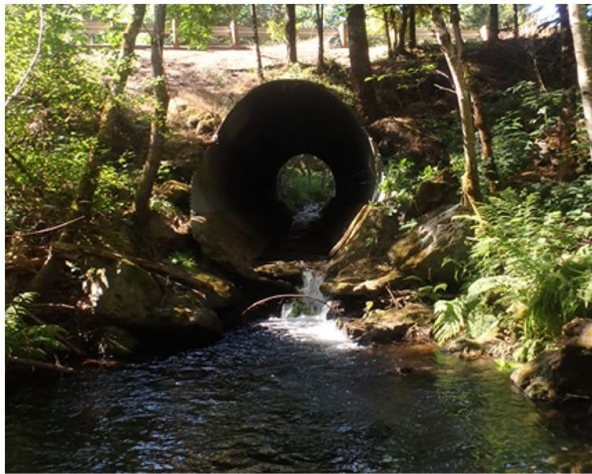
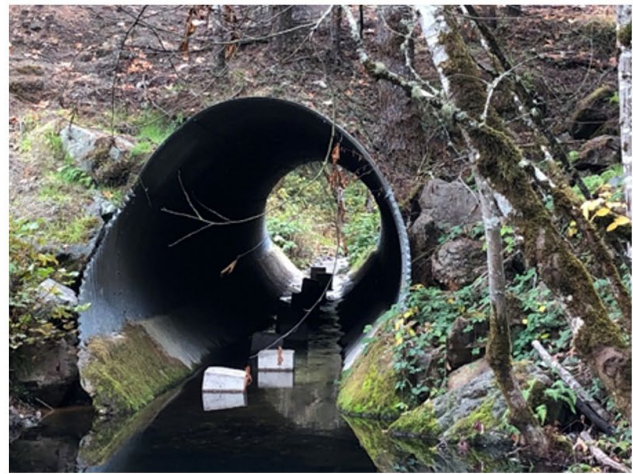
Figure 14: Canyon Creek Culvert Repair, Before and After

Description: Two photos, the first shows the outlet end of the culvert with water running through it, this clearly illustrates the perched condition of the culvert. The second photo shows standing water at the post-repaired outlet of the culvert, and fish blocks placed through the culvert.

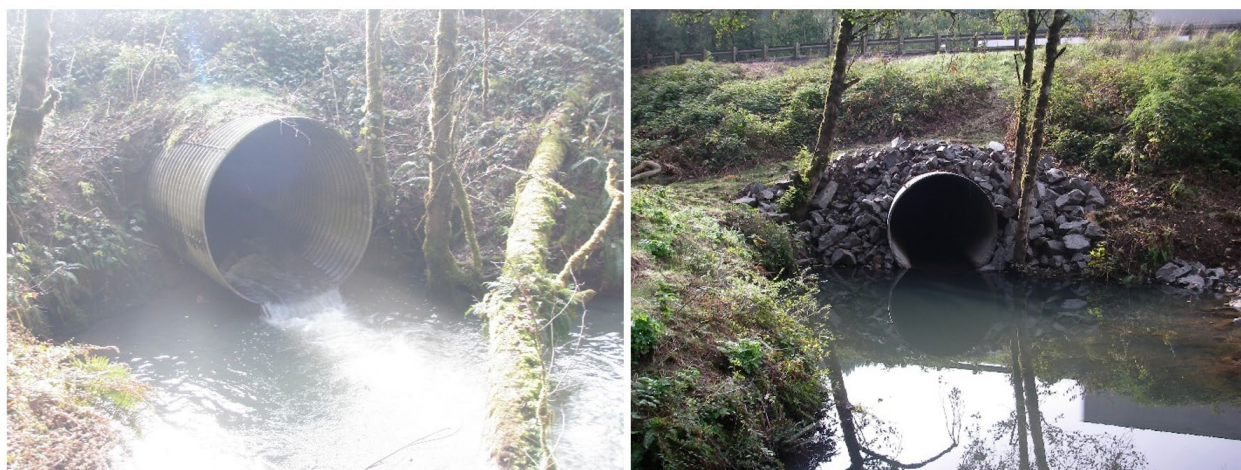
Figure 15: Pass Creek Culvert Repair, Before and After

Description: Two images, the first shows the outlet of the culvert and a perch creating a jump height pre-repair. The second image shows water running through the culvert backwatered with no jump height post-repair.

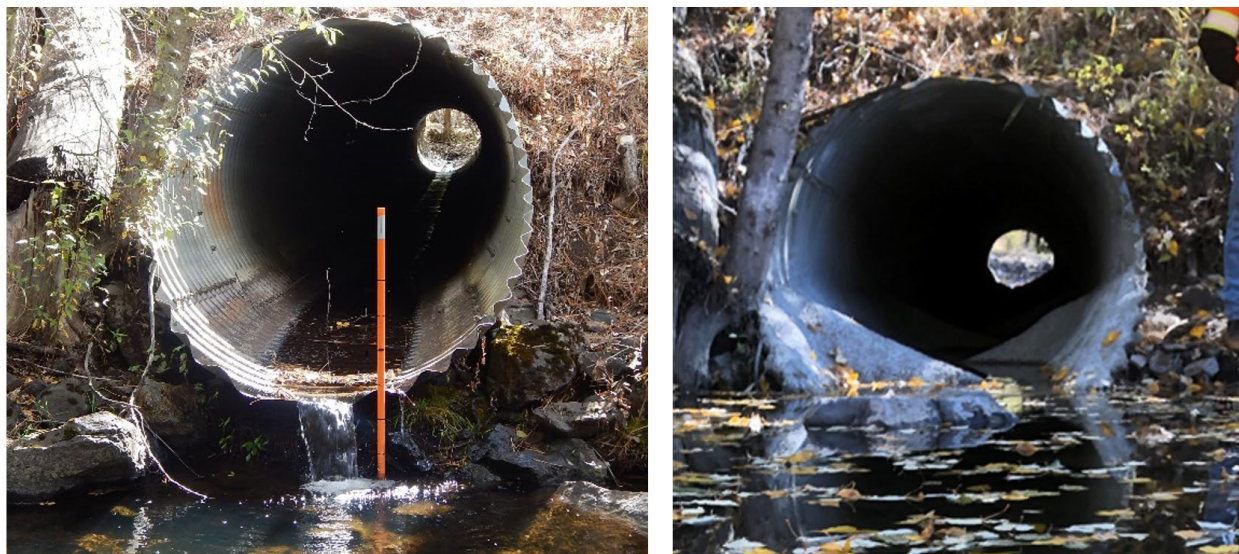
Figure 16: Marley Creek Culvert Repair, Before and After

Description: Two images, the first shows water running through the perched culvert pre-repair. The second image shows water backwatered to the culvert outlet with alternating baffles post-repair.
