Culvert Repair Programmatic Agreement (CRPA) Pilot Final Report

Report Prepared by
William Warncke and Allen Gillette, ODOT

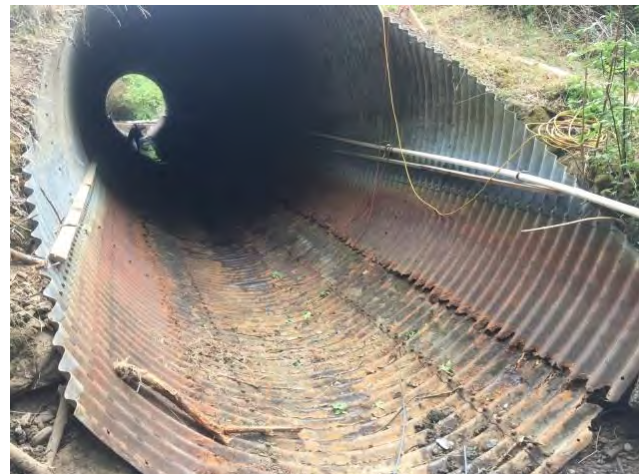
All of the 2016 culvert repair projects were repaired by invert paving. Invert paving adds a layer of reinforced concrete in the bottom of the culvert to both seal the bottom and keep water in the culvert barrel, and to provide a connection to complete the culvert circumference thereby repairing the structural capacity of the pipe. There are other repair techniques available under the CRPA but the 2016 repair locations were all metal pipes, either Corrugated Metal Pipe (CMP) or multi-plate culverts with significant invert rusting (see photo of Oakpoint Creek Culvert - to right). Several different types of fish passage improvements were included as part of these invert paving repairs (see below).

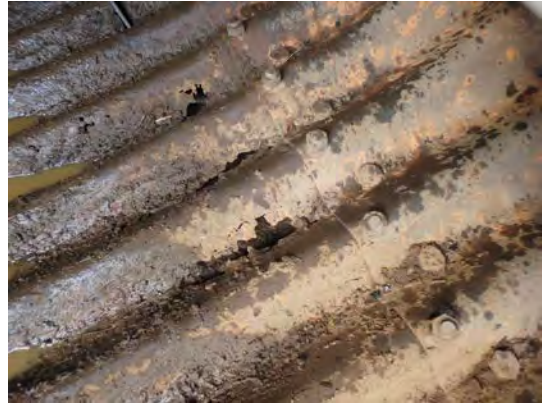
Rusted invert and voids under the culvert (9/20/16)

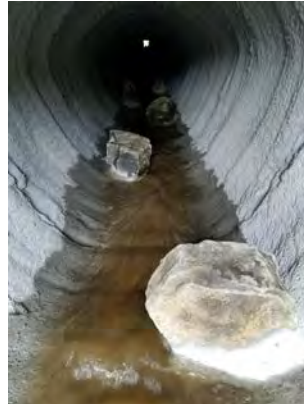
Inside culvert
showing fish rocks and centrifugally cast
concrete

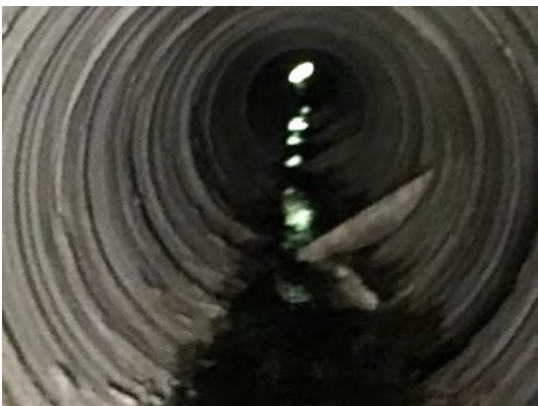
Inside culvert showing centrifugally cast concrete liner and corner baffles

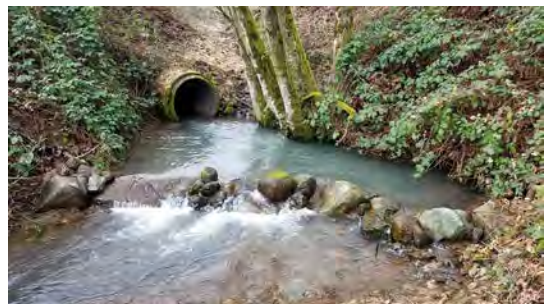
Downstream weir at winter base flow – February 2018

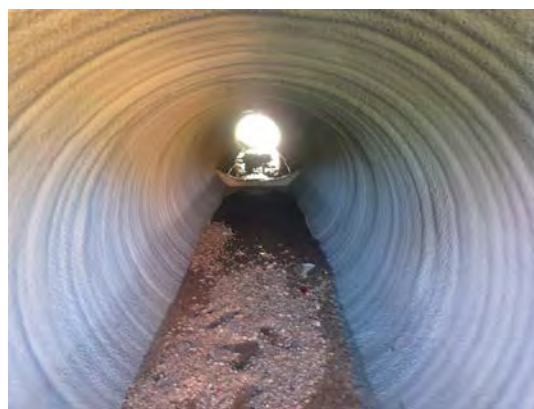
Inside of culvert showing centrifugally cast concrete liner

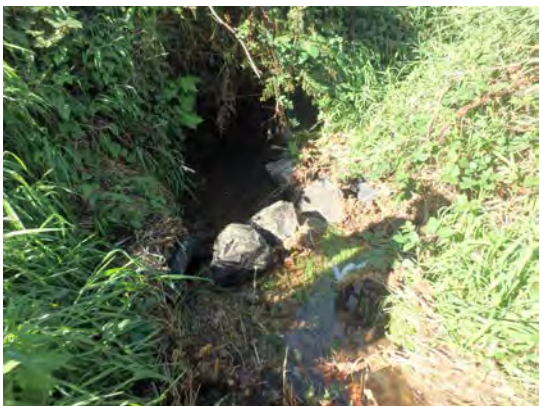
Downstream rock weir to back water up to culvert outlet
