**EPOXY COATED  
REINFORCEMENT STUDY**

**Final Report**

**STATE RESEARCH PROJECT #527**

June 1999

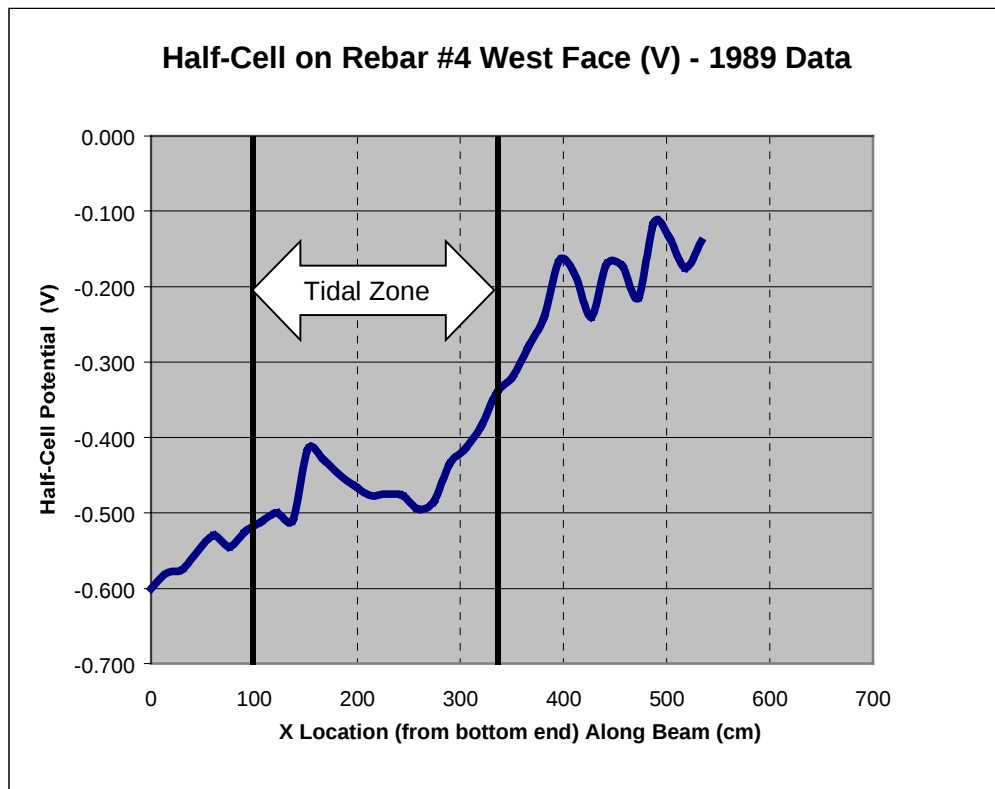
Figure 3.1: 1989 Half Cell Potential Profile for the Removed Test Beam

At the Laboratory, half-cell potential measurements were taken to develop a potential profile for the beam. Figure 3.1 provides the half-cell testing results. The tidal zone on the beam was estimated to be between 1.0 to 3.35 m, as measured from the bottom end of the beam.

As can be seen in Figure 3.1, the potential for corrosion within the tidal zone was more negative than the -0.35 V threshold, indicating a 90% probability that corrosion was occurring.

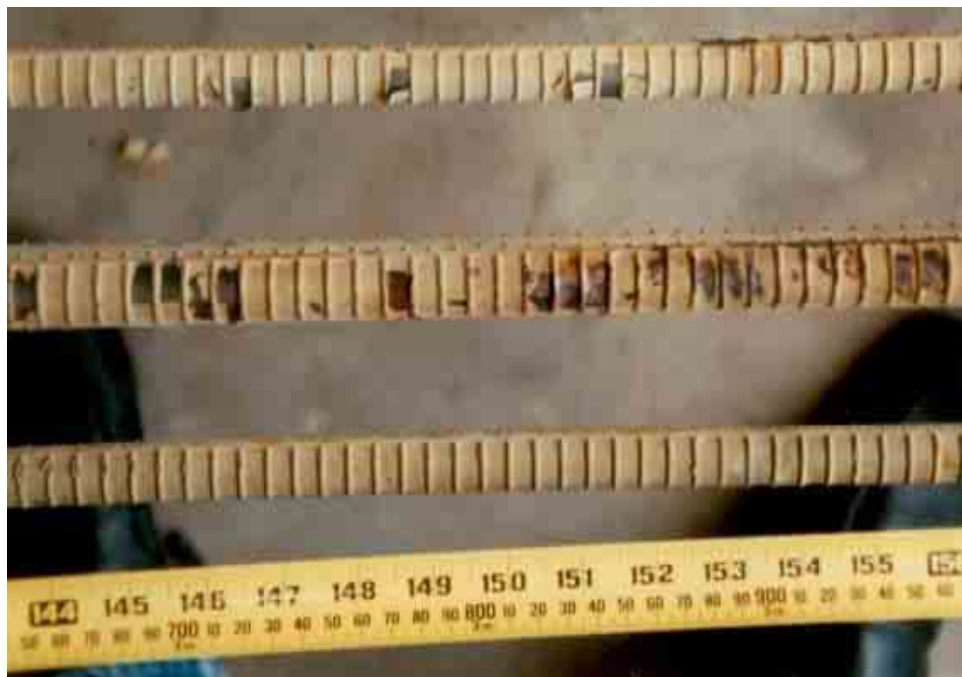
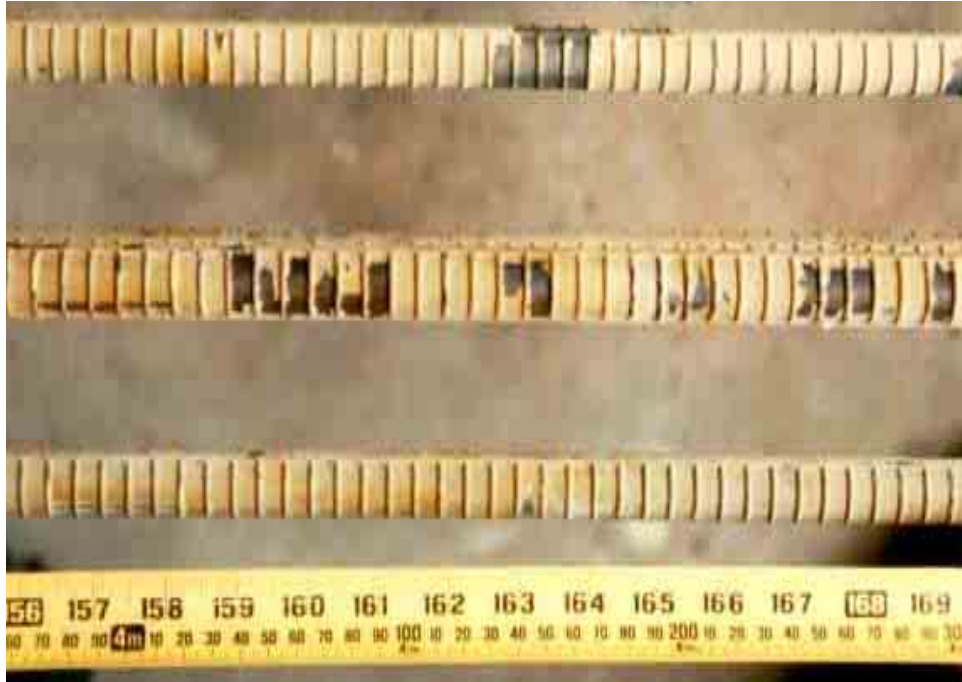
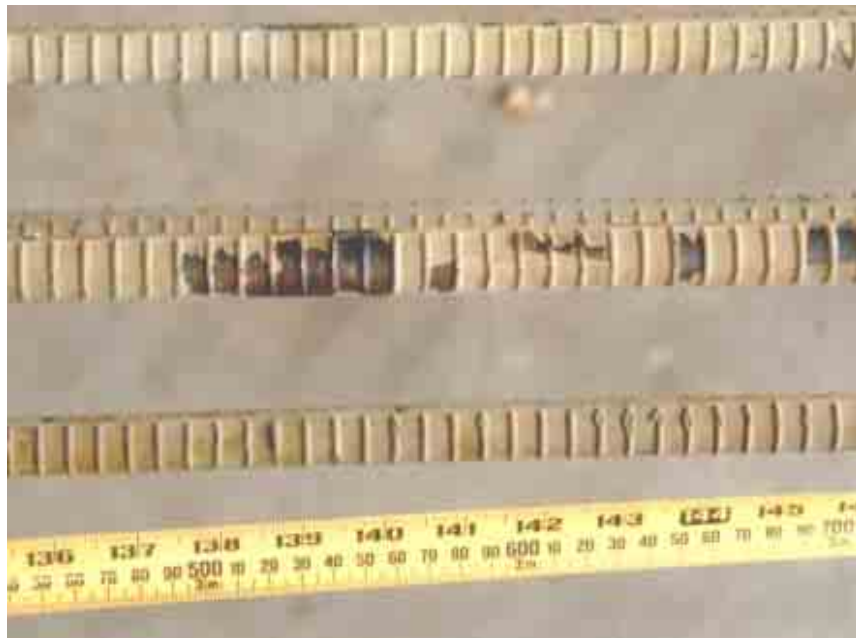
After the half-cell potential tests were completed, the concrete was removed and the epoxy coated reinforcement exposed for visual examination. Corrosion areas were observed on two of the longitudinal #5 bars as well as several #3 hoops. Figures 3.2 through 3.4 illustrate the corrosion on the longitudinal bars measured from the top end of the beam. The locations were within the beam's tidal zone, 3.0 to 4.4 m from top end of the beam (1.3 to 3.1 m from the bottom end).

Figure 3.2: Corrosion Along the Longitudinal Bar

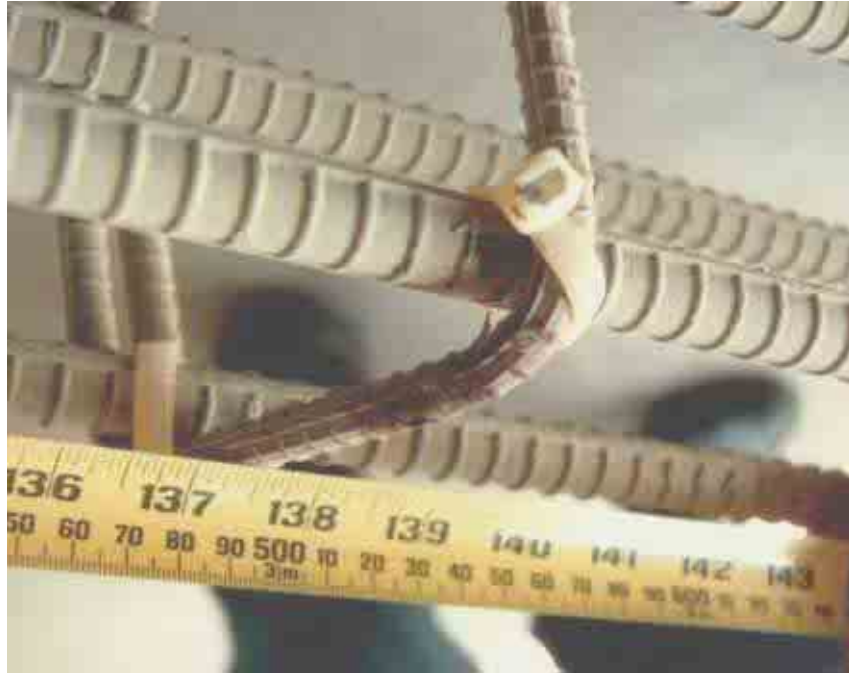
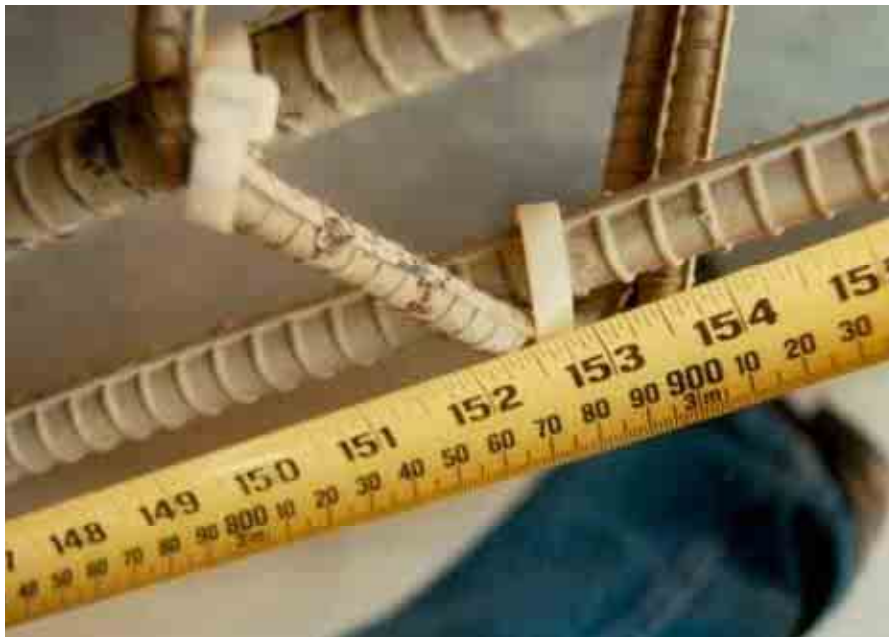
There was also corrosion noted on hoop reinforcement located between 3.5 and 4.0 m measured from the top end of the beam (2.1 to 2.6 m from bottom end). Figures 3.5 and 3.6 show corrosion, also occurring in the tidal zone.

Figure 3.5: Corrosion Along a #3 Hoop

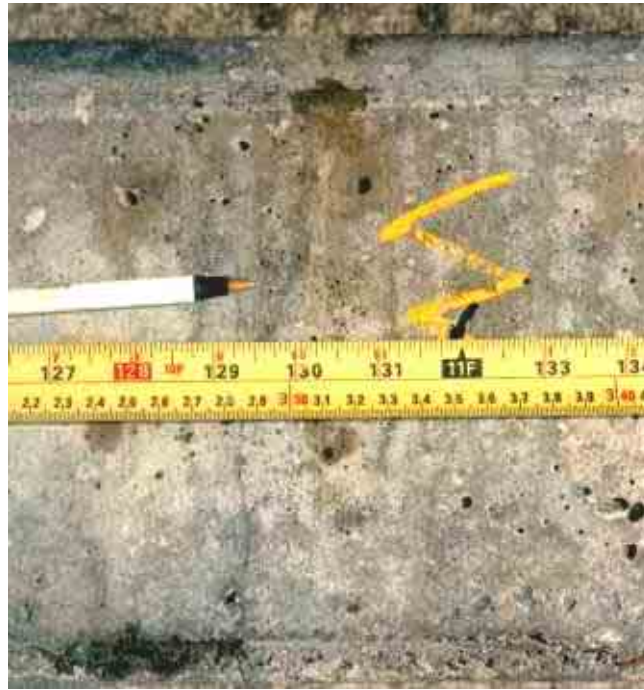
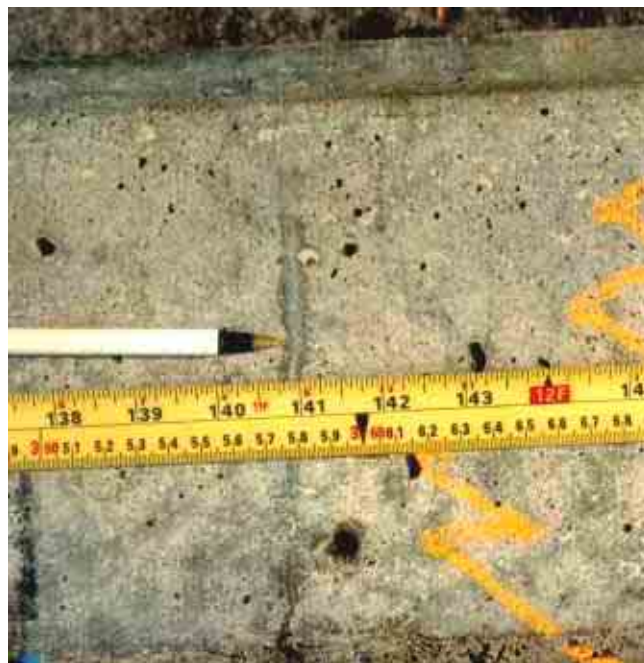
As seen in Figures 4.2 and 4.3, transverse cracking was noted on the beam, particularly in the upper half. The spacing of the cracks in this section occurred about every 200 to 250 mm, which mirrored the spacing of the hoop reinforcement. There are several possible factors that could have contributed to the cracking. These include:

- Reduced depth of cover of concrete at the hoop locations (50 to 64 mm);

- Expansion and contraction of the hoop reinforcement; and
- Corrosion of the hoop reinforcement with subsequent disruption and cracking of the concrete.

Figure 4.2: Transverse Cracking Propagated from the Reinforcing Hoop

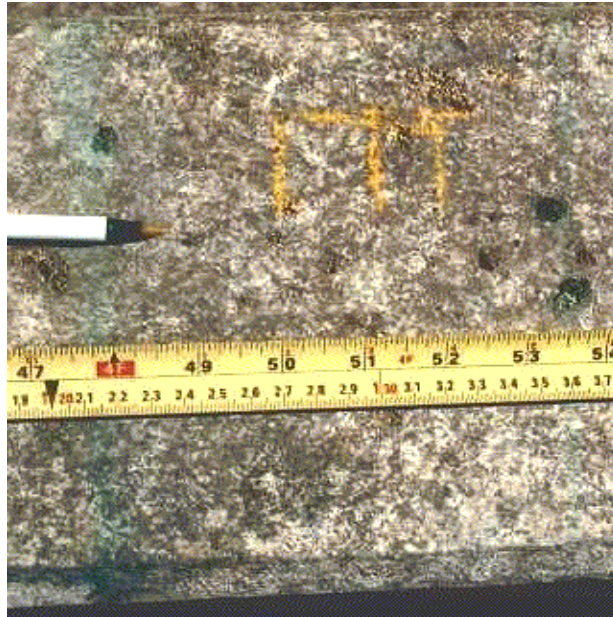
There was also some random cracking noted in the tidal and submerged zones of the beam (Figure 4.4). These were hairline type cracks with no apparent pattern. Cracks were hard to identify in these areas because of the surface discoloration caused by the barnacles.

Figure 4.4: Hairline Cracks Noted in the Submerged Zone

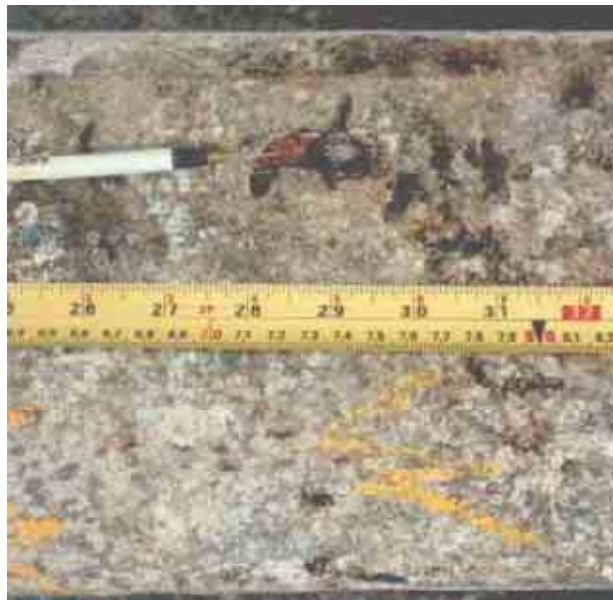
Of the four exposed faces of the beam, the west face had the most surface defects, especially in the submerged zone. Figure 4.5 shows some of the pockmarks that were found on this face of the beam.

Figure 4.5: West Face of the Beam with Pockmarked Areas

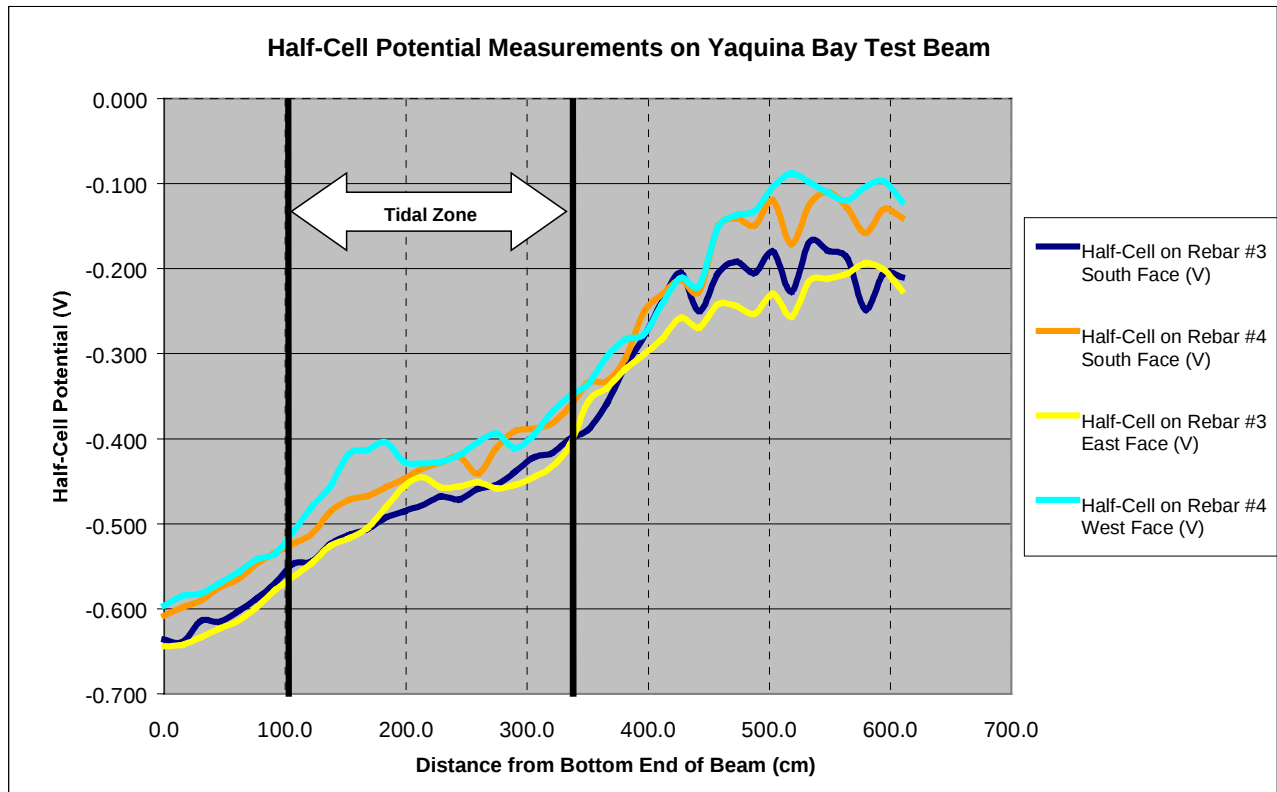
Figure 4.8: Half-Cell Potential Measurements Along Each Exposed Face of the Beam

Figure 4.8 shows there were no wide variations in the readings for each group. In the submerged zone (0 to 1.0 m), the potential levels are more negative than “-0.50 V”. The potential for corrosion is therefore much higher in this zone. However, because of the lack of available oxygen in the seawater, the corrosion process is very slow.

In the tidal zone, oxygen is readily available for diffusion into the concrete and the corrosion rate in the presence of chlorides is much higher. Within this zone, the half-cell potential measurements were more negative than the “-0.35 V” threshold, indicating a 90% probability that corrosion could occur.

The numeric values of the half-cell potential measurements decreased as the distance along the beam increased. Within the dry zone, the readings were in the “-0.40 V to -0.35 V” range at the tidal zone/dry zone interface, but became more positive towards the top end of the beam. Based on the half-cell potential readings, the probability of corrosion occurring in the higher portions of the dry zone was low.

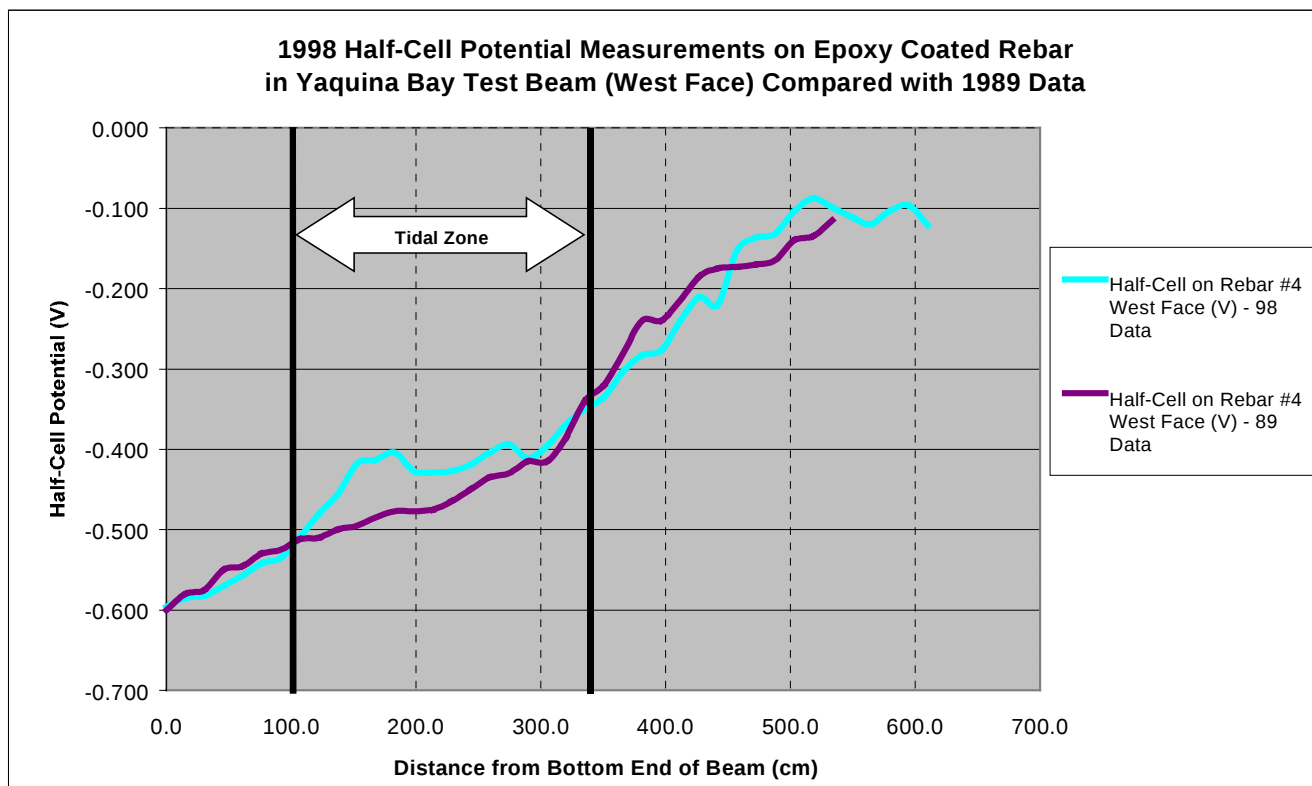
Figure 4.9: Comparisons of Half-Cell Potential Measurements for 1998 and 1989 Along the West Face for Bar #3

Figure 4.9 shows a comparison of the half-cell measurements taken from the 1989 test beam to the half-cell measurements taken in 1998. The two graphs are reasonably close and there appears to be little difference in the two sets of half-cell potential measurements.

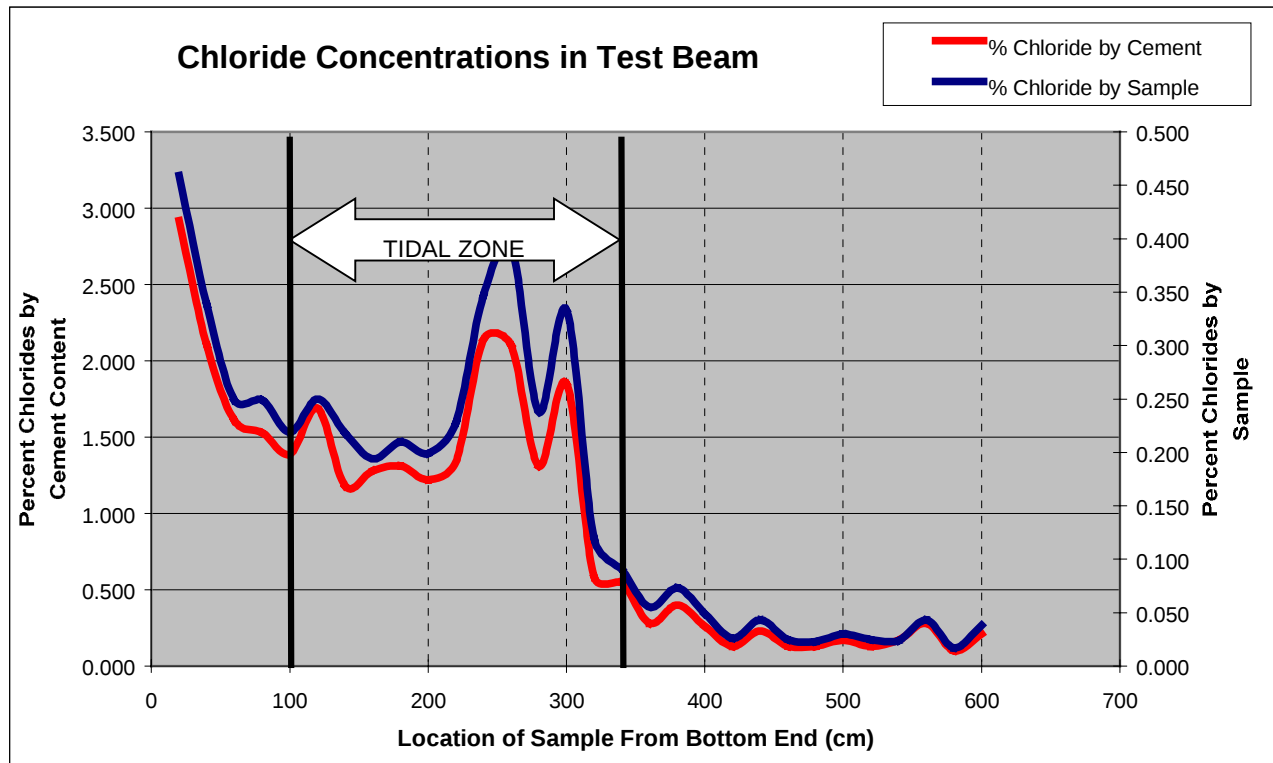
Figure 4.10: Chloride Concentrations Along the West Face From the Bottom End of the Beam

comprised of material taken from the beam's surface to a depth of 100 mm. Chloride concentration was then determined by testing for total chlorides in the sample and total chloride concentration by cement. The latter test was done to reduce errors occurring as a result of variable levels of aggregate in the powder sample. The results of the testing are shown in Figure 4.10.

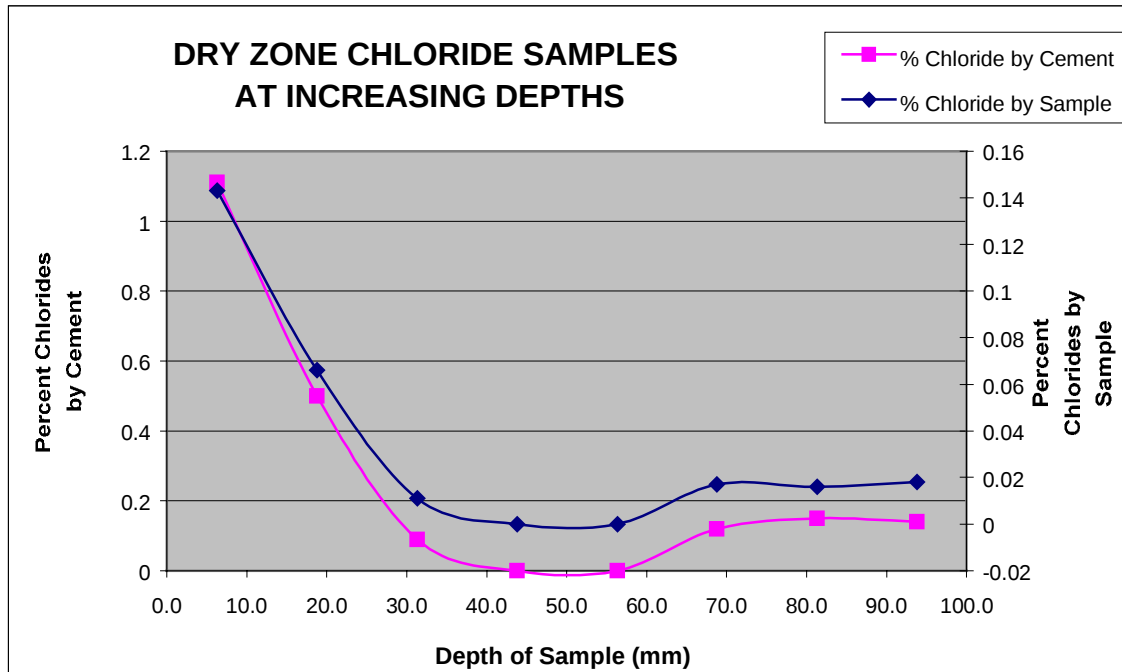
Figure 4.11: Chloride Testing on Samples Taken at Varying Depth Levels in the Dry Zone

In the dry zone (Figure 4.11), the graphs show that the chloride concentration decreases with increasing depth to a depth of 62.5 mm where the concentration is negligible. At greater depths, the chloride concentration increases slightly. There is no apparent explanation for this other than possible sampling or testing error at these low concentrations.

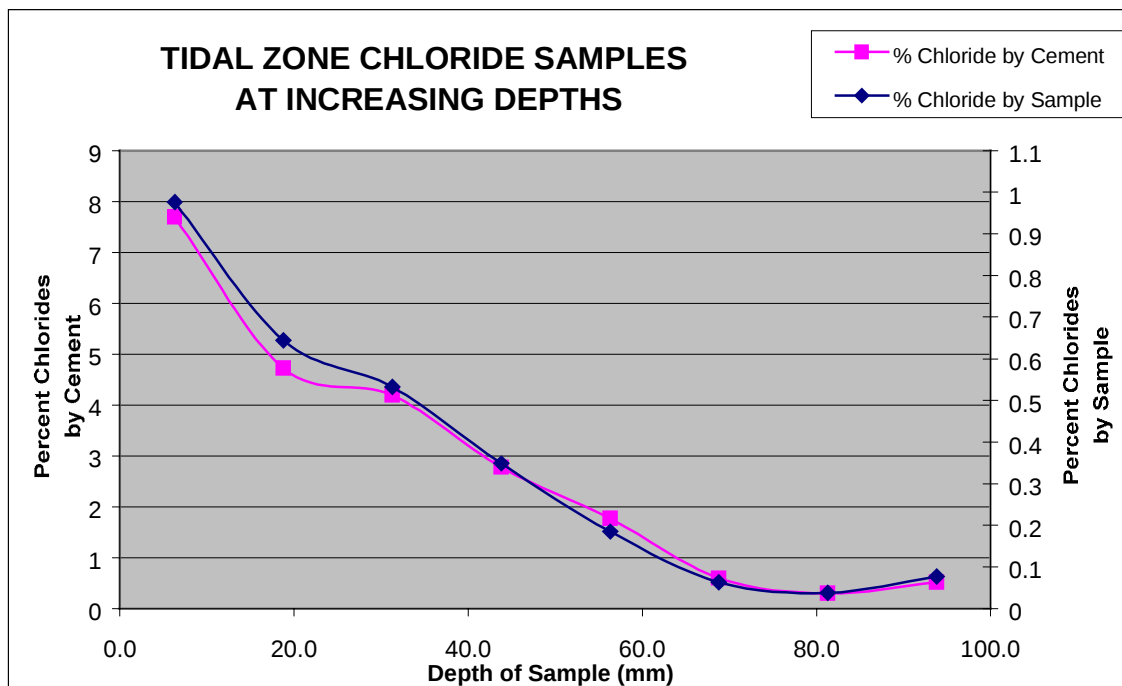
Figure 4.12: Chloride Testing on Samples Taken At Varying Depth Levels in the Tidal Zone

In the tidal zone (Figure 4.12), chloride concentration decreased as the depth where the sample was taken increased. At the interval, 87.5 to 100 mm however, the concentrations did appear to increase slightly, which again could be the result of sampling or testing error.

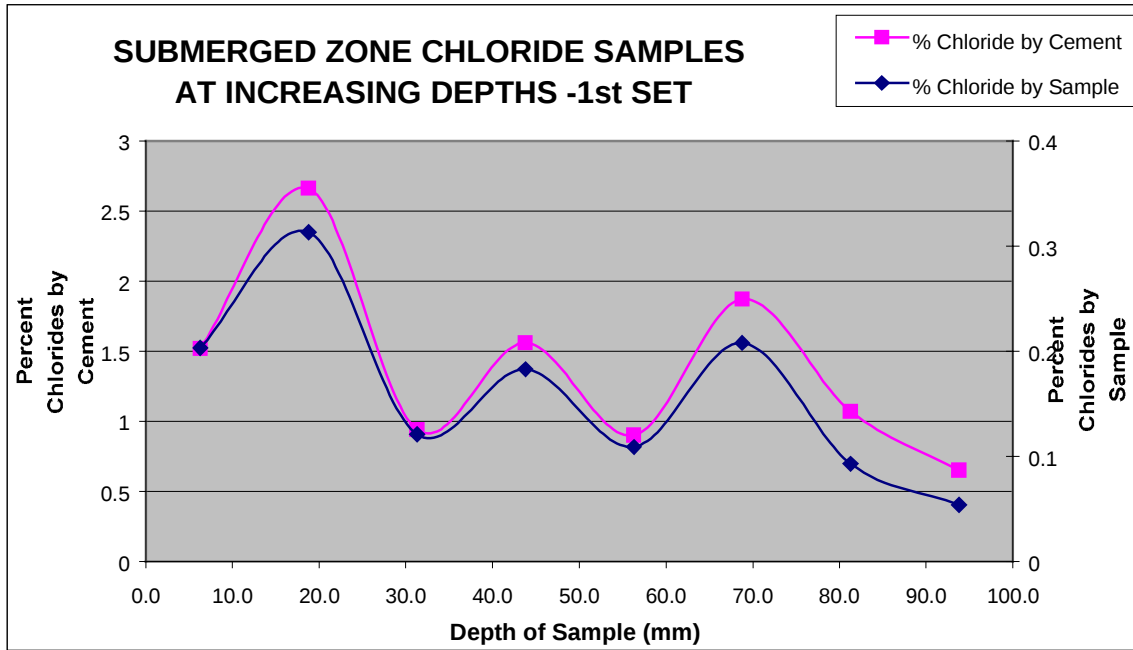
Figure 4.13: Chloride Testing on the First Set of Samples Taken at Varying Depth Levels in the Submerged Zone

In the submerged zone (Figure 4.13), the concentrations did not follow the classical pattern recorded for sampling in the other two zones. As depth increased, chloride concentration also increased for three of the eight samples (12.5 to 25.0 mm, 37.5 to 50.0 mm, and 62.5 to 75.0 mm). As a result of this irregular pattern, a second group of chloride samples were taken for the submerged zone (Figure 4.14).

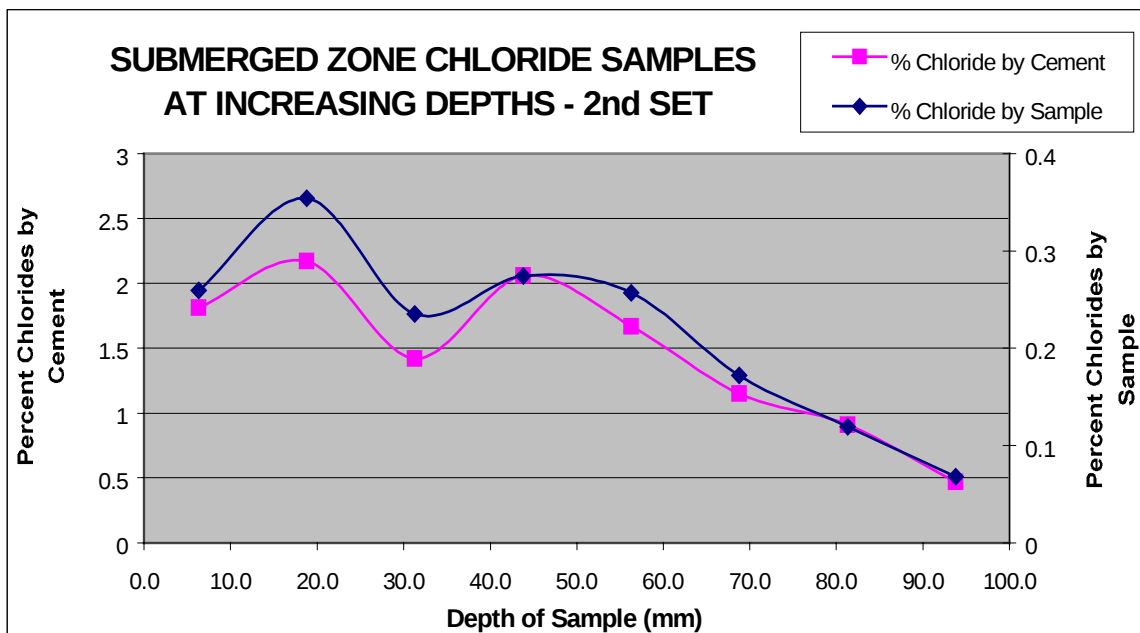
Figure 4.14: Chloride Testing on the Second Set of Samples Taken at Varying Depth Levels in the Submerged Zone

As seen in Figure 4.14, the chloride concentrations did increase at two of the same depth intervals (12.5 to 25.0 mm and 37.5 to 50.0 mm) as previously measured in the first set of samples for the dry zone. There is no apparent explanation for the irregular pattern in the two groups of dry zone samples.

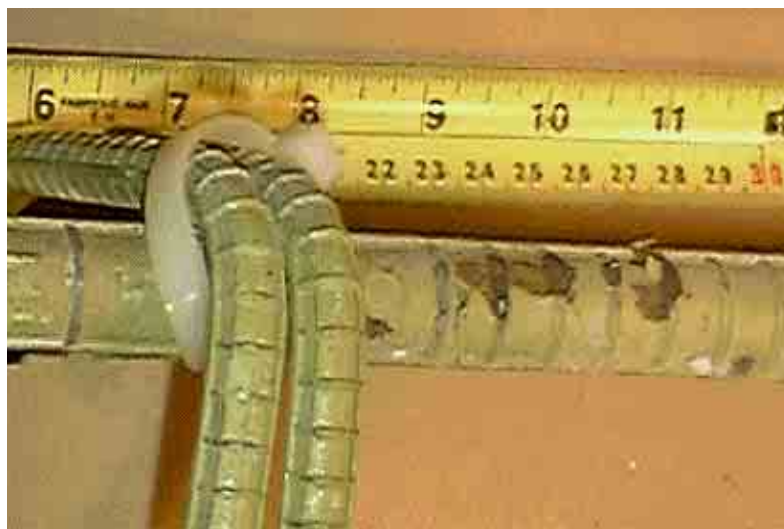
Corrosion was observed at approximately 200 mm and 950 mm from the bottom end along rebar #3 (Figure 4.15). The other bars appeared to have no visible signs of corrosion. Some corrosion was found on each of the hoops (Figure 4.16).

Figure 4.15: Observed Corrosion of Longitudinal Rebar in the Submerged Zone

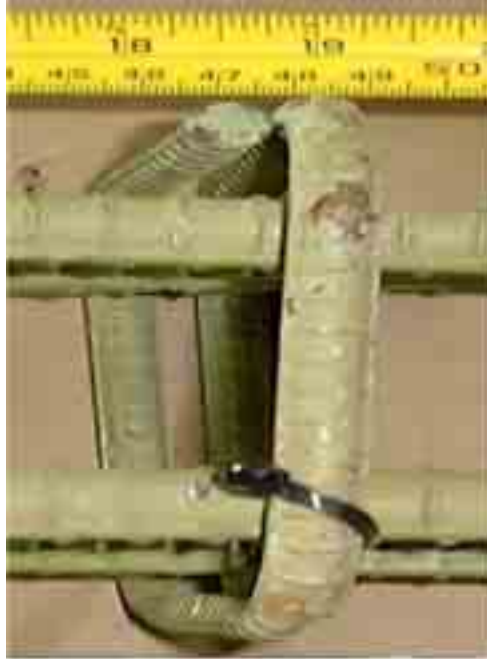
Figure 4.16: Observed Corrosion of Hoop in the Submerged Zone

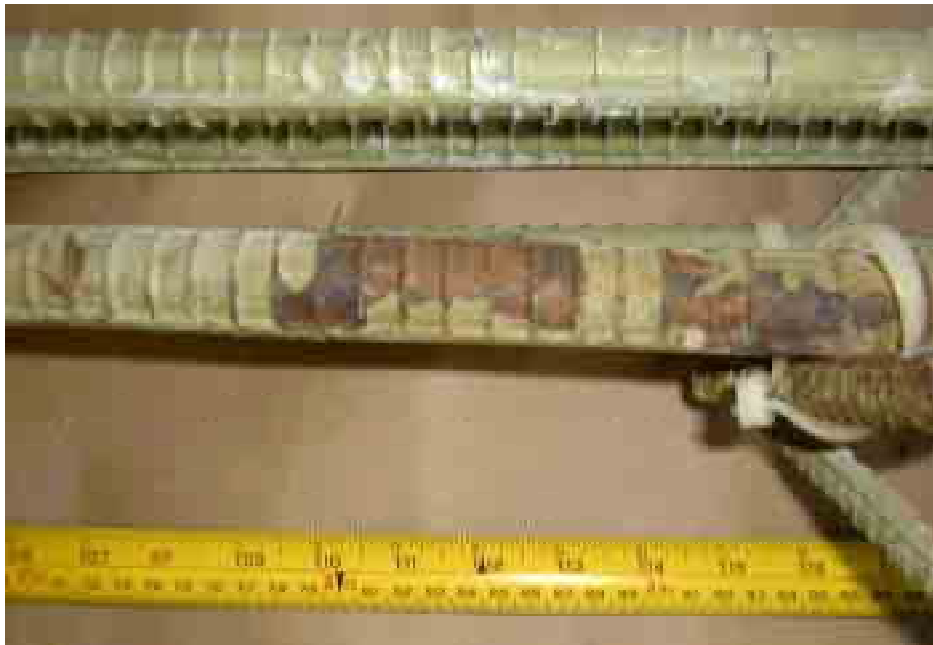
Corrosion was observed in many areas on the Scotchlite 213 epoxy coated reinforcement along rebar # 1 and the hoops. There was extensive corrosion between 2.6 and 3 m as measured from the bottom end of the beam along rebar #1. The other bars had no visible signs of corrosion. Figures 4.17 and 4.18 show two areas of corrosion along rebar #1.

Figure 4.17: Corrosion Along Rebar #1 (2.8 to 2.95 m from bottom end of beam)

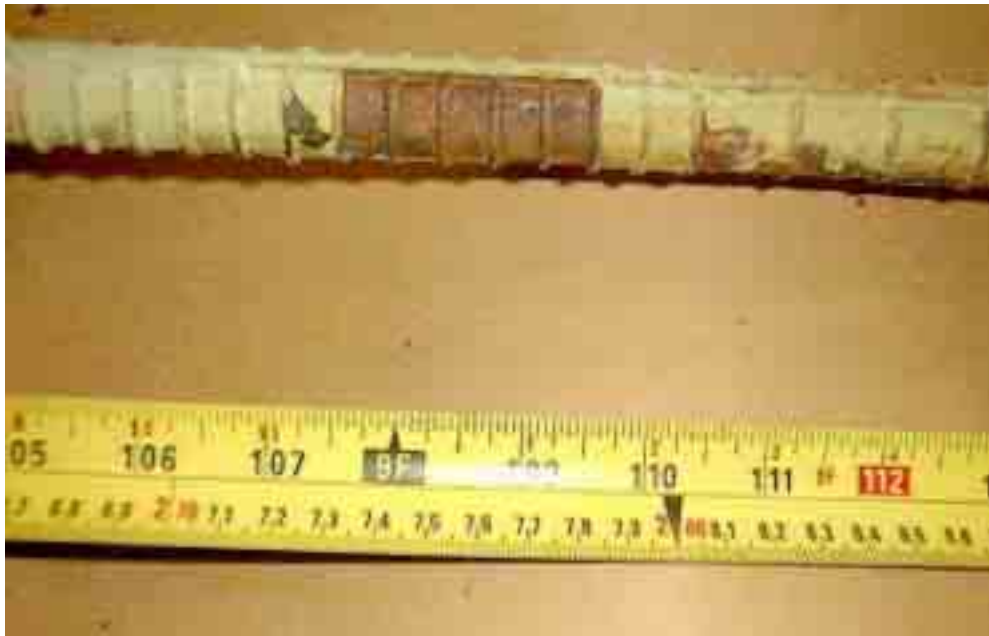
Figure 4.18: Corrosion Along Rebar #1 (2.75 m from bottom end of the beam)

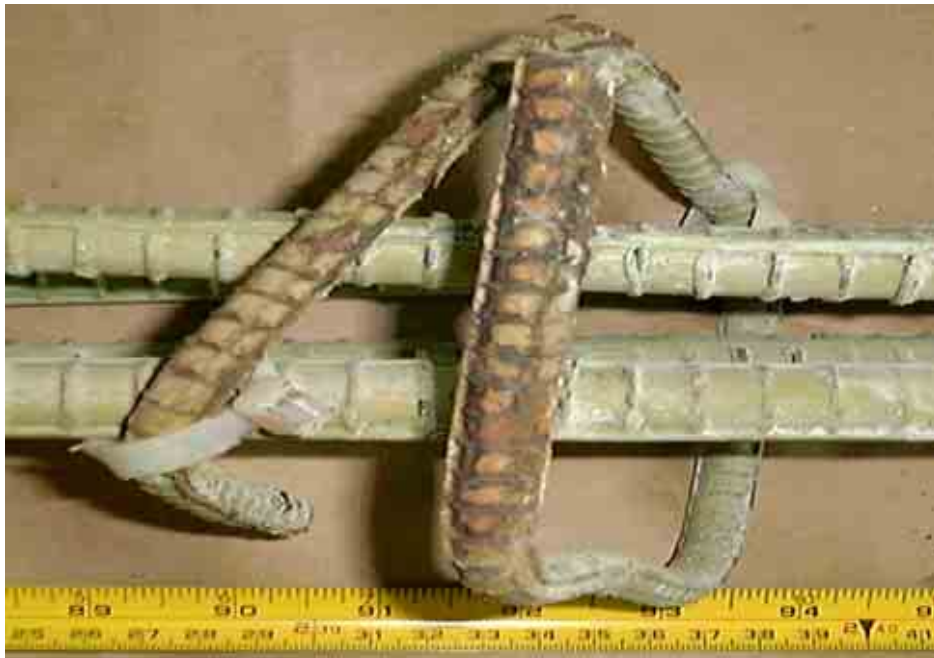
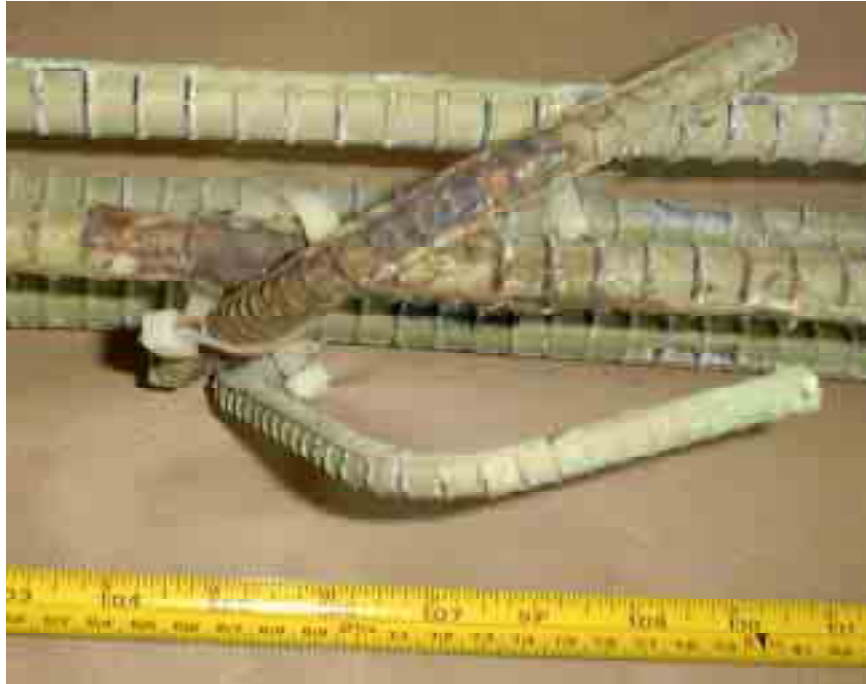
There was corrosion observed in all but one of the hoops in the tidal zone. The hoop that did not show signs of corrosion, was positioned in the beam at the high end of the tidal zone. Figures 4.19. and 4.20 illustrate the degree of corrosion appearing on the hoop reinforcement.

Figure 4.19: Hoop Corrosion in the Tidal Zone

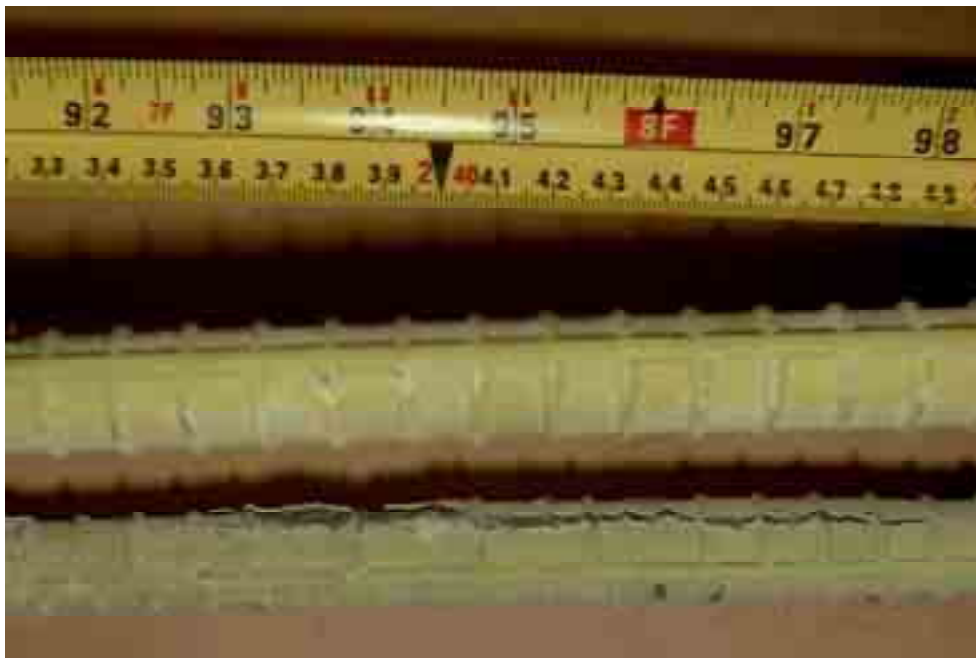
As noted earlier, there was significant adhesion loss of the coating within the tidal zone. An example of disbondment of the coating from the steel is shown in Figure 4.21.

Figure 4.21: Disbondment of the Epoxy Coating in the Tidal Zone

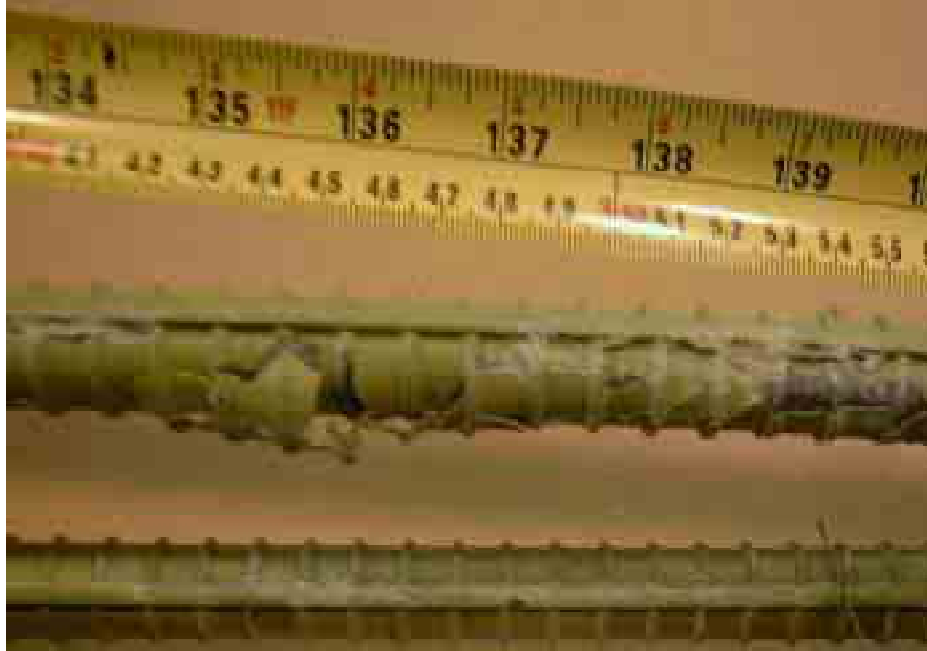
Within the dry zone, most of the Scotchlite 213 epoxy coated reinforcement appeared to be in good condition. Visible corrosion was not apparent in this area. There was some disbondment of coating closer to the tidal zone boundary (Figure 4.22).

Figure 4.22: Disbondment of the Coating at the Tidal and Dry Zone Interface
