BR#08492---YAMHILL OVERFLOW --- HWY 39 (OR18) --- MP 45.76

OSU  
OREGON STATE UNIVERSITY  
CIVIL AND CONSTRUCTION ENGINEERING

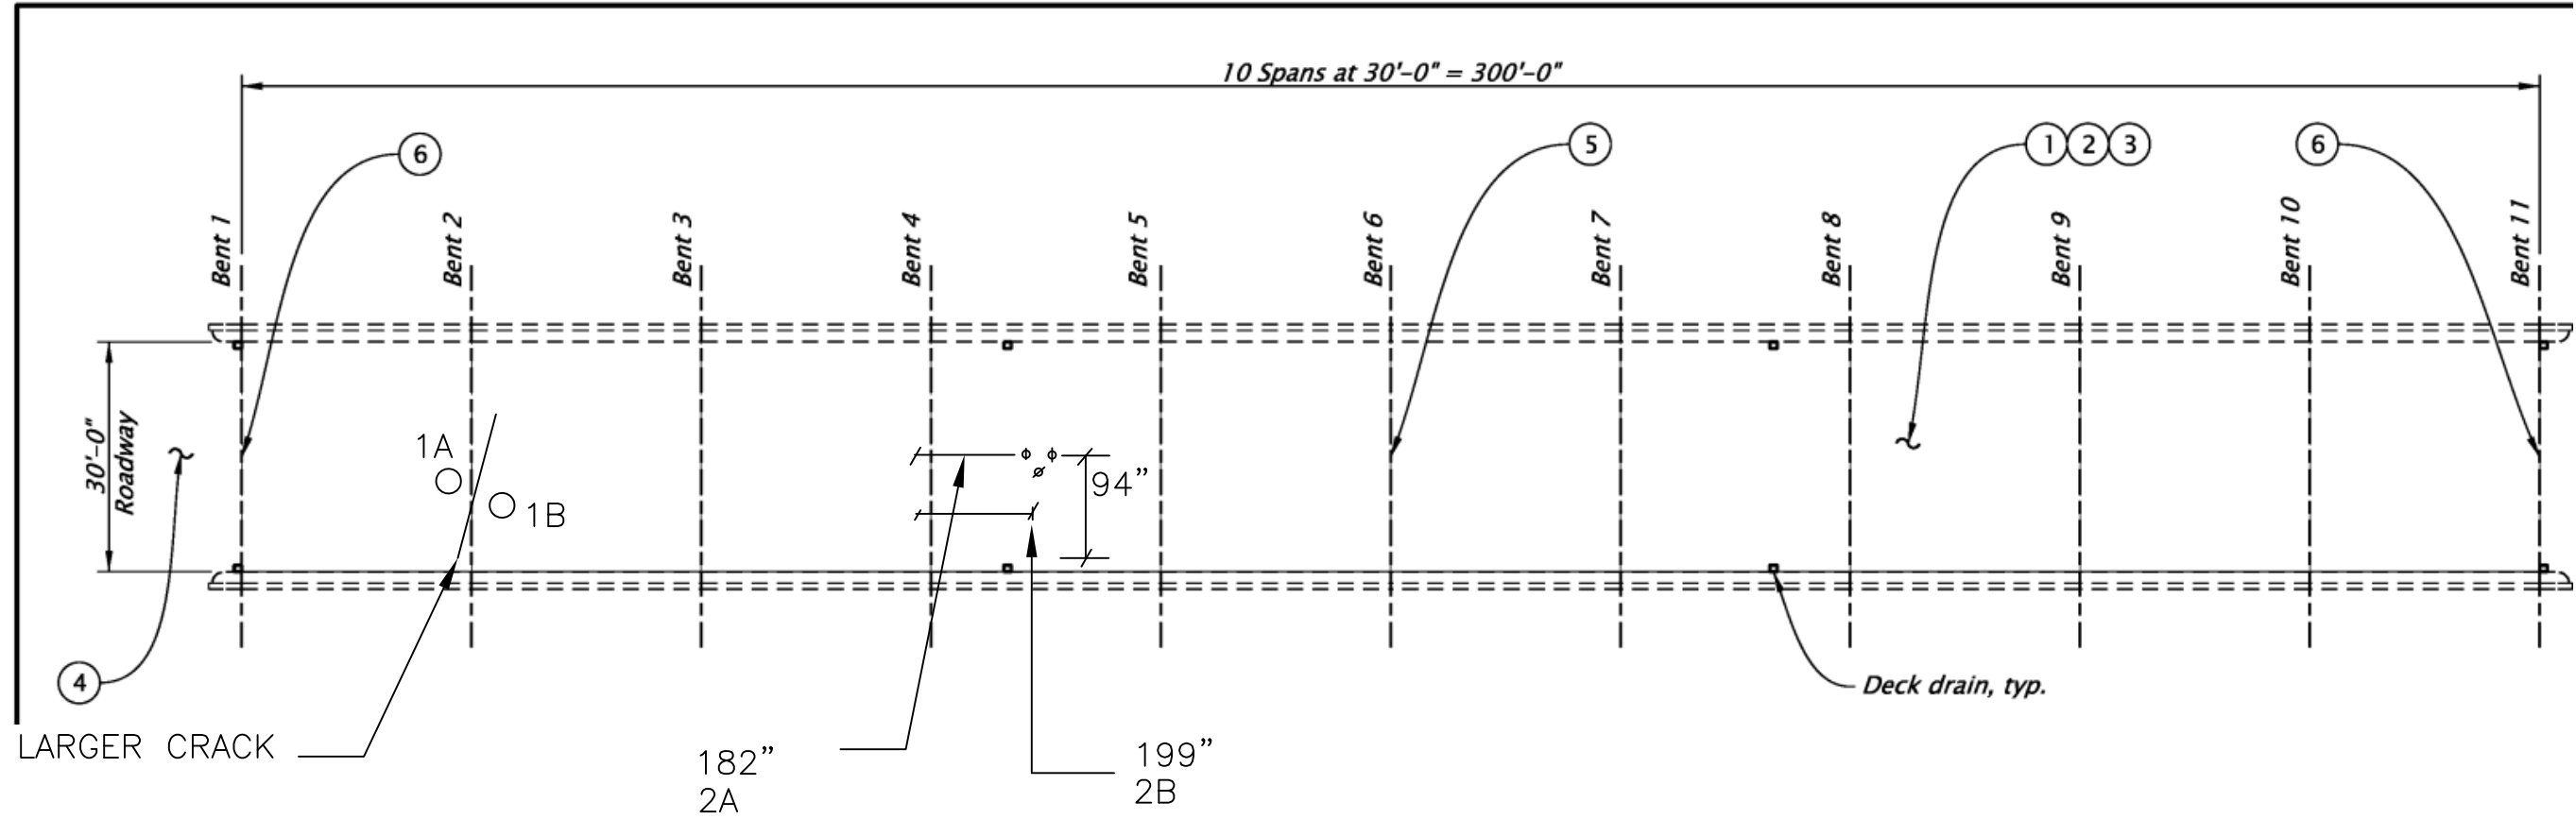
CORES LABELED

1A- THROUGH CRACK OVER BENT 2  
1B- ADJACENT TO CRACK

SOUND  
CONCRETE (NO CRACKS)  
CENTER OF TRAVEL LANE
