# **FACTORS FOR IMPROVED FISH PASSAGE WATERWAY CONSTRUCTION**

**Final Report**

**SPR 654  
OTREC-RR-11-19**

**ODOT/OTREC**

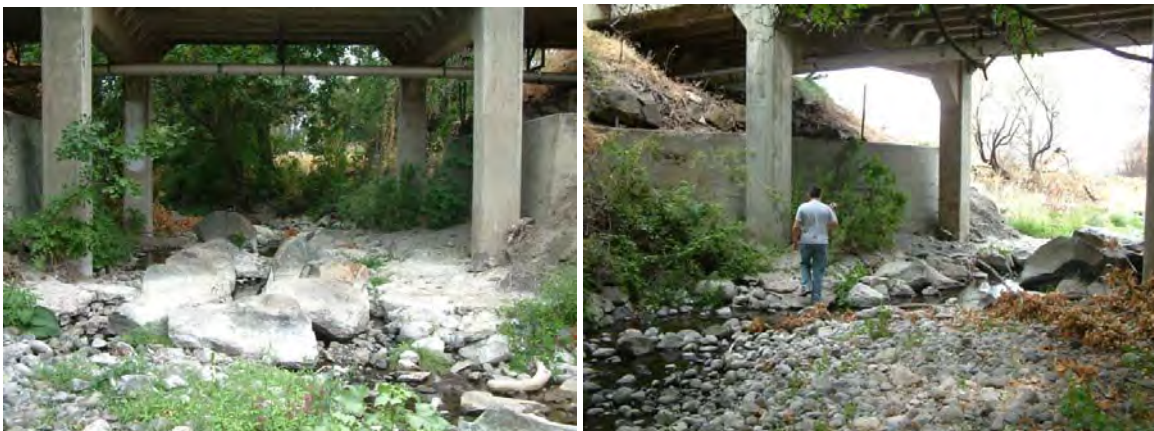
Figure 4.12: Site 10 - Chenoweth Creek downstream and upstream

Some history was available for this structure: Repairs to the channel located under the remnant bridge were performed in September of 2006 by applying concrete to the eroded streambed and placement of compacted streambed materials over the concrete base to provide fish passage to steelhead and salmon. Chenoweth Creek had exceptional winter flows in 2006 just after the concrete bed was installed. This resulted in structural failure of the concrete, extensive streambed material movement and loss of fines. In August 2007, subsurface flow was observed under the concrete channel liner and remaining streambed material immediately downstream of the structure as shown in Figure 4.13. Large boulders served to concentrate stream flow, created backwater and flow vortexes in the channel. In September 2007, ODOT made further repairs to this passage by removing the mid portion of the concrete bed and replacing streambed materials (NMFS Washington 2008).

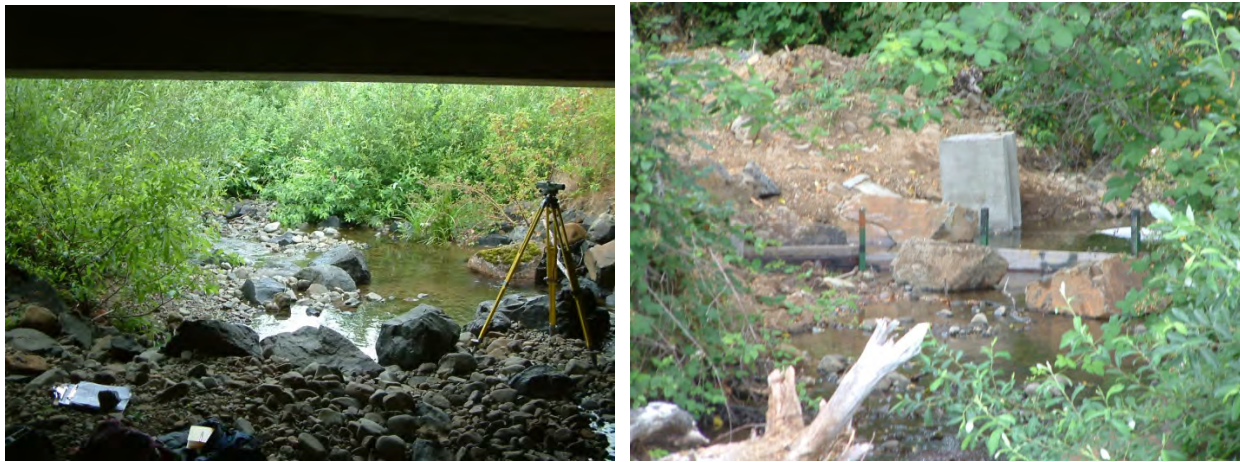
Figure 4.18: Site 16 - Jackass Creek downstream and upstream

Jackass Creek is located in Polk County and crosses highway 18 at MP 19.16. Access to the creek was from the downstream side (Figure 4.18 left) and was not particularly difficult. There were no problems in gathering any of the information and slopes and cross-sections were obtained easily. The upstream side of the creek (Figure 4.18 right) had an artificial block that created a small pool. In addition, the upstream channel had several high jumps (greater than 12 inches (30 cm)).
