## Timber Pile Cap Repairs

Travis Kinney

### Dairy Creek Over Flow Bridge Case Study

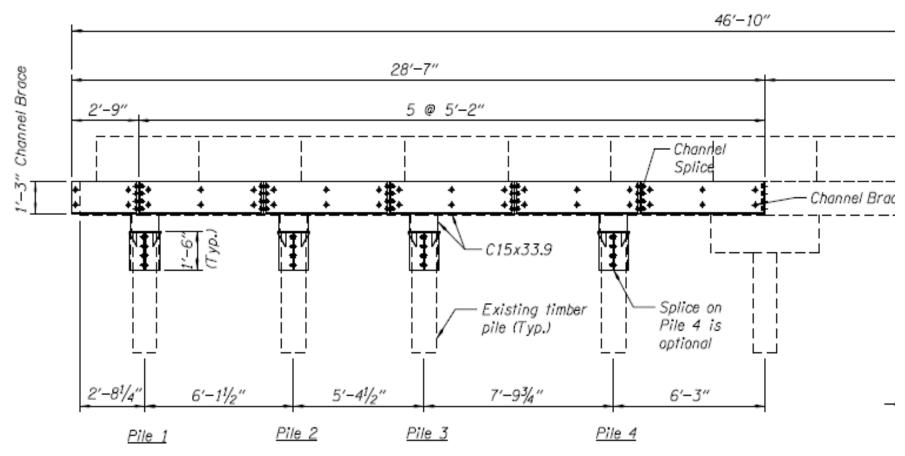
BENT 3 ELEVATION

• Repairing timber pile cap in place using channels.

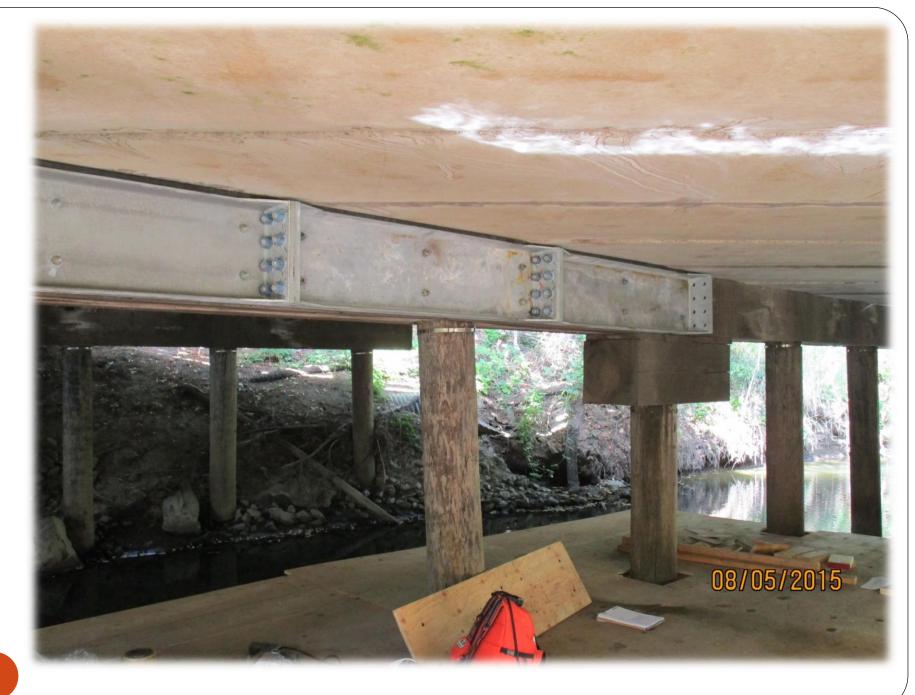
#### Cross-section of cap

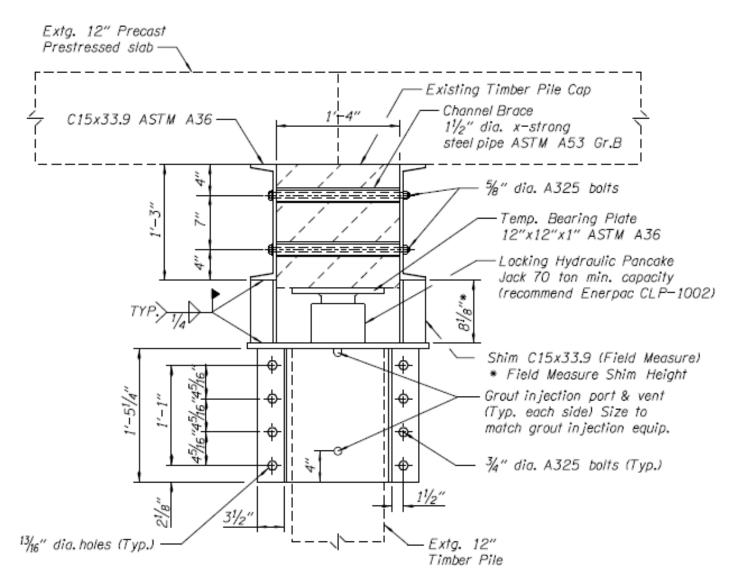
• Installing channel shims to connect steel cap to pile splice.

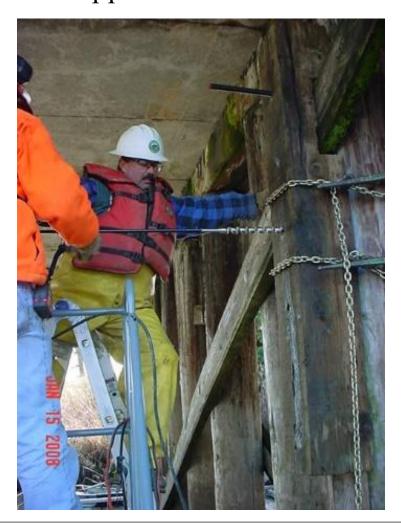
Bolting bolts to timber piles to support new beams

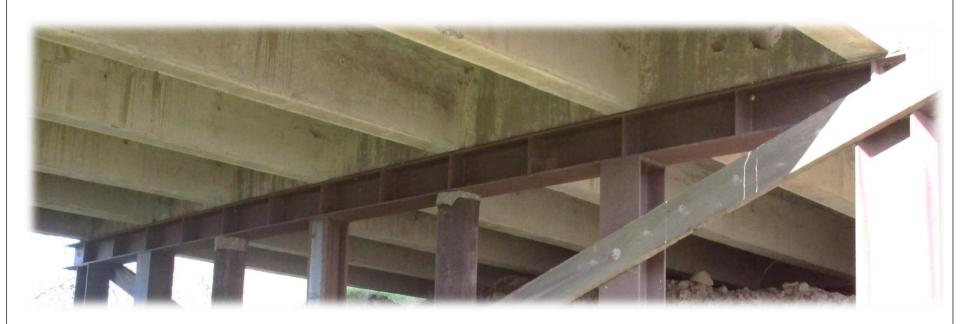
- Timber member usually replaced with Steel H Beam of similar size.
- Requires shoring the structure while old cap is removed and new cap is installed.

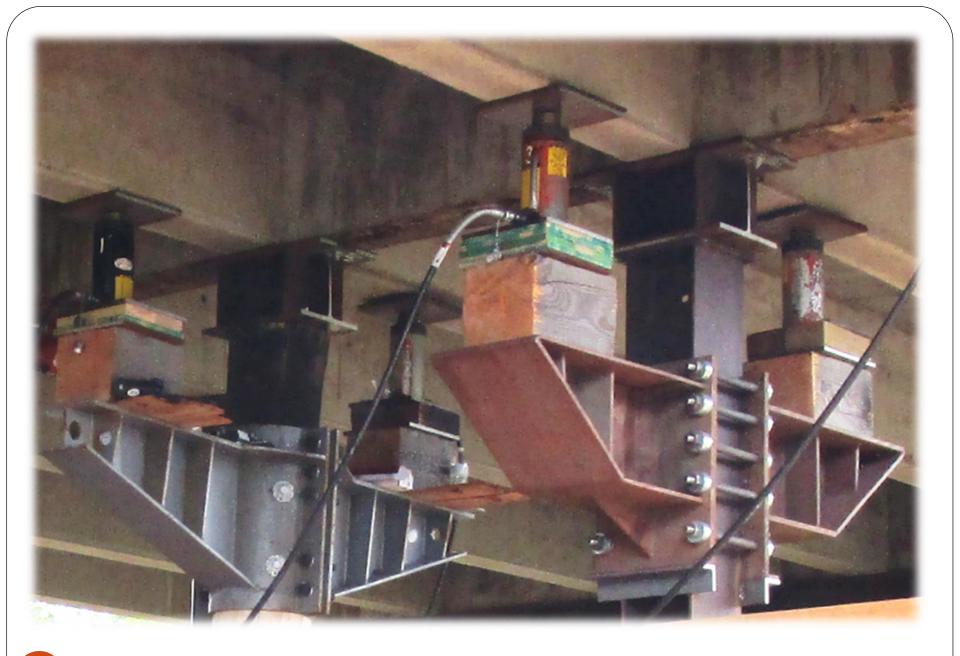
- Use to jack and shore the superstructure during pile cap repairs.
- They have been in heavy use by ODOT bridge crews and Local Agency bridge crews.
- Crews had clamps fabricated to fit on square piles also.
- Bridge is typically left open to all traffic throughout the project.
- First used in 1980's?
- Video of replacement available on YouTube.

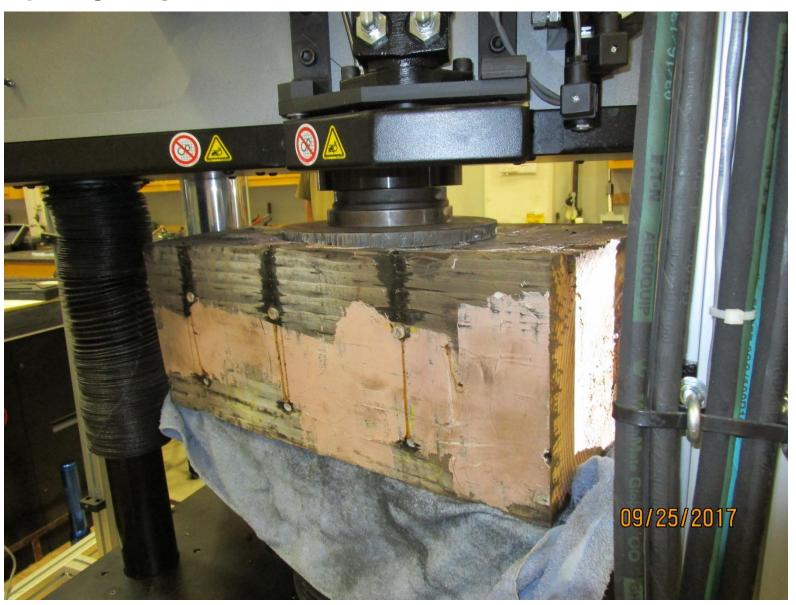
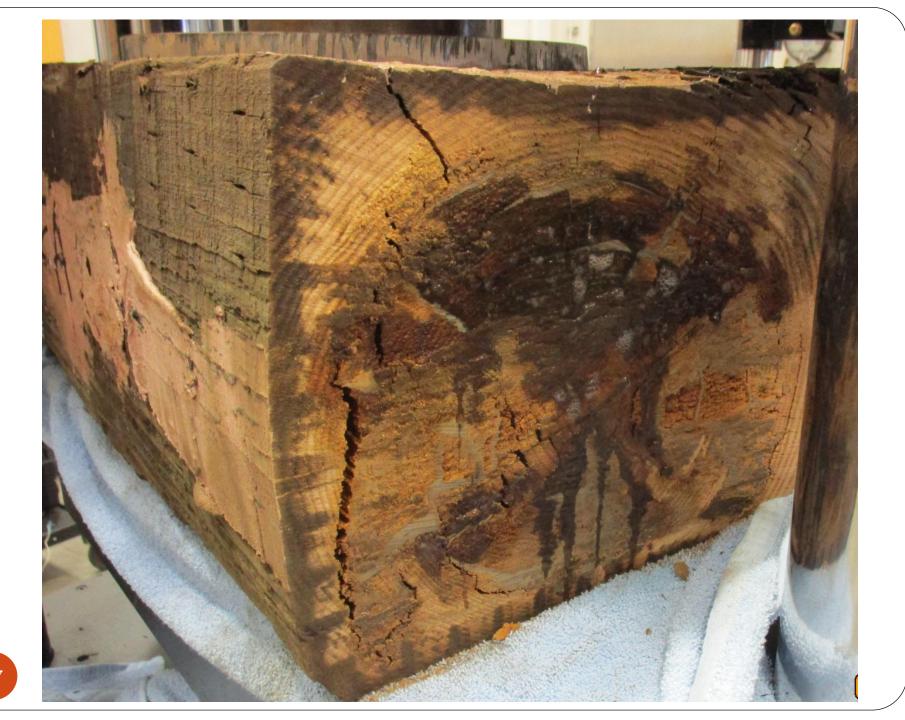
### **Epoxy Injection Destructive Test**

- Encapsulation:
  - Useful when utilities or shoring constraints make full removal problematic.
  - \$50,000 \$80,000.
  - Connection to piles can be difficult. (w/o is temporary)
  - Not feasible on abutments.
- Cap Replacement:
  - \$25,000 \$65,000
  - Shoring dominates design constraints and overall cost.
- Epoxy Injection:
  - Not recommended at this time as a viable cap repair.

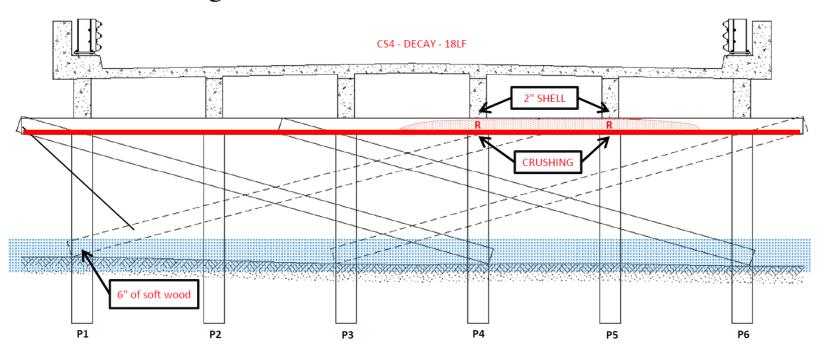
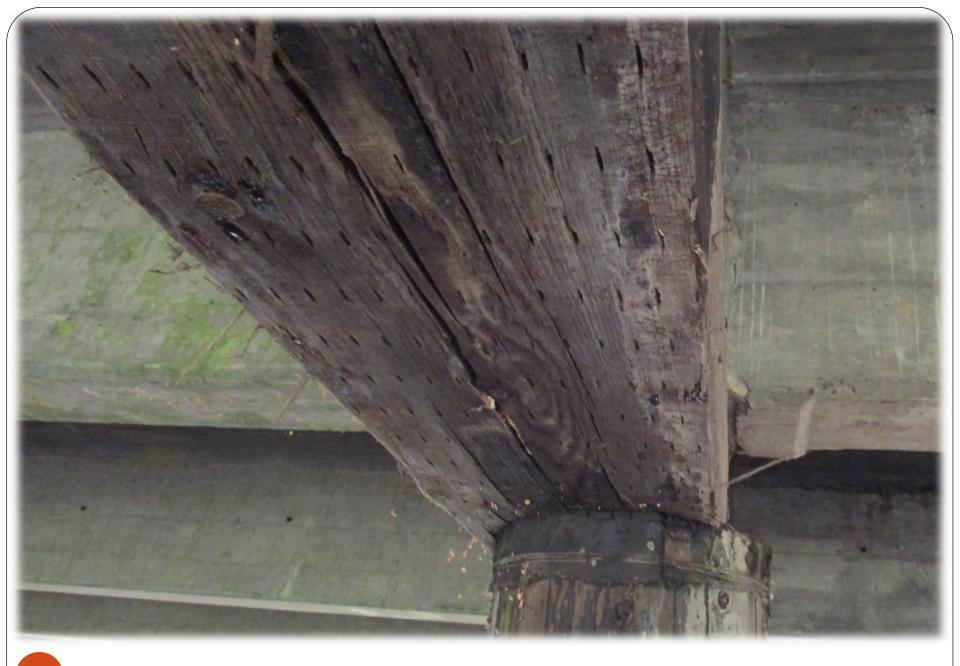
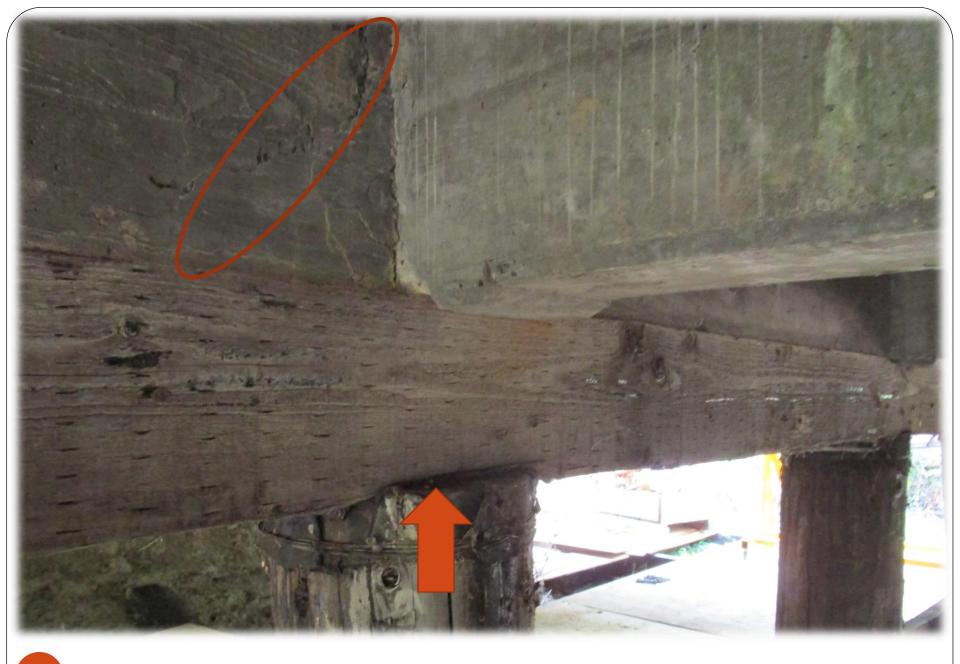
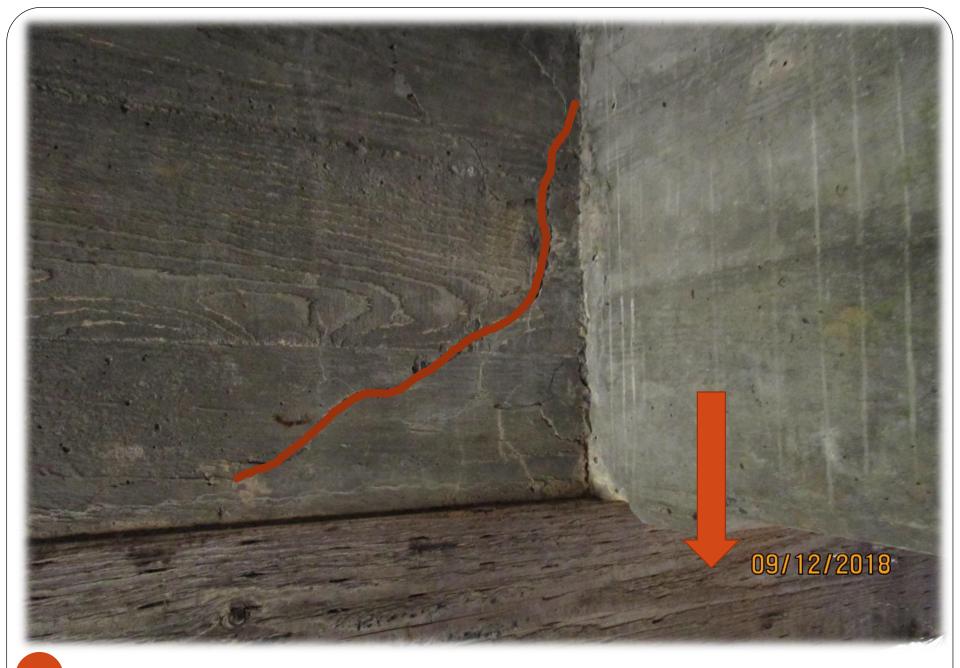
#### **Timber Boring Report**

- Inspected in April of 2018.
- Identified Significant rot and crushing above two interior piles.
- Substructure condition rating reduced to NBI 4.
- Load Posting Letter Drafted

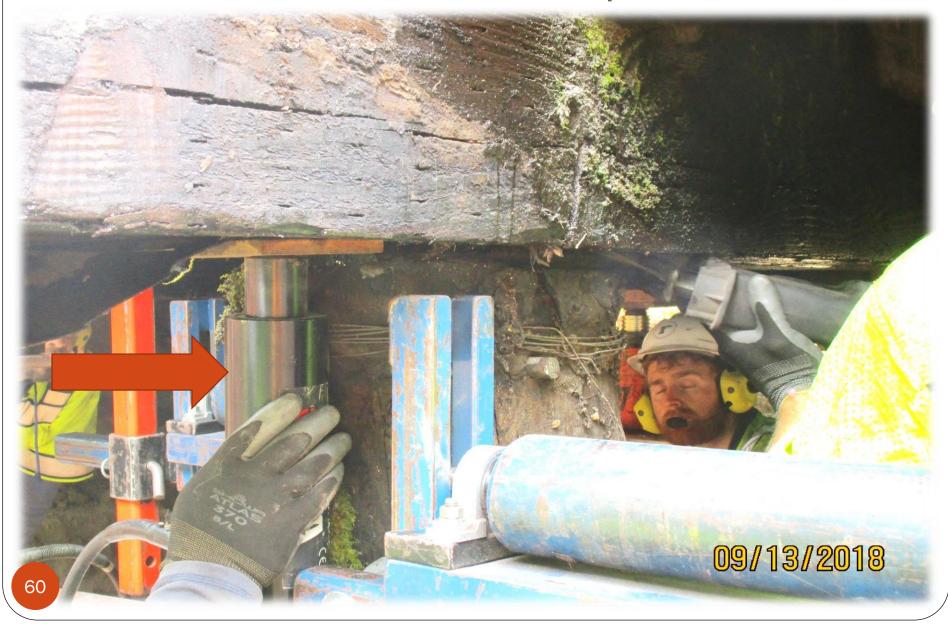
## Use Small Jack to Get Cap off Piles

# Cut Drift Pins 09/13/2018
