Over-Height Vehicle Collision Assessment and Repair Methodology

Tanarat Potisuk, PhD, PE, SE

Prestressed Concrete Standards Engineer

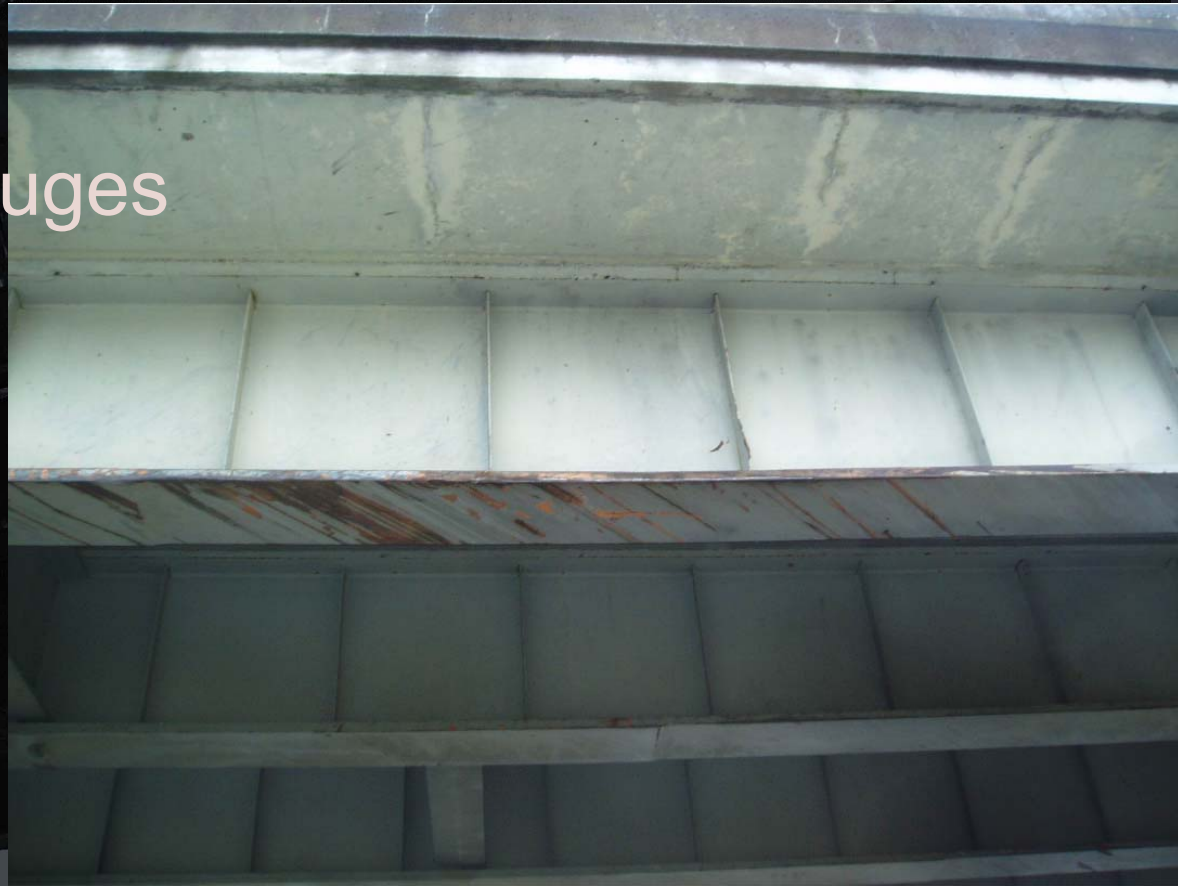
Hwy 162 Culver Rd

- Minor - no repair or minimal repair
 - Paint scrapes
 - Small nicks or gouges
 - Small girder web out of plumb

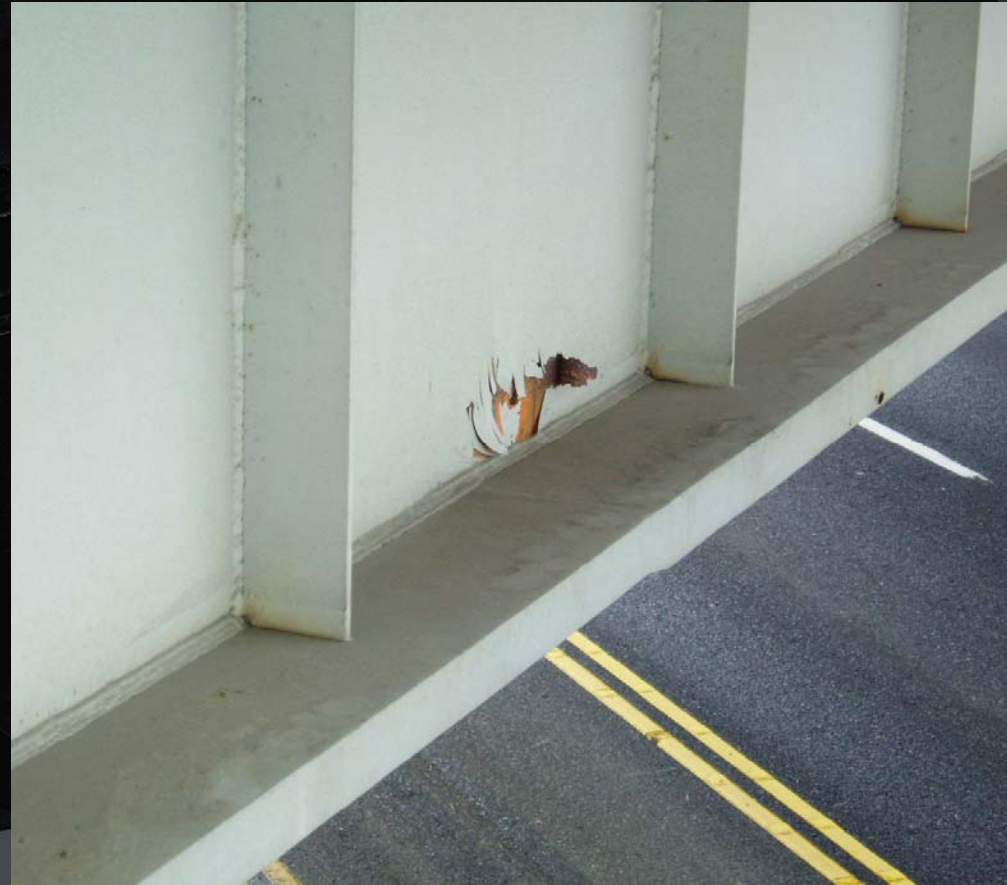
Hwy 162 Culver Rd

- Minor - no repair or minimal repair
 - Paint scrapes
 - Small nicks or gouges
 - Small girder web out of plumb

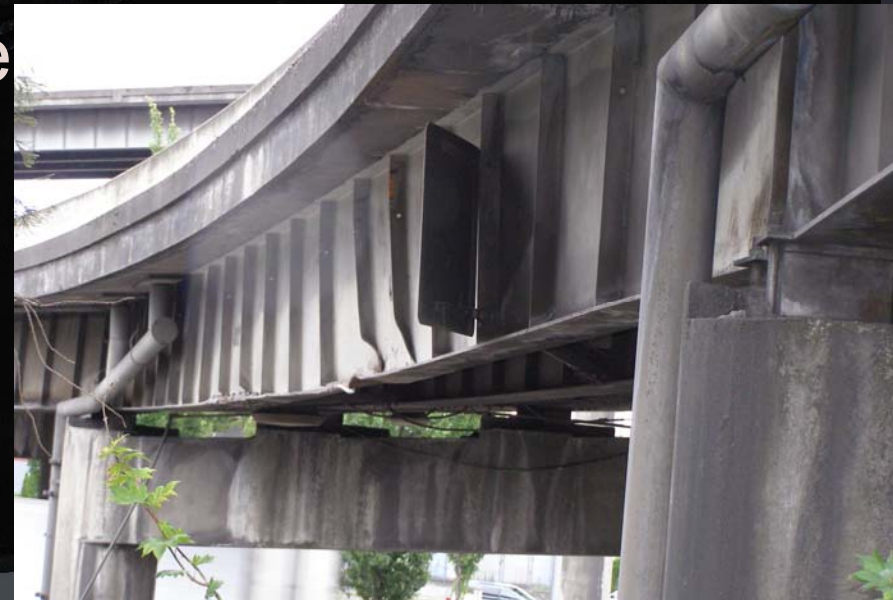
Morrison Ramp

- Moderate - repair or partial replacement
 - Moderate flange bends
 - Moderate girder web out of plumb
 - Tearing of web and flange

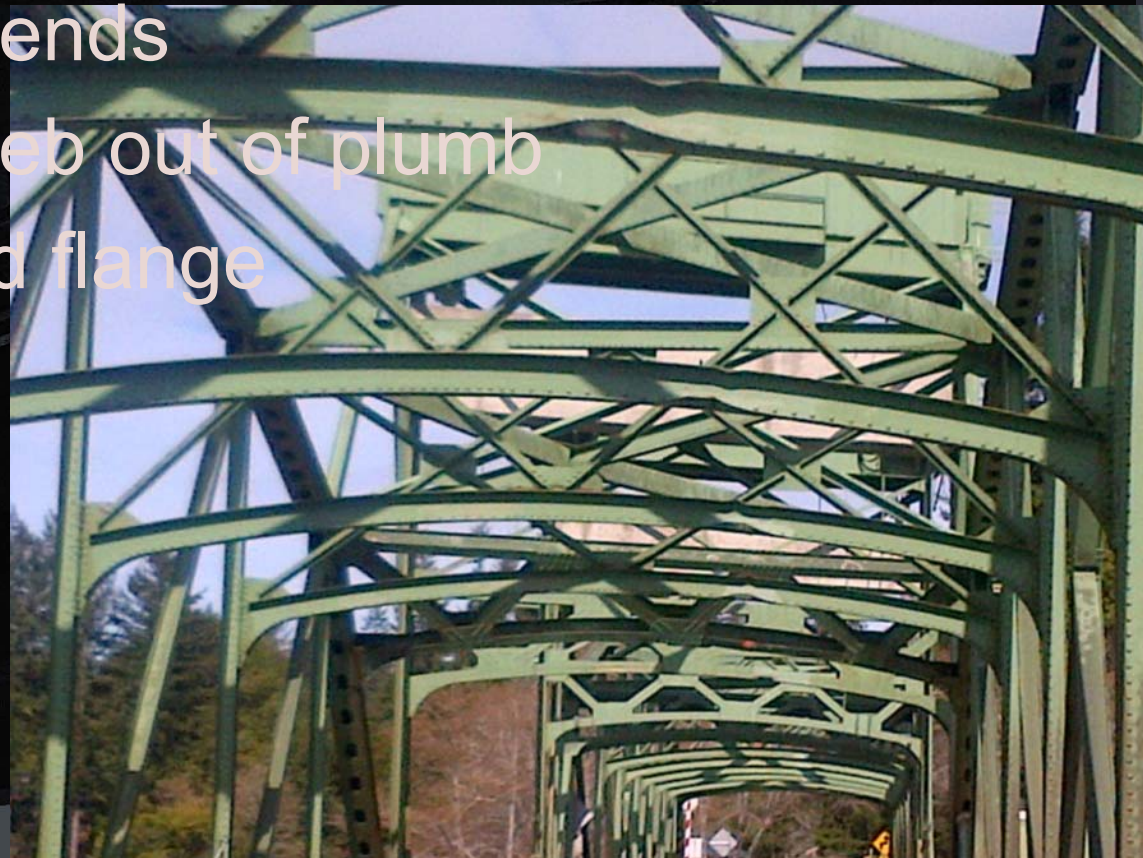
Chandler Bridge

- Moderate - repair or partial replacement
 - Moderate flange bends
 - Moderate girder web out of plumb
 - Tearing of web and flange

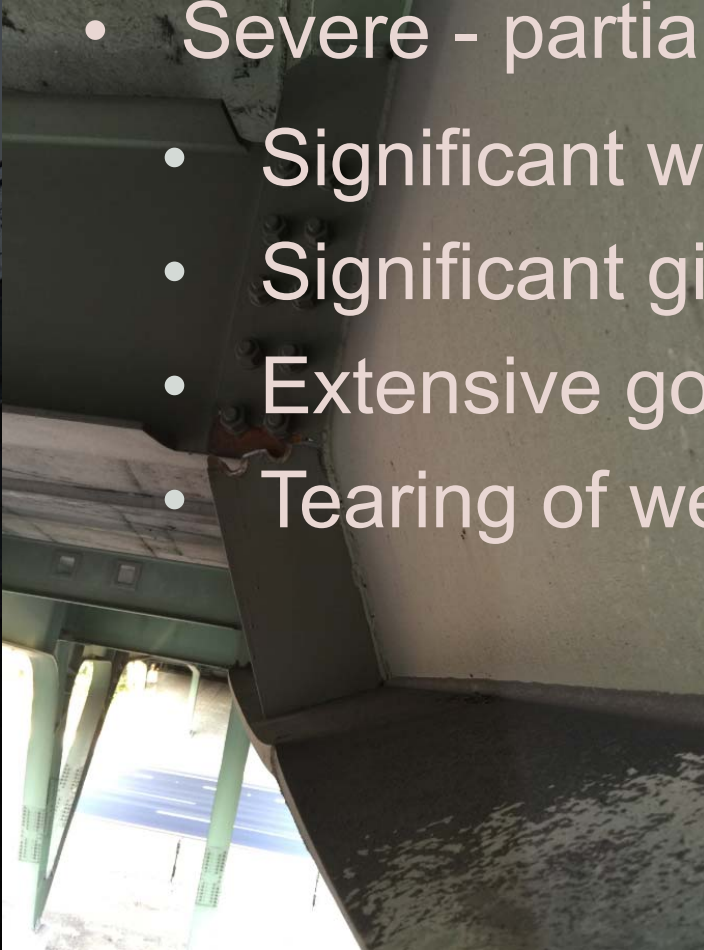
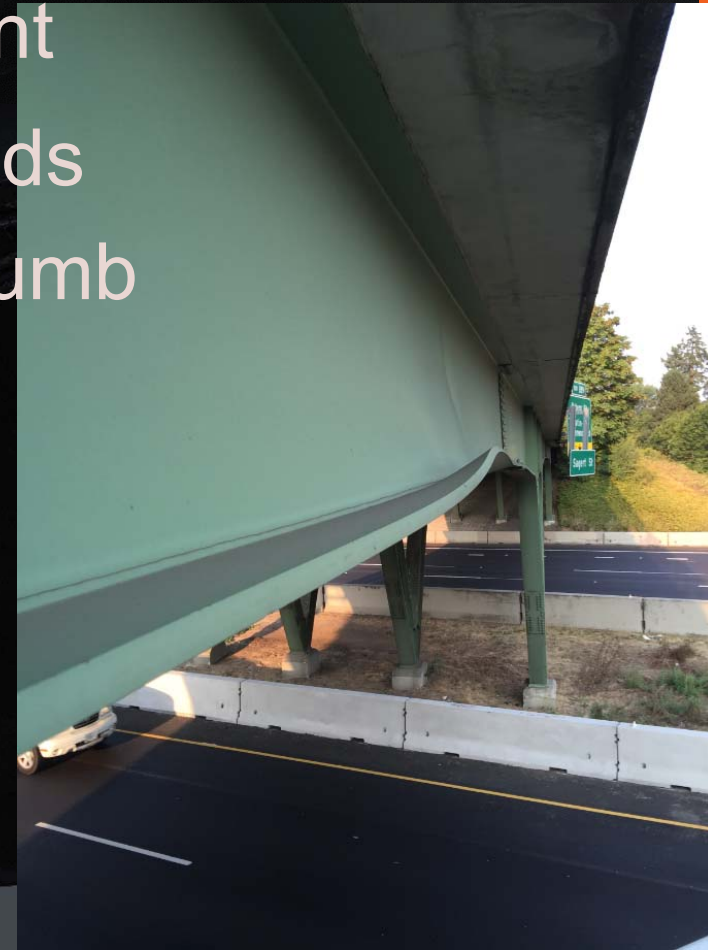
SW Sagert Rd over I-5

- Severe - partial or full replacement
 - Significant web and flange bends
 - Significant girder web out of plumb
 - Extensive gouges
 - Tearing of web and flange

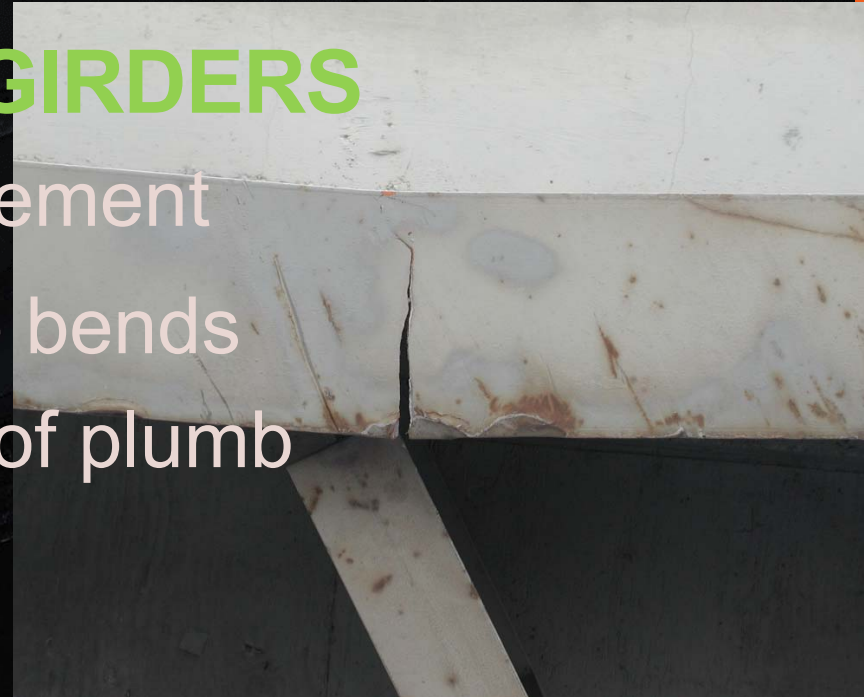
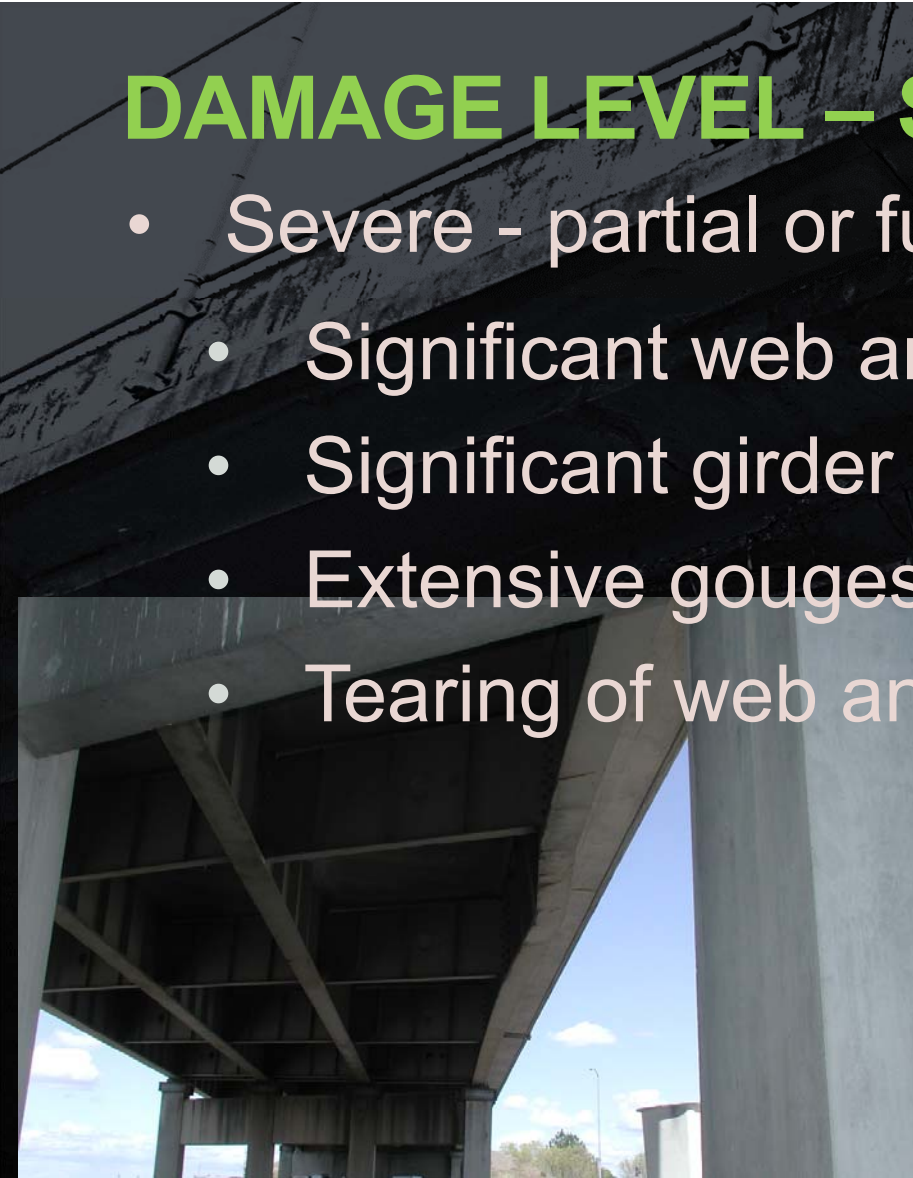
N Ontario IC

- Severe - partial or full replacement
 - Significant web and flange bends
 - Significant girder web out of plumb
 - Extensive gouges
 - Tearing of web and flange

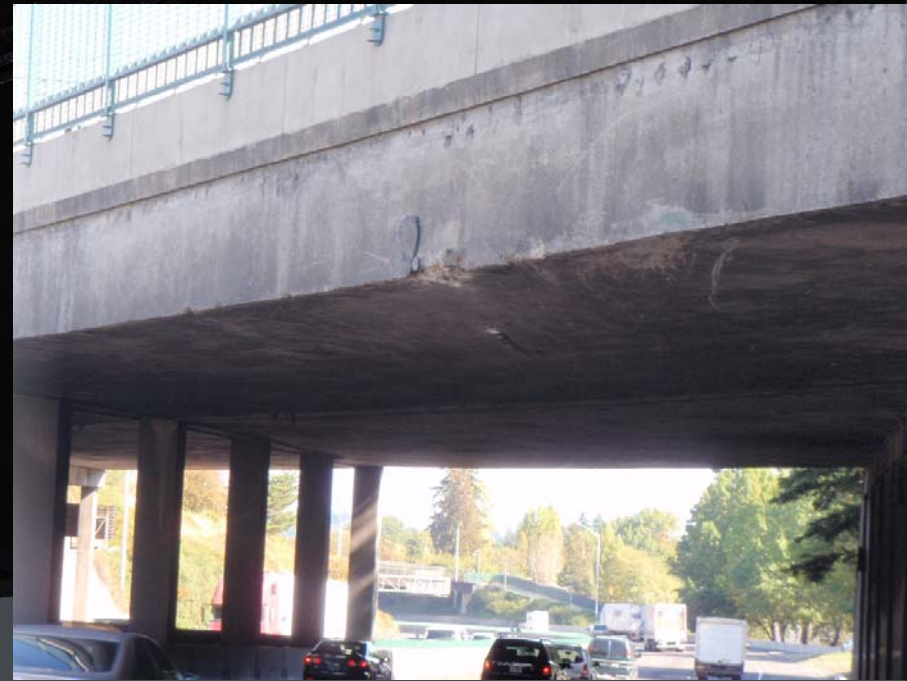
Barbur Blvd over I-5

- Minor - no repair or minimal repair
 - Minor concrete spalling
 - Partially exposed rebar or strands
 - Not through cracks

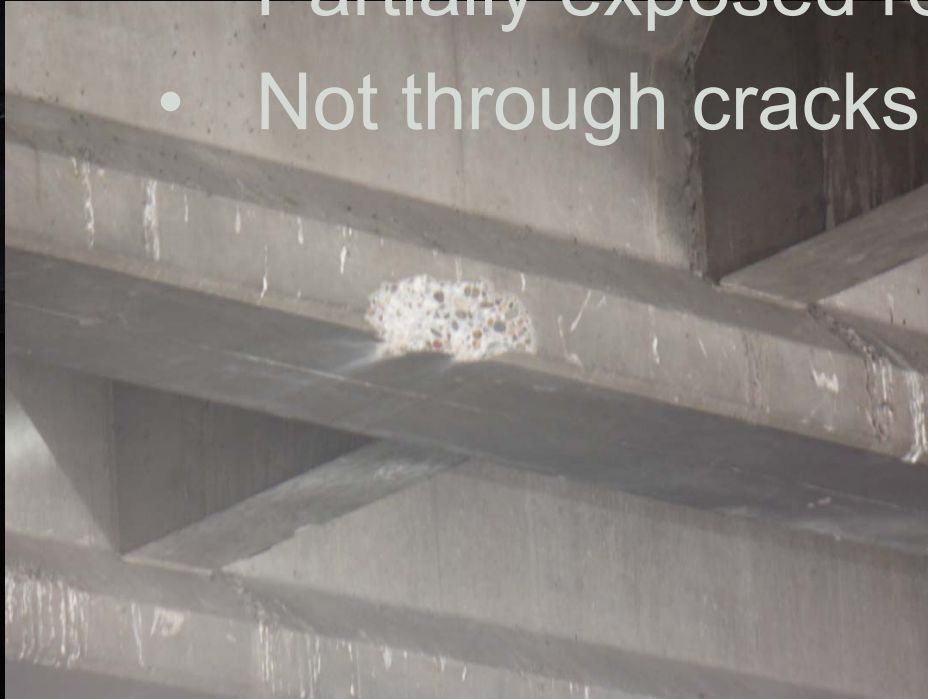
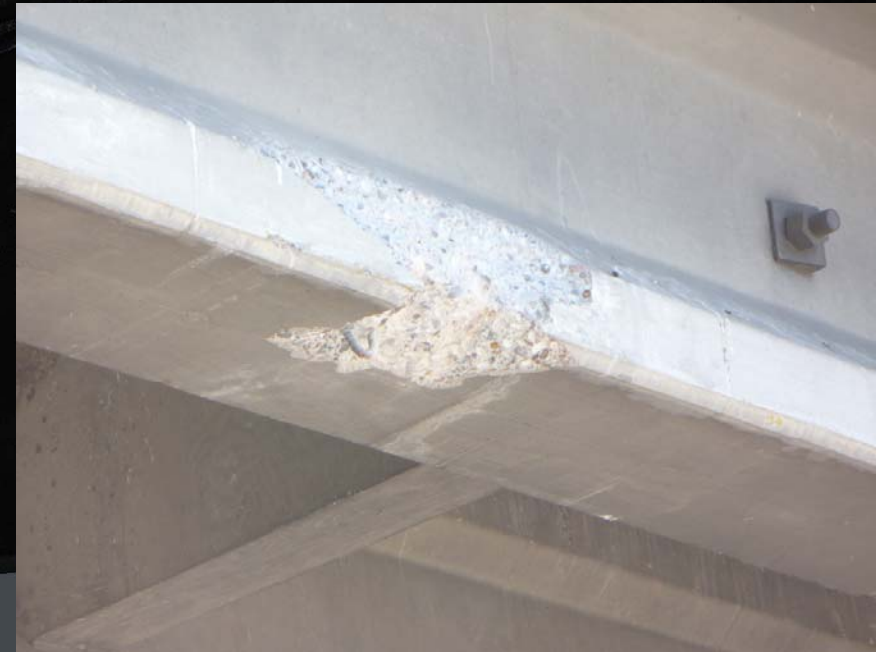
Hwy 1 over McAndrews

- Minor - no repair or minimal repair
 - Minor concrete spalling
 - Partially exposed rebar or strands
 - Not through cracks

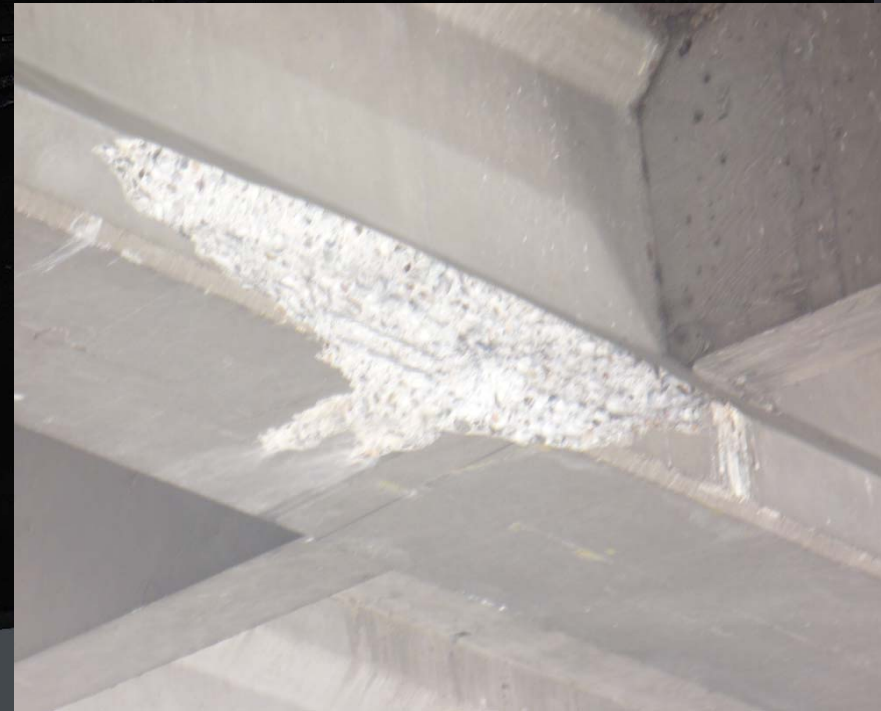
Hwy 1 over McAndrews

- Moderate - repair or partial replacement
 - Moderate concrete spalling
 - Exposed rebar or strands
 - Through cracks
 - Less than 25%? of rebar or strands severed

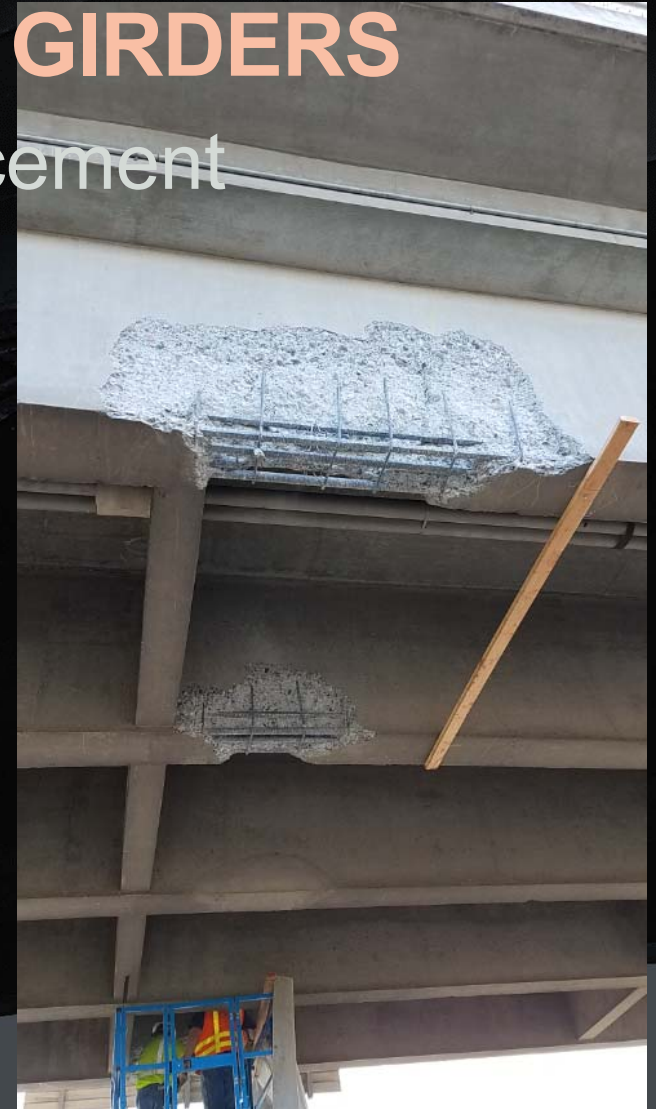
Boardman IC

- Moderate - repair or partial replacement
 - Moderate concrete spalling
 - Exposed rebar or strands
 - Through cracks
 - Less than 25%? of rebar or strands severed

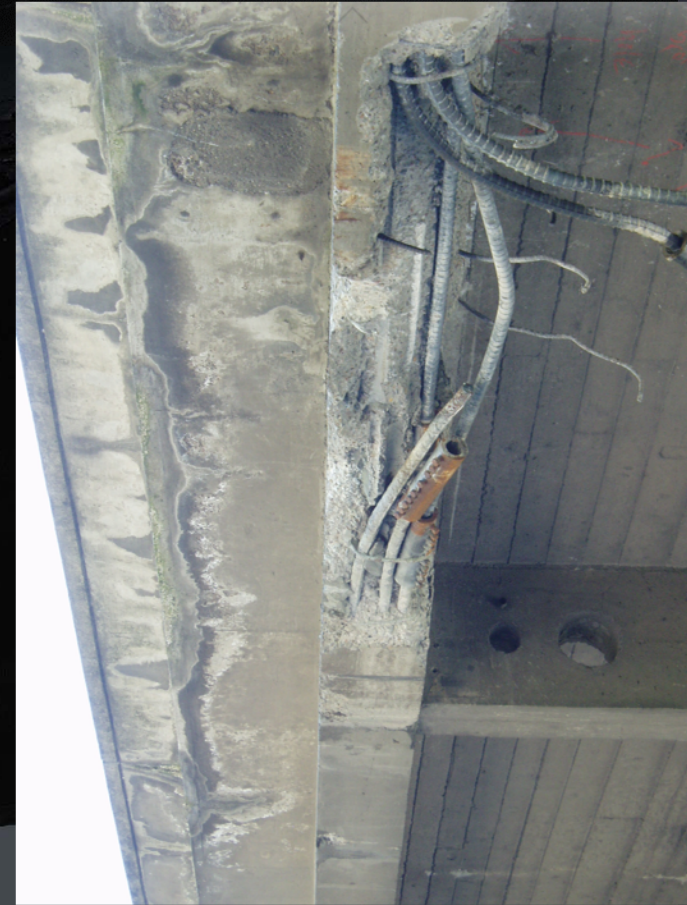
Saginaw Br

- Severe - partial or full replacement
 - Large area of concrete spalling
 - Exposed rebar or strands
 - Large through cracks
 - More than 25%? of rebar or strands severed

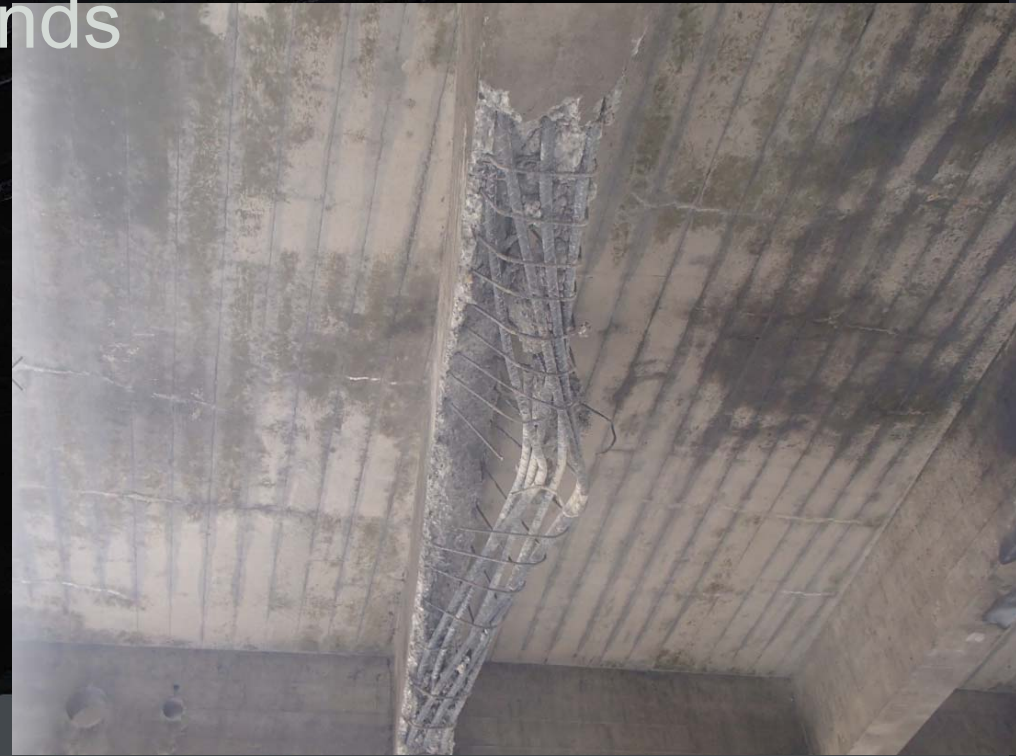
Hwy 37 over Hwy 102 at Banks

- Severe - partial or full replacement
 - Large area of concrete spalling
 - Exposed rebar or strands
 - Large through cracks
 - More than 25%? of rebar or strands severed

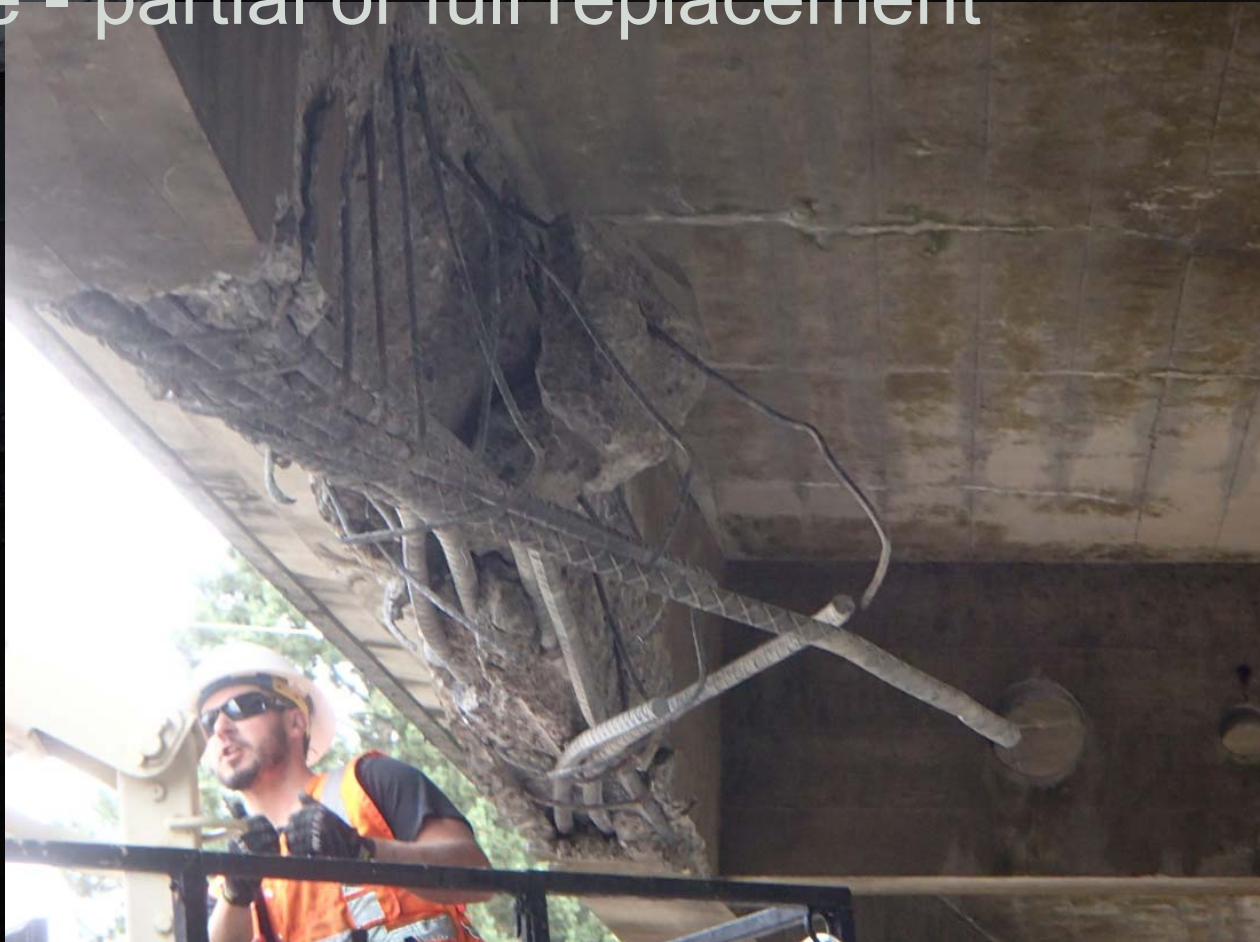
Hwy 37 over Hwy 102 at Banks

- Severe - partial or full replacement

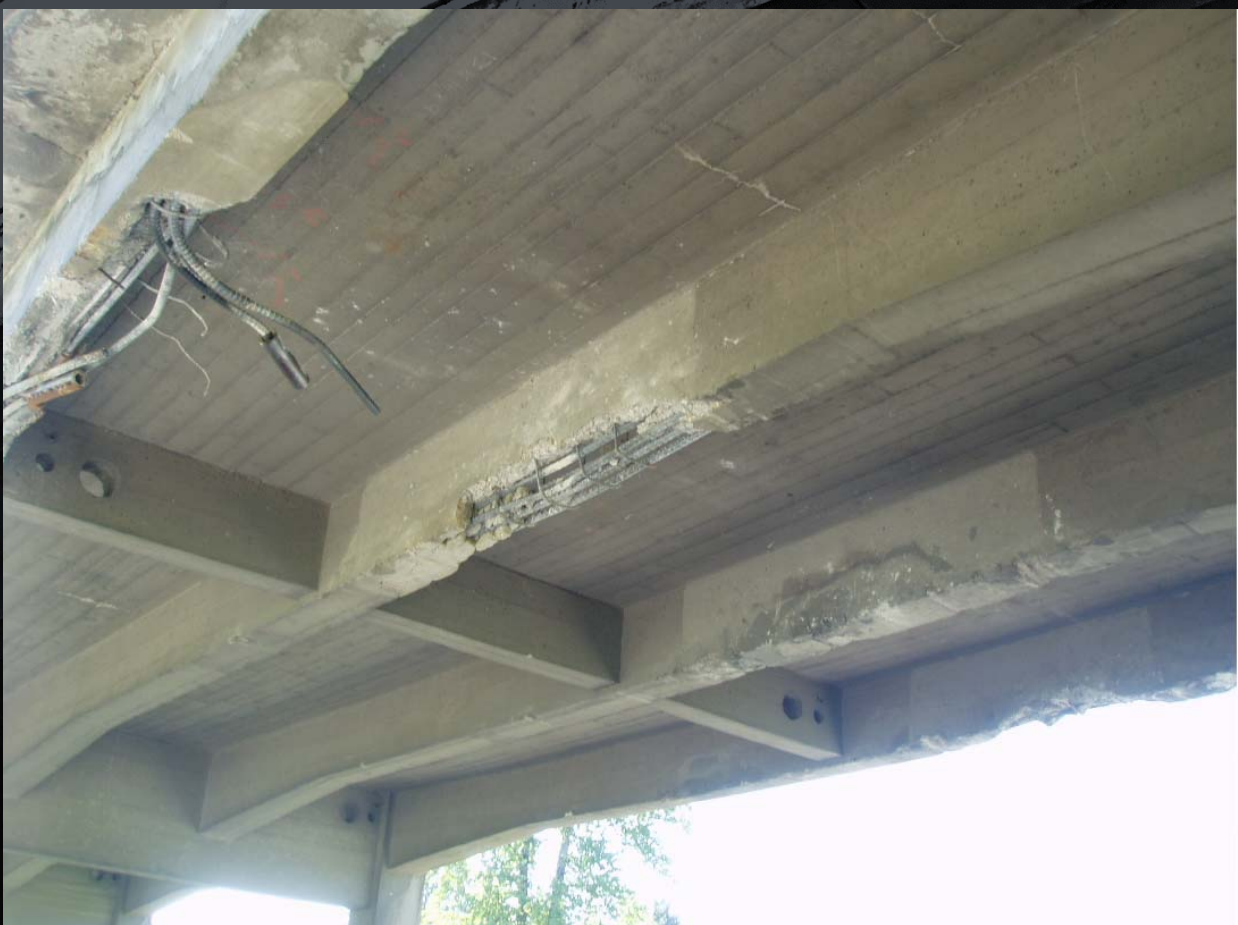
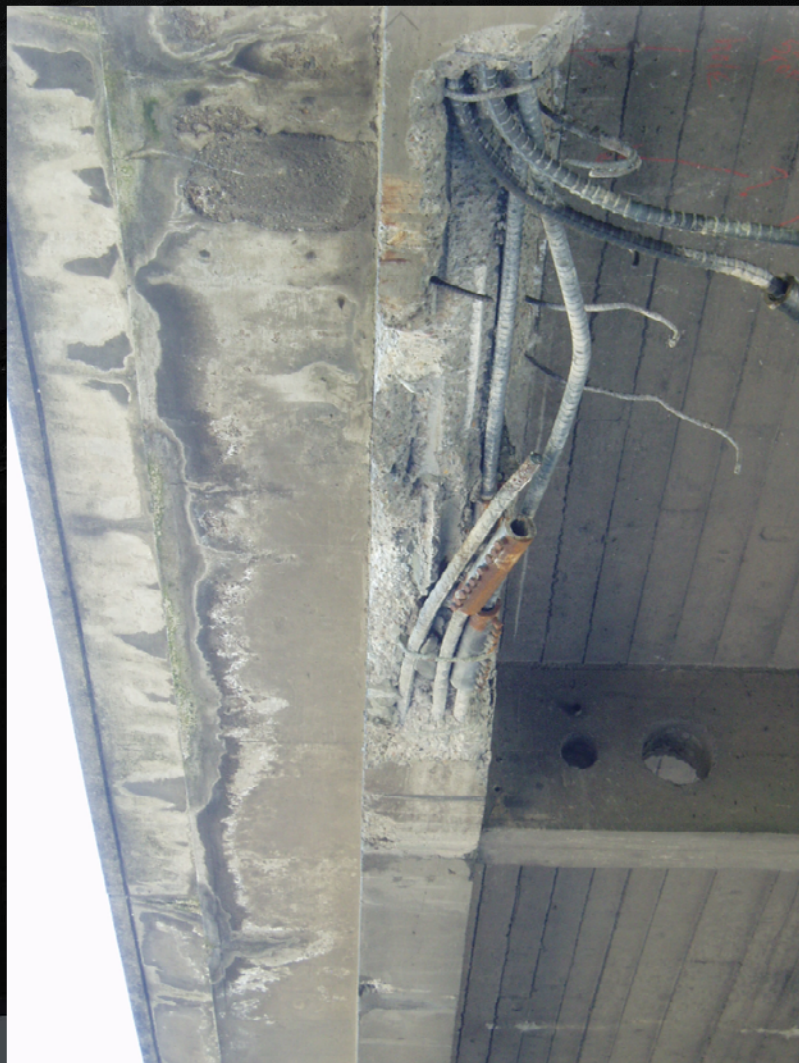
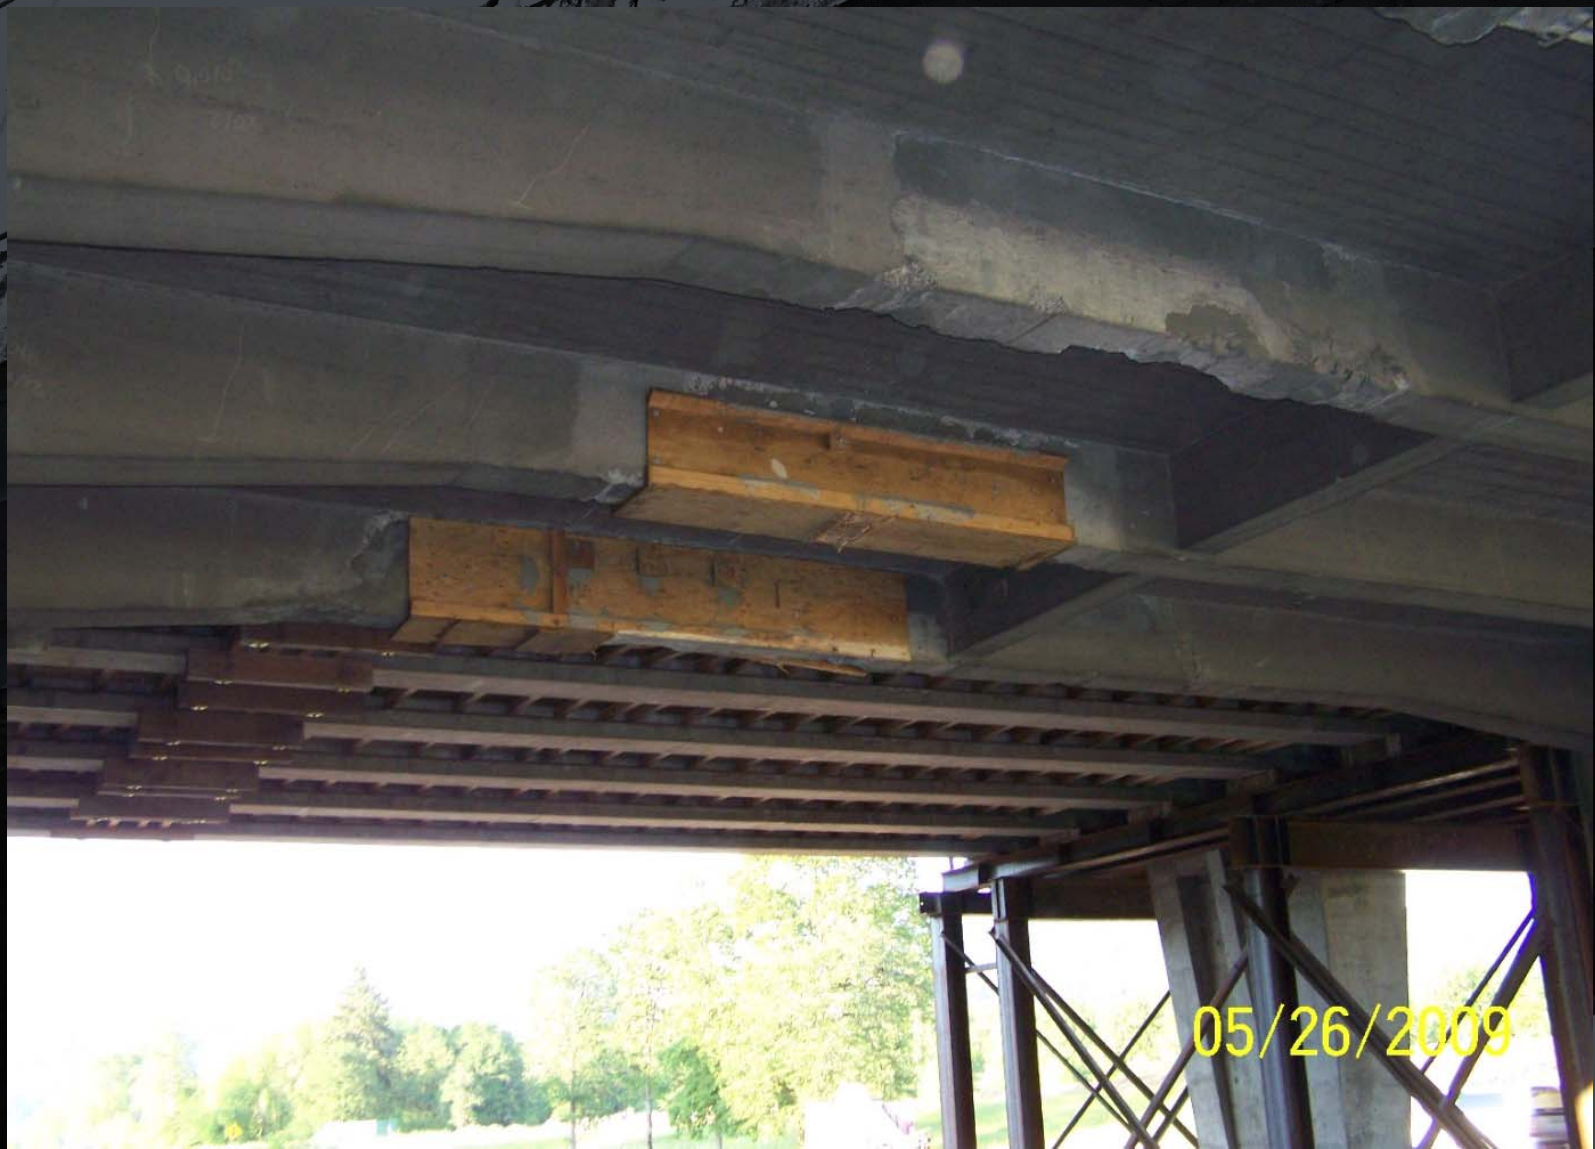
Saginaw Bridge

PAST INCIDENT – REPLACED RCDG

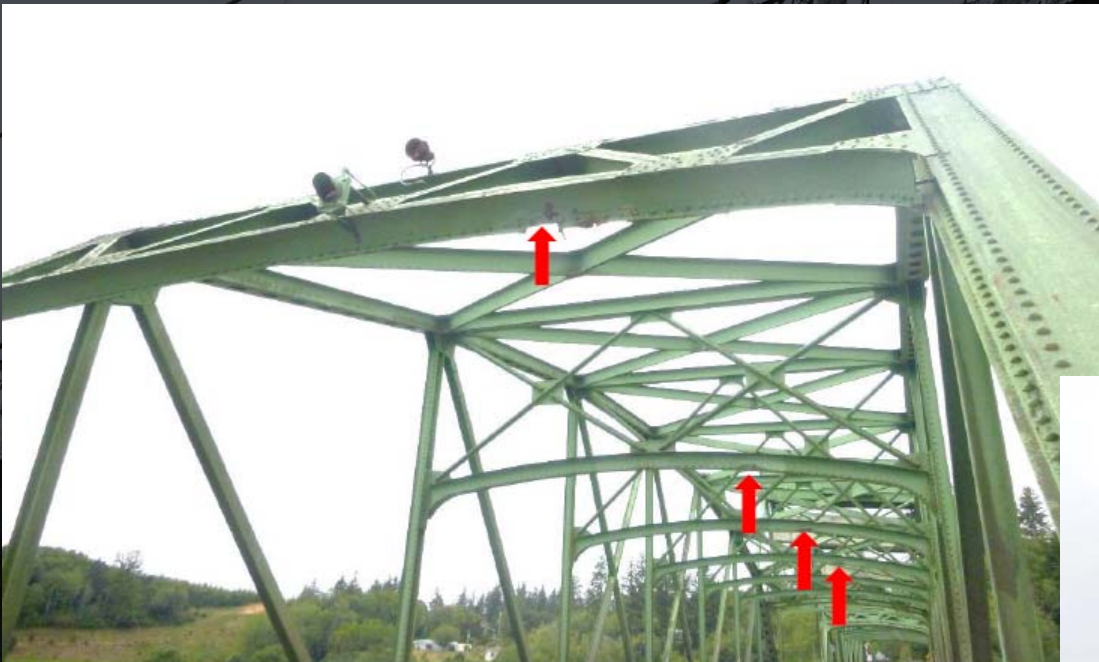
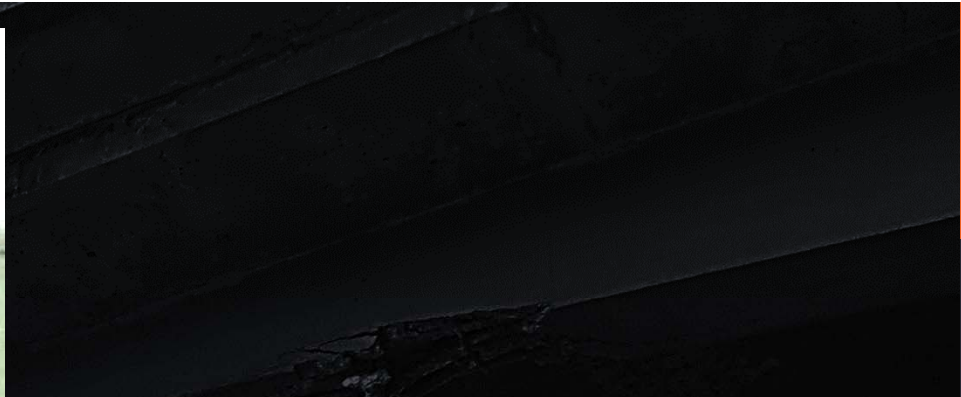
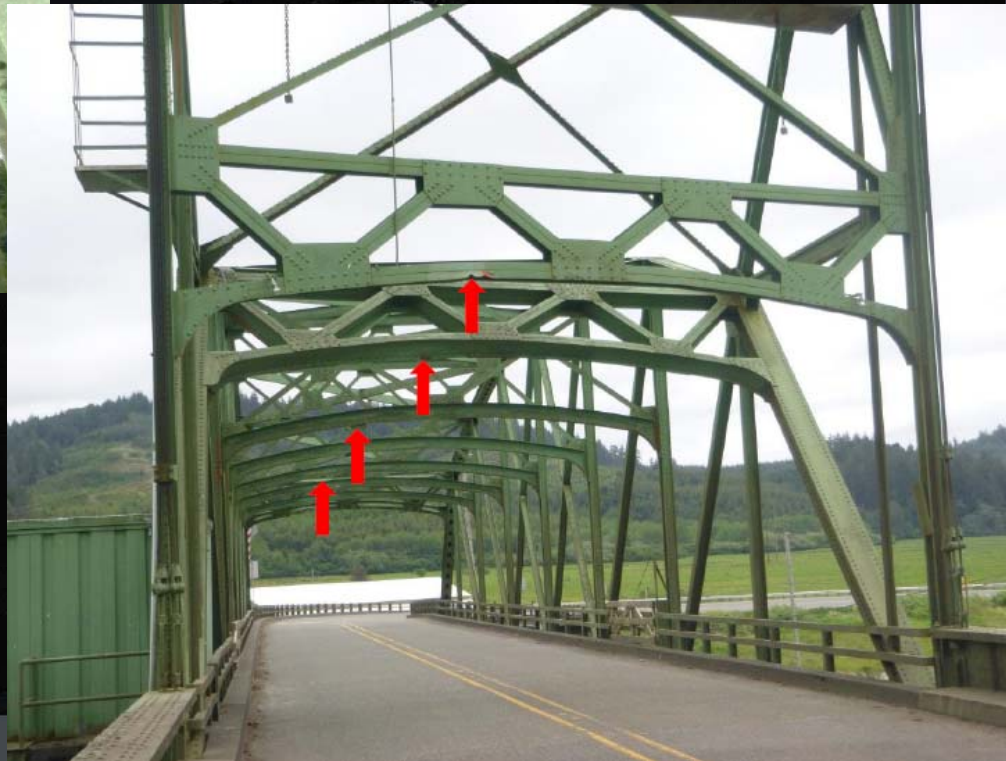
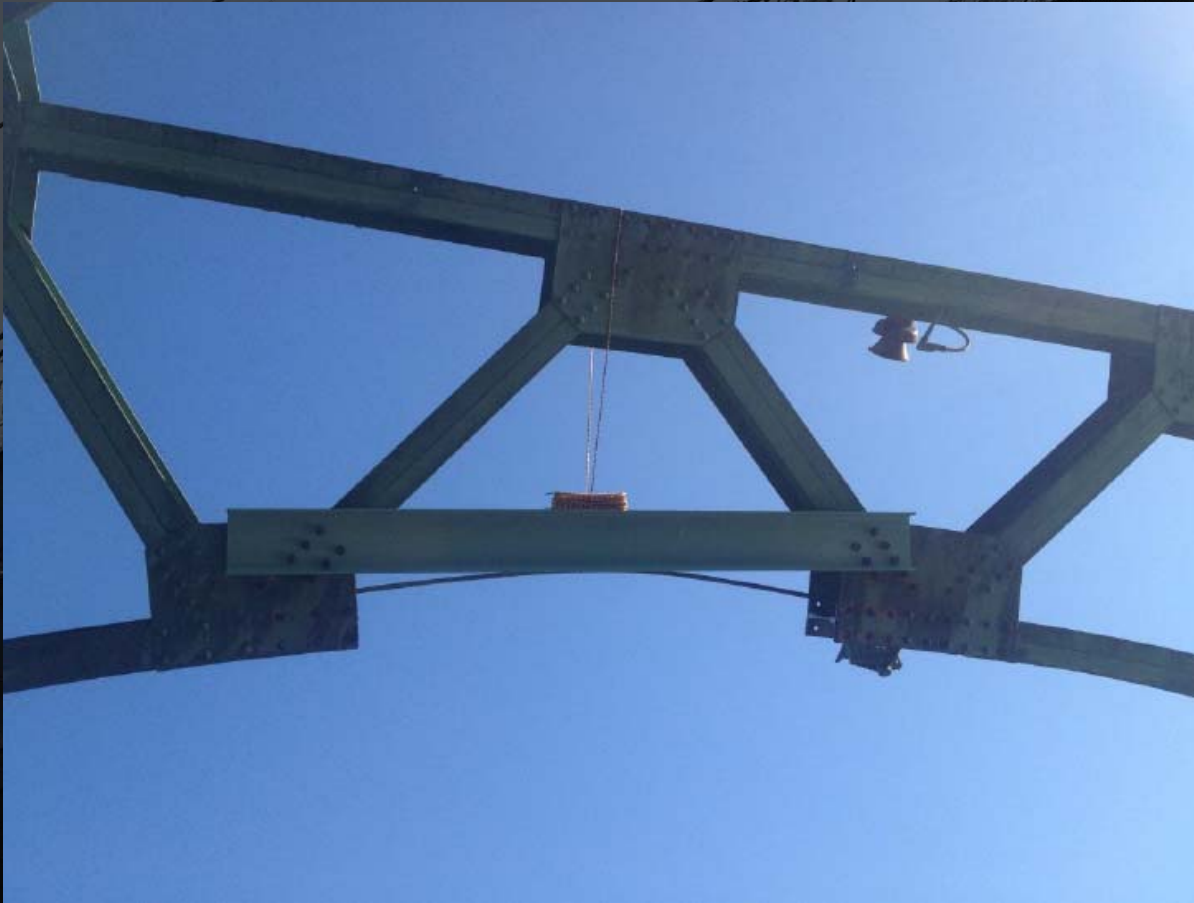
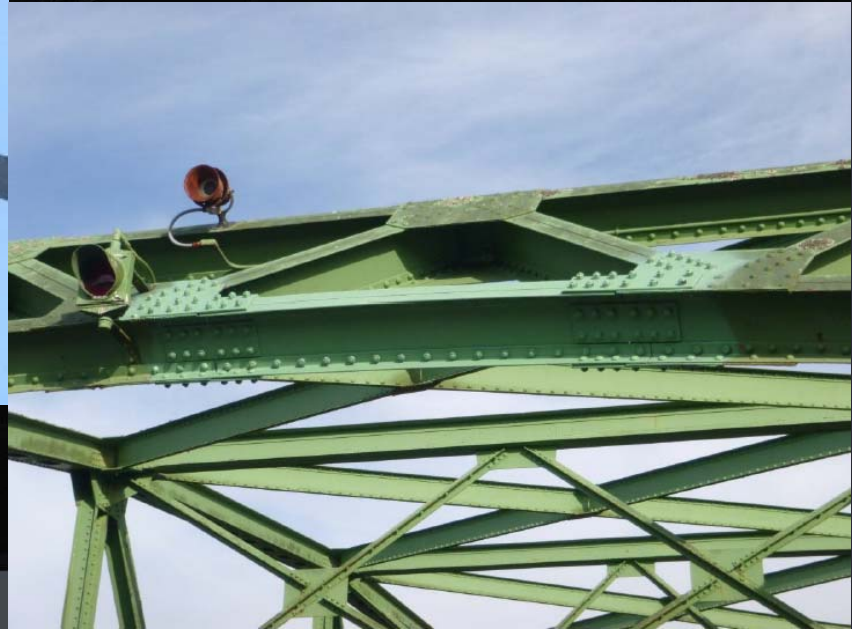
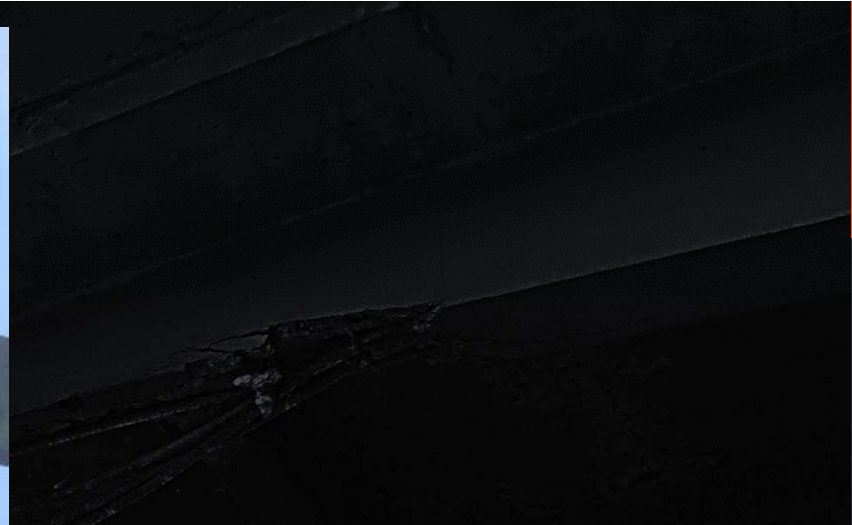
Chandler Bridge

PAST INCIDENT – REPAIR BY BOLTING

- Localized repair or replacement
- Flame straightening
- Hot mechanical straightening
- Cold mechanical straightening

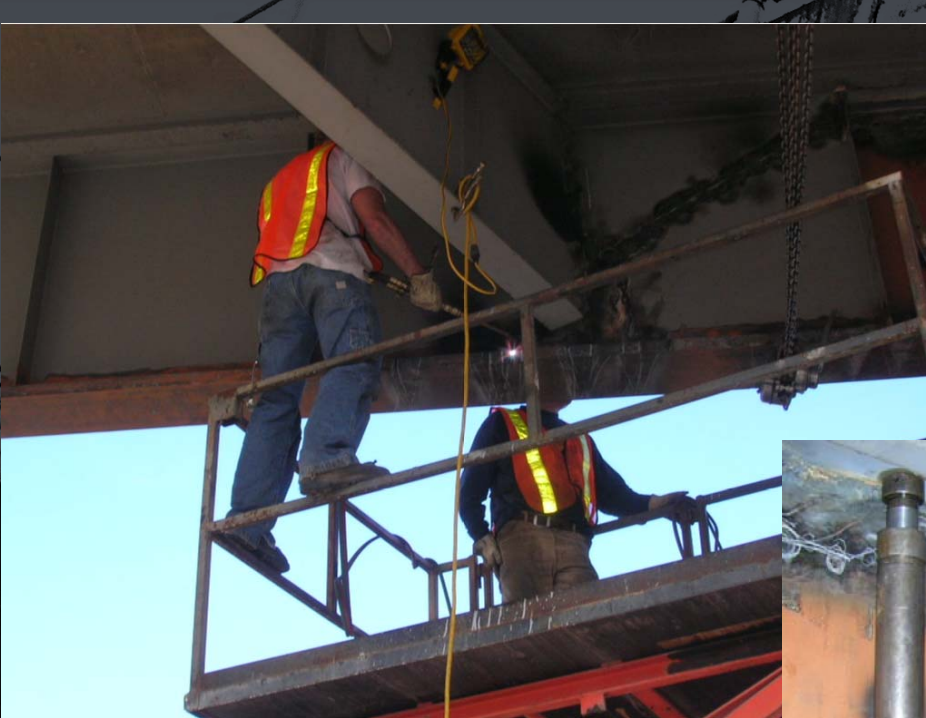
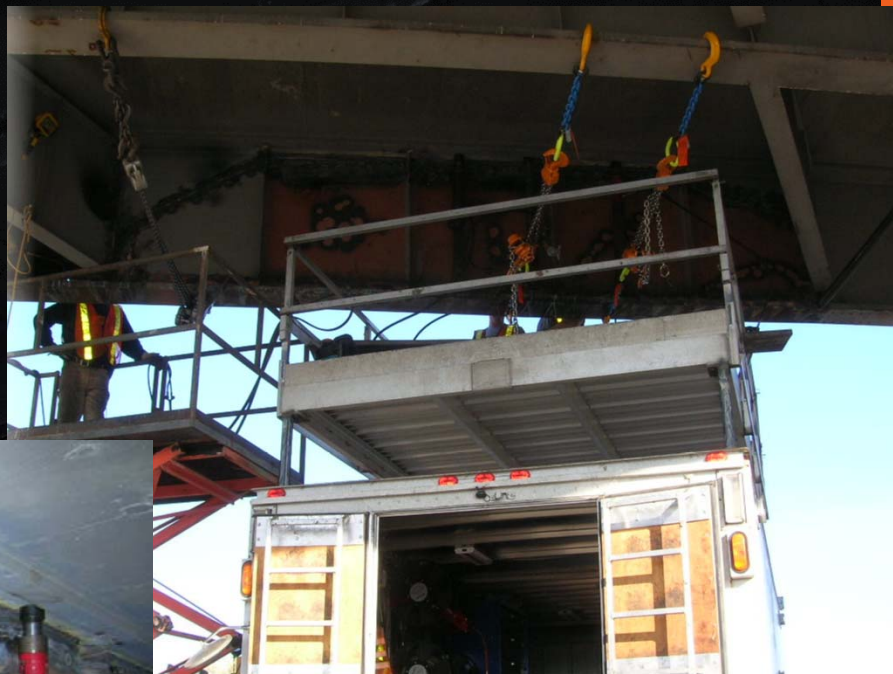
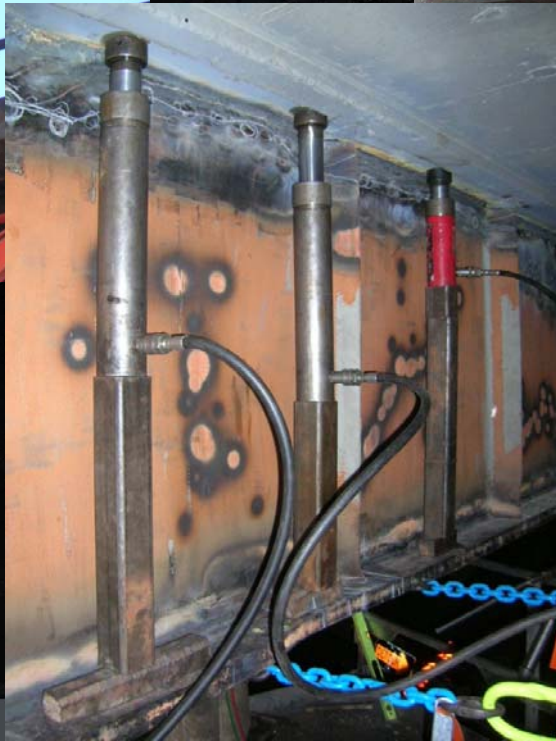
BR# 08635 GIRDER 1 SPAN 3 PRIOR TO REPAIR

IMPACT POINT

7/8 INCH WIDE CRACK
