Over-Height Vehicle Collision Assessment and Repair Methodology

Tanarat Potisuk, PhD, PE, SE

Prestressed Concrete Standards Engineer

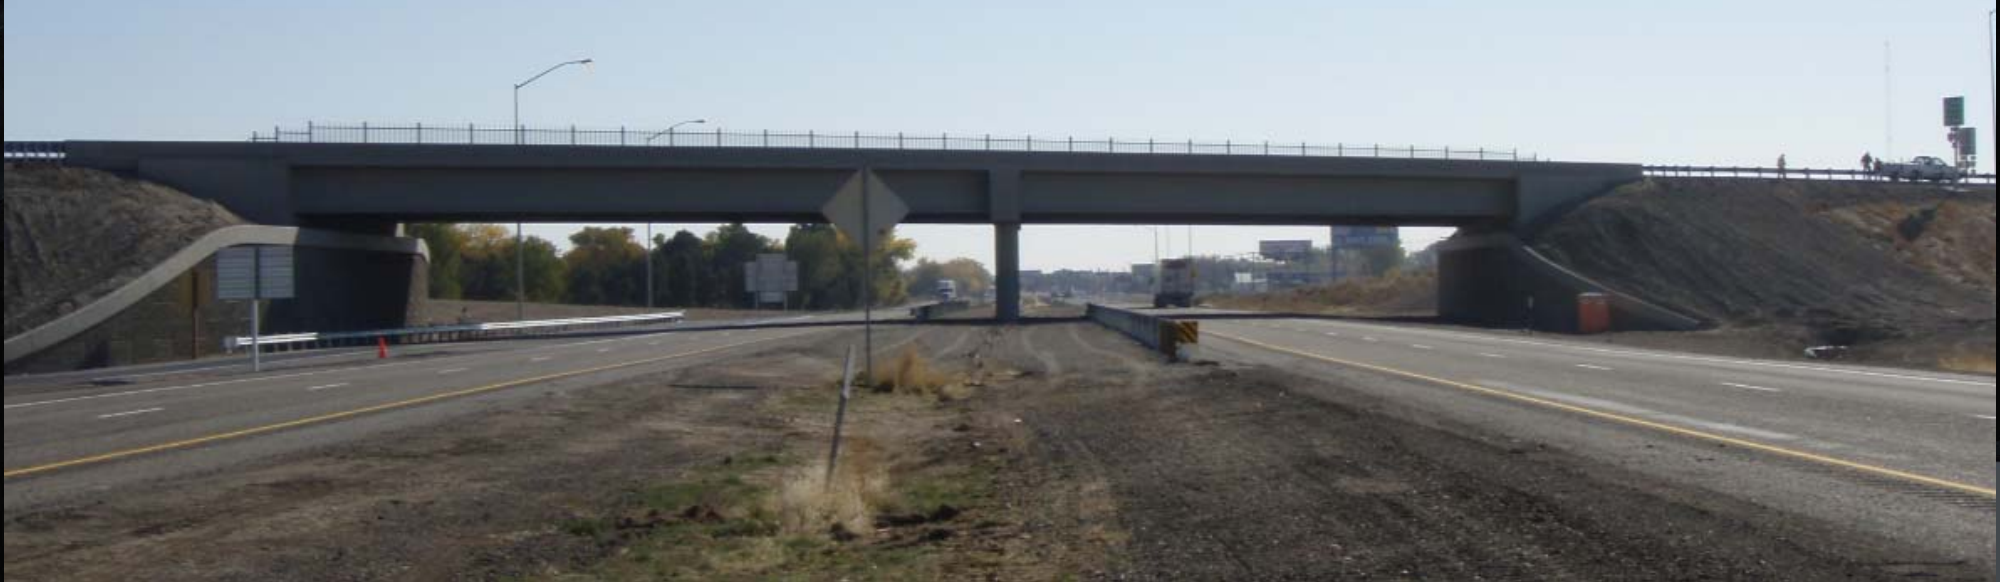
N ONTARIO I/C
BR# 20398 HWY 455 MP 25.20
RT ELEV 10/27/08
IM20398_A1.jpg

PAST INCIDENT – REPAIR THEN REPLACED
