DAVID EVANS AND ASSOCIATES INC.

Timber Pile Repair

Presented by Travis Kinney

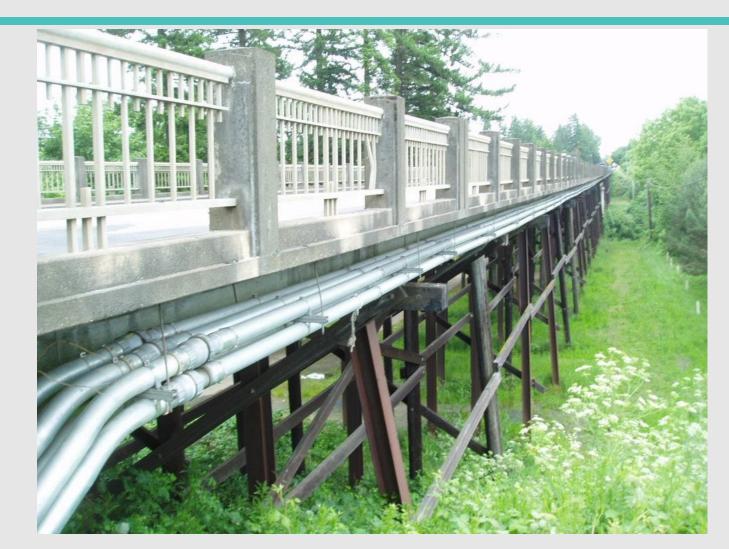
South Yamhill Bridge

- Built in 1951.
- Located in Willamette Valley.
- Reinforced Concrete Deck Girder on Timber Pile Trestles.
- 990 ft. in length.
- 34 Timber Bents.
- 204 timber piles (as constructed).
- Estimated cost of replacement = \$35 Million.

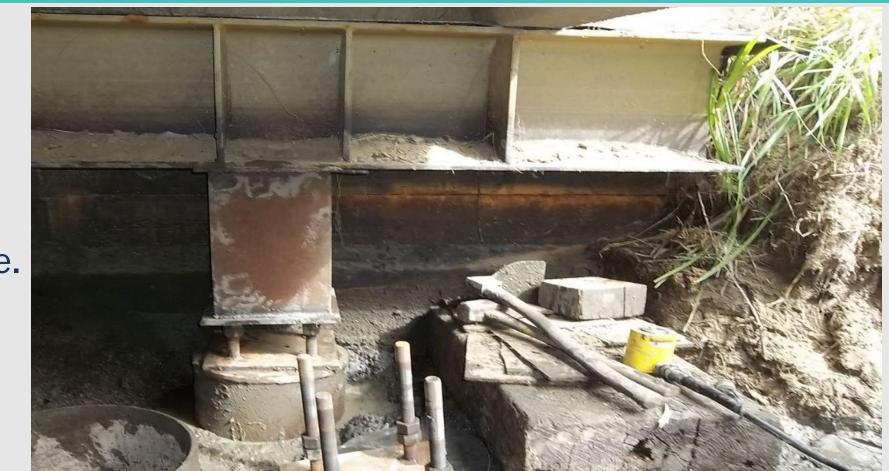
- Difficult to install in tight spaces. (abutments).
- Steel cage difficult to stage.

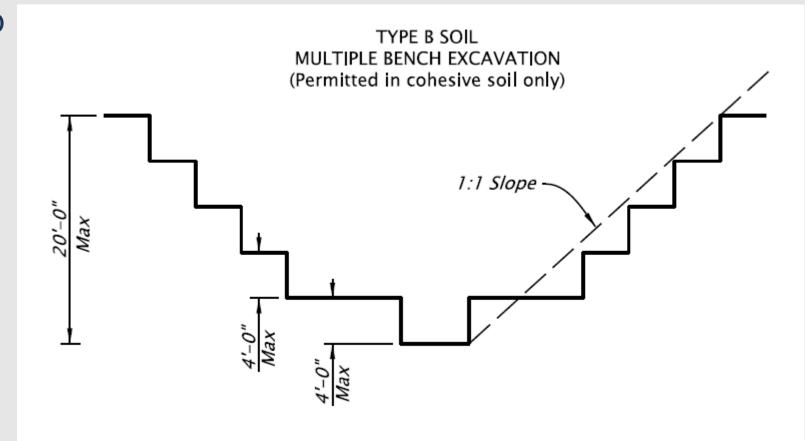
- Required excavation to continue at least 2' deeper than rot.
- If rot extended more than 2' below ground level then shoring or benching excavation was required.

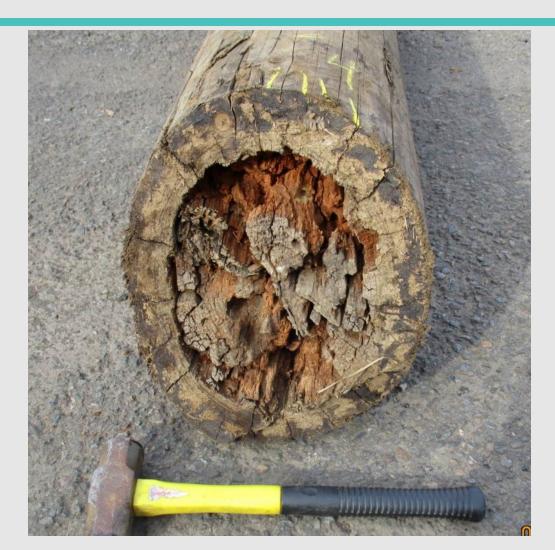
How much rot is too much to repair?

- Replace reinforced concrete collar with oversized steel pipe pile grouted to timber pile.
- Allow splice at a location with less than 100% solid timber section.
- Auger out remaining rotten timber pile core and fill cavity with high early strength concrete.

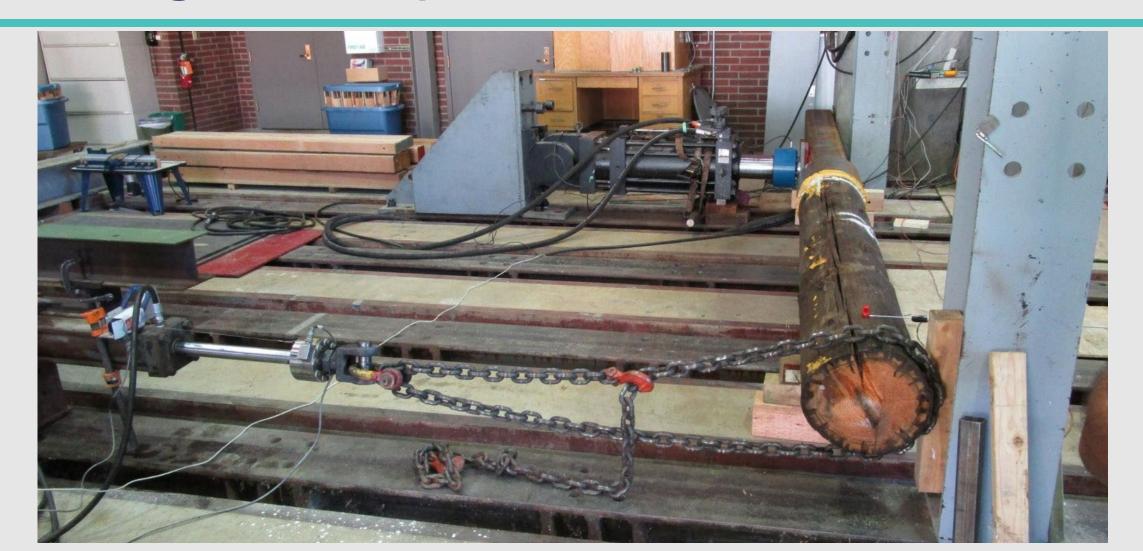
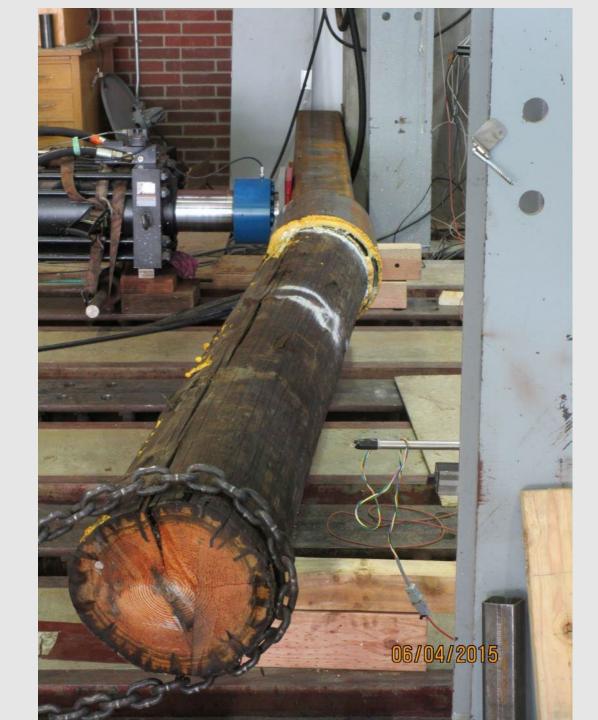
Bending Test Setup

- All three failed at the base of the splice.
- Loading at failure was about what you'd expect for an unrepaired pile with 2" shell.
- Load remained about constant through 12" 24" of deflection.

- New pile repair can be used to fully restore axial capacity for short columns.
- Lateral demand and remaining capacity should be evaluated as part of repair plan.
- May need to add some bracing depending on application, or make the splice at a section with no rot.

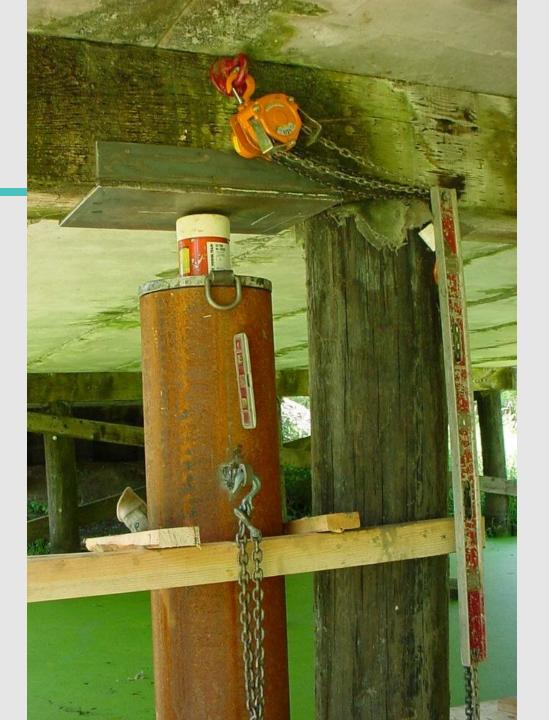
Jack in Helper Piles

- Very useful in water or when shoring can't feasible.
- Challenge is getting enough load capacity in the helper to replace the one pile.
- May need two piles to completely replace one.
- If the rotted pile isn't removed, the inspectors will still rate it. (Temporary)

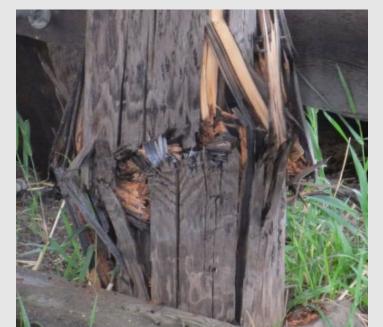
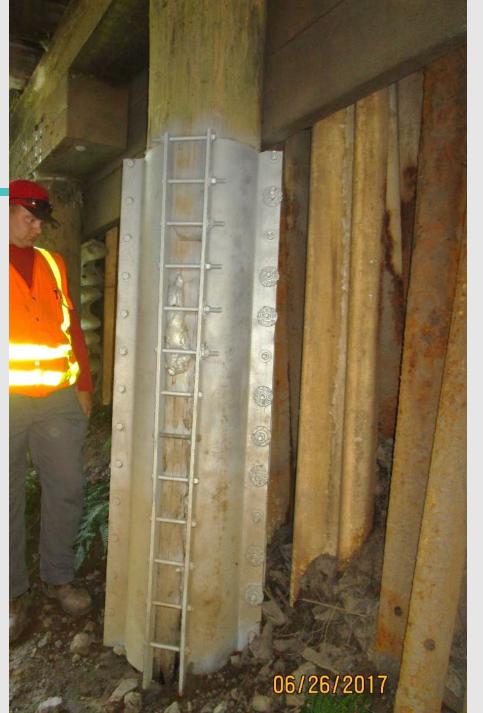
Banding Piles:

- Piles tend to fail but mushrooming outwards.
- Installing steel sleeves to hold the pile together can buy some time.
