Steel Repairs

- Emergency repairs to correct superstructure impact damage
- Two recent case studies
- Muscott Bridge
 - Highway 130 over Little Nestucca River
 - Tillamook County
- Bridge 08616
 - Highway 34 to 99W ramp
 - Corvallis

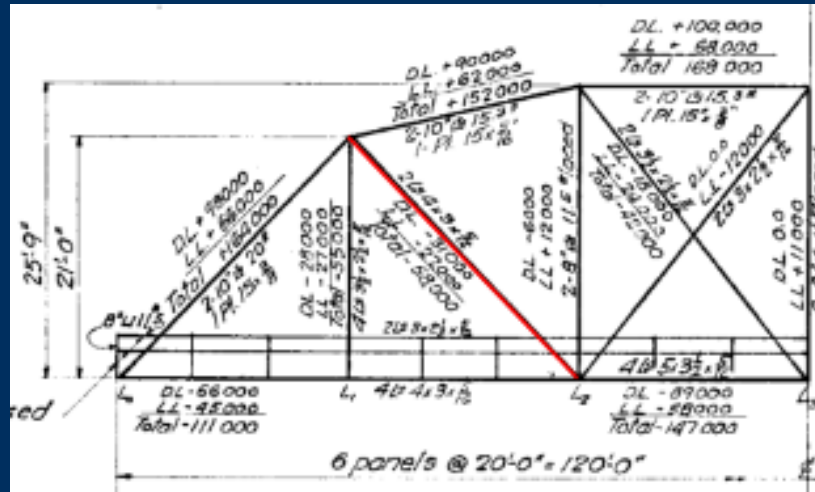
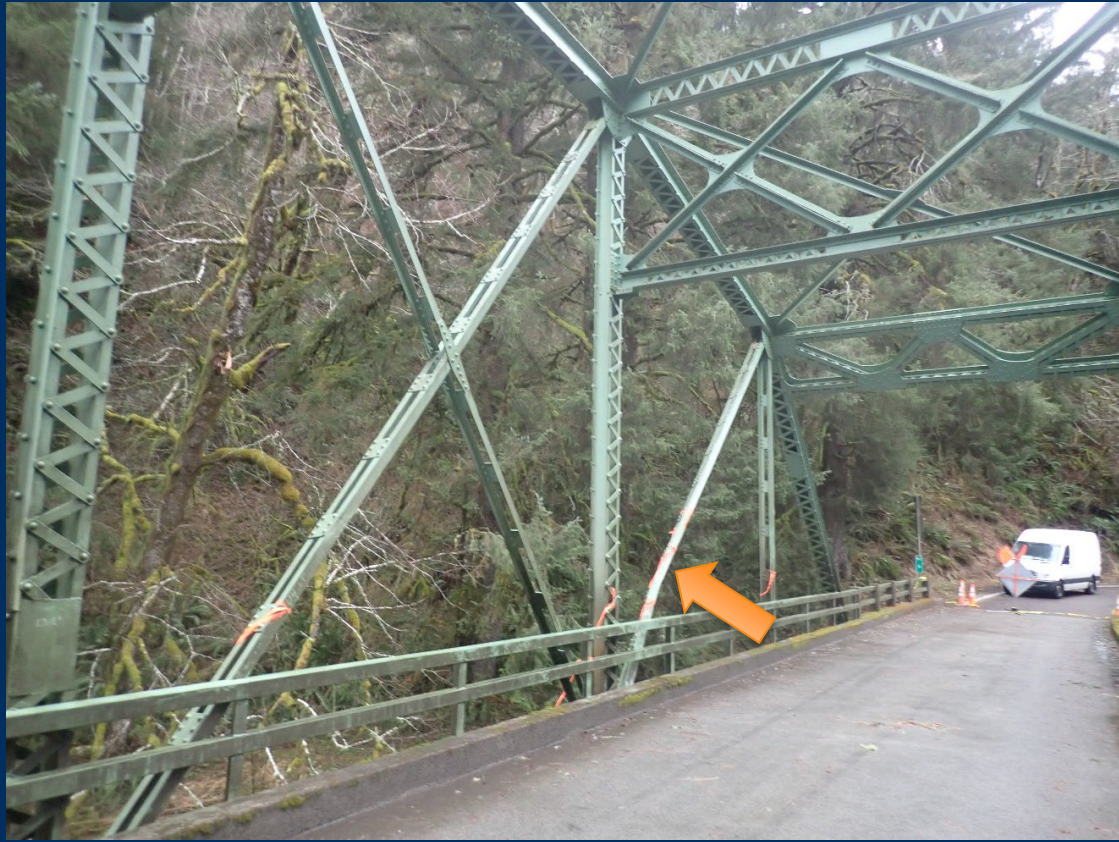
- 120-foot riveted steel through truss
- Snowplow impact to North Truss
- Severe damage to Member U1-L2

- Built-up tension member
- 2L4x3x5/16 with tie plates
- Full fracture of one angle
- Partial fracture of second angle
- Severe distortion of member

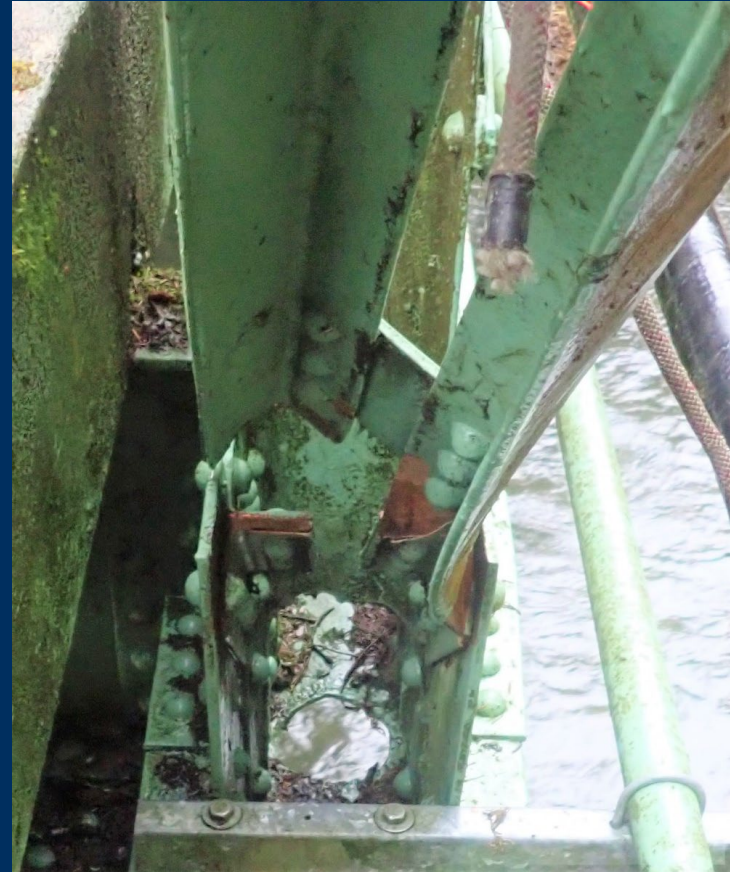
- Bridge closed by ODOT
- Long detour
- Rapid return to service required
- Member replacement

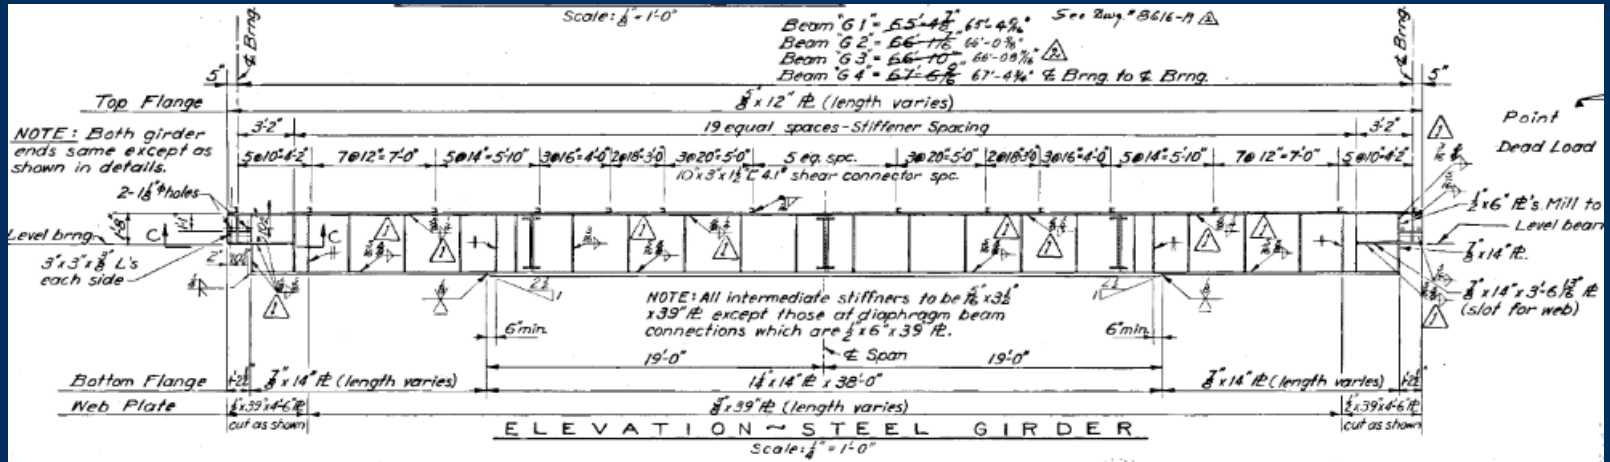
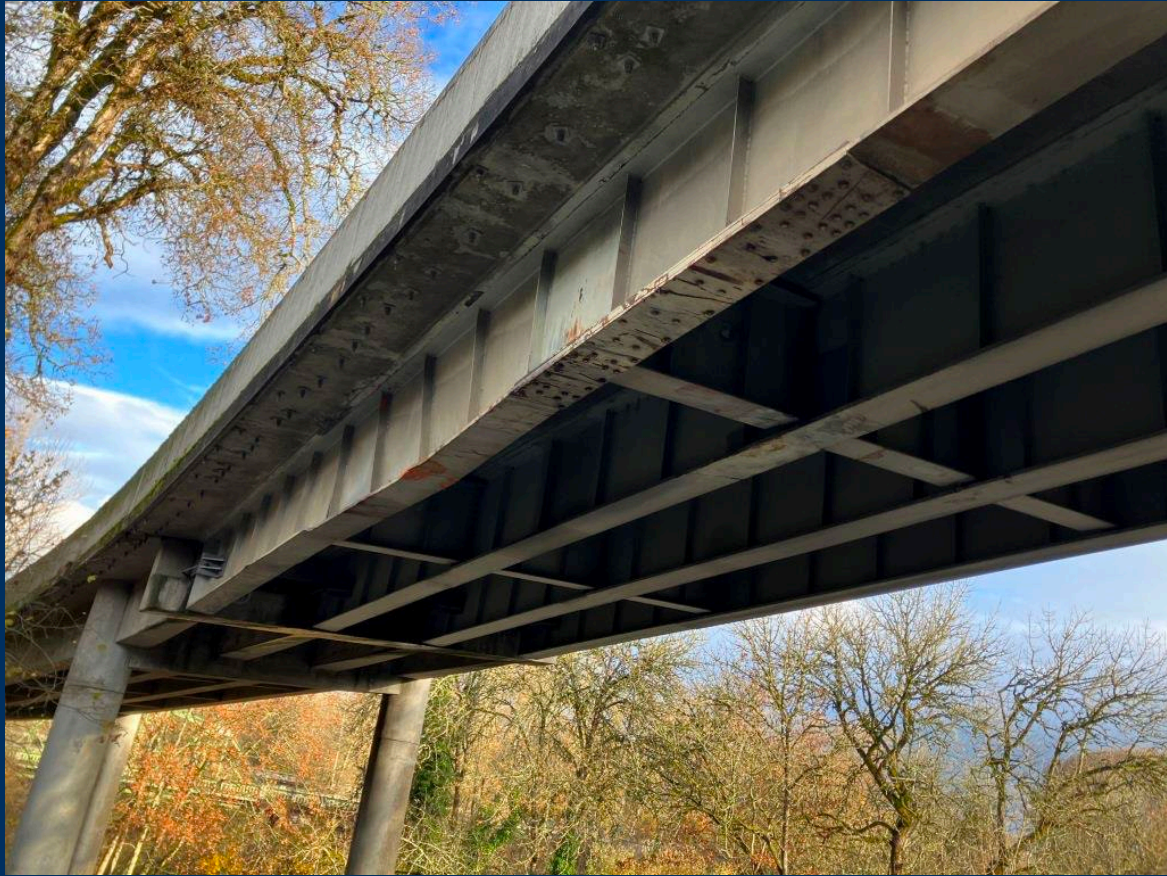
- Welded steel plate girders carrying single lane ramp
- Four girders, 66-foot span, 40-inches deep
- Over-height load impact to north fascia girder (logging processor)

- Full flange fracture
- Partial web fracture
- Partial flange fracture
- Web rupture at diaphragm
- Existing repairs of prior impact damage

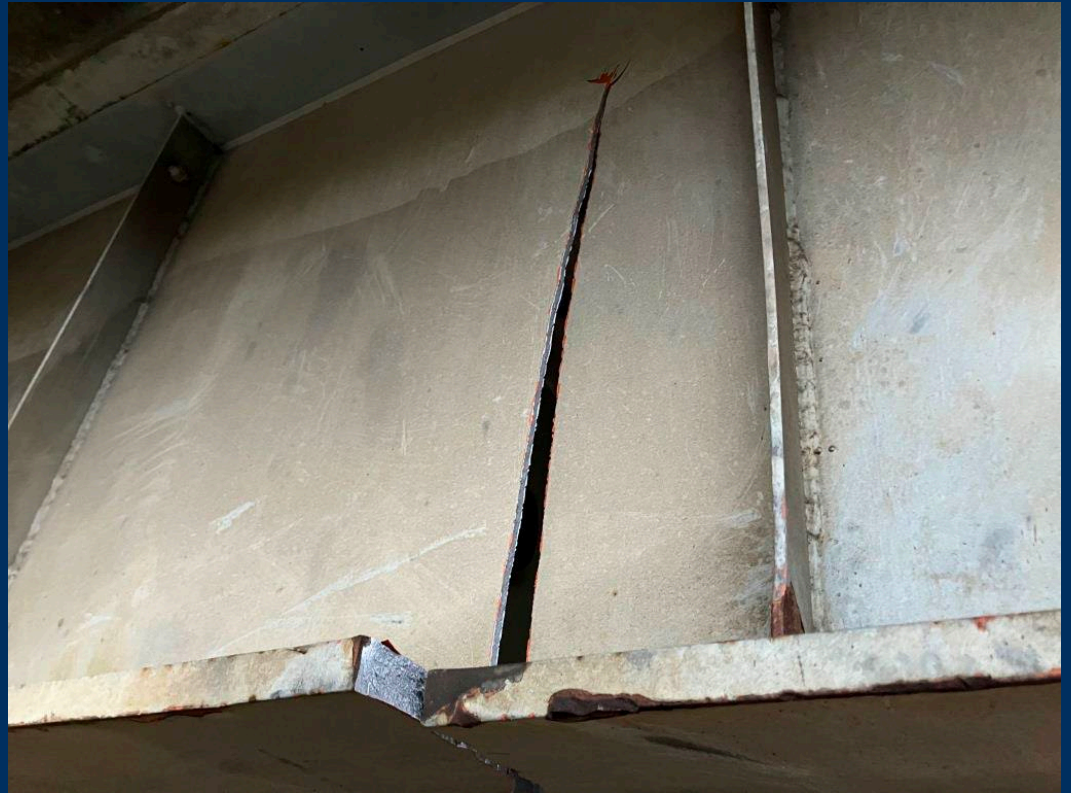
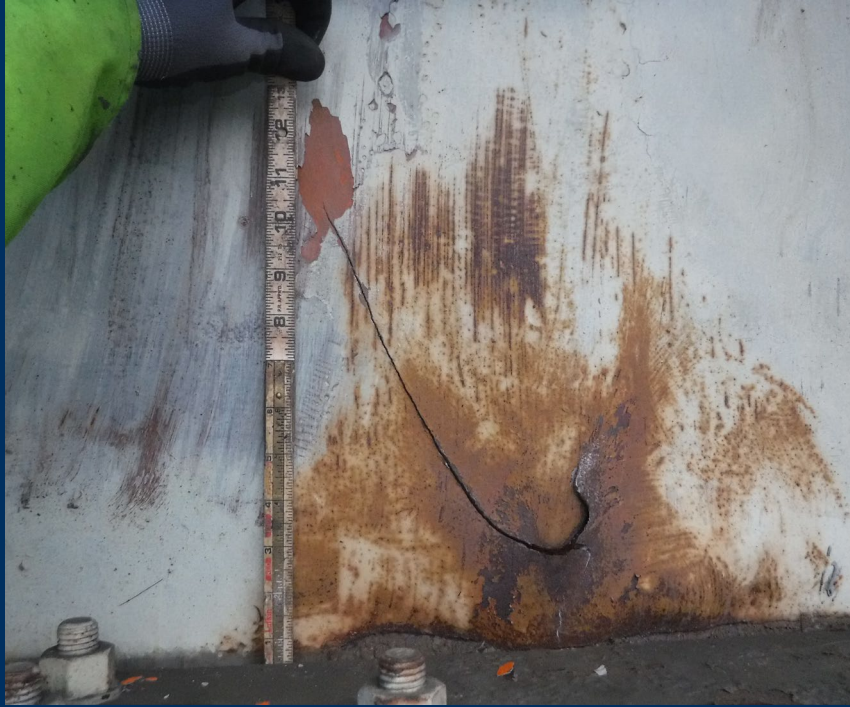
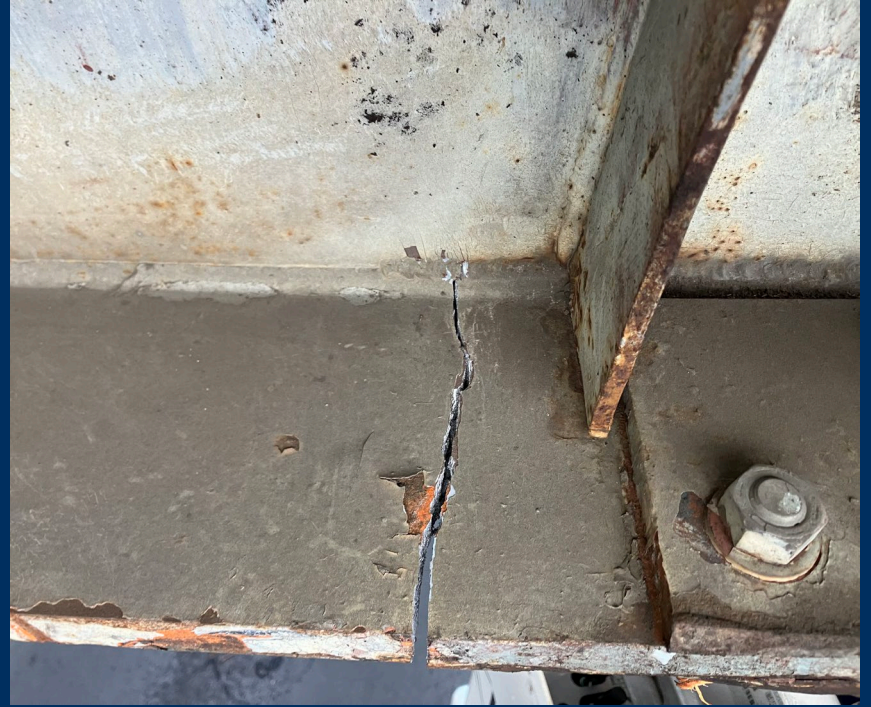
- Bridge initially closed by ODOT
- ODOT load rating
- Re-opened with temporary barrier to move traffic over south girders
- Emergency repair

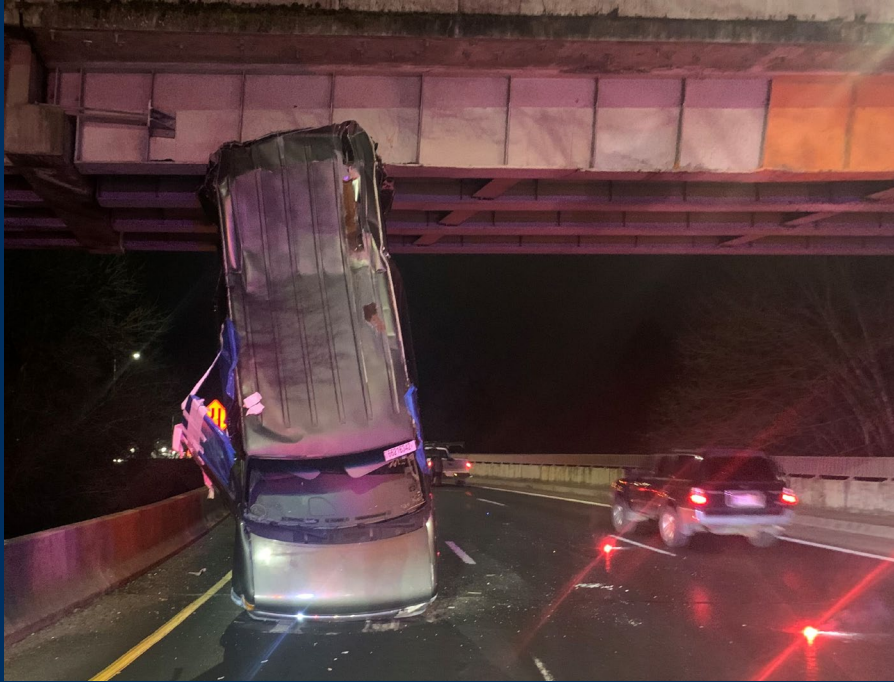
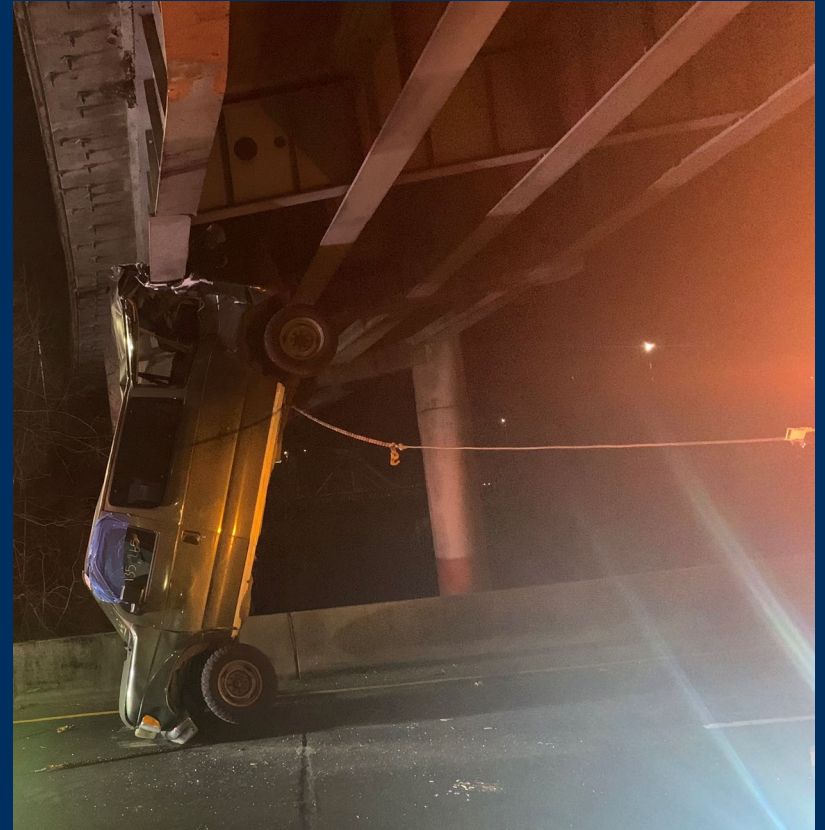
- Second impact during paint removal
- No additional damage
