Road Safety Audit Report

US 20 Road Safety Audit

Albany-Corvallis Highway No.31

Audit Dates: March 19-20, 2012

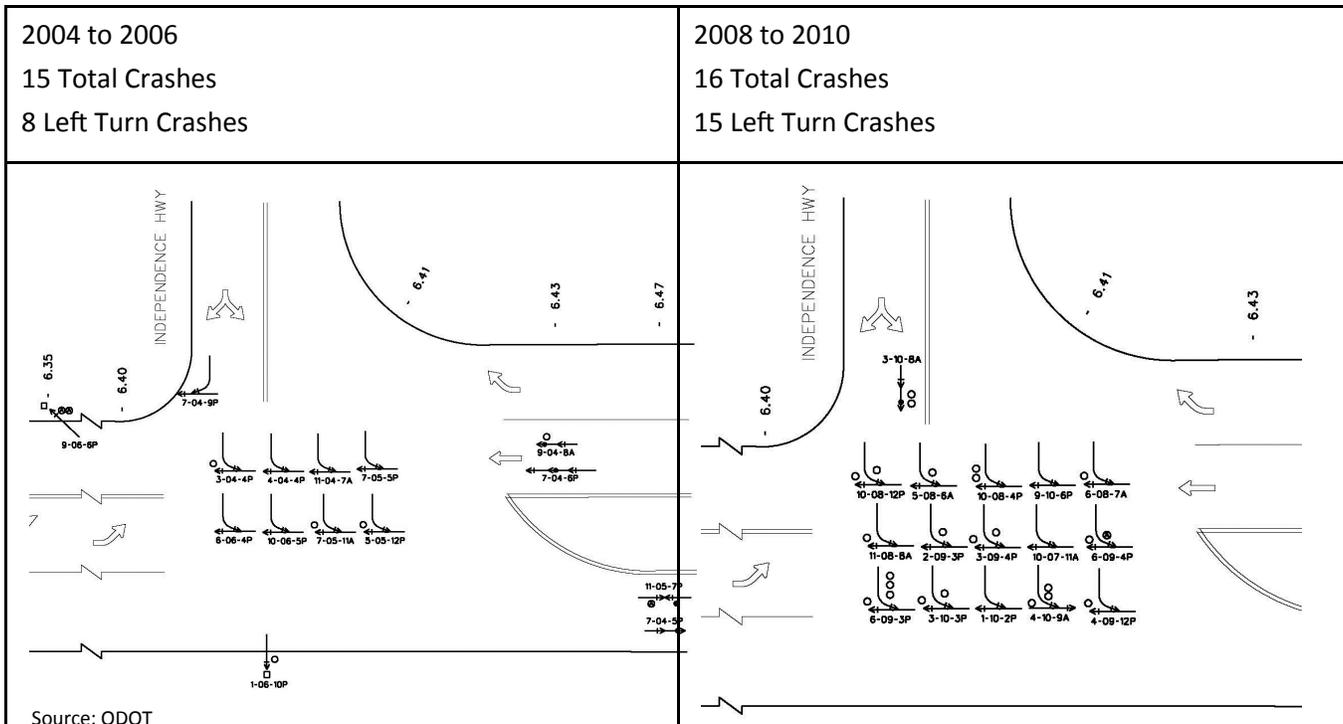
Figure 5: Crash Diagram – Independence Highway

from 2004 to 2006 and from 2008 to 2010 (See Figure 5). Data from 2007 was excluded from the crash diagram because a Statewide Transportation Improvement Program safety project rebuilt the left and right turn lanes to current standards in 2007 and added new signage and flashing warning beacons.

The crash diagrams put together by ODOT revealed that most every type of crash had been eliminated after the 2007 improvements, with the exception of the left turn crashes, which have since doubled.

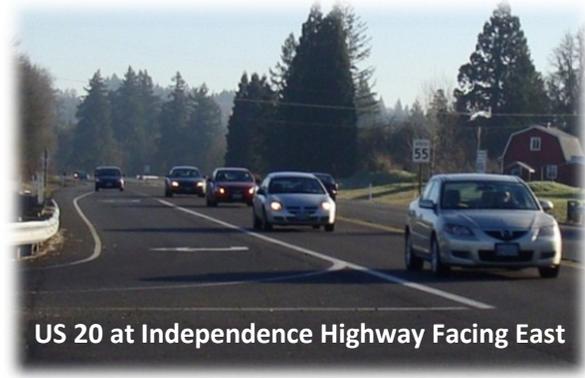
US 20 at Independence Highway Facing East

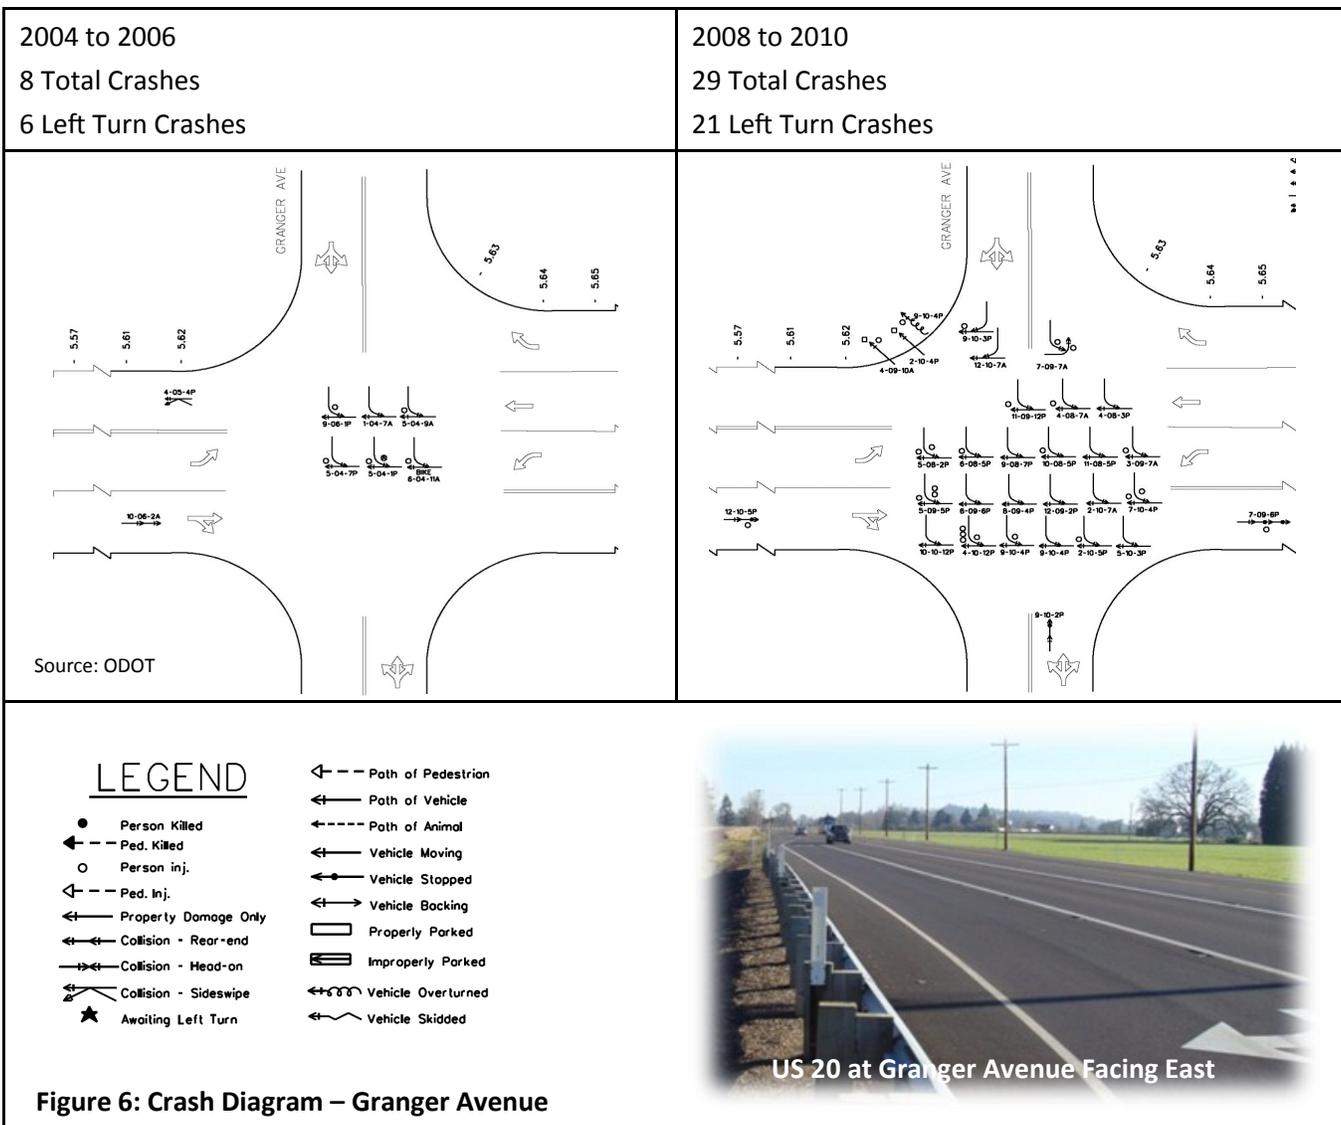
Figure 6: Crash Diagram – Granger Avenue

Figure 6 shows the crash diagrams created by ODOT using data from 2004 to 2006 and from 2008 to 2010. Data from 2007 was excluded from the crash diagram because a Statewide Transportation Improvement Program safety project rebuilt the left and right turn lanes to current standards in 2007.

As with the intersection at Independence Highway, the crash diagrams put together by ODOT revealed that left turning crashes more than tripled after the improvements were installed in 2007. Unlike at Independence Highway, other types of crashes increased at Granger Avenue in addition to the left turning crashes.
