BARBUR BOULEVARD ROAD SAFETY AUDIT

SW Capitol Highway to SW Naito Parkway

October 2015

ODOT Region 1 Traffic 123 NW Flanders Portland, OR 97209 503.731.8220 Prepared by:

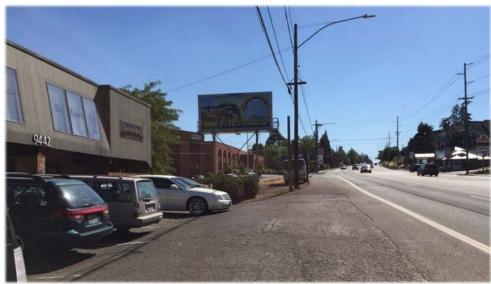
Exhibit 18. Parking adjacent to roadway at businesses near SW 35th Avenue interrupts sidewalk

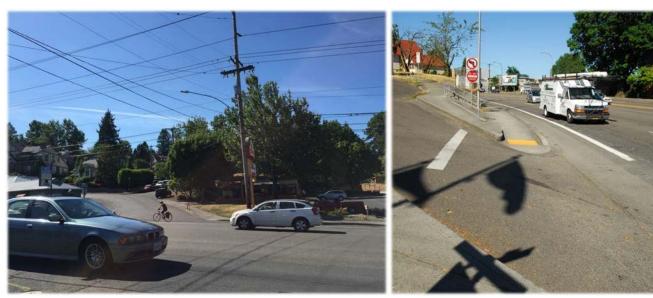
A number of intersections and driveways along the corridor are skewed, as shown in Exhibit 19. In some cases, this contributes to limited sight distance; wide, fast right-turns; and steep approaches.

Exhibit 19. Skewed intersection of Taylors Ferry Road (left) and at SW View Point Terrace (right)

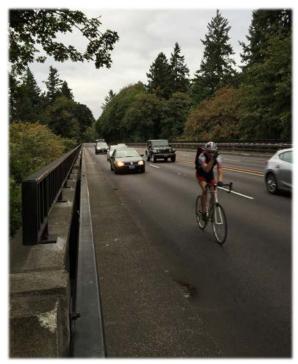
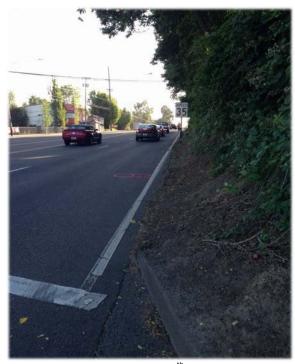
While bicycle lanes are provided on the majority of the corridor, there are several segments with no marked bicycle lanes. This condition negatively impacts safety for both drivers and bicyclists. The left image in Exhibit 20 shows no bicycle lanes on the Vermont Bridge and the right image shows a segment with no bicycle facility north of 24th Avenue. Bicyclists conflict with cars in long right-turn lanes and tapers, narrow/pinch points (such as at SW Capitol Highway and SW 19th Avenue), and locations with parking on-street or adjacent to the roadway.

Exhibit 20. Lack of bicycle lane on Newbury and Vermont Bridges (left) and north of SW 24th Avenue (right)

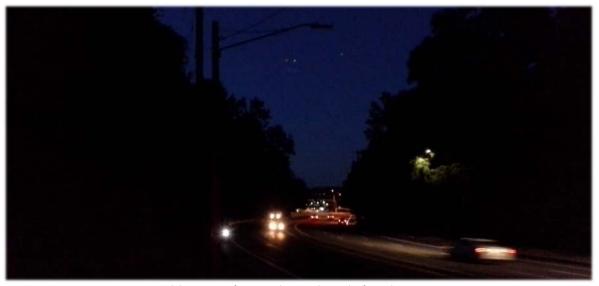
While overall lighting on the corridor is consistent (uniform) and updated [from High Pressure Sodium (HPS) to Light Emitting Diodes (LED)], lighting is not updated on some portions of the corridor. There are some intersections that appear dark, such as Barbur Boulevard/SW Capitol Highway, Barbur Boulevard/SW Bertha Boulevard approach, and the curve near SW Hamilton Street. Exhibit 26 shows tree canopies obstructing roadway lighting along the inside of the curve immediately south of the Hamilton Street intersection. The RSA Team also noticed existing street lights that were not functional, which the team communicated to maintenance staff. The bridges appear dark as there is no lighting or edge striping. Exhibit 27 graphs the crashes by severity and lighting conditions. As seen in the graph, eight of the ten fatalities occurred during dark with light conditions, as did five of the 18 incapacitating injury crashes. Three of the bicycle crashes and six of the pedestrian crashes occurred during dark with light conditions.

Exhibit 26. View from corridor at night south of Hamilton Street

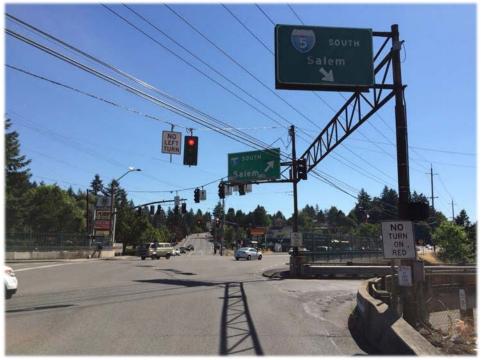
The RSA Team observed some signs blocked by vegetation and noted street name signs are difficult to see, particularly in the dark. The team also noted that wayfinding signage along the corridor is confusing in places, particularly to I-5. For example, the wayfinding signs for southbound vehicles on Barbur Boulevard are also visible from the Capitol Highway approach, as shown in Exhibit 28. Delineation to define spaces and conflict areas is missing, particularly in sections with numerous wide accesses.

Exhibit 28. Signage at Barbur Boulevard/Capitol Highway

- Clear and maintain vegetation along the corridor.
- Reevaluate wayfinding signage and find opportunities to clarify signage.
- Relocate and replace signage as appropriate.
- Consider advance intersection signage ("Next Signal" signs) for better wayfinding.

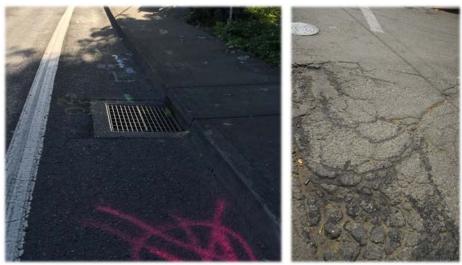
The RSA Team noted locations where the pavement quality is poor or the pavement seam is in the bicycle lane. This creates an uncomfortable ride for bicyclists and may increase the risk of bicyclists being redirected unexpectedly. In addition, some grate inlets in the bicycle lane are uneven as a result of past overlay projects.

Exhibit 29. Grate in bicycle lane and pavement quality

Function	Classification	Reasoning
Exposure	Category I	Few locations along corridor
Probability	Category I	Not historically reported as a crash cause
Consequence	Category I	Relatively low risk
Overall	Category I	-

- Consider bicycle lane conditions and opportunities for improvement during overlay and construction.
 - o The RSA Team is aware that any pavement preservation project up to the curb may trigger ADA improvements. The team suggests that when there is any improvement, the project should consider addressing uneven bicycle lane conditions without changing the scope of the specific project.

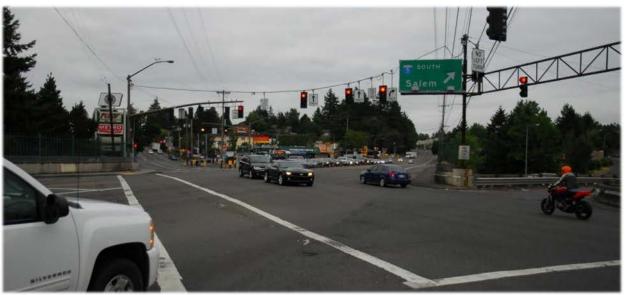
Exhibit 31. Northbound left-turning vehicles waiting for a gap at Barbur Boulevard/SW Capitol Highway

- High volume of vehicles on all approaches at this intersection.
- Northbound left-turners to I-5 south observed making their turn on red due to a lack of gaps during their permissive green.

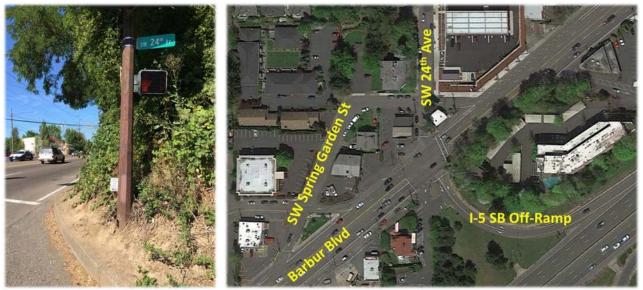
The improvements will address several of the issues observed by the RSA Team, such as the lack of pedestrian facilities on the northeast corner and lack of bicycle lanes through the intersection (as shown in Exhibit 50 left image). The RSA Team noted issues with access management at the intersection, particularly with the Pancake House and its access to the I-5 southbound off-ramp. The alignment of SW Spring Garden Street also results in closely spaced intersections and driveways in the vicinity of SW 24th Avenue.

Exhibit 50. Northeast corner lacking pedestrian facilities at Barbur Boulevard/SW 24th Avenue (left) and aerial view from Google

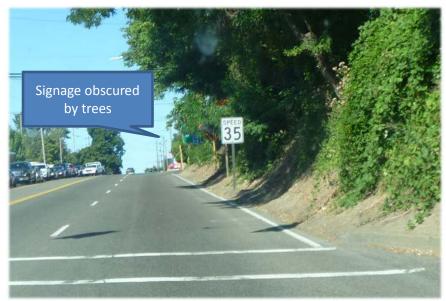
The RSA Team observed additional issues, such as obscured freeway signage for northbound I-5 on-ramp (Exhibit 52) and the lack of clarity for desired routes to freeway.

Exhibit 52. Obscured I-5 signage from northbound Barbur Boulevard just past SW 24th Avenue

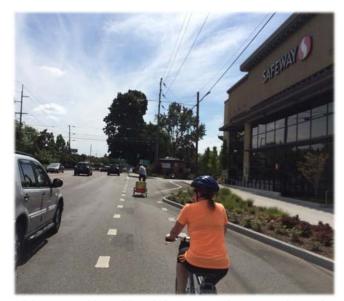
- Bicycle and pedestrian facilities end northeast of the intersection with fill embankment on both sides (Exhibit 57, left image).
- Queues on SW 19th Avenue were observed to block SW Multnomah Way, so vehicles were observed weaving through the queue to access SW Multnomah Way (frontage road).

- The northbound bus stop is nearside in the right-turn lane, providing challenges for through cyclists, right-turning vehicles, and buses merging back in to the through lane (Exhibit 57, right image).

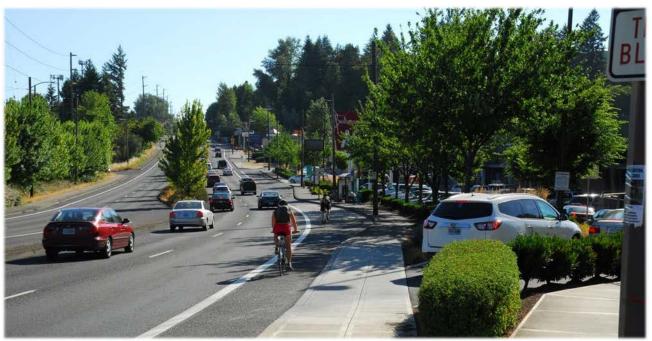
The two entrances to Fred Meyer along the site's frontage create conflicts with bicyclists, particularly at the northern entrance which is located in close proximity to the signal at SW Bertha Boulevard (shown in Exhibit 63). Queues from this entrance were observed to spill back in the bicycle lane and through auto lane. There is also a shared bus pullout in front of the Fred Meyer, which can cause confusion between bicyclists and buses about whom has the right-of-way.

Exhibit 63. Southbound on Barbur at northern Fred Meyer entrance

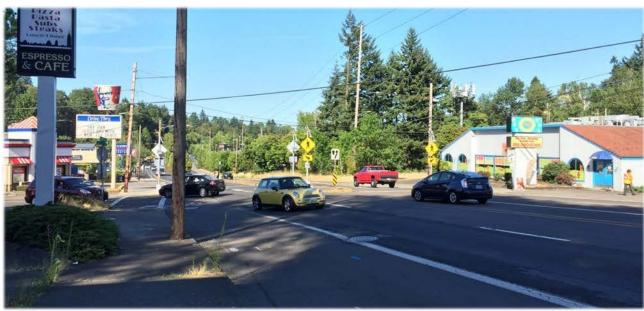
- Northbound left-turning vehicles from Barbur Boulevard to SW 13th Street were observed using the active RRFB cycle as an opportunity to turn left, as shown in Exhibit 64. Some confusion was observed between southbound through vehicles and bicyclists about who has the right-of-way to proceed after the RRFB was activated.
- The skewed approach of SW Multnomah Way contributes to inadequate sight distance for rightturning vehicles onto Barbur Boulevard.
- The transition across the bike lane to the right-turn lane at Custer is long and undefined.

Exhibit 64. Vehicles using activated RRFB cycle to turn on to and from SW 13th Avenue

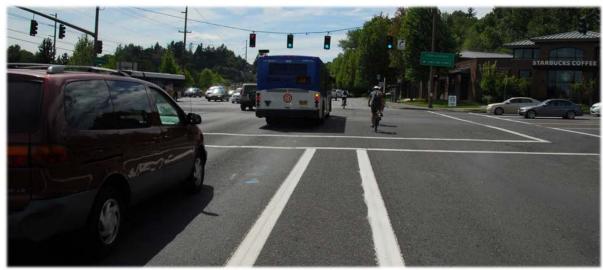
Exhibit 72. Southbound bus crossing the bicycle lane

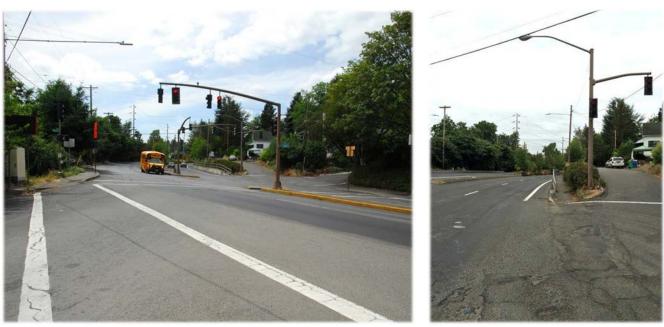
Exhibit 73. Barbur Boulevard and SW Miles Street intersection (looking south) and bicycle lane abutting retaining wall

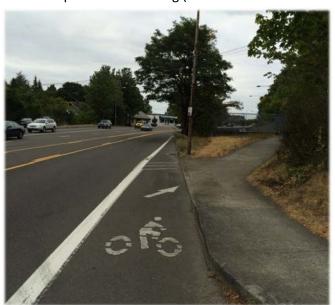
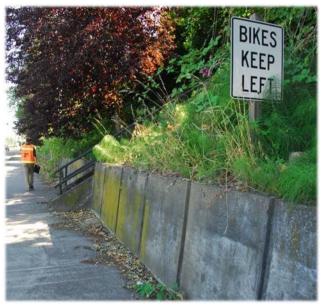
Exhibit 89. Bicycle lane entrance to multi-use path around Naito Parkway (left), Stairs jutting in to multi-use path without signage or marking (right)
