# OR 211 ROAD SAFETY AUDIT REPORT › MP 14.0-24.0

NOVEMBER 2022

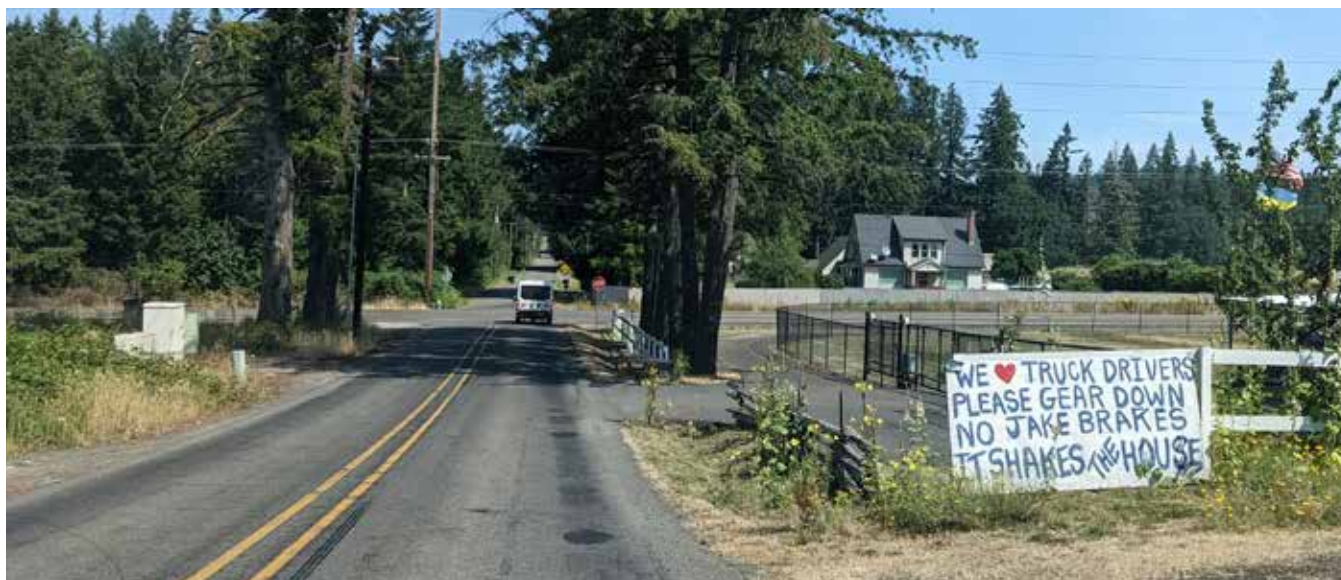
FIGURE 9: NORTHBOUND APPROACH TO OR 211 ON DHOOGHE ROAD

To the south, Dhooghe Road leads to a rock quarry approximately 2.2 miles from OR 211, generating significant truck traffic. The northbound approach to OR 211 on both Dhooghe Road and Oswalt Road have a long, steep downhill grade that restricts visibility of the upcoming intersection.

- Trim vegetation around existing signs
- Install systemic stop-controlled intersection visibility upgrades

- Modify adjacent drainage ditches and culverts to reduce hazards
- Widen corner radii and/or shoulder of the intersection

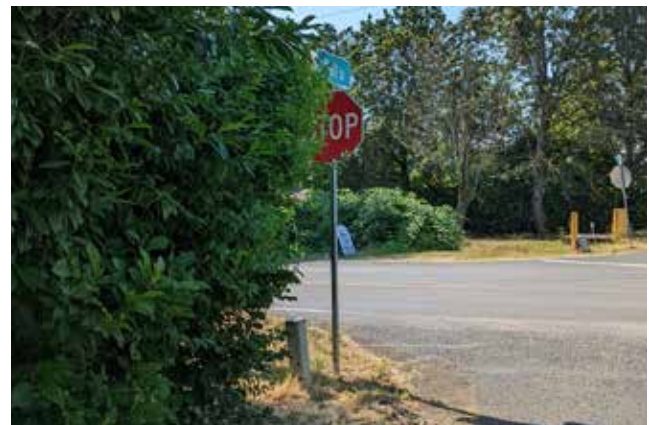
FIGURE 10: OVERGROWN VEGETATION AT OR 211 AND WALL STREET, LOOKING SOUTH

The southbound approach had two stop signs, one of which was obstructed by overgrown vegetation, shown in Figure 10.
