Subject: Response to Request for Additional Information - ERM Independent Hazard Analysis for
Edge Cable Holdings

RESPONSE TO REQUEST FOR ADDITIONAL INFORMATION - ERM INDEPENDENT HAZARD ANALYSIS FOR EDGE CABLE HOLDINGS

FIGURE 1 Jupiter Plan View and HDD Profile

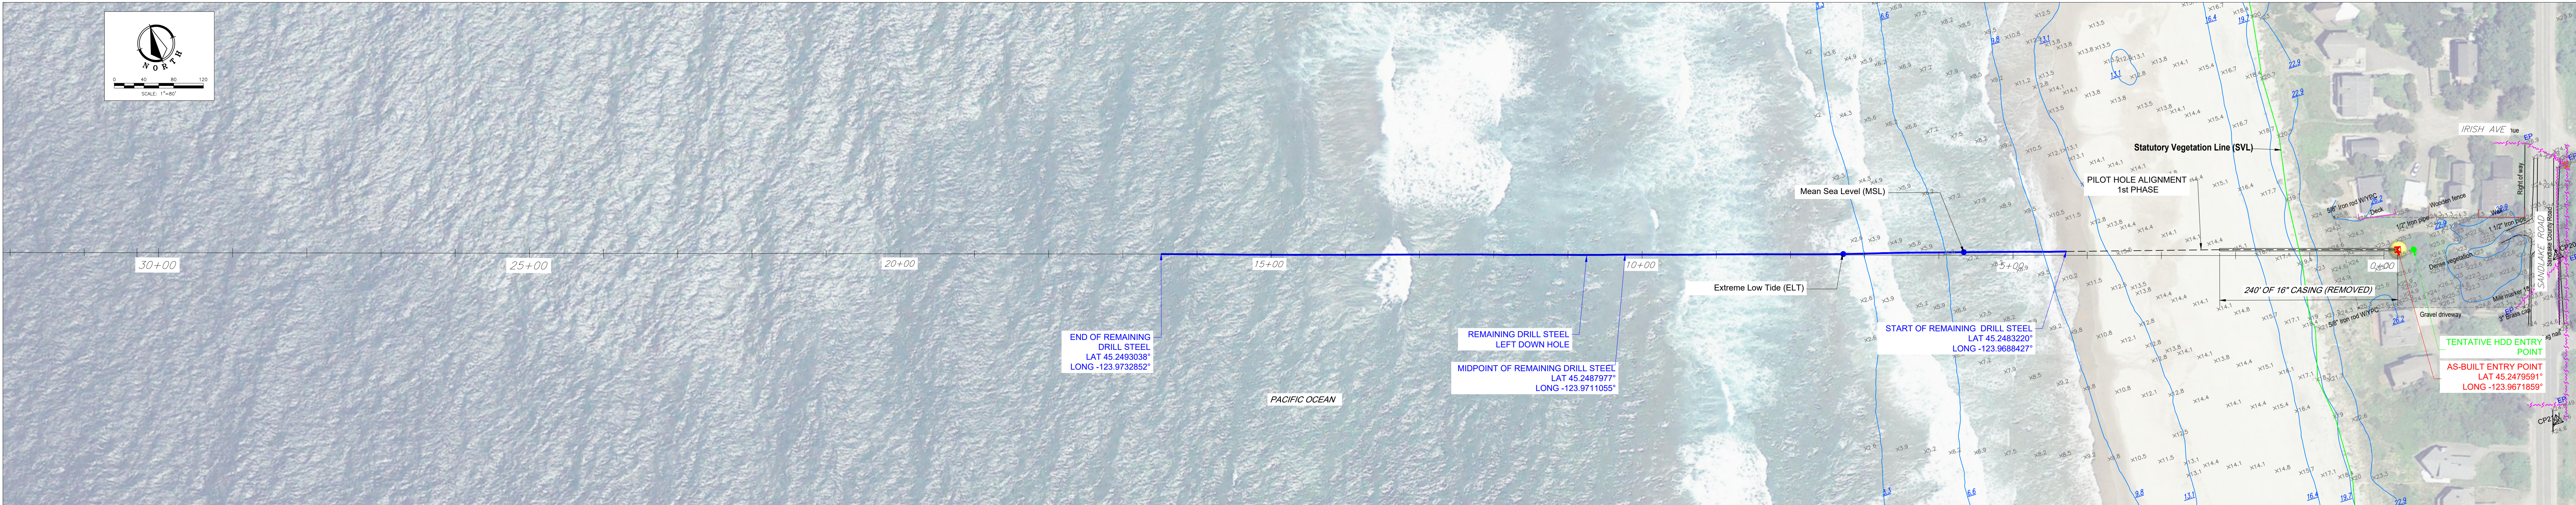
HDD Plan View
SCALE: 1"=80'

ERM’s Independent Hazard Analysis (Analysis) for the Jupiter Drill Break was developed in response to the pipe break incident that occurred on 28 April 2020. The definition of Remaining Materials provided in the Analysis is inclusive of the materials that remained in place as a result of the incident. As shown on Figure 1, the Remaining Materials extend approximately 300 feet into OPRD’s jurisdiction (the “ocean shore”) from the Extreme Low Tide line, ranging in depth from -47.1 to -75.1 feet [NAVD88] as shown on Figure 1). It is important to note that the segment of the Remaining Materials within OPRD’s jurisdiction includes steel bore pipe and surrounding drill mud but **does not** include the drilling components on the seaward end of the pipe (i.e., drill head, Monel, ParaTrack probe, ParaTrack gyro module, and jetting module); those remaining components are **outside** of OPRD’s jurisdiction.

Please see description above in Response #1 and Figure 1 attached for a clear specification of Remaining Materials within the ocean shore boundaries.

As requested, the locations and depths of Remaining Materials and the borehole path beneath the ocean shore are depicted on Figure 1, which includes a plan and cross sectional view drawn to scale. As shown on Figure 1, the Remaining Materials extend approximately 300 feet into OPRD’s jurisdiction (the “ocean shore”) from the Extreme Low Tide line, ranging in depth from -47.1 to -75.1 feet [NAVD88]. The demarcation of the ocean shore boundaries, specifically the Extreme Low Tide (based on Lowest Astronomical Tide) and Statutory Vegetation Line (SVL) are shown on the figure to visually illustrate the Remaining Materials in relation to these boundaries.

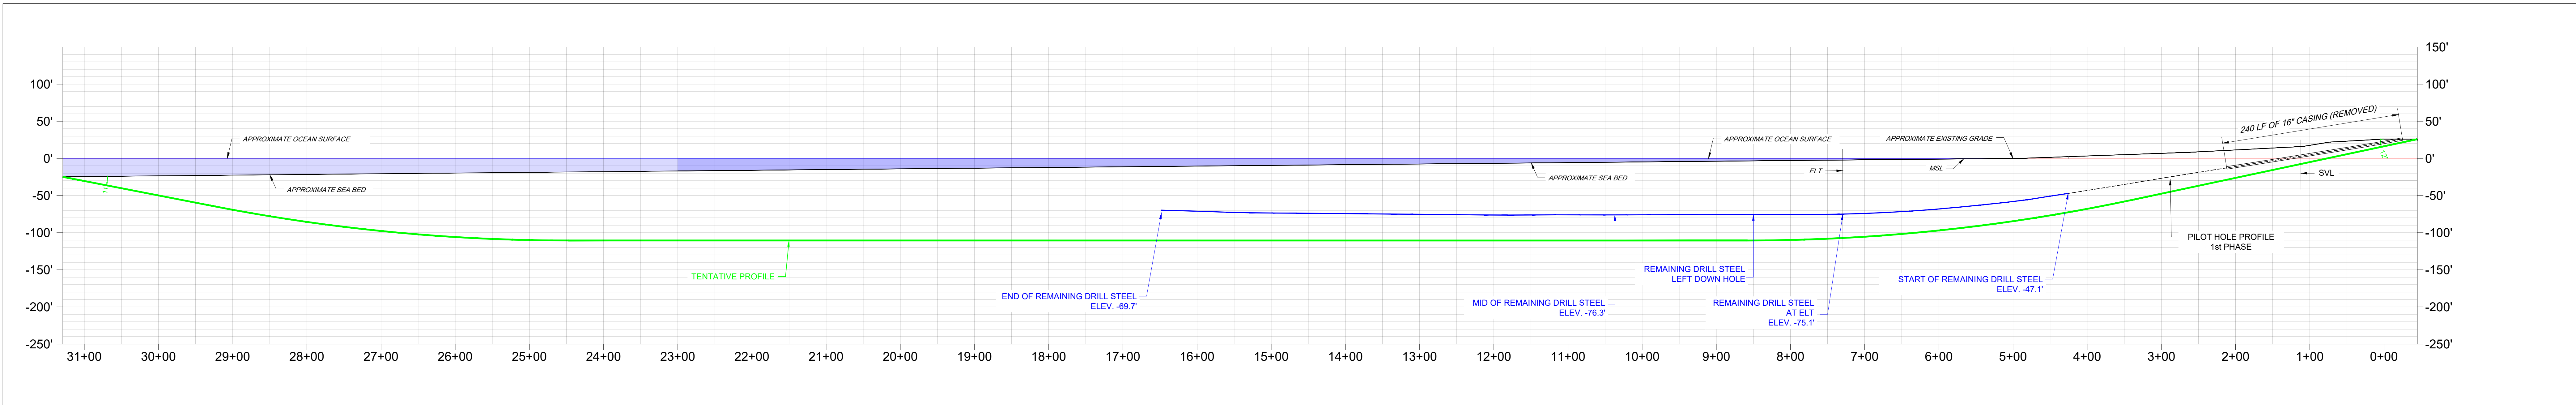
HDD Profile
HOR. SCALE: 1"=80'
VER. SCALE: 1"=80'

The locations and depths of Remaining Materials and the borehole path beneath the ocean shore are depicted on Figure 1.

The “new borehole” (“2021 borehole”) design will be confirmed upon completion of additional geotechnical surveys. The 2021 borehole (shown as the green line labelled “Tentative Profile” on Figure 1), in proximity to the previous borehole (“2020 borehole”), does not present risk for significant displacement of the 2020 bore pipe or liquefaction of drilling mud nor does it affect the stability of the subsurface where the 2021 borehole will advance. While the drilling contractor has indicated that they will make every effort to avoid contact with the Remaining Materials, as described below, the risks associated with direct contact are negligible.

It is known at this time that the 2021 borehole entry point will be set back from the 2020 borehole entry point and the 2021 borehole will likely be at a deeper (rather than shallower) profile than the 2020 borehole. Specifically, the 2021 entry point will be set back from the 2020 borehole entry point to avoid subsurface sediment previously disturbed. The 2021 operations will utilize 16-inch steel casing to extend seaward further than the casing for the 2020 operation to direct the 2021 borehole path deeper than the end of the broken pipe. Once at the desired depth, the drill bit will advance horizontally. This process will advance the 2021 borehole path below the depth of the 2020 borehole path and avoid direct contact with Remaining Materials and collapsed portion of the 2020 borehole.
