OREGON PARKS AND RECREATION DEPARTMENT OCEAN SHORE PERMIT APPLICATION

SHORELINE PROTECTION STRUCTURES

Seawall back to original size and height with 5'-6' riprap: Riprap double layer at bottom half of wall

**Engineering Geologic Investigation
for Oceanfront Protection Along Siletz Spit
between Tax Lot 156, Map 08-11-09DD
and Tax Lot 200, Map 07-11-34CB
Lincoln County, Oregon**

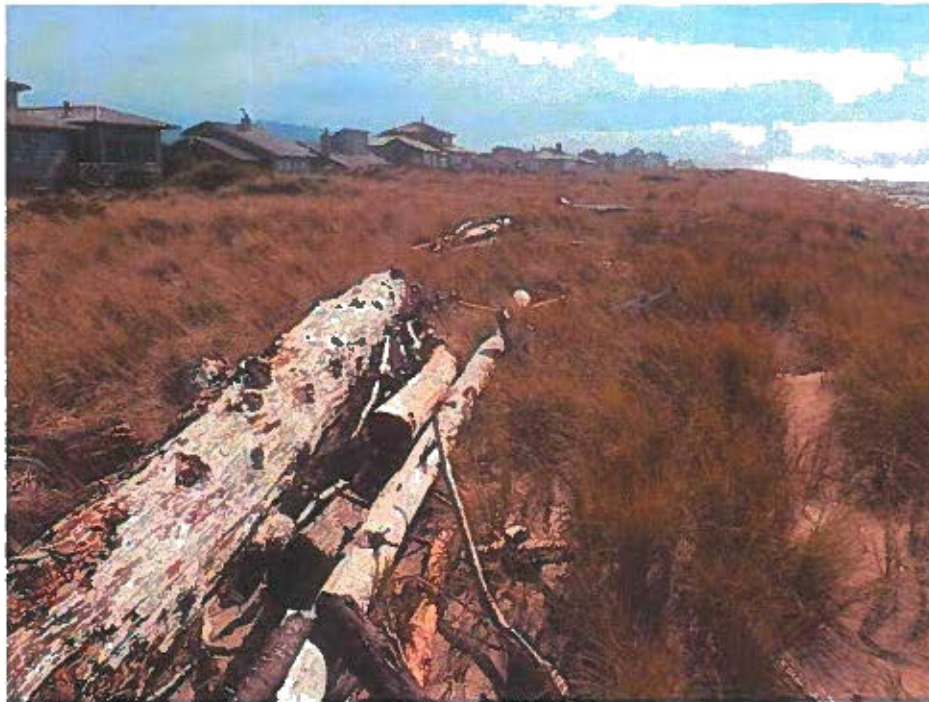
Photo 5 – View of drift logs on top of the vegetated foredune in the northern portion of the site.

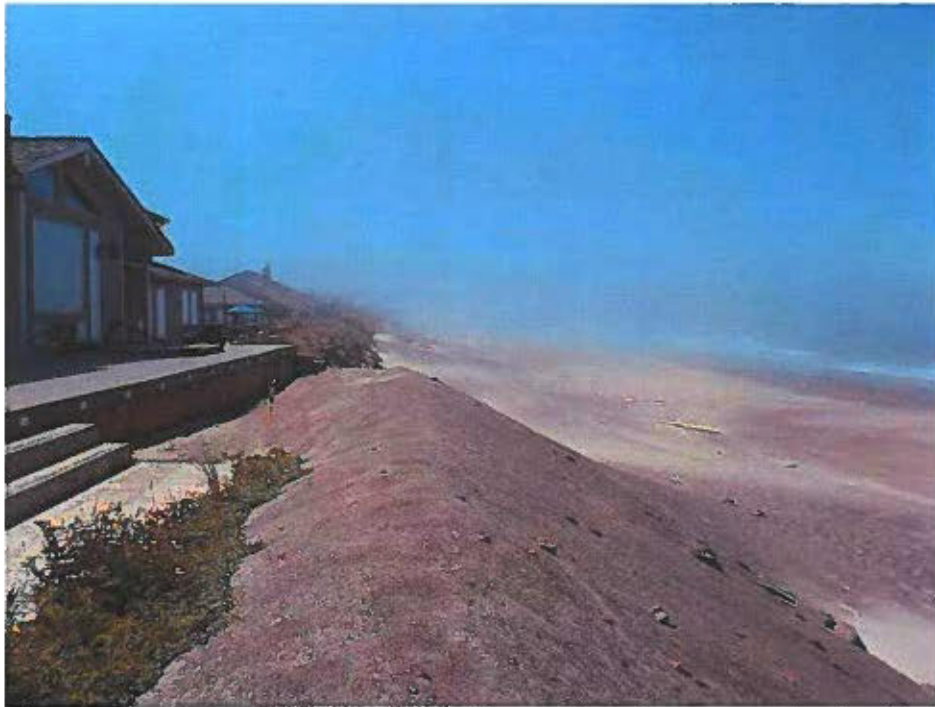
Photo 9 – Southerly view along the top of a recently built revetment fronting Tax Lot 1000, Map 08-11-03CB. Severe erosion during winter 2018/2019 necessitated emergency construction of this revetment to prevent further damage to the house. (Also see Appendix A-2)

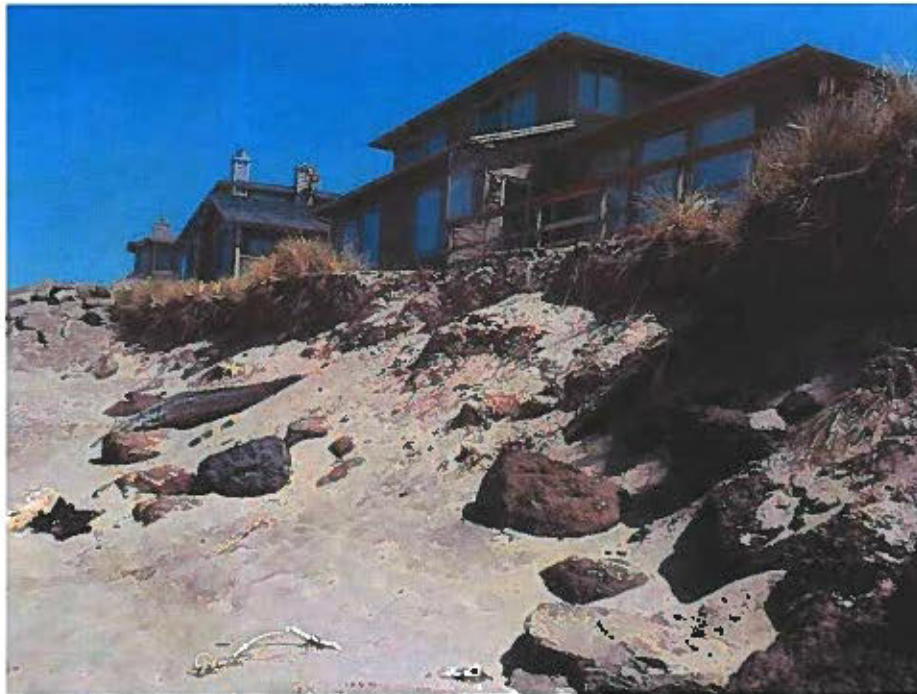
Photo 10 – View of the erosion scarp and damaged revetment fronting Tax Lot 900, Map 08-11-03CB. Note the inadequate size and poor quality of the armor stone of the damaged revetment. (Also see Appendix A-2)

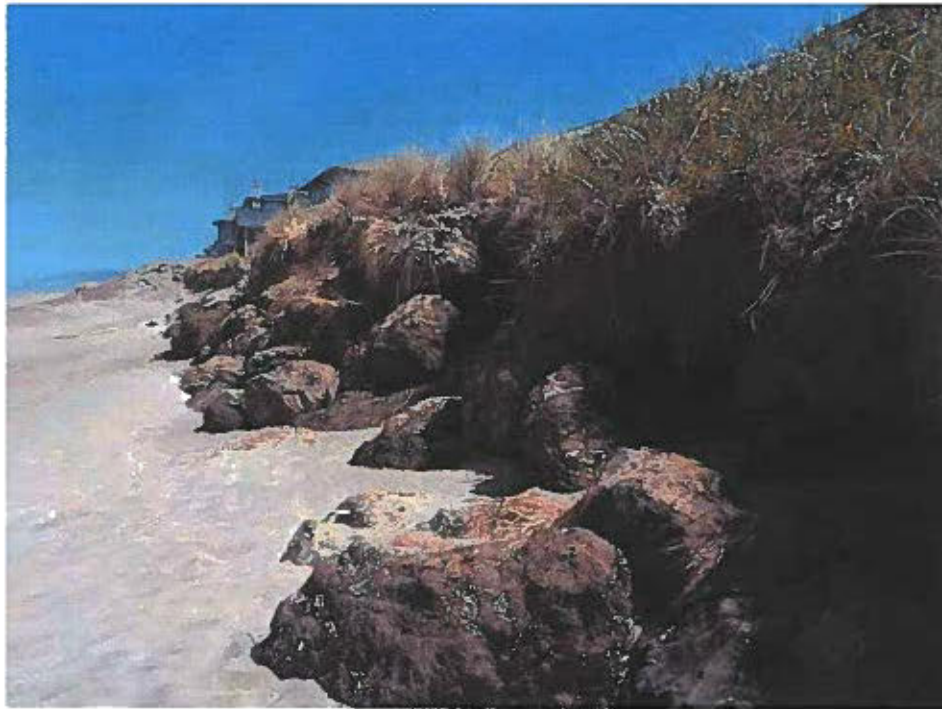
Photo 11 – Close-up view of the inadequate armor stone exposed during the winter of 2018/2019.

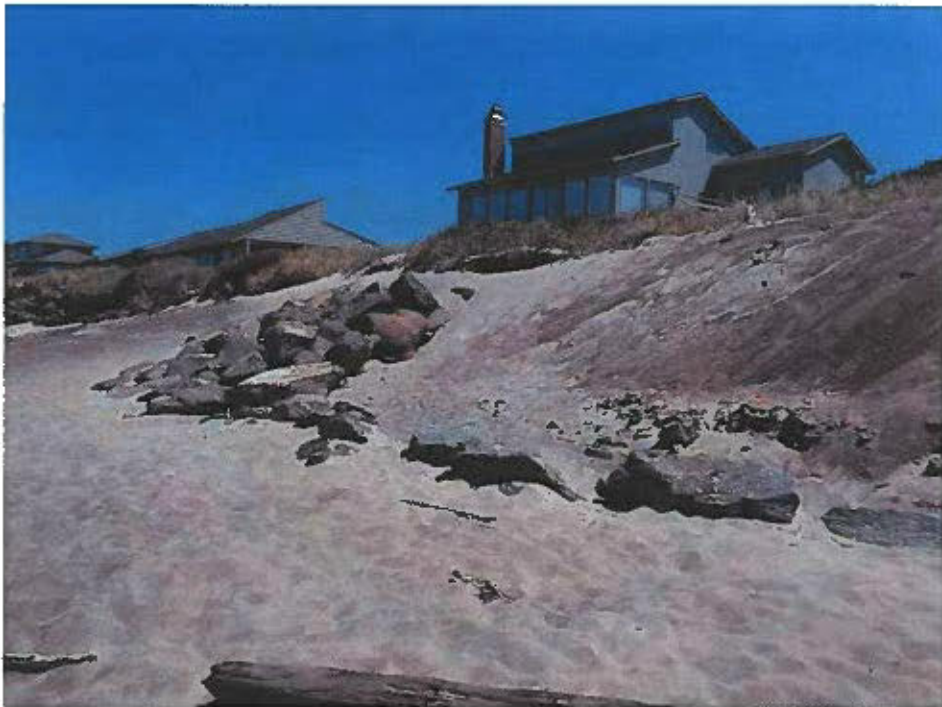
Photo 12 – View of the revetments fronting the beach in the area of Tax Lot 700, Map 08-11-03CB where the rock quality improves. Reconstruction of revetments occurred between Tax Lot 700, Map 08-11-03CB and Tax lot 204, Map 08-11-03CC to the south after severe erosion along this stretch of beach in 2016. (Also see Appendix A-2)

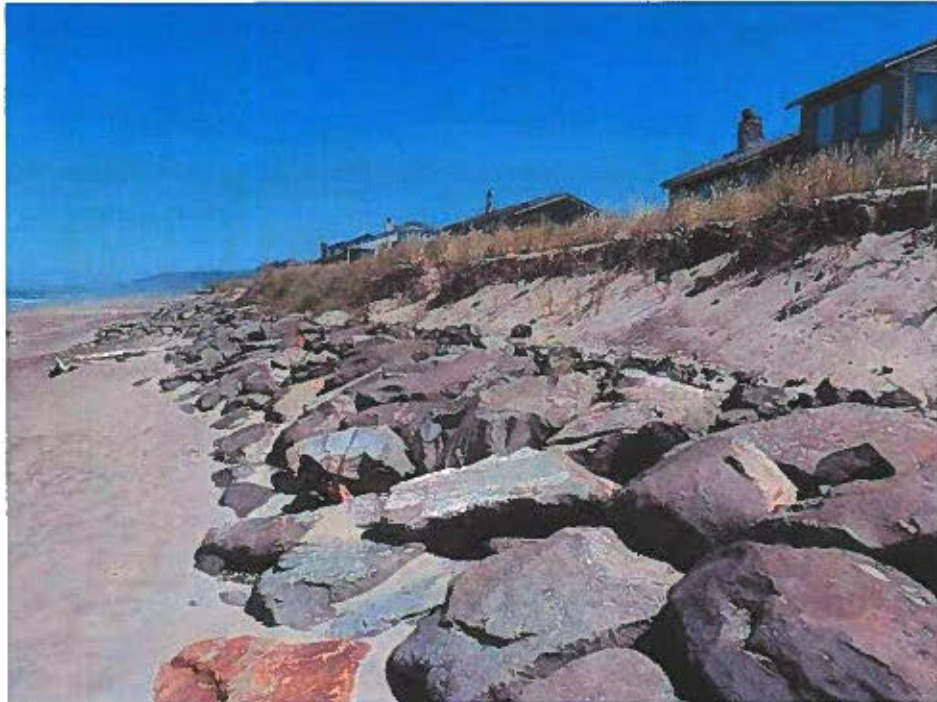
Photo 13 – Close-up view of the top of the revetment fronting Tax Lot 401, Map 08-11-03CB. Note the shallow revetment angle ($\sim 15^\circ$; $\sim 3.5H:1V$) and the erosion on the dune east of the revetment caused by overtopping of the revetment.

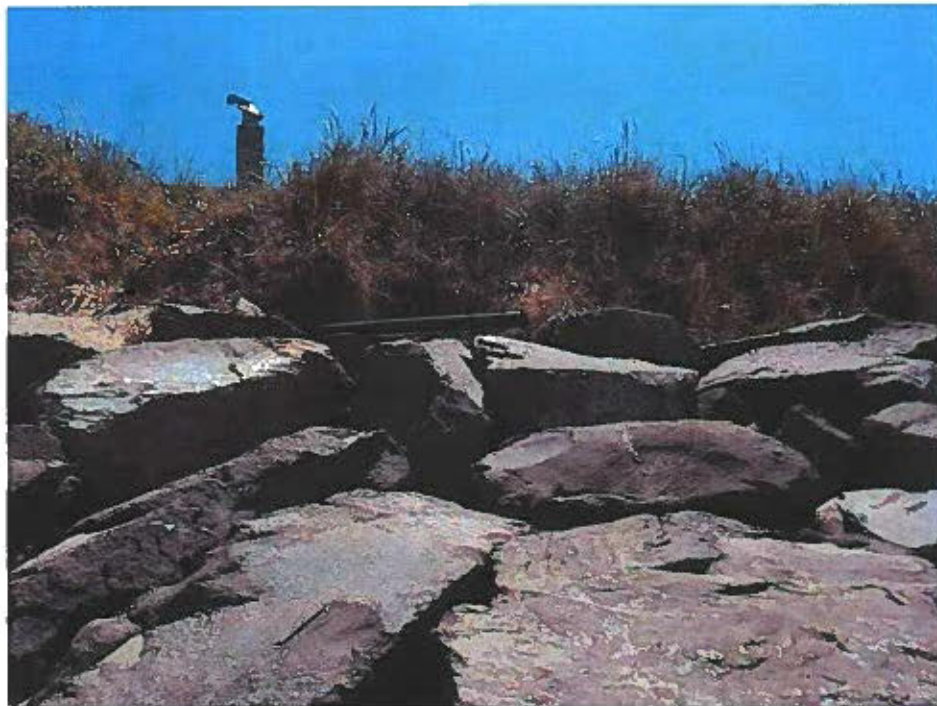
Photo 14 – View of drain pipe discharging to the riprap armor stone.

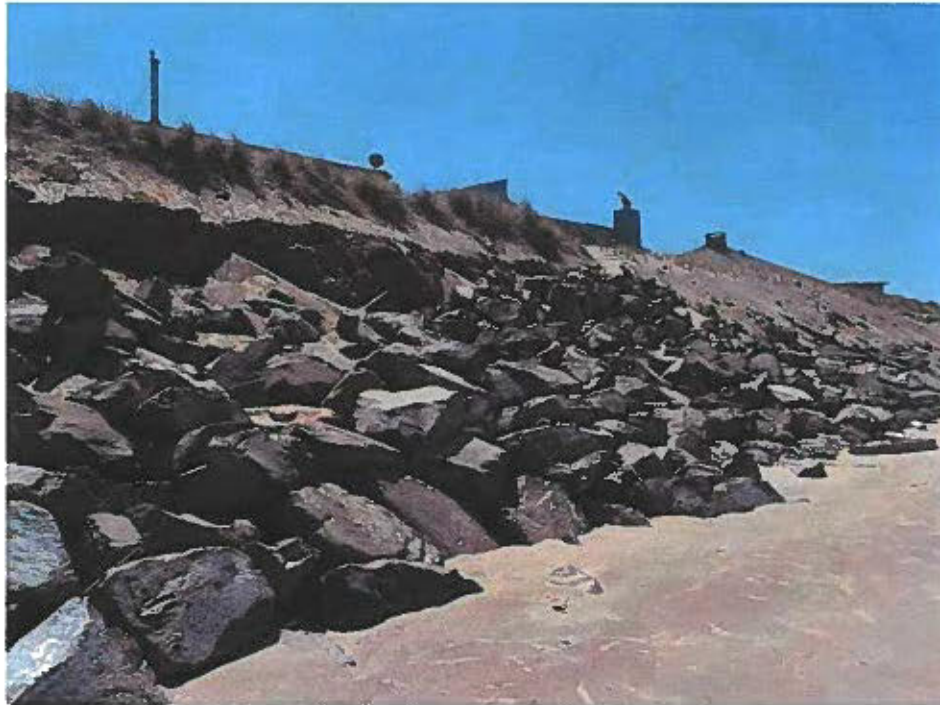
Photo 15 – View of damaged recently constructed revetment fronting Tax Lot 219, 08-11-03CC (Also see Appendix A-2).

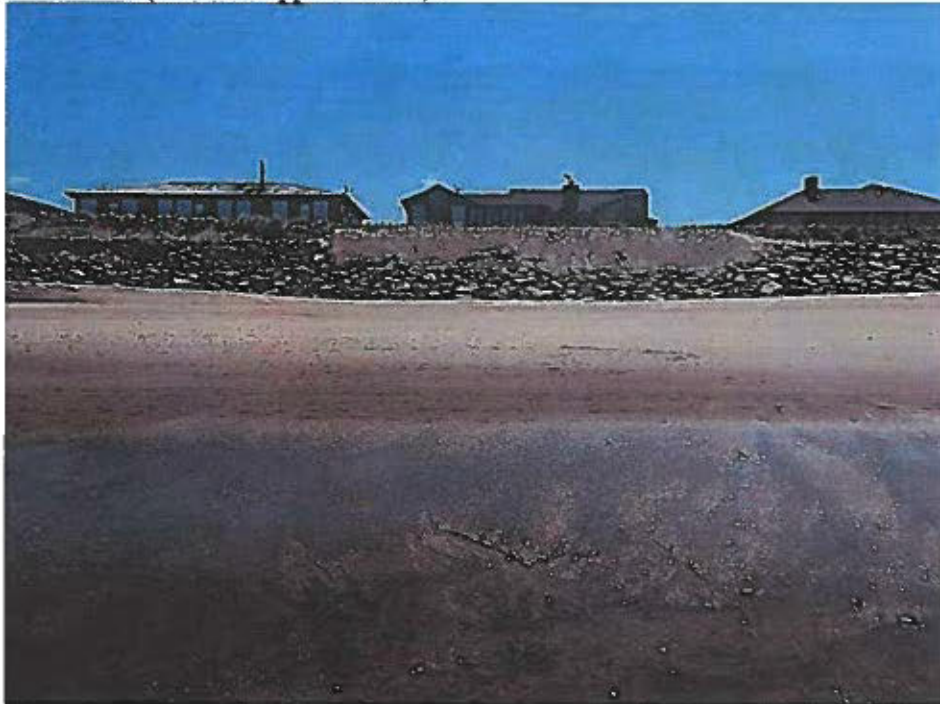
Photo 16 – View to the west of the revetments fronting Tax Lots 217 (right), 218 (center) and 219 (left), Map 08-11-03CC. The height of the revetment fronting Tax Lot 218 was recently raised to help mitigate overtopping (Also see Appendix A-2).

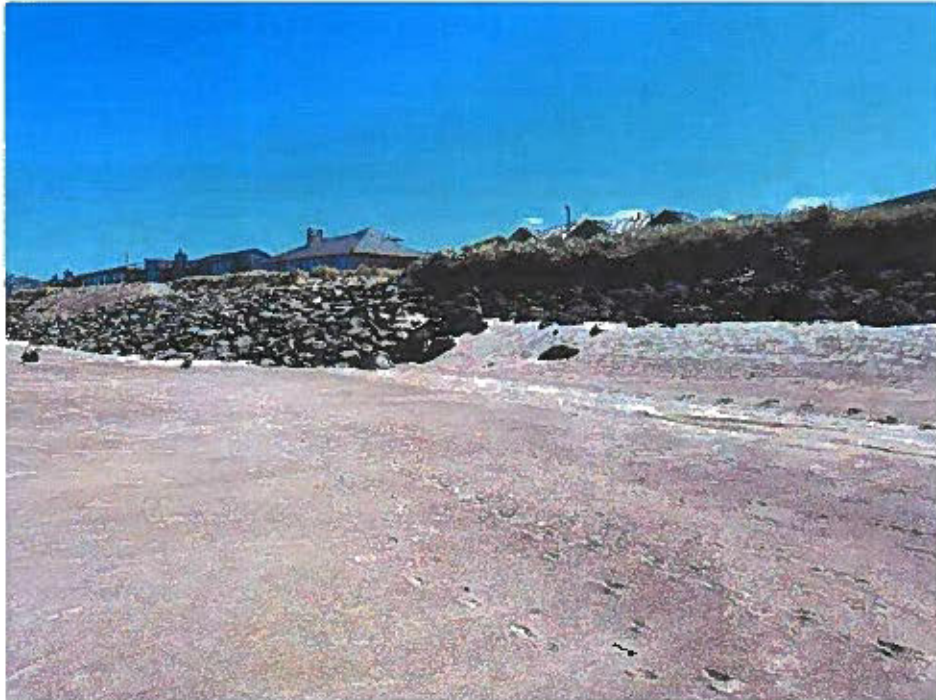
Photo 17 – Southeasterly view of the transition from competent high-quality rock at the southern extent of the recently constructed (2016) revetments to low-quality basalt breccia rock to the south.

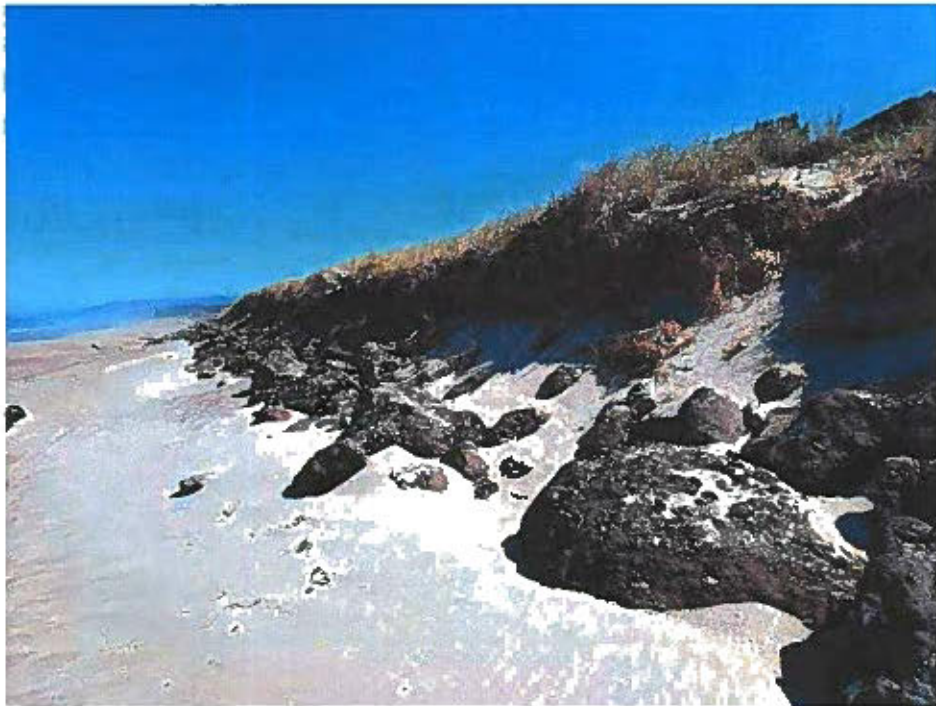
Photo 18 – View of the loosely stacked basalt breccia armor stones used in construction of the original revetments.

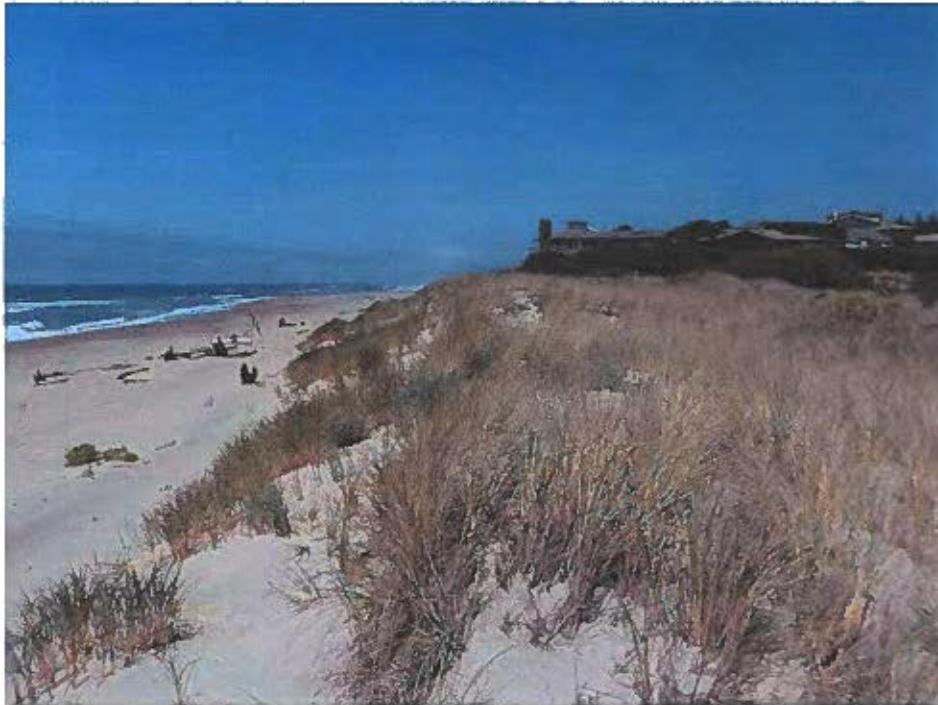
Photo 19 – Northerly view of the foredune fronting the “park” (Tax Lot 235, Map 08-11-09AA, and Tax Lot 139, Map 08-11-09AD) which does not have a riprap revetment.

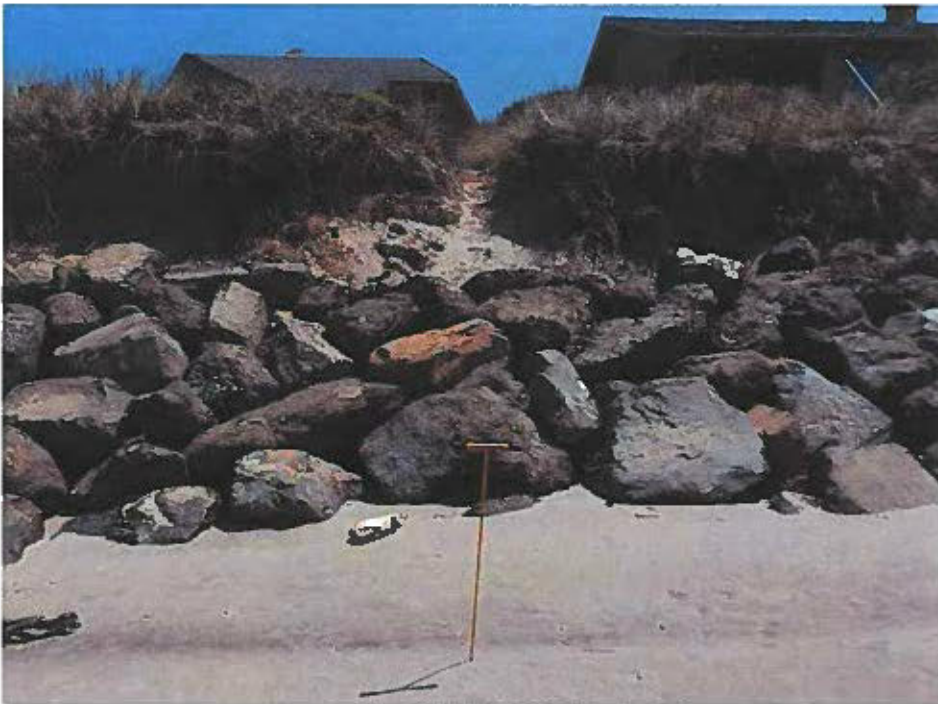
Photo 20 – View of a revetment where competent rock is mixed with poor-quality basaltic breccia.

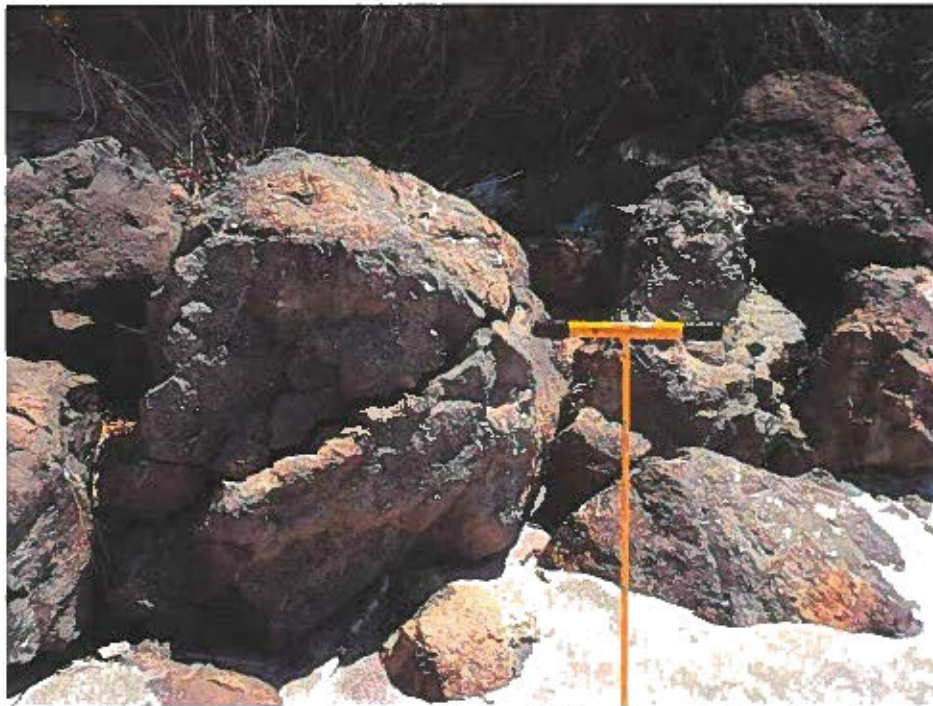
Photo 21 – Close-up view of poor-quality basaltic breccia and pillow basalt armor stones. Note the fractures in the stones.

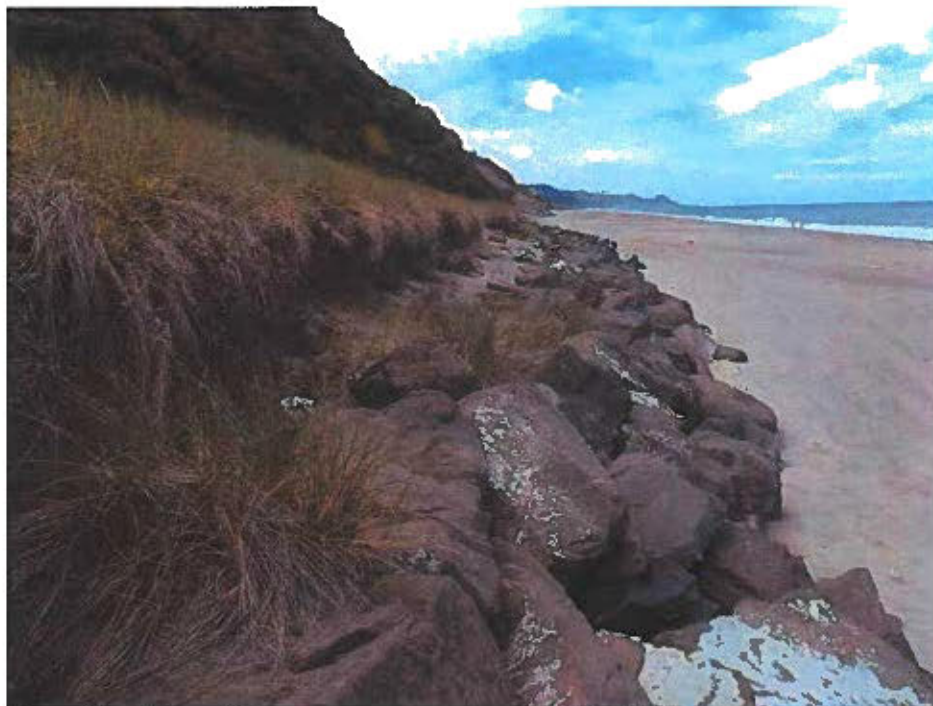
Photo 22 – View of the revetment near the southern extent of the site. Note the erosion above and behind the top of the revetment indicating previous overtopping of the revetment. (Photo taken 07/06/2018)

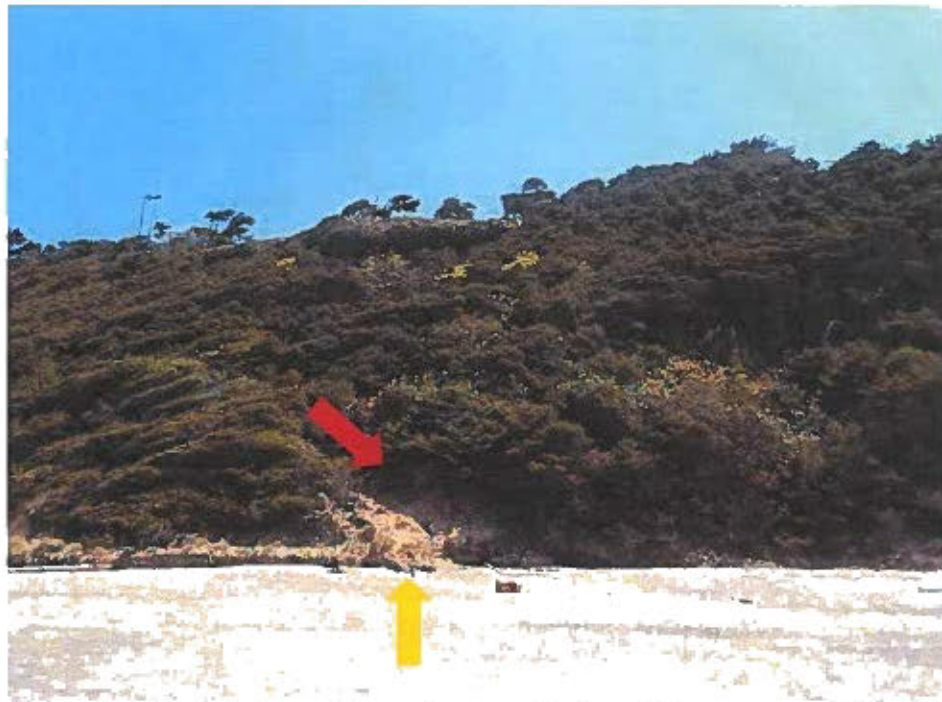
Photo 23 – Westerly view of the southern termination of the revetment (indicated with yellow arrow) along the northern property boundary of Tax Lot 156, Map 08-11-09DD. Note the erosion at the toe of the bluff immediately south of the termination of the revetment (indicated with red arrow). (Photo taken 05/31/2019)

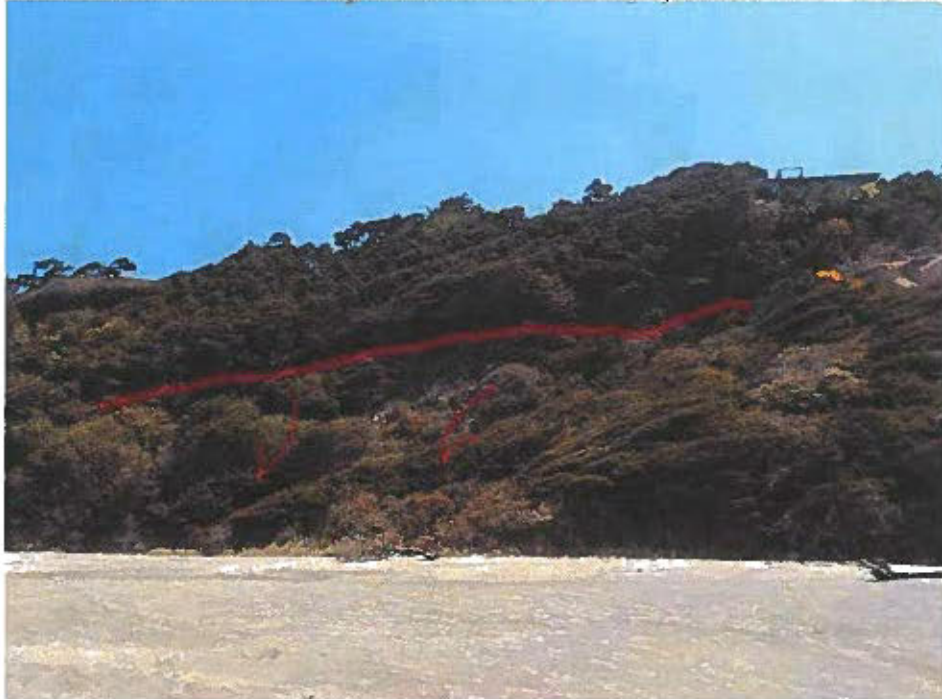
Photo 24 – View of the bluff slope on the western portion of Tax Lot 156, Map 08-11-09DD that has experienced shallow failures due to erosion of the toe of the bluff. Shallow landslide scarp indicated with red line; direction of movement indicated with red arrows.

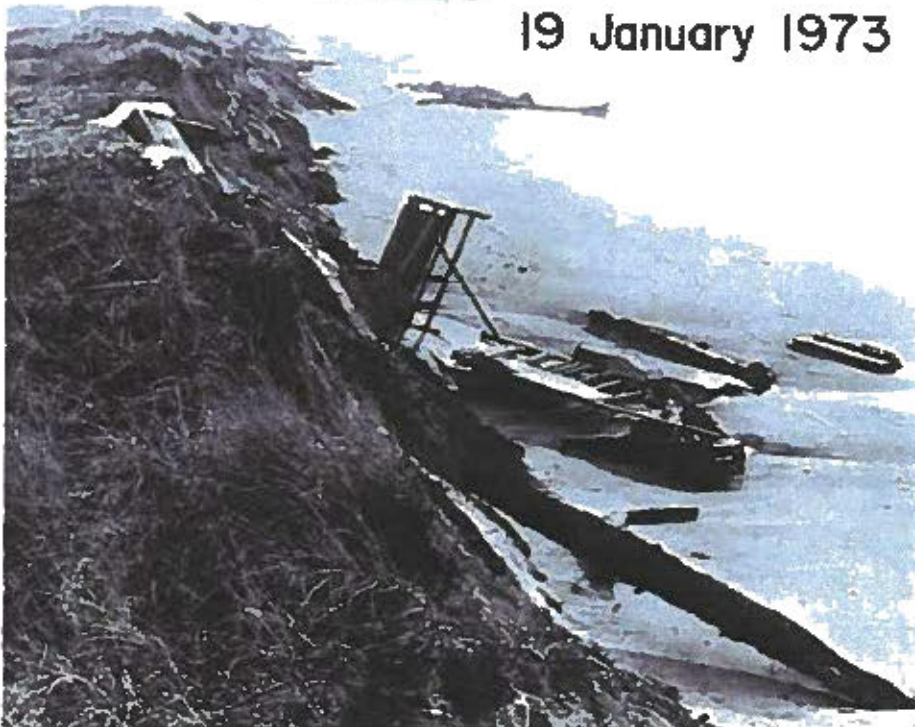
Figure 2. Erosion and destruction of the house under construction on lot 226 of Siletz Spit.

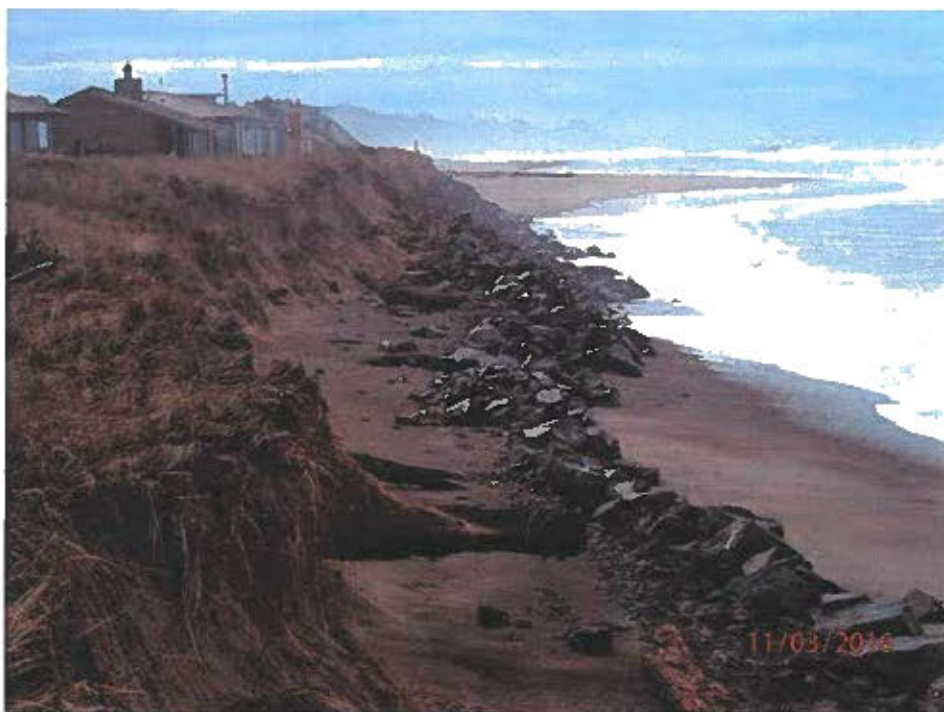
Photo 6 – March 2016 storm damage to riprap at Salishan affected 11 properties. Wave overtopping, inadequate design and poor construction contributed to the problem. From Sennewald (2018)

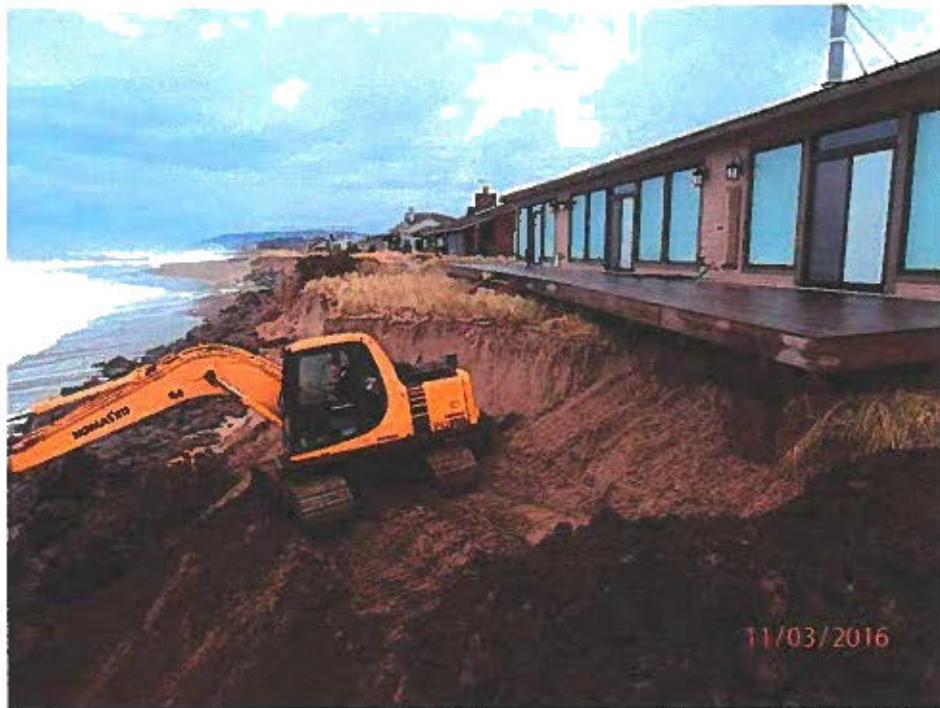
Photo 7 – Photo of emergency repairs underway to protect Tax Lot 219, Map 08-11-03CC. From Sennewald (2018)

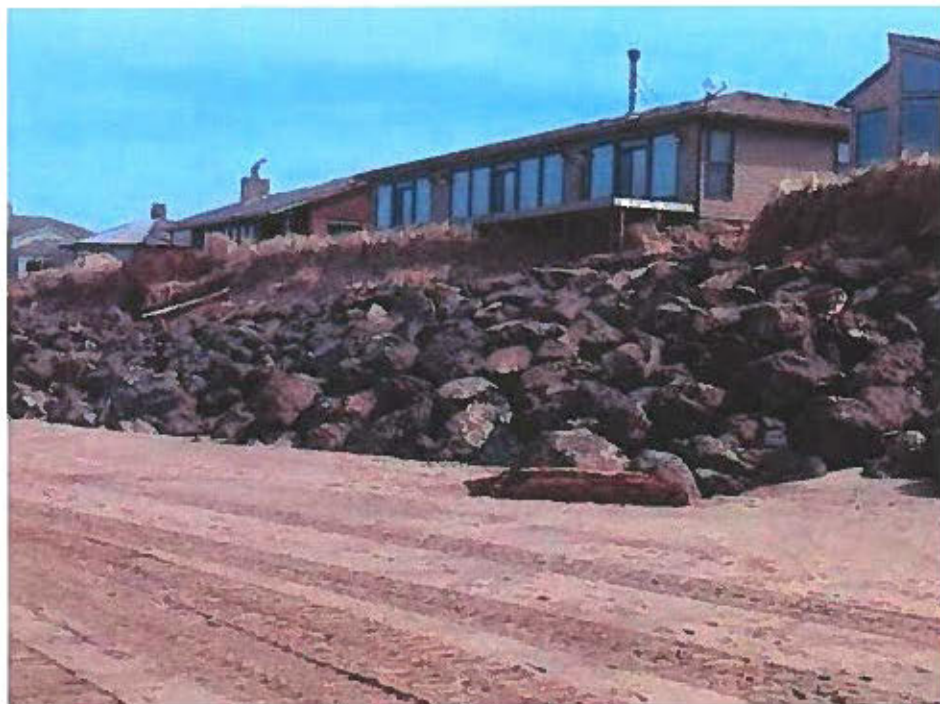
Photo 8 – Photograph taken 16 March, 2016, of emergency repairs completed at Tax Lot 219, Map 08-11-03CC. Provided to HGSA by a Salishan Leaseholder.

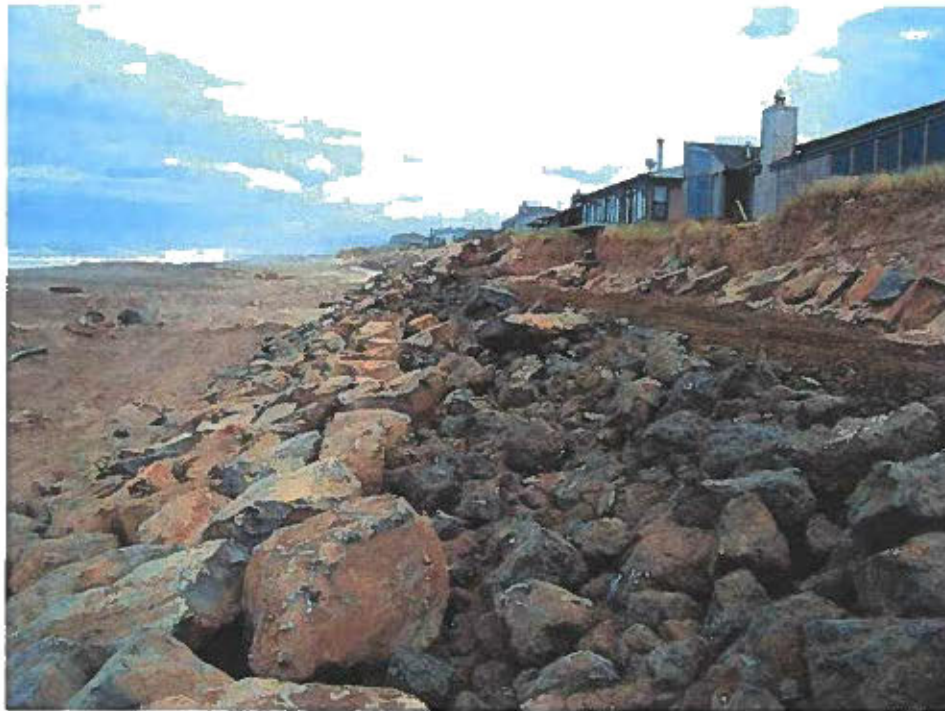
Photo 9 – Northerly view of the revetment fronting Tax Lot 218, Map 08-11-03CC during permitted repair work. Note the single layer of armor stone and lack of filter fabric backing the revetment. Photo taken by HGSA on 05/21/2016.

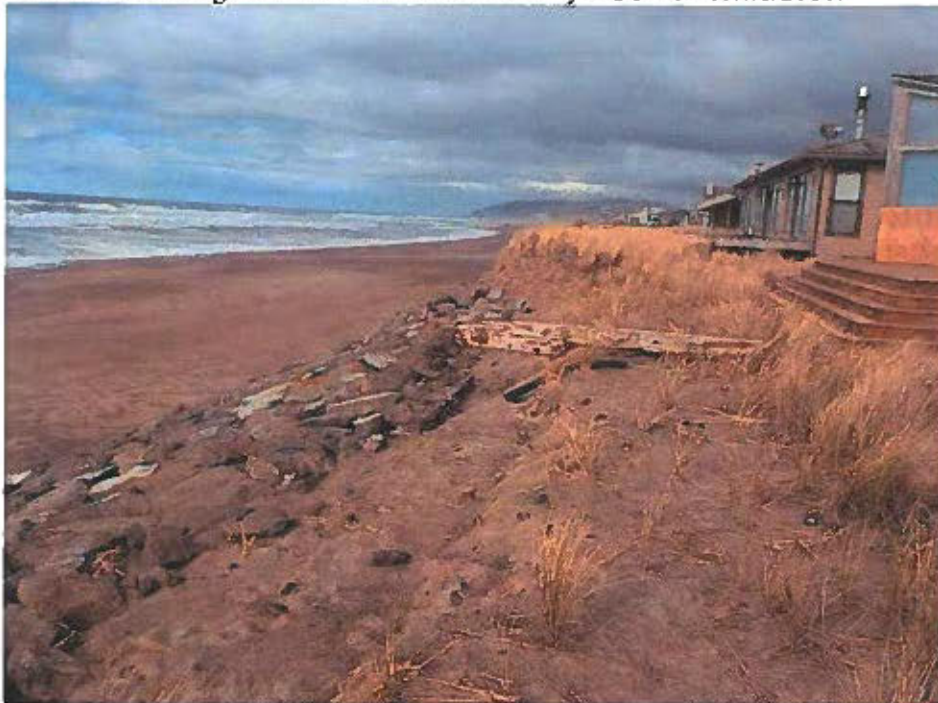
Photo 10 – Northerly view of the top of the revetment at Tax Lot 218, Map 08-11-03CC after the 2018/2019 winter when the revetment was overtopped. Note the erosion of the topping sand, the drift log on the top of the dune, and the plywood used to protect the windows. Photo taken by HGSA on 03/01/2019.

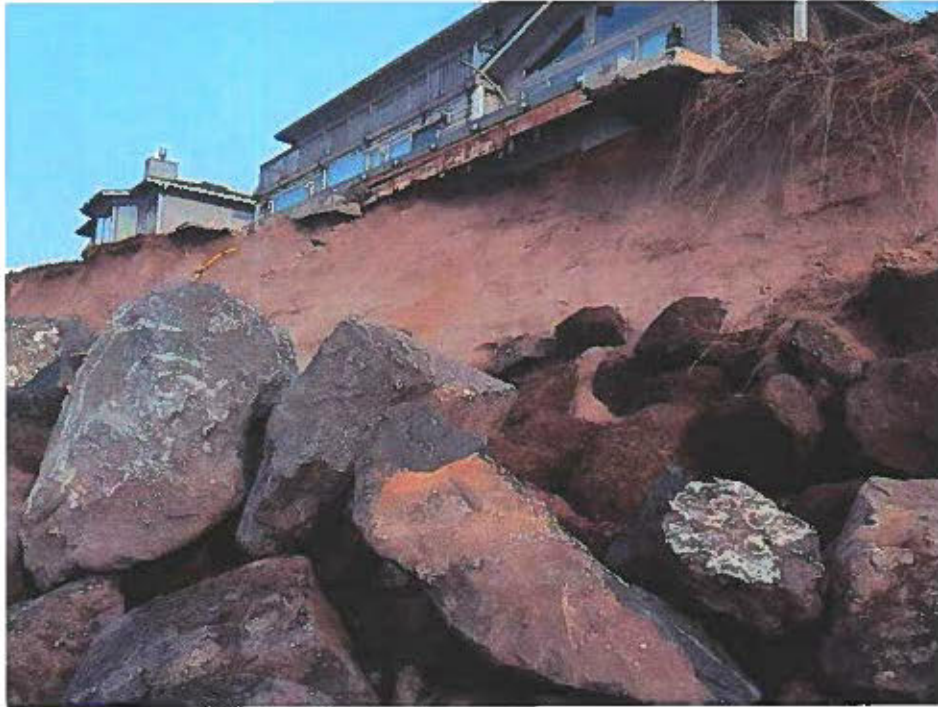
Photo 11 – View of the erosion that damaged the structure at Tax Lot 1000, Map 08-11-03CB, and riprap placed under an emergency permit. Photo taken on January 7, 2019 and submitted to oregonshores.org by user “ORbeach”.

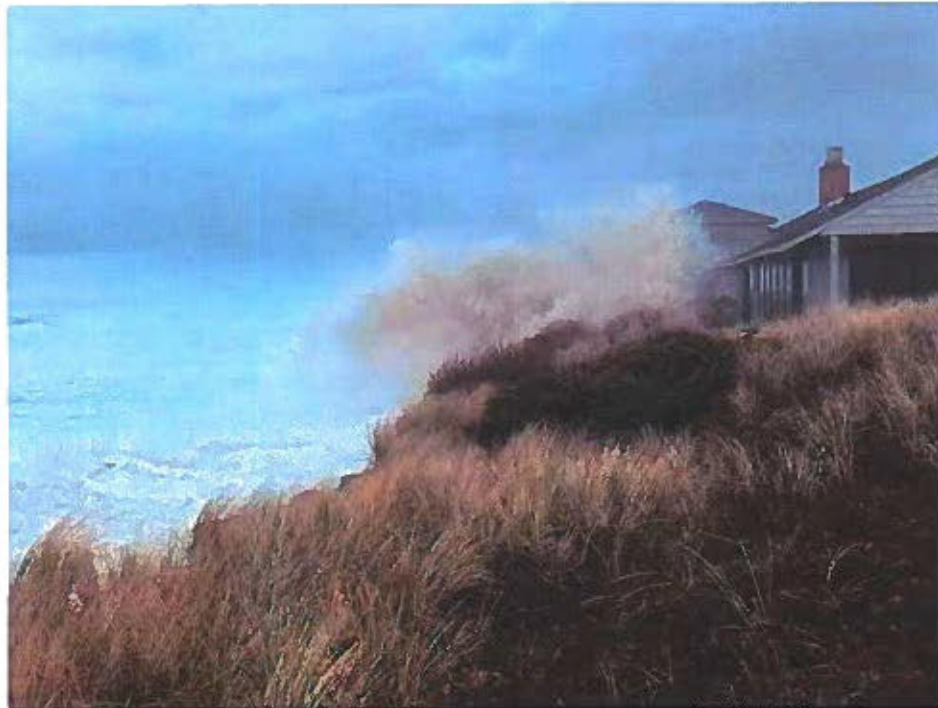
Photo 12 – View of wave splash overtopping the reveitment fronting Tax Lot 701, Map 08-11-03CB, and landing on the roof of the house. Photo extracted from video provided by Jay Sennewald.
