OREGON SCHOOL FOR THE DEAF

Facilities Assessment Update 2024

BRIC ARCHITECTURE, INC. FEBRUARY 2024

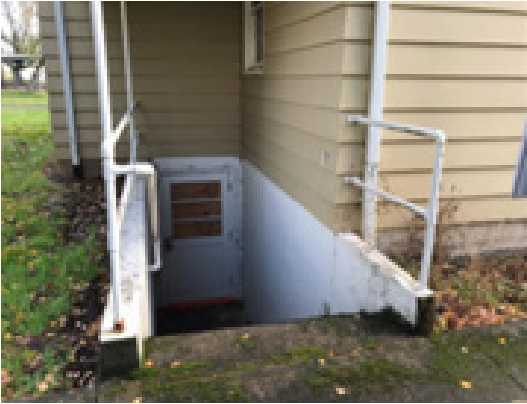
C20 Stairs - Safety

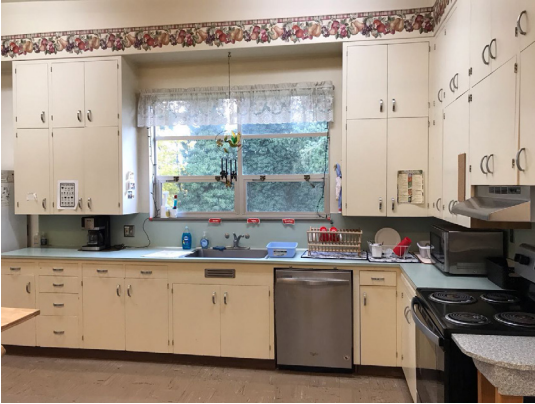
E20 Furnishings – Accessibility

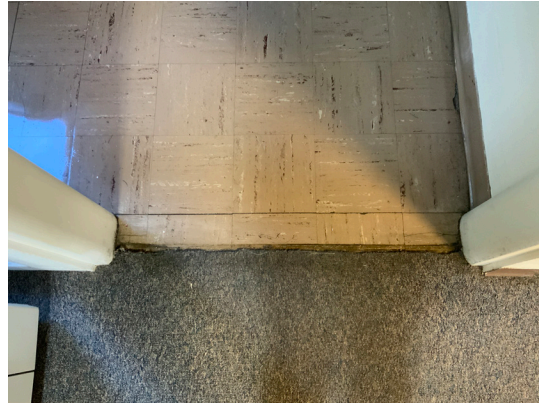
C30 Interior Finishes – Hazardous Materials

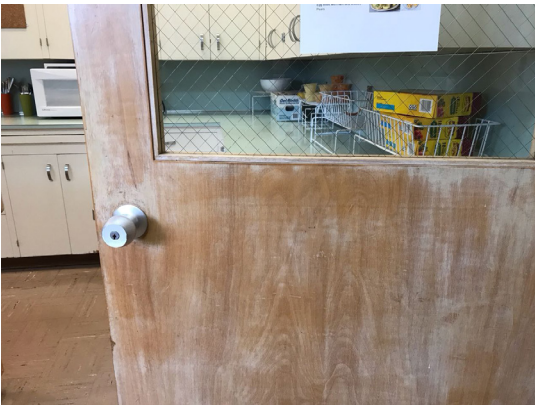
C10 Interior Construction – Accessibility

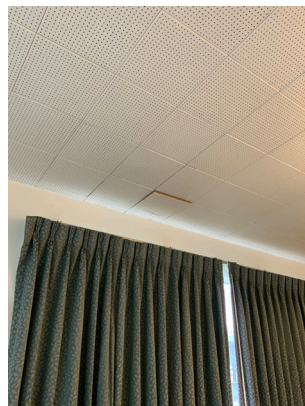
C30 Interior Finishes – Hazardous Materials

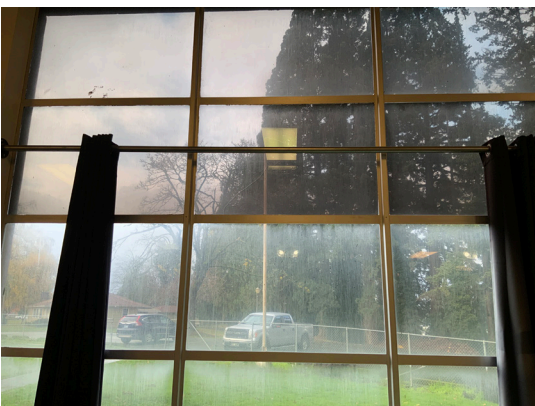
B20 Exterior Enclosure – Energy

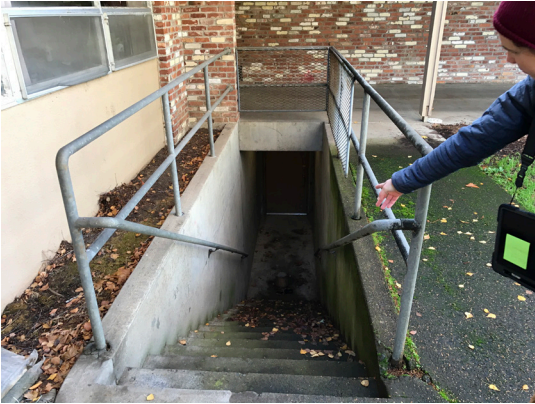
C20 Stairs – Safety

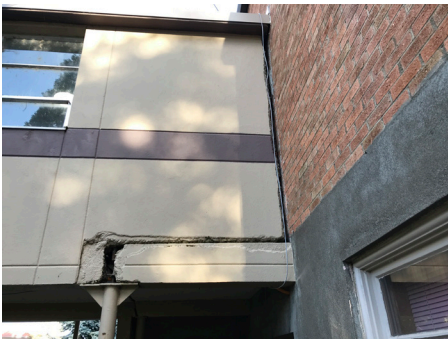
B10 Superstructure – Safety

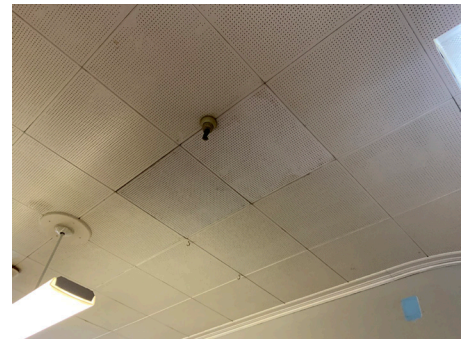
C30 Interior Finishes – Hazardous Materials

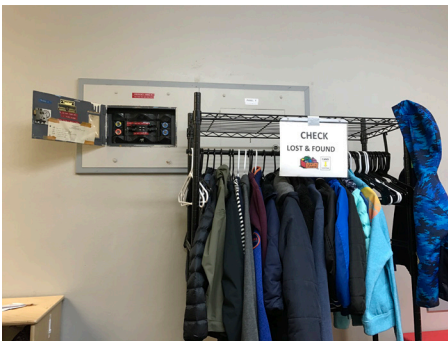
D50 Electrical Systems – Safety

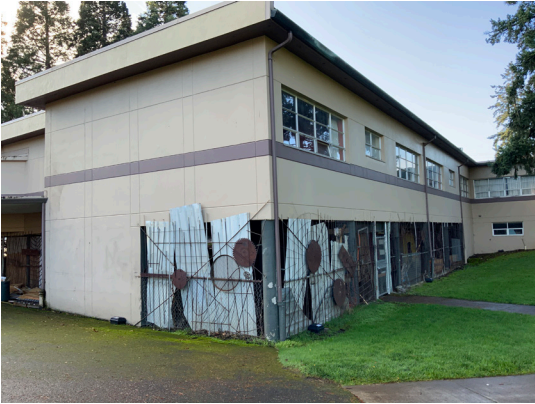
B10 Superstructure – Seismic

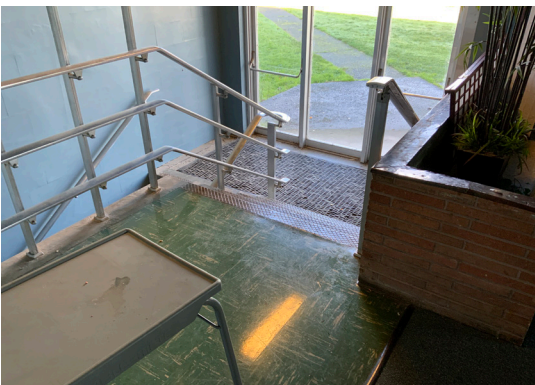
C20 Stairs – Fire Life Safety/Code, Hazardous Materials, and Deferred Maintenance

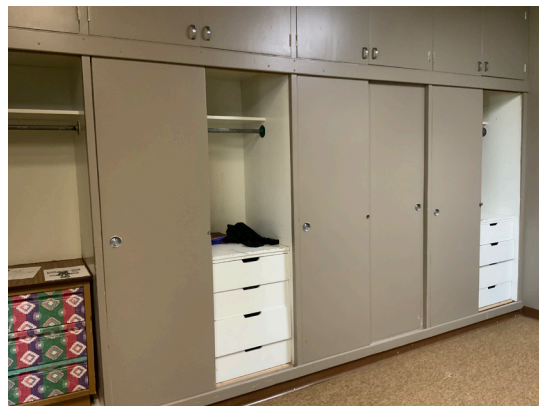
E20 Furnishings – Deferred Maintenance

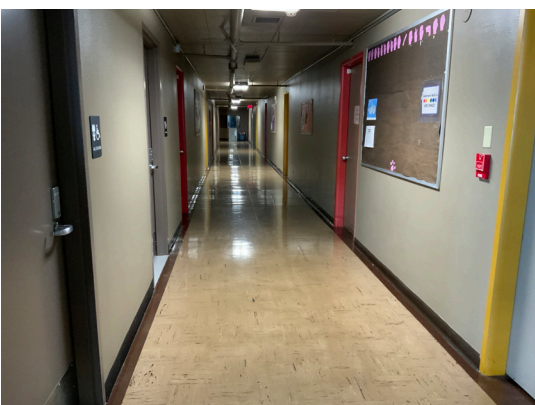
C30 Interior Finishes – Hazardous Materials

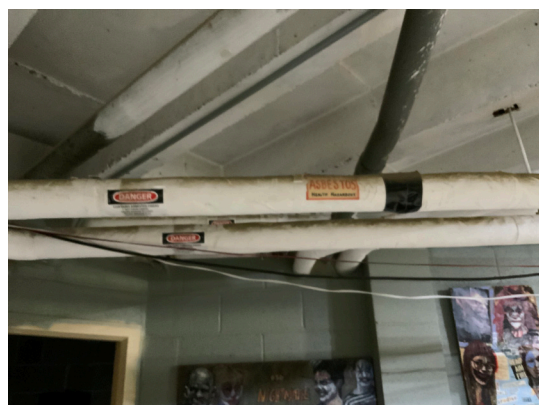
D30 HVAC Systems – Hazardous Materials

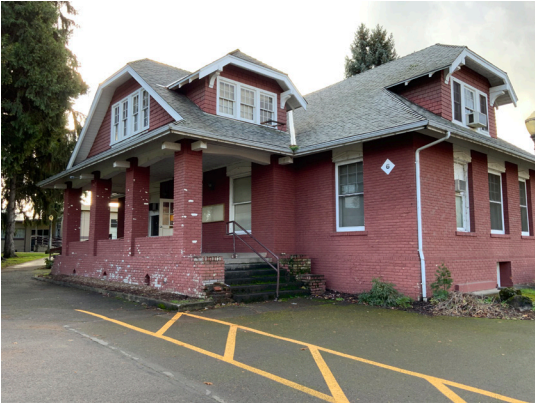
B20 Exterior Enclosure – Deferred Maintenance

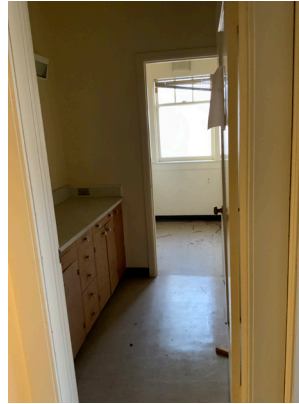
C30 Interior Finishes – Hazardous Materials

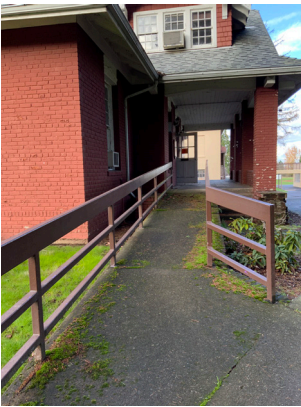
C20 Ramp and Stairs – Accessibility

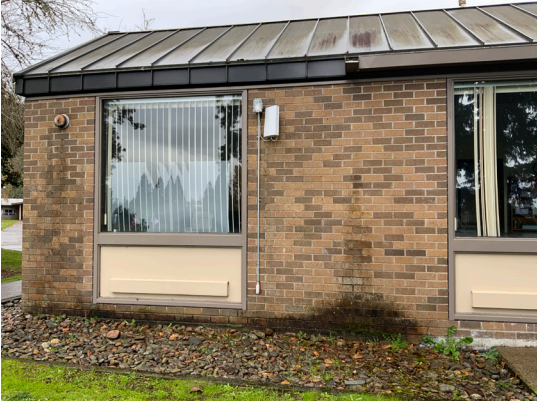
B20 Exterior Enclosure – General Maintenance

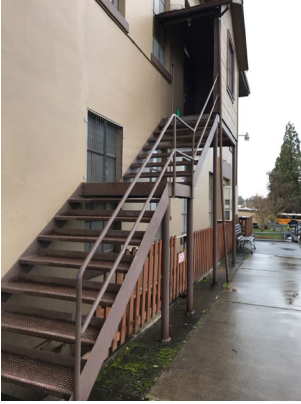
C20 Stairs – Safety

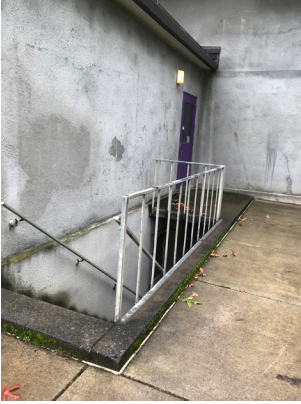
C20 Stairs – Safety

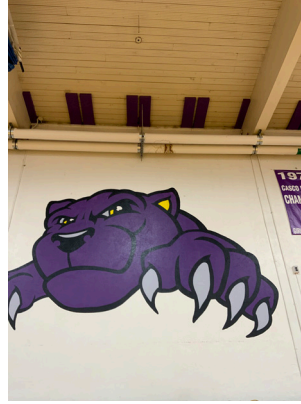
D30 HVAC Systems – Hazardous Materials

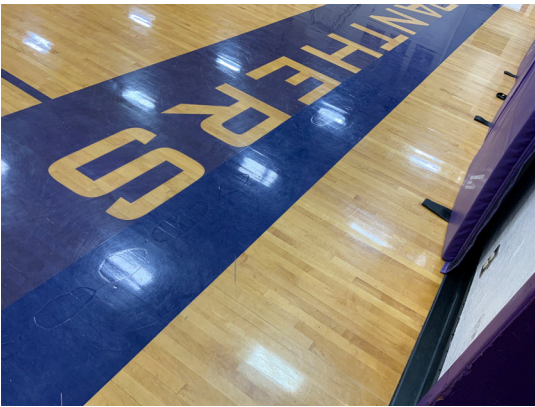
C30 – Interior Finishes – Deferred Maintenance

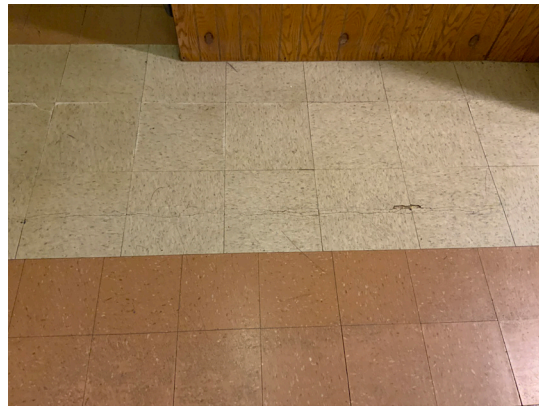
C30 Interior Finishes – Hazardous Materials

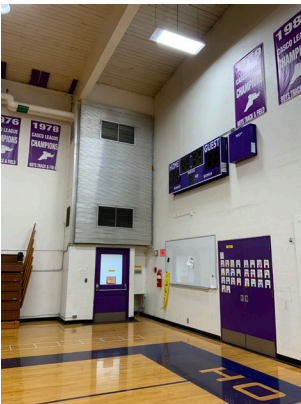
B20 Exterior Enclosure -Fire Life Safety/Code

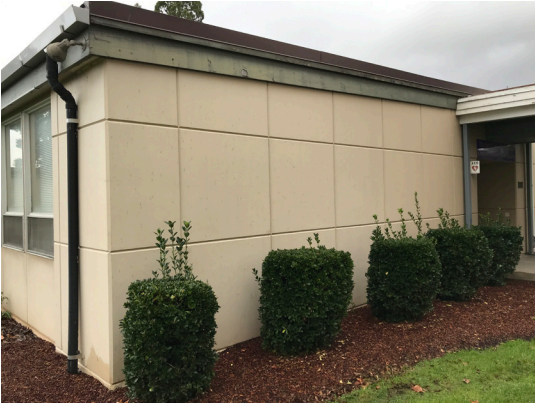
B20 Exterior Enclosure – Deferred Maintenance

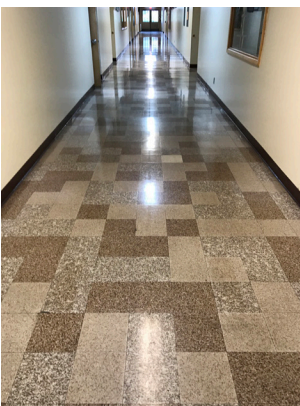
C30 Interior Finishes – Hazardous Materials

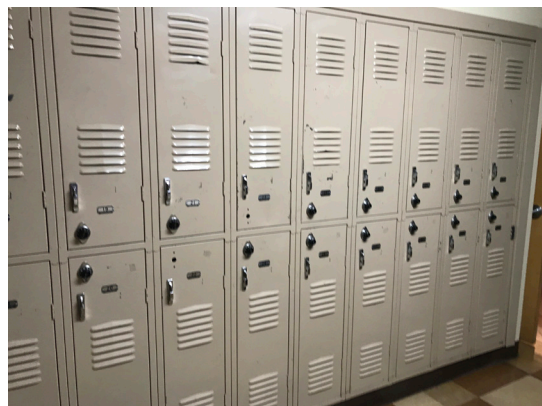
E10 Equipment – Deferred Maintenance

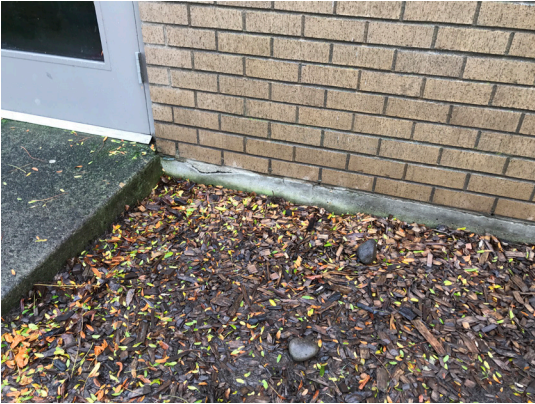
A10 Foundation – Structural

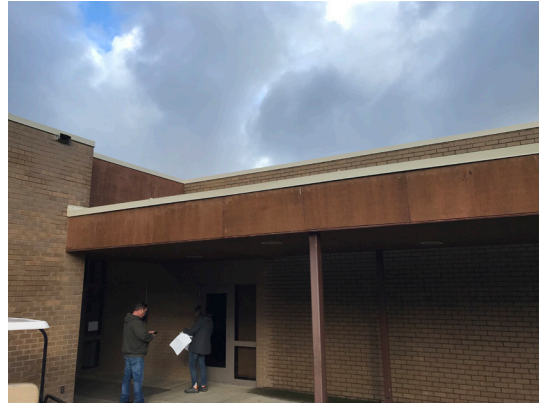
B20 Exterior Enclosure – Deferred Maintenance

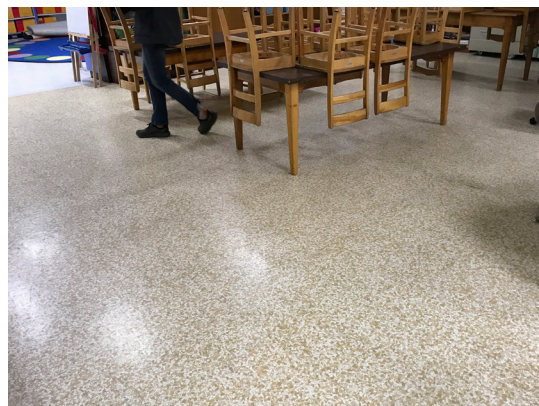
C30 Interior Finishes – Hazardous Materials

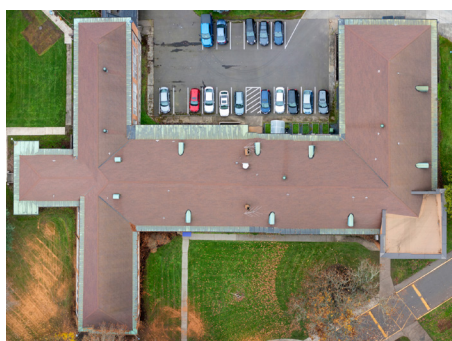
#4 KUENZI HALL

Findings Copper at Perimeter. Original roof. Active roof leaks. Replace Comp Shingles and repair Copper and transitions.
