## Bakken Crude Oil Spill Barge E2MS 303 Lower Mississippi River February 2014

Gulf of Mexico SSCs: Dr Paige Doelling Adam Davis LT Kyle Jellison LSU Lab: Scott Miles

### **Details of the Spill**

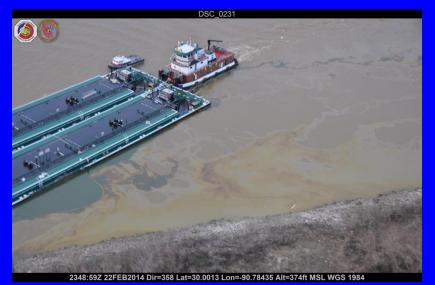
Photo Credit: Coast Guard

On initial overflight, all that was visible downstream of spill site was "light, milky, silvery sheen" Barge pulled near bank, initial oil released was dark, but quickly transitioned to yellowish emulsion and silvery sheen

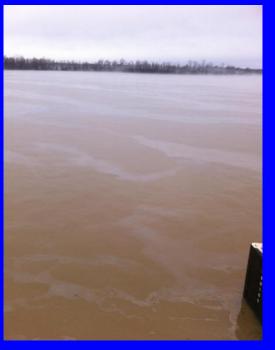
Photo Credit: Coast Guard River Mile Marker 127

Some potentially recoverable product noted, sheen appearance still "light, milky, silvery"

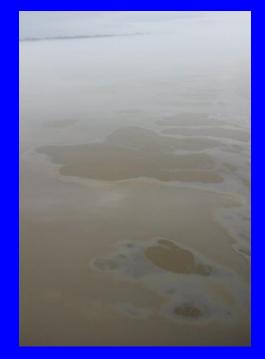
Photo Credit: Coast Guard River Mile Marker 113

Some pockets of recoverable oil trapped in barge fleet extending from River Mile Marker 153 to 151 (256 barges)

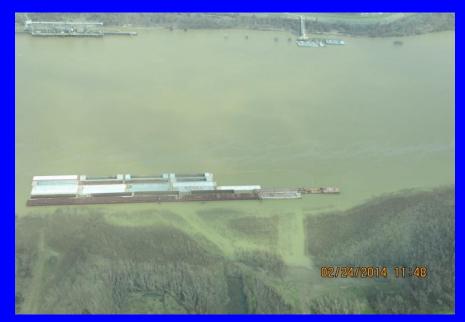
Photo Credit: Coast Guard

Continued sheening from barge fleet, prior to decontamination Product at initial spill site cleaned up, required only high volume, low-pressure flushing

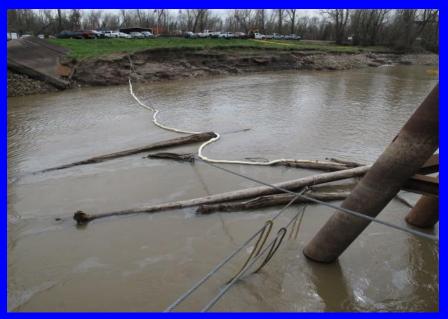
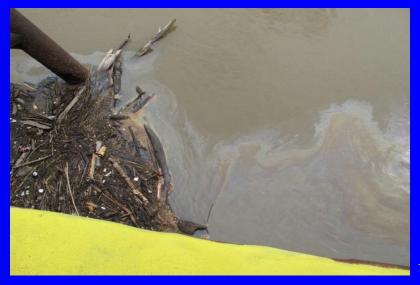
## Day 6: Sheen Near Barge Fleet at River Mile Marker 151

Coloration of sheen and emulsion fairly consistent with that observed immediately post spill Rainbow sheen and slight yellowish emulsion visible following decontamination operations at barge fleet

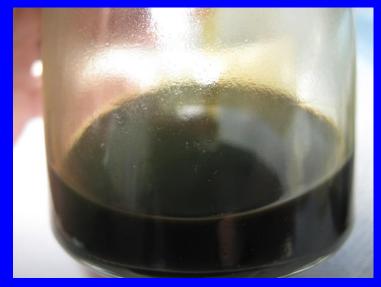
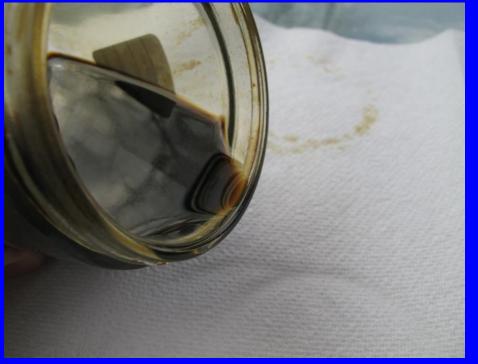
## Appearance of Bakken Crude Oil Spilled in this Incident

"Looks like two-stroke oil mixed with gasoline" Low viscosity, flows much more like a diesel or gasoline than a crude oil
