Oregon Schools Seismic Feedback Form

Philomath Middle School
2021 Chapel Drive
Philomath, OR 97370

RE: Philomath Middle School Seismic Evaluation

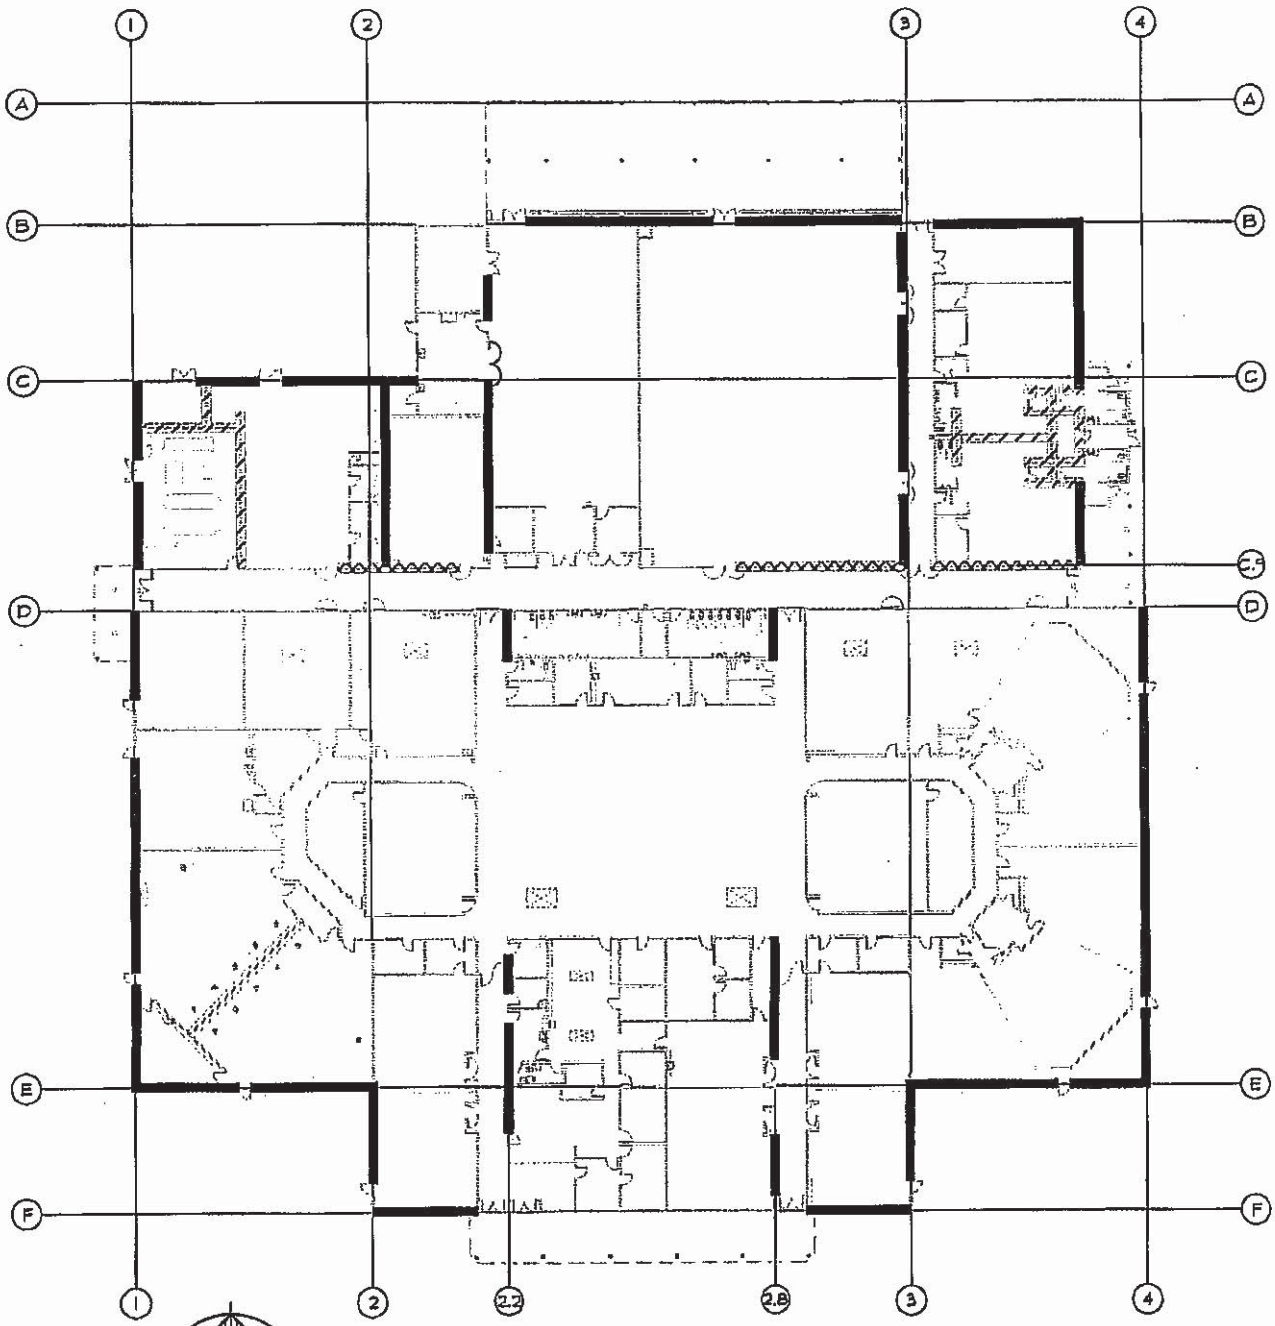
EXISTING WALL TYPES

Accompanying this report is a floor plan which indicates which walls are existing shear walls and which walls are existing masonry walls. This plan also indicates which walls we would recommend be upgraded in the future to be plywood sheathed shear walls.

3. In the event of a code level earthquake, most of the wood shear walls in the building would receive more load than their allowable capacities. The shear wall lines at grids B, F, 1, 3 and 4 have adequate shear capacity to meet the code required loads, but the other wall lines do not. The overstressed walls typically have between 60% and 80% of the code required shear capacity. The drawings did not indicate that holdowns were used at any of the shear walls in this building. Many shear walls, particularly walls running in the east-west direction require light to medium capacity holdowns with up to a 6250 lbs uplift capacity. At the walls with higher uplift loads, it is possible that the foundations do not have an adequate capacity for a code level earthquake, but we can not accurately evaluate the foundations without knowing the allowable soil bearing pressure for the soil. This would require an evaluation and report from a geotechnical engineer. For the purpose of our analysis, it was assumed that a shear wall line exists at grid 3.9. Without a shear wall line at either grid 3.9 and/or 4, the shear walls at grids C and E would be greatly overstressed. As it is, there are extensive gypsum sheathed bearing walls at grids 3.9 and 4 that will provide a significant amount of shear resistance, though not enough to meet current code loads.

- EXISTING SHEAR WALLS
- /////// EXISTING MASONRY WALLS
- ~~~~~ PROPOSED NEW SHEAR WALLS

- A. There are several upgrades that should be made to the existing wood sheathed shear walls (item #3 previously noted). At locations where the existing walls are overstressed, either the nailing of existing wall sheathing will need to be increased or new shear wall sheathing added on the other side of the wall. Additional wall sill plate anchor bolts will be needed and new holdowns will need to be installed. New posts will need to be installed inside the walls at holdown locations and new studs will need to be installed at shear walls that require heavy nailing. This can be problematic at locations with existing electrical conduit, plumbing or other similar things inside the wall. Extensive removal and replacement of wall finishes on one side of shear walls will be required. As was noted previously, the existing bearing walls at either grid 3.9 or 4 will need to be upgraded with new wood sheathing and holdowns.

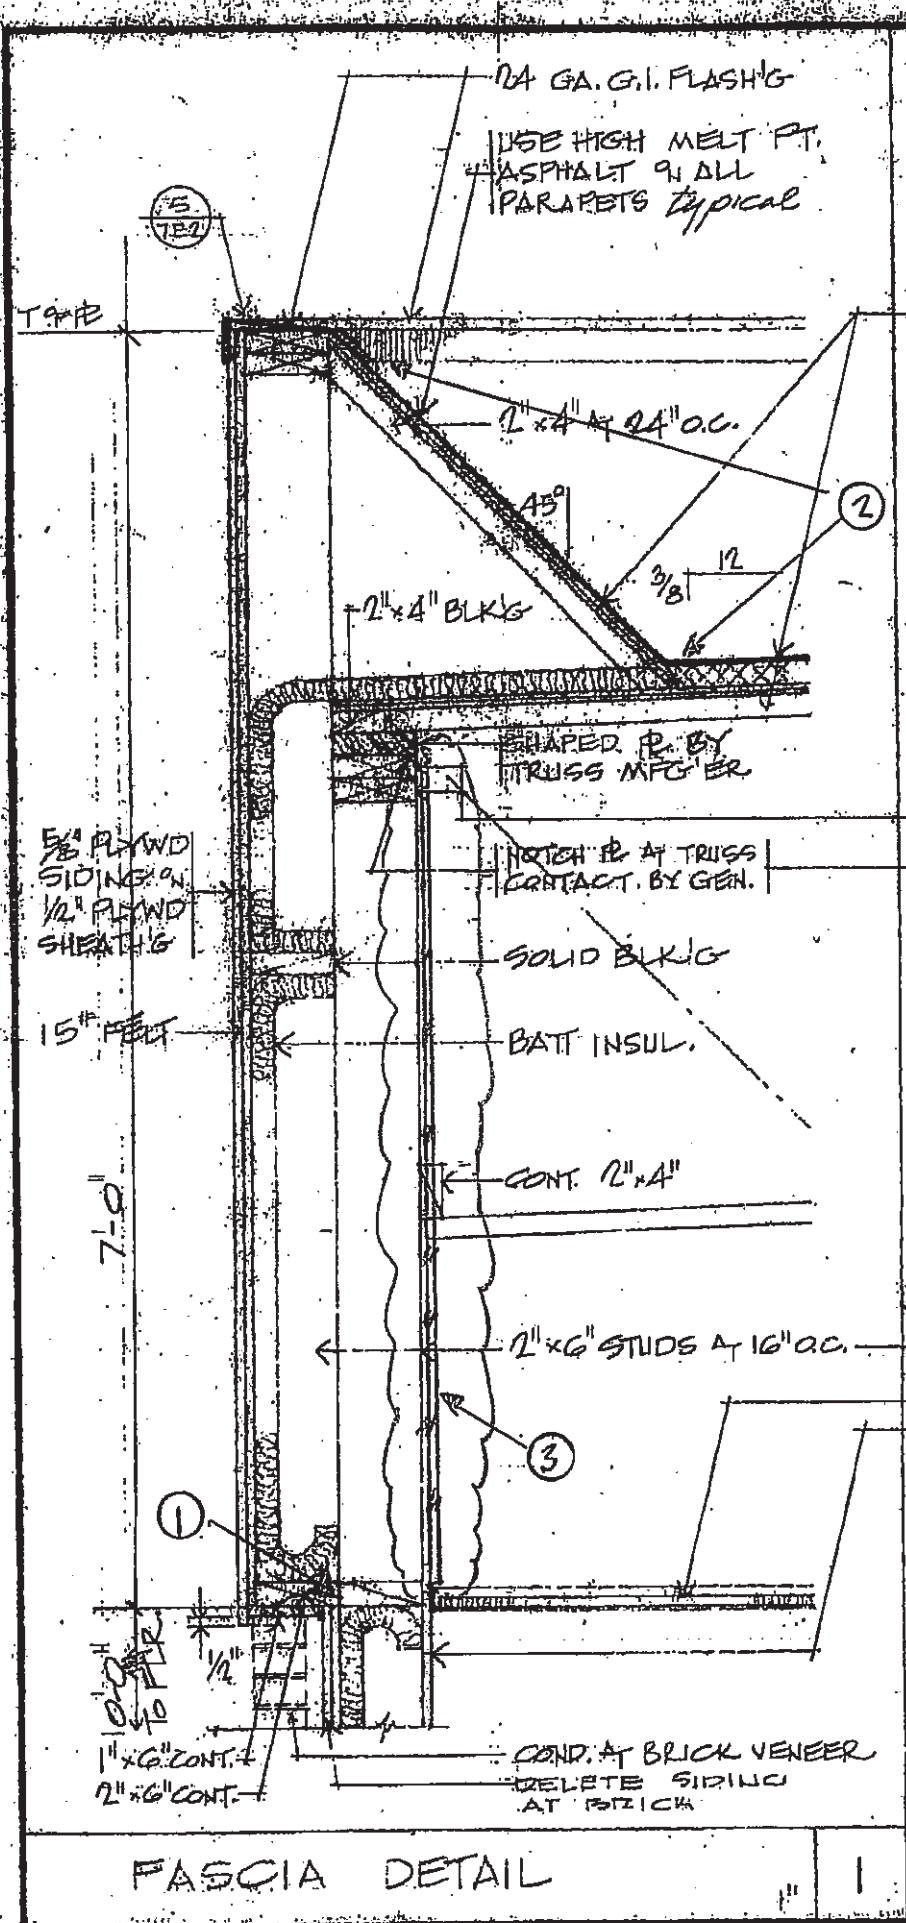
TYPICAL EXTERIOR DETAIL

1. The drawings indicate that the original building designers did not provide adequate connections between the shear walls and the roof diaphragm or clearly detailed load paths between the roof and the walls. There are no dedicated collector elements to tie the buildings roof to the shear walls. In an earthquake, the seismic load will be spread out evenly across the roof. A collector element (also sometimes referred to as a drag strut) would be an element like a beam line or wall plate line that would extend across the building that would "collect" the dispersed load and provide a path for the load to reach a shear wall. At exterior shear walls, the shear wall sheathing typically runs continuously up to the bottom of exterior soffits and canopies rather than running continuously up to the roof. Instead, the sheathing bumps out to the edge of the soffit making for a convoluted load path that is not detailed in the drawings. See the marks on a typical exterior detail accompanying this report as an example.

① THE EXISTING SHEAR WALL SHEATHING STOPS AT THE BASE OF THE SOFFIT, THE CONNECTION BETWEEN THE BLOCK AT THE BASE OF THE FASCIA AND THE SHEATHING IS NOT CLEAR.

② THE LOAD PATH FROM THE ROOF TO THE SHEAR WALL SHEATHING IS - FROM THE ROOF SHEATHING TO THE CRICKET SHEATHING - FROM THE CRICKET SHEATHING TO THE FASCIA TOP R. - FROM THE FASCIA TOP R. TO THE FASCIA SHEATHING - FROM THE FASCIA SHEATHING TO THE FASCIA BOTTOM R. - FROM THE FASCIA BOTTOM R. TO THE SHEAR WALL SHEATHING

- B. At the existing perimeter shear walls with offset parapets and soffits, as was noted in item 1, the load path from the roof to the shear wall below is convoluted. We recommend that new shear wall sheathing be installed from where the shear wall sheathing stops below, to the wall top plate. See the accompanying marks noted on an existing wall detail for more information.

③ AS PART OF A FUTURE SEISMIC UPGRADE WE WOULD RECOMMEND THE INSTALLATION OF NEW SHEAR WALL SHEATHING TO THE WALL TOP R.
