Oregon Schools Seismic Feedback Form **PART 1 - GENERAL INFORMATION** 1. Date of submittal 9-19-14 2. County Coos 3. School district or special education district North Bend School Dist, 13 4. Name and title of person submitting report Rhonda Hoffine - Maintenance Director 5. Year for reporting - Please submit a separate form for each school report 2014

Hillcrest Elementary School

Rapid Visual Screening - Senate Bill #2 - Seismic Needs Assessment Oregon Department of Geology and Mineral Industries

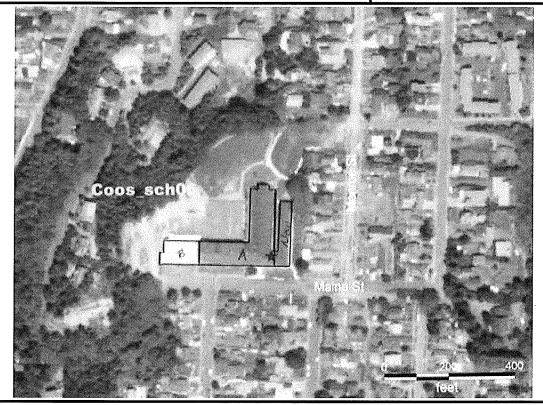
Selsmicity Zone: Very High										
FEMA 154 Rapid Visual Screening Score Card										
	Туре			Plan Irreg		Post- Bench	Soil C	Soil D	Soil E	RVS Score
Primary	W2	3.8	-2	-0.5	0	0	-0.4	0	0	0.9
Secondary		0	0	0	0	0	0	0	0	0
Tertiary		0	0	0	0	0	0	0	0	0

W2 0.9

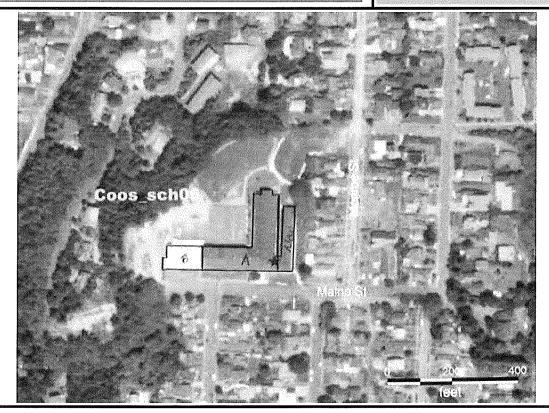
Hillcrest Elementary School

FEMA 154 Rapid Visual Screening Score Card										
	Type			Plan Irreg		Post- Bench	Soil C	Soil D	Soll E	RVS Score
Primary	RM1	2.8	-1	-0.5	0	0	-0.4	0	0	0.9
Secondary		0	0	0	0	0	0	0	0	0
Tertiary		0	0	0	0	0	0	0	0	0

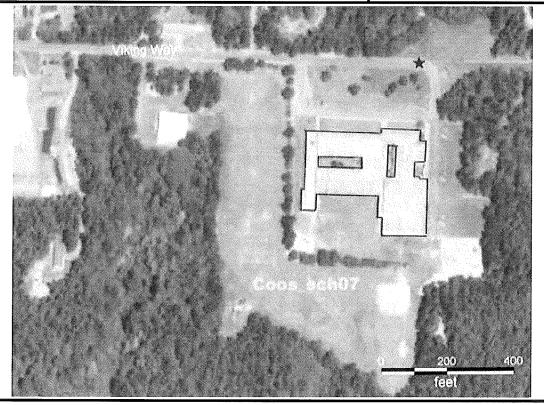
North Bay Elementary School

Selsmicity Zone: Very High										
FEMA 154 Rapid Visual Screening Score Card										
	Туре			Plan Irreg		Post- Bench	Soil C	Soil D	Soil E	RVS Score
Primary	RM1	2.8	-1	-0.5	0	0	0	-0.6	0	0.7
Secondary	W2	3.8	-2	-0.5	0	0	0	-0.8	0	0,5
Tertiary		0	0	0	0	0	0	0	0	0

W2 0.5

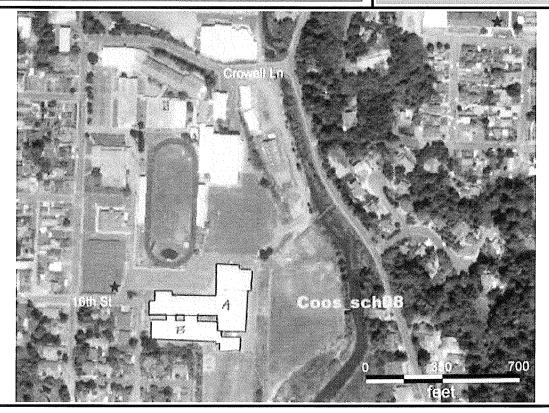
North Bend Middle School

Seismicity Zone: Very High										
FEMA 154 Rapid Visual Screening Score Card											
Basic Vert Plan Pre- Post- RVS Type Score Irreg Irreg Code Bench Soil C Soil D Soil E Score											
Primary	RM1	2.8	-1	-0.5	0	0	0	-0.6	0	0.7	
Secondary	S3	3.2	0	-0.5	0	0	0	-0.6	0	2.1	
Tertiary		0	0	0	0	0	0	0	0	0

RM1 0.7

High (>10%)

S3 on the top and RM1 on the bottom.

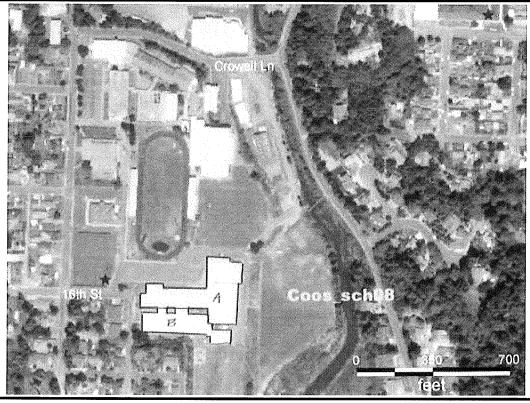
North Bend Middle School

Seismicity Zone: Very High										
FEMA 154 Rapid Visual Screening Score Card										
	Туре			Plan Irreg		Post- Bench	Soil C	Soil D	Soll E	RVS Score
Primary	RM1	2.8	-1	-0.5	0	0	0	-0.6	0	0.7
Secondary		0	0	0	0	0	0	0	0	0
Tertiary		0	0	0	0	0	0	0	0	0

RM1 0.7

High (>10%)

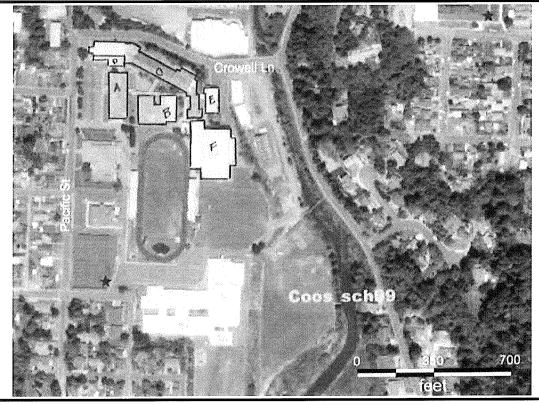
North Bend Senior High School

FEMA 154 Rapid Visual Screening Score Card										
	Туре			Plan Irreg		Post- Bench	Soil C	Soil D	Soil E	RVS Score
Primary	RM1	2.8	0	0	0	0	-0.4	0	0	2.4
Secondary	PC2	2.4	0	0	0	0	-0.4	0	0	2
Tertiary		0	0	0	0	0	0	0	0	0

PC2 2

Moderate (>1%)

Enrollment 706	Year Built (Field Verified)	Year Built (Alt. Source)	Est. Decade Built
Total Area (square ft)	Number of Stories	Basement No	Pounding Potential
Plan Irregularities None		Vertical Irregularities None	
None None None None None		None None	
Falling Hazards Heavy Cladding (thick stone or cor	ncrete)	Poor Conditions None	
None		None

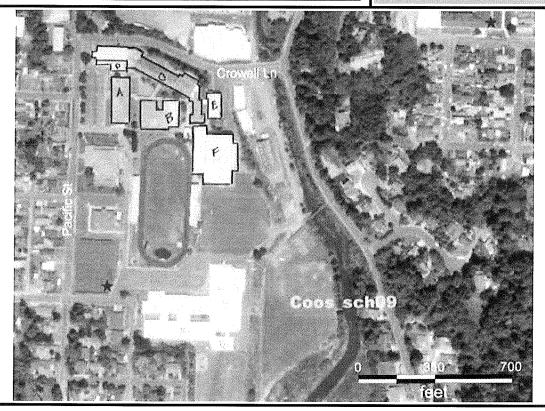
Seismicity Zone: Very High										
FEMA 154 Rapid Visual Screening Score Card										
	Туре			Plan Irreg		Post- Bench	Soil C	Soll D	Soil E	RVS Score
Primary	RM1	2.8	-1	-0,5	0	0	-0.4	0	0	0.9
Secondary		0	0	0	0	0	0	0	0	0
Tertiary		0	0	0	0	0	0	0	0	0

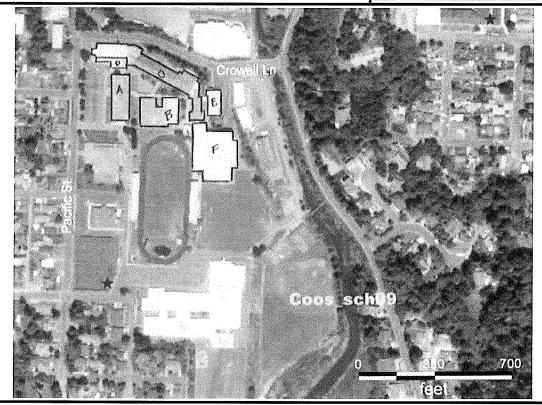
Coos_sch09C

FEMA 154 Rapid Visual Screening Score Card										
	Туре	Basic Score	Vert Irreg	Plan Irreg	Pre- Code	Post- Bench	Soil C	Soil D	Soil E	RVS Score
Primary	W2	3.8	-2	-0.5	0	0	-0.4	0	0	0.9
Secondary		0	0	0	0	0	0	0	0	0
Tertiary		0	0	0	0	0	0	0	0	0

Final RVS Score
Final Type Final Score
W2 0.9

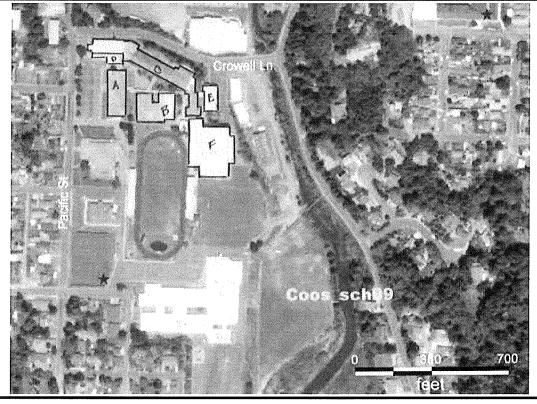
Coos_sch09D

FEMA 154 Rapid Visual Screening Score Card										
	Туре			Plan Irreg		Post- Bench	Soil C	Soil D	Soil E	RVS Score
Primary	RM1	2.8	-1	-0.5	0	0	-0.4	0	0	0.9
Secondary		0	0	0	0	0	0	0	0	0
Tertiary		0	0	0	0	0	O	0	0	0

Final RVS Score
Final Type Final Score
RM1 0.9

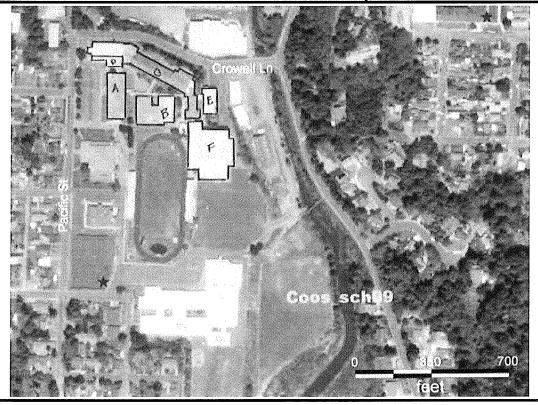
North Bend Senior High School

Seismicity Zone: Very High										
FEMA	FEMA 154 Rapid Visual Screening Score Card									
	Туре			Plan Irreg		Post- Bench	Soil C	Soil D	Soil E	RVS Score
Primary	RM1	2.8	-1	-0.5	0	0	-0.4	0	0	0.9
Secondary		0	0	0	0	0	0	0	0	0
Tertiary		0	0	0	0	0	0	0	0	0

RM1 0.9

High (>10%)

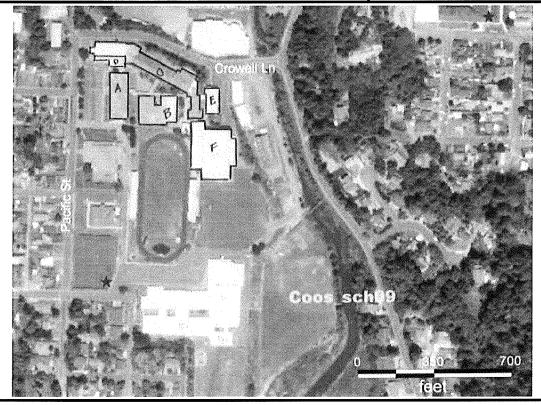
North Bend Senior High School

Seismicity Zone: Very High										
FEMA 154 Rapid Visual Screening Score Card										
	Туре			Plan Irreg		Post- Bench	Soil C	Soil D	Soil E	RVS Score
Primary	RM1	2.8	-1	-0.5	0	0	-0.4	0	0	0.9
Secondary	C2	2.8	-1	-0.5	0	0	-0.4	0	0	0.9
Tertiary		0	0	0	0	0	0	0	0	0

RM1 0.9

High (>10%)
