Oregon Seismic Status Report - 2016

District Wide Seismic Evaluation - Marion County, Oregon

December, 2013

Prepared By:
ZCS Engineering, Inc.
524 Main Street, Suite 2
Oregon City, OR 97045
Tel: 503.659.2205
Fax: 503.659.2433

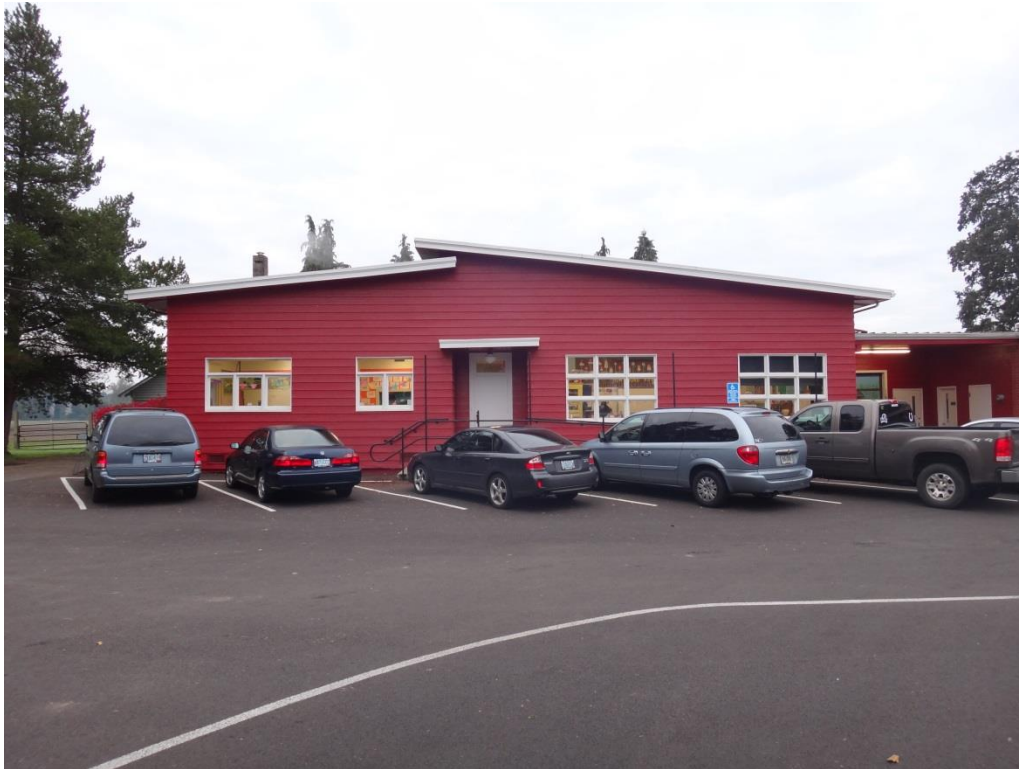
Figure 1: Bethany Charter School

Building	Deficiency
Original	<ul style="list-style-type: none"> • LOAD PATH: Due to presence of rock/rubble stem walls, no lateral load path is present to grade. • URM CHIMNEYS: An unreinforced masonry chimney is present. • STRAIGHT SHEATHING: A straight sheathed roof diaphragm is present.
1968 & 1974	<ul style="list-style-type: none"> • TIES: Brick veneer is present on the front elevation and is not likely tied to structure.
Gymnasium	<ul style="list-style-type: none"> • LOAD PATH: The bow string truss load path is suspect. Bow string truss design has proven to be unreliable, particularly under high loads and/or seismic events. • FOUNDATION PERFORMANCE: The slab-on-grade is cracked, substantially in some locations. • SHEAR STRESS: The straight sheathing on the gymnasium walls exceeds the allowable stress for a straight sheathed wall.
Covered Play Structure	<ul style="list-style-type: none"> • LOAD PATH: The outside play area was constructed without lateral support on two sides. • DETERIORATION OF WOOD: The outside play area walls show signs of deterioration.

- A)** The rubble rock foundation supporting the original school building needs to be strengthened and solidified and the roof diaphragm may need strengthened. Recommendations include:

- Retrofitting the existing walls with cast-in-place concrete footings and stemwalls.
 - Provide attachment of the existing walls to the new foundation elements.

- Install plywood sheathing above existing straight sheathed diaphragm.
- B)** The covered play area only has lateral resistance on two sides of the structure and is showing signs of deterioration on several structural members. Recommendations and alternates include:

- Add an embedded pole system or in-fill one bay in each direction with shearwalls to provide lateral resistance on all sides.
 - Remove and replace weather damaged structural elements with treated member.

- C)** The gymnasium structure is supported by two bow string trusses which have shown low reliability in the past. The walls are also constructed out of straight sheathing. Recommendations include:

- Retrofit the bowstring trusses to ensure they provide adequate strength during code events.
 - Sheath the walls with plywood sheathing and replace the siding.

- D)** Remove the URM chimney
- E)** The brick veneer present on the 1968 addition is likely not tied to structure. Additional inspection should be performed and if veneer ties are not present retrofit ties should be installed.

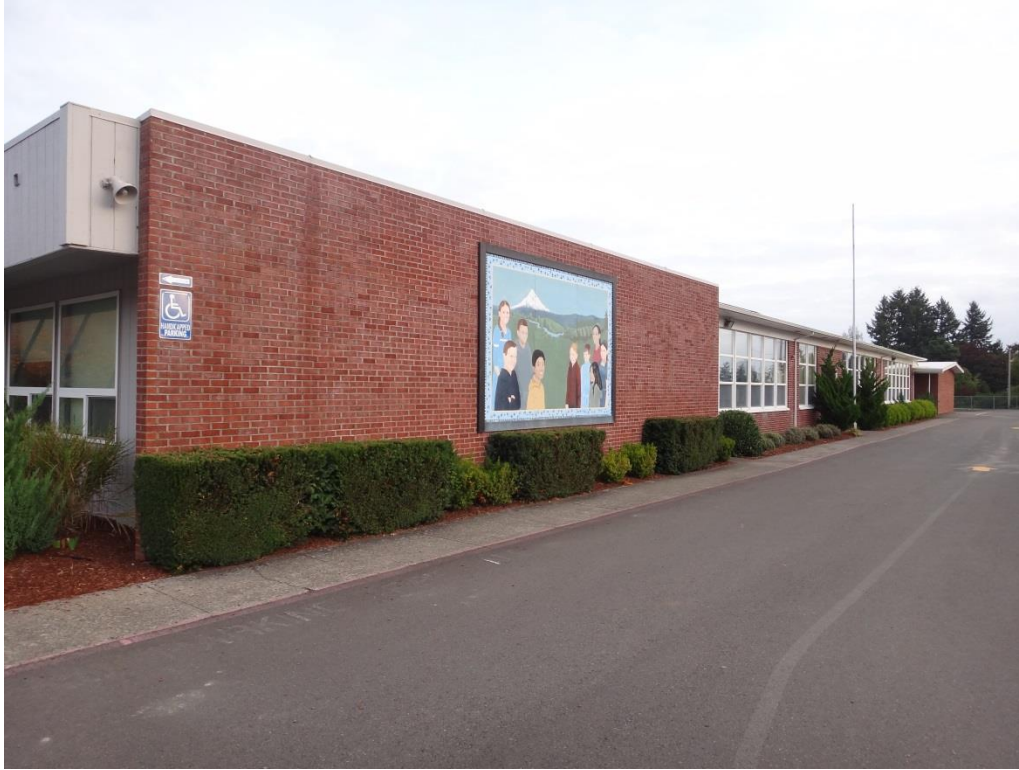
Figure 2: Butte Creek Elementary School

Building	Deficiency
Original	<ul style="list-style-type: none"> • URM: Unreinforced masonry walls are present and have shown to be unstable during seismic events. • NARROW WOOD SHEAR WALLS: More openings than shear wall indicate additional shear wall may be required. • URM CHIMNEYS: An unreinforced masonry chimney is present. • SPAN: Straight sheathed diaphragm spans farther than 24 feet. • DETERIORATION: The gymnasium roof appears to be yielding due to its own self-weight. • LOAD PATH: Drag elements above the cafeteria windows appear to be suspect. This could prevent load from reaching the shear walls. • STRAIGHT SHEATHING: A straight sheathed roof diaphragm is present.

1962 Addition	<ul style="list-style-type: none"> • NARROW WOOD SHEAR WALLS: More openings than shear wall indicate additional shear wall may be required. • TIES: The brick veneer is likely not tied to stud framing.
1966 Addition	<ul style="list-style-type: none"> • DETERIORATION: The exterior roof fascia is deflecting due to its own self-weight. • TIES: The exterior brick veneer is likely not tied to stud framing. • DETERIORATION: The brick veneer shows signs of fatigue and weathering.
1978 Addition	<ul style="list-style-type: none"> • LOAD PATH: The original portion of the exterior canopy is likely not connected properly for out-of-plane loading to the concrete tilt-up panel walls of the gymnasium. • PANEL-TO-PANEL CONNECTIONS: Joint filler present between tilt-up concrete panels shows signs of deterioration. • ADJACENT BUILDINGS: The gymnasium and the adjacent classroom building do not meet the required clear distance.

- A)** The walls of the original school structure are made of unreinforced masonry and are unreliable during seismic events. The roof is straight sheathed and does not meet aspect ratios for existing structures. The gymnasium roof appears to be yielding beneath its own weight and needs to be shored and rehabilitated. Recommendations include:

- Remove and replace damaged portion of original gymnasium roof or strengthen the existing system with new underslung beams.
 - Install a continuous load path element above the existing windows in the gymnasium to drag lateral loads into the shear walls below.

- Remove the URM chimney.
- B)** The 1962 addition has brick veneer that likely does not have ties to the supporting framing. There are also isolated locations where the brick veneer is damaged. This addition does not have much shear wall length available. Recommended improvements include:

- Add brick veneer ties to existing brick veneer.
 - Replace brick veneer in locations damage is present.

- Selectively in-fill windows to provide adequate shear wall length.
- C)** The 1966 addition is generally in good condition. The roof on one end of the structure is currently sagging where it overhangs at an egress location. Additionally, the brick veneer likely does not have veneer ties to framing and some of the bricks appear to be damaged. Recommendations for improvements include:

- Repair or retrofit roof where fascia elements are sagging.
 - Add brick veneer ties to existing brick veneer.
 - Replace brick veneer in locations damage is present.

- D)** The 1978 addition appears to be in good condition. At some point an outdoor covered play area was added and attached to the structure. The attachment at the top of the concrete tilt-up panels is of concern and needs to be investigated and/or retrofit. Additionally, some of the concrete tilt-up panels have deteriorated joint sealant. The gymnasium is directly adjacent to nearby classrooms constructed using different construction materials. The gymnasium is also much taller than the adjacent classrooms. The difference in materials and height could cause problems with pounding during a seismic event. Recommendations include:

- Provide strapping between the gymnasium and adjacent building to limit effects of pounding.

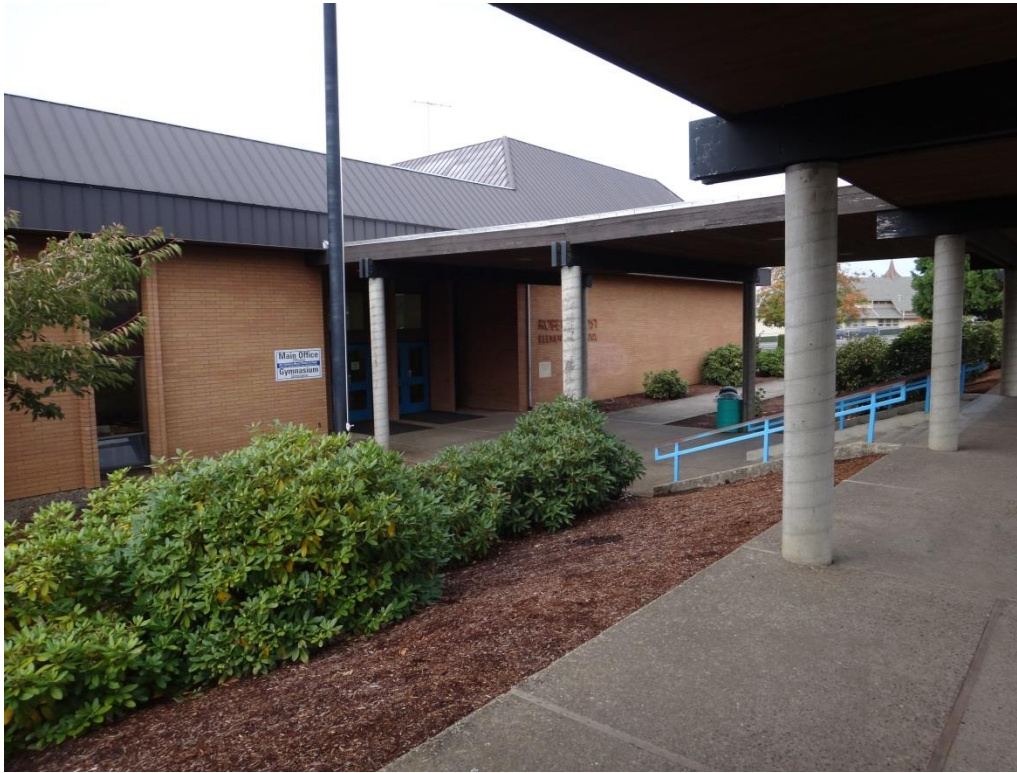
Figure 7: Robert Frost Elementary School

The slight belly in the ceiling of the gymnasium should be monitored for additional movement. In the event that additional movement occurs a registered engineer should be consulted to perform further evaluation.

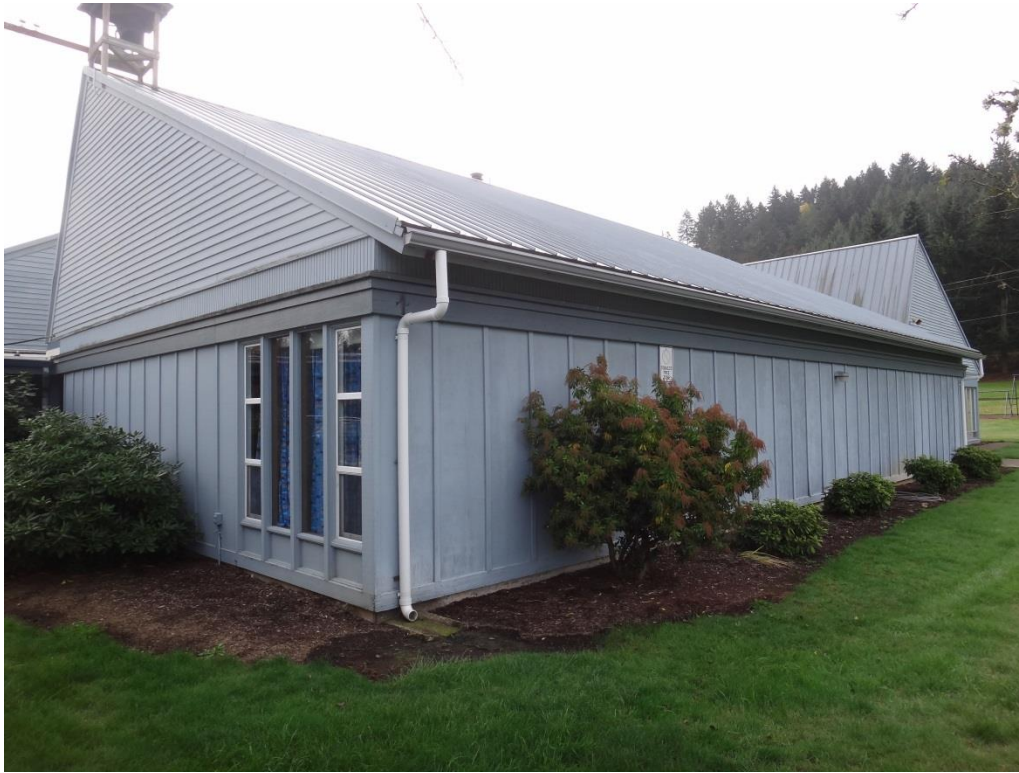
Figure 8: Scotts Mills Elementary School

- Scotts Mills Elementary – High Seismic Hazard
 - The gymnasium was originally designed as a pre-manufactured metal building with beam and column frame lines. When the building was constructed, the structural program was altered and the metal building roof system was utilized. In place of the steel columns, masonry walls and pilasters were constructed to support the steel girders. It is our opinion the metal roof diaphragm does not provide adequate out-of-plane support for the tall masonry walls and that no diaphragm to wall connections are present. To rectify this deficiency a structural steel system could be added to the perimeter walls to support the masonry under out-of-plane loading conditions.

- Retrofit the existing CMU and metal building hybrid system to accommodate in-plane and out-of-plane loading. Provide connections to transfer loads to shearwalls and add cable bracing to develop diaphragm forces.
- Provide a beam and column line as required to support the cantilevered end of the storage room overhang.
- Install a concrete pad beneath the tank located outside of the gymnasium.

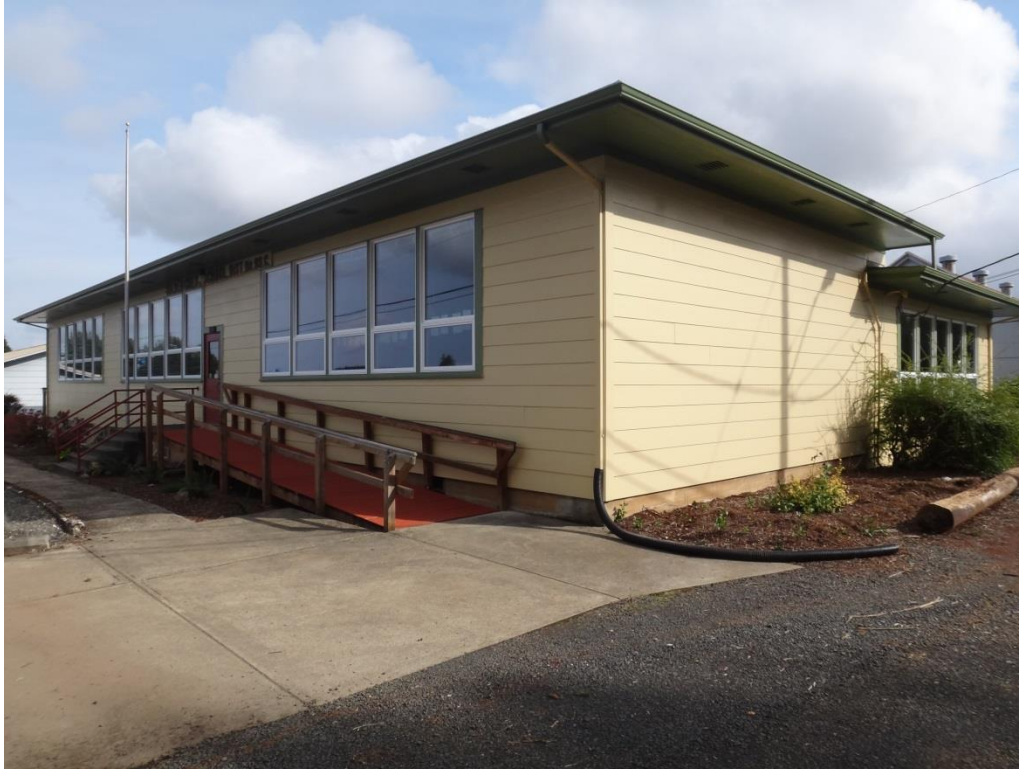
Figure 9: Silver Crest Elementary School

- Silver Crest Elementary – Moderate Seismic Hazard
 - The 1970 addition to Silver Crest that houses the music room and library was framed utilizing a post and beam system with knee braces and rafters with collar ties. There was visible movement of the system, particularly at joints, and the connections are suspect. It is our opinion that this system would be unreliable during a code lateral event. Retrofitting the system or installing a new roof system is recommended.

- C)** Another notable concern at the school was the large fish tank located in the office. The fish tank weighs approximately one ton and could potentially cause damage or block the exit during a seismic event. Miscellaneous recommendations include:
- Move the fish tank or restrain it from moving laterally.
