Oregon Seismic Status Report - 2017

School District/ESD: Pilot Rock 2

District Wide Seismic Evaluation for the Pilot Rock School District 2R Umatilla County, Oregon

September, 2017

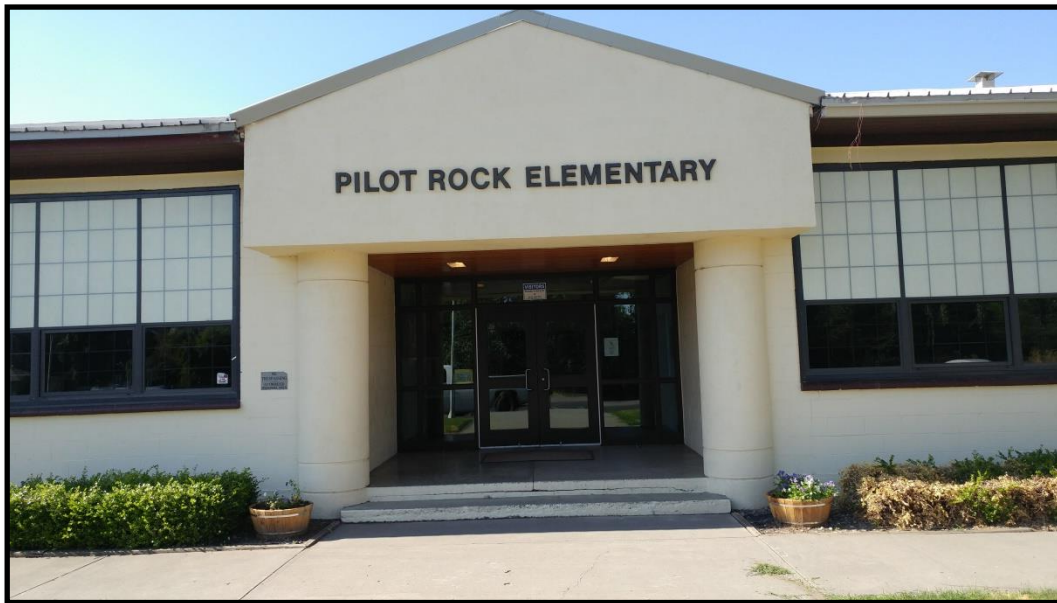
Figure 1: Pilot Rock Elementary School

Building	Deficiency
1948 Original [RM1] Seismic Hazard: High	<ul style="list-style-type: none"> • WALL ANCHORAGE: Out-of-plane connections at the top of wall are not present. • DIAPHRAGM ATTACHMENT: The diaphragms are not properly attached to shear walls below. • STRAIGHT SHEATHING: The straight sheathed diaphragm does not have adequate in-plane shear capacity. • DIAPHRAGM SPAN: The unblocked diaphragm spans greater than 40-feet. • WOOD STRUCTURAL SHEAR WALLS: The wood sheathed shear walls do not have adequate capacity. • LARGE WINDOW LENGTHS: The glazing package along the longitudinal walls reduces the available shear wall lengths and do not have adequate capacity. • HOLDOWNS: Holdown devices are not present to transfer overturning forces to foundation elements. • INCIDENTAL NON-STRUCTURAL ITEMS: There are typically many non-structural items found in similar buildings. These consist of HVAC equipment, heavy tall cabinetry, unbraced suspended ceiling, hot water piping, etc.

1948 Gym [C2A] Seismic Hazard: High	<ul style="list-style-type: none"> • WALL ANCHORAGE: Out-of-plane connections at the top of wall are not present. • DIAPHRAGM ATTACHMENT: The diaphragms are not properly attached to shear walls below. • STRAIGHT SHEATHING: The straight

<p>sheathed diaphragm does not have adequate in-plane shear capacity.</p> <ul style="list-style-type: none"> INCIDENTAL NON-STRUCTURAL ITEMS: There are typically many non-structural items found in similar buildings. These consist of HVAC equipment, heavy tall cabinetry, unbraced suspended ceiling, hot water piping, etc.
<p>1962 Addition [C2A]</p> <p>Seismic Hazard: High</p>	<ul style="list-style-type: none"> WALL ANCHORAGE: Out-of-plane connections at the top of wall are not present. DIAPHRAGM ATTACHMENT: The diaphragms are not properly attached to shear walls below. DIAPHRAGM SPAN: The unblocked diaphragm spans greater than 40-feet. LARGE WINDOW LENGTHS: The glazing package along the longitudinal walls reduces the available shear wall lengths and do not have adequate capacity. GYP SUM SHEAR WALLS: The gypsum sheathed shear walls do not have adequate capacity. HOLD DOWNS: Hold down devices are not present to transfer overturning forces to foundation elements. INCIDENTAL NON-STRUCTURAL ITEMS: There are typically many non-structural items found in similar buildings. These consist of HVAC equipment, heavy tall cabinetry, unbraced suspended ceiling, hot water piping, etc.

Building	Deficiency
<p>1948 Original [RM1]</p> <p>Seismic Hazard: High</p>	<ul style="list-style-type: none"> WALL ANCHORAGE: Provide out-of-plane attachment between walls and roof diaphragms DIAPHRAGM ATTACHMENT: Provide new in-plane hardware directly attaching the diaphragms to the shear walls below. STRAIGHT SHEATHING: Remove the existing roofing and install a new layer of plywood over the existing straight sheathing providing an adequate diaphragm. WOOD STRUCTURAL SHEAR WALLS: Provide additional nailing or sheathing as necessary to

<p>increase the available shear walls capacity to acceptable levels.</p> <ul style="list-style-type: none"> • LARGE WINDOW LENGTHS: Remove and replace existing window packages in strategic locations and infill. • HOLDOWNS: Provide new foundation elements as necessary and new holdowns to properly. • INCIDENTAL NON-STRUCTURAL ITEMS: There are typically many non-structural items found in similar buildings. These consist of HVAC equipment, heavy tall cabinetry, unbraced suspended ceiling, hot water piping, etc.
<p>1948 Gym [C2A]</p> <p>Seismic Hazard: High</p>	<ul style="list-style-type: none"> • WALL ANCHORAGE: Provide out-of-plane attachment between walls and roof diaphragms • DIAPHRAGM ATTACHMENT: Provide new in-plane hardware directly attaching the diaphragms to the shear walls below. • STRAIGHT SHEATHING: Remove the existing roofing and install a new layer of plywood over the existing straight sheathing providing an adequate diaphragm. • INCIDENTAL NON-STRUCTURAL ITEMS: There are typically many non-structural items found in similar buildings. These consist of HVAC equipment, heavy tall cabinetry, unbraced suspended ceiling, hot water piping, etc.

<p>1962 Addition [C2A]</p> <p>Seismic Hazard: High</p>	<ul style="list-style-type: none"> • WALL ANCHORAGE: Provide out-of-plane attachment between walls and roof diaphragms • DIAPHRAGM ATTACHMENT: Provide new in-plane hardware directly attaching the diaphragms to the shear walls below. • DIAPHRAGM SPAN: Provide new blocking at over spanned diaphragms. • LARGE WINDOW LENGTHS: Remove and replace existing window packages in strategic locations and infill. • GYPSUM SHEAR WALLS: Provide plywood sheathing and nailing as necessary to increase the available shear walls capacity to acceptable levels. • HOLDOWNS: Provide new foundation elements as necessary and new holdowns to properly. • INCIDENTAL NON-STRUCTURAL ITEMS: There are typically many non-structural items found in similar buildings. These consist of HVAC equipment, heavy tall cabinetry, unbraced suspended ceiling, hot water piping, etc.

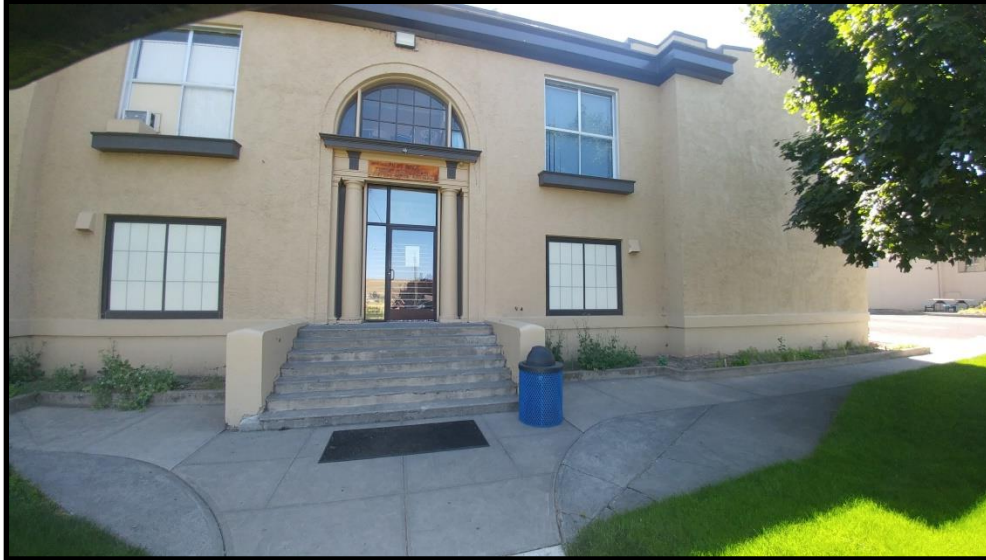
Figure 2: Pilot Rock Middle School

Building	Deficiency
1919 Original [URM] Seismic Hazard: High	<ul style="list-style-type: none"> • WALL ANCHORAGE: Out-of-plane connections at the top of wall are not present. • DIAPHRAGM ATTACHMENT: The diaphragms are not properly attached to shear walls below. • STRAIGHT SHEATHING: The straight sheathed diaphragm does not have adequate in-plane shear capacity. • DIAPHRAGM SPAN: The unblocked diaphragm spans greater than 40-feet. • WOOD STRUCTURAL SHEAR WALLS: The wood walls in the attic are not sheathed for transfer of in-plane shear forces. • LARGE WINDOW LENGTHS: The glazing package along the longitudinal walls reduces the available shear wall lengths and do not have adequate capacity. • HOLDOWNS: Holdown devices are not present to transfer overturning forces to foundation elements. • INCIDENTAL NON-STRUCTURAL ITEMS: There are typically many non-structural items found in similar buildings. These consist of HVAC equipment, heavy tall cabinetry, unbraced suspended ceiling, hot water piping, etc.

Mid 1900s Additions [URM] Seismic Hazard: High	<ul style="list-style-type: none"> • WALL ANCHORAGE: Out-of-plane connections at the top of wall are not present. • DIAPHRAGM ATTACHMENT: The diaphragms are not properly attached to shear walls below. • STRAIGHT SHEATHING: The straight sheathed diaphragm does not have adequate in-plane shear capacity. • DIAPHRAGM SPAN: The unblocked diaphragm spans greater than 40-feet. • WOOD STRUCTURAL SHEAR WALLS: The wood walls in the attic are not sheathed for transfer of in-plane shear forces. • LARGE WINDOW LENGTHS: The glazing package along the longitudinal walls reduces the available shear wall lengths and do not have adequate capacity. • HOLDOWNS: Holdown devices are not present

-
- to transfer overturning forces to foundation elements.
 - **INCIDENTAL NON-STRUCTURAL ITEMS:** There are typically many non-structural items found in similar buildings. These consist of HVAC equipment, heavy tall cabinetry, unbraced suspended ceiling, hot water piping, etc.
-

Building	Deficiency
1919 Original [URM] Seismic Hazard: High	<ul style="list-style-type: none"> • WALL ANCHORAGE: Provide out-of-plane attachment between walls and roof diaphragms • DIAPHRAGM ATTACHMENT: Provide new in-plane hardware directly attaching the diaphragms to the shear walls below. • STRAIGHT SHEATHING: Remove the existing roofing and install a new layer of plywood over the existing straight sheathing providing an adequate diaphragm. • WOOD STRUCTURAL SHEAR WALLS: Provide additional nailing or sheathing as necessary to increase the available shear walls capacity to acceptable levels. • LARGE WINDOW LENGTHS: Remove and replace existing window packages in strategic locations and infill. • HOLDOWNS: Provide new foundation elements as necessary and new holdowns to properly. • INCIDENTAL NON-STRUCTURAL ITEMS: There are typically many non-structural items found in similar buildings. These consist of HVAC equipment, heavy tall cabinetry, unbraced suspended ceiling, hot water piping, etc.

Mid 1900s Additions [RM1] Seismic Hazard: High	<ul style="list-style-type: none"> • WALL ANCHORAGE: Provide out-of-plane attachment between walls and roof diaphragms • DIAPHRAGM ATTACHMENT: Provide new in-plane hardware directly attaching the diaphragms to the shear walls below. • STRAIGHT SHEATHING: Remove the existing roofing and install a new layer of plywood over the existing straight sheathing providing an adequate diaphragm. • WOOD STRUCTURAL SHEAR WALLS: Provide

- **LARGE WINDOW LENGTHS:** Remove and replace existing window packages in strategic locations and infill.
 - **HOLDOWNS:** Provide new foundation elements as necessary and new holdowns to properly.
 - **INCIDENTAL NON-STRUCTURAL ITEMS:** There are typically many non-structural items found in similar buildings. These consist of HVAC equipment, heavy tall cabinetry, unbraced suspended ceiling, hot water piping, etc.
-

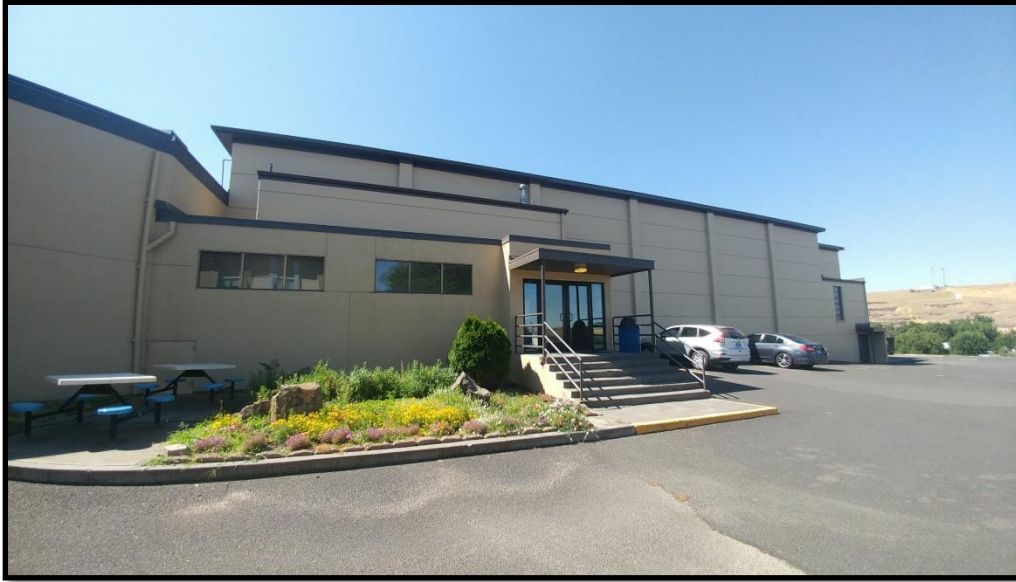
Figure 3: Pilot Rock High School

Building	Deficiency
1955 Original [C2A] [RM1] Seismic Hazard: High	<ul style="list-style-type: none"> • WALL ANCHORAGE: Out-of-plane connections at the top of wall and mezzanine to wall are not present. • DIAPHRAGM ATTACHMENT: The diaphragms are not properly attached to shear walls below. • STRAIGHT SHEATHING: The straight sheathed diaphragm does not have adequate in-plane shear capacity. • DIAPHRAGM SPAN: The unblocked diaphragm spans greater than 40-feet. • WOOD STRUCTURAL SHEAR WALLS: The wood walls in the attic are not sheathed for transfer of in-plane shear forces. • LARGE WINDOW LENGTHS: The glazing package along the longitudinal walls reduces the available shear wall lengths and do not have adequate capacity. • HOLDOWNS: Holdown devices are not present to transfer overturning forces to foundation elements. • INCIDENTAL NON-STRUCTURAL ITEMS: There are typically many non-structural items found in similar buildings. These consist of HVAC equipment, heavy tall cabinetry, unbraced suspended ceiling, hot water piping, etc.

1962 Addition [RM1] Seismic Hazard: High	<ul style="list-style-type: none"> • WALL ANCHORAGE: Out-of-plane connections at the top of wall are not present. • DIAPHRAGM ATTACHMENT: The diaphragms are not properly attached to shear walls below. • DIAPHRAGM SPAN: The unblocked diaphragm spans greater than 40-feet. • WOOD STRUCTURAL SHEAR WALLS: The wood walls in the attic are not sheathed for transfer of in-plane shear forces. • LARGE WINDOW LENGTHS: The glazing package along the longitudinal walls reduces the available shear wall lengths and do not have adequate capacity. • HOLDOWNS: Holdown devices are not present to transfer overturning forces to foundation elements. • INCIDENTAL NON-STRUCTURAL ITEMS:

There are typically many non-structural items found in similar buildings. These consist of HVAC equipment, heavy tall cabinetry, unbraced suspended ceiling, hot water piping, etc.

Building	Deficiency
1956 Original [C2A] [RM1] Seismic Hazard: High	<ul style="list-style-type: none"> • WALL ANCHORAGE: Provide out-of-plane attachment between walls and roof diaphragms and walls and mezzanine floor. • DIAPHRAGM ATTACHMENT: Provide new in-plane hardware directly attaching the diaphragms to the shear walls below. • STRAIGHT SHEATHING: Remove the existing roofing and install a new layer of plywood over the existing straight sheathing providing an adequate diaphragm. • WOOD STRUCTURAL SHEAR WALLS: Provide additional nailing or sheathing as necessary to increase the available shear walls capacity to acceptable levels. • LARGE WINDOW LENGTHS: Remove and replace existing window packages in strategic locations and infill. • HOLDOWNS: Provide new foundation elements as necessary and new holdowns to properly. • INCIDENTAL NON-STRUCTURAL ITEMS: There are typically many non-structural items found in similar buildings. These consist of HVAC equipment, heavy tall cabinetry, unbraced suspended ceiling, hot water piping, etc.

1950s Addition [RM1] Seismic Hazard: High	<ul style="list-style-type: none"> • WALL ANCHORAGE: Provide out-of-plane attachment between walls and roof diaphragms • DIAPHRAGM ATTACHMENT: Provide new in-plane hardware directly attaching the diaphragms to the shear walls below. • WOOD STRUCTURAL SHEAR WALLS: Provide additional nailing or sheathing as necessary to increase the available shear walls capacity to acceptable levels. • LARGE WINDOW LENGTHS: Remove and replace existing window packages in strategic locations and infill.

-
- **HOLDOWNS:** Provide new foundation elements as necessary and new holdowns to properly.
 - **INCIDENTAL NON-STRUCTURAL ITEMS:** There are typically many non-structural items found in similar buildings. These consist of HVAC equipment, heavy tall cabinetry, unbraced suspended ceiling, hot water piping, etc.
-
