Oregon Seismic Status Report - 2018

Structural Seismic Evaluation Report

Imbler High School

September, 2016

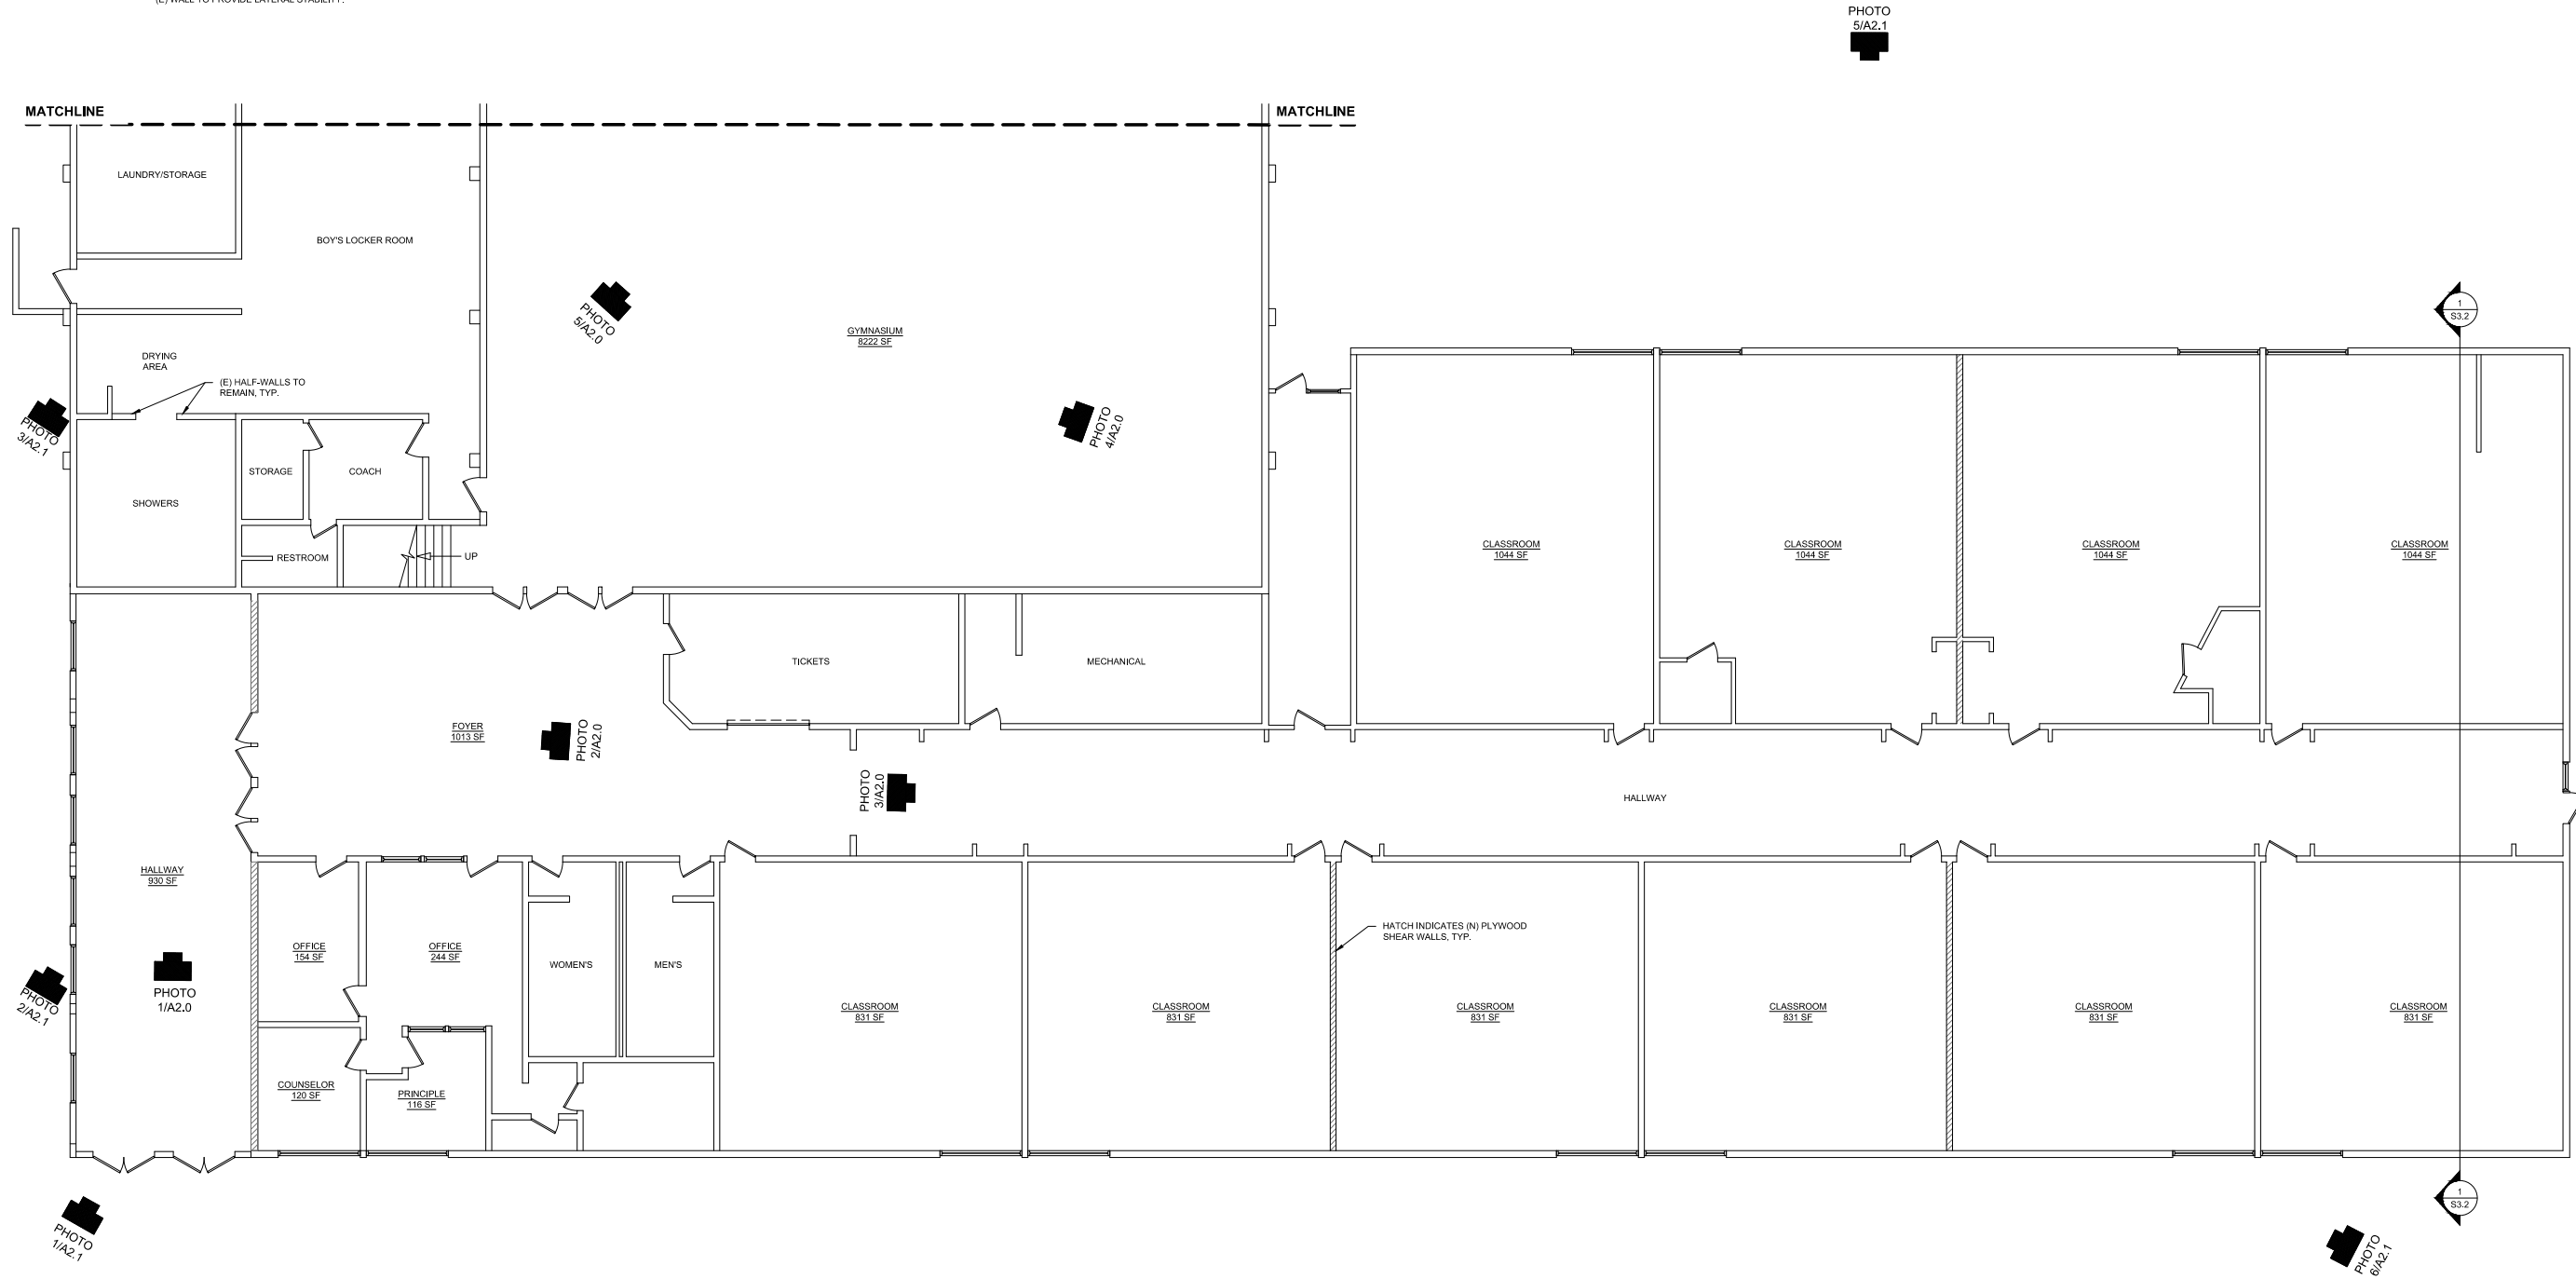
1 FLOOR PLAN-AREA "A"
 A1.0 1/8"= 1'-0"

HATCH INDICATES (N) SHEAR WALL ON ONE SIDE OF (E) WALL TO PROVIDE LATERAL STABILITY.

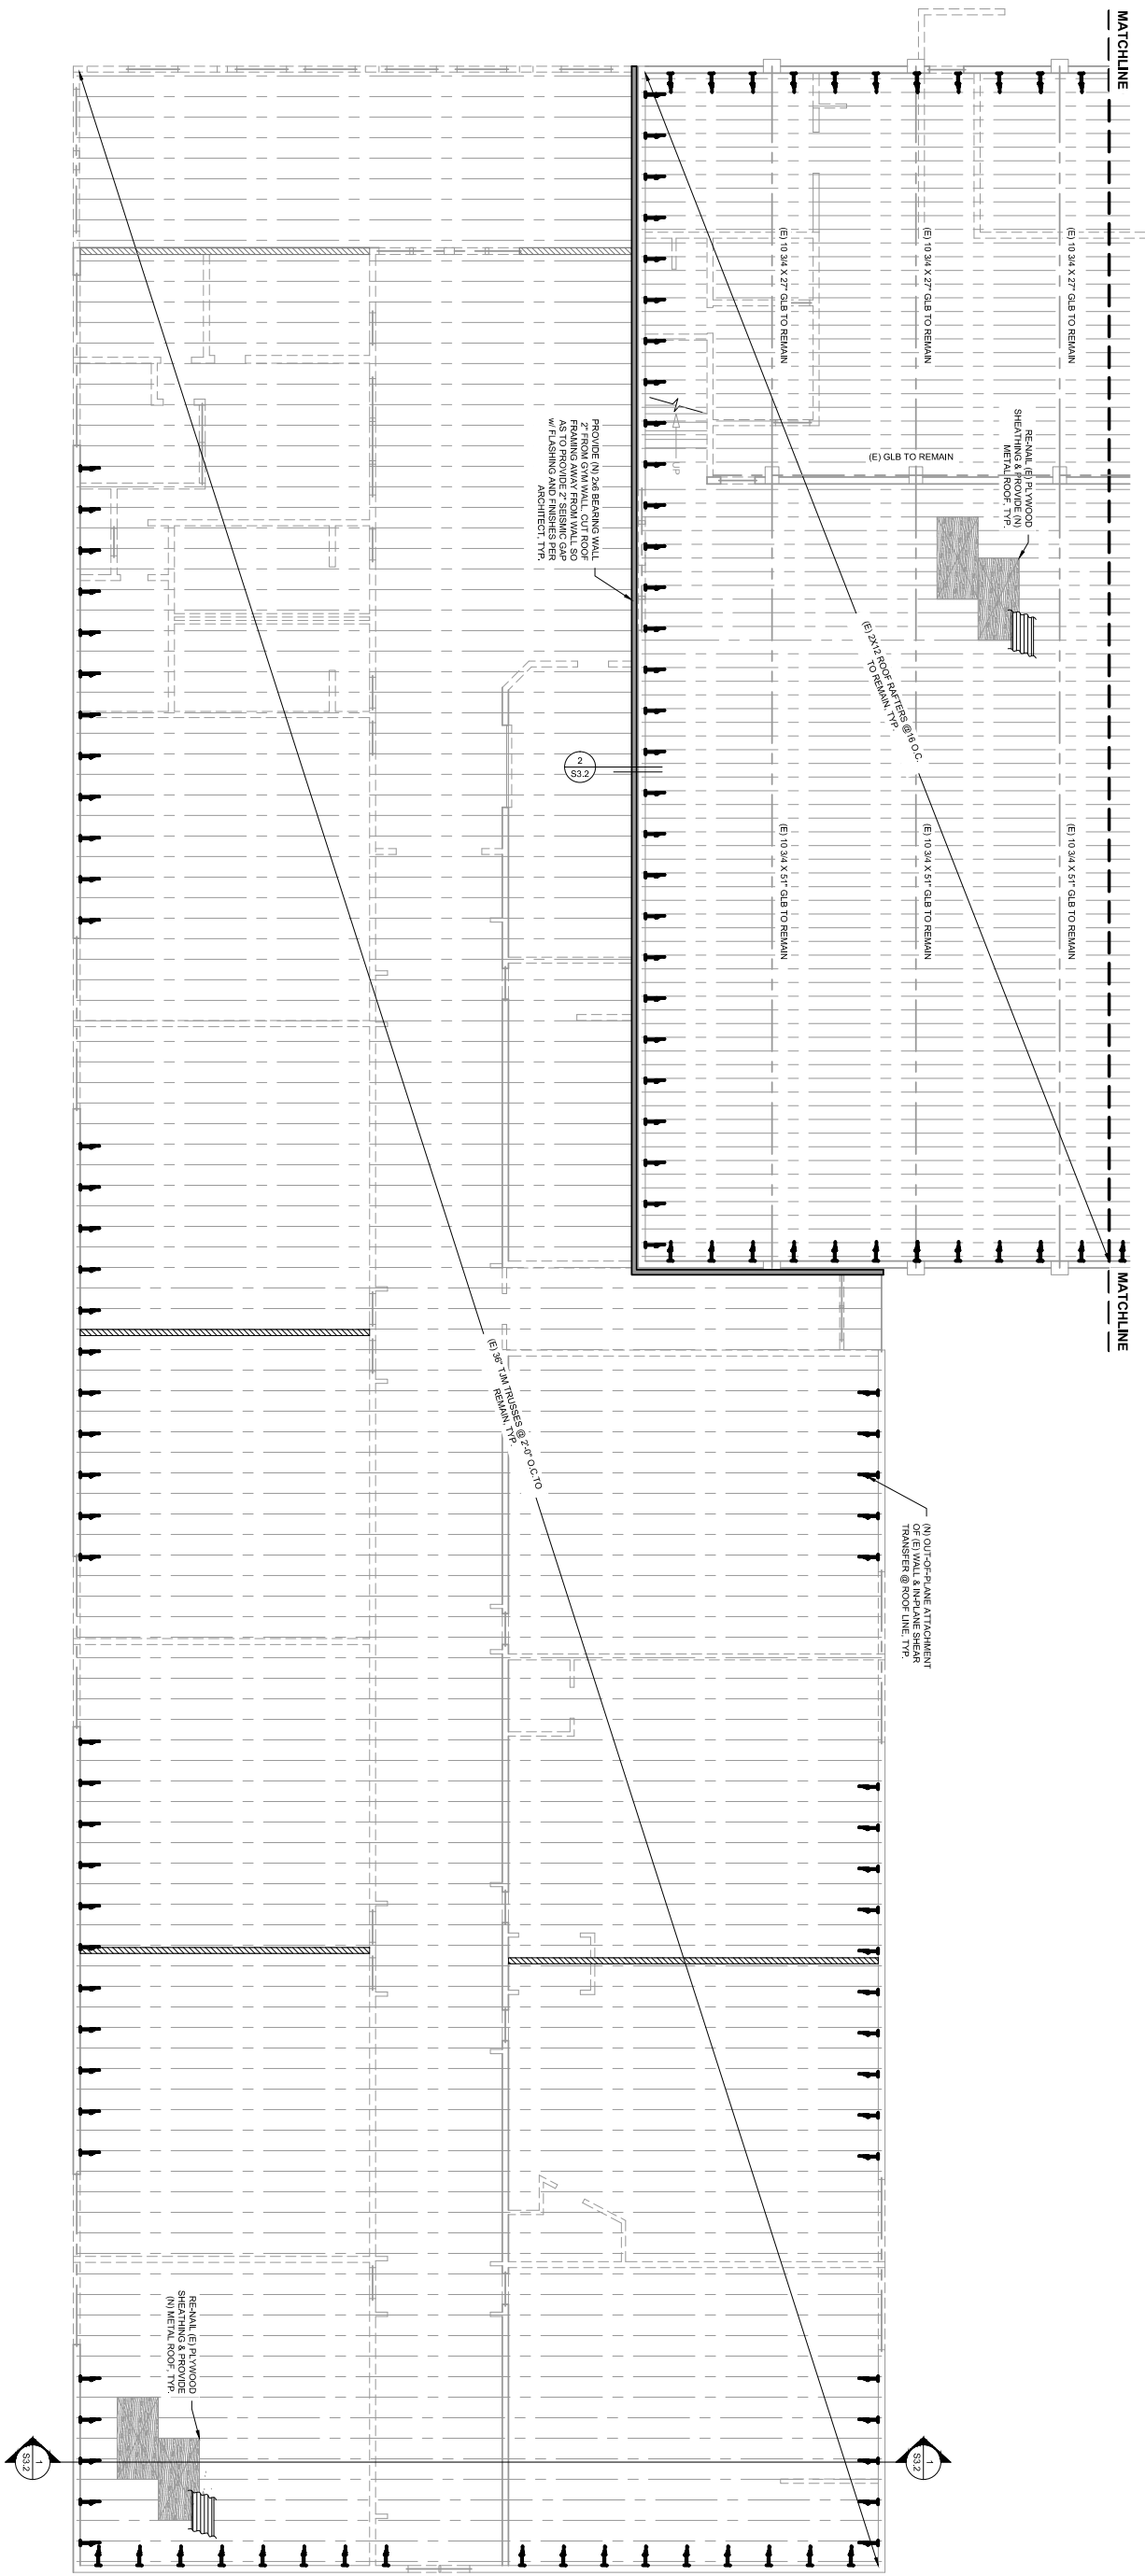
1 ROOF FRAMING PLAN-AREA "A"
S3.0
1/8" = 1'-0"

HATCH INDICATES FLOOR TO BE STRENGTHENED & REPAIRED
