# Oregon Seismic Status Report - 2019

# District Wide Seismic Evaluation for the Pilot Rock School District 2R Umatilla County, Oregon

September, 2017

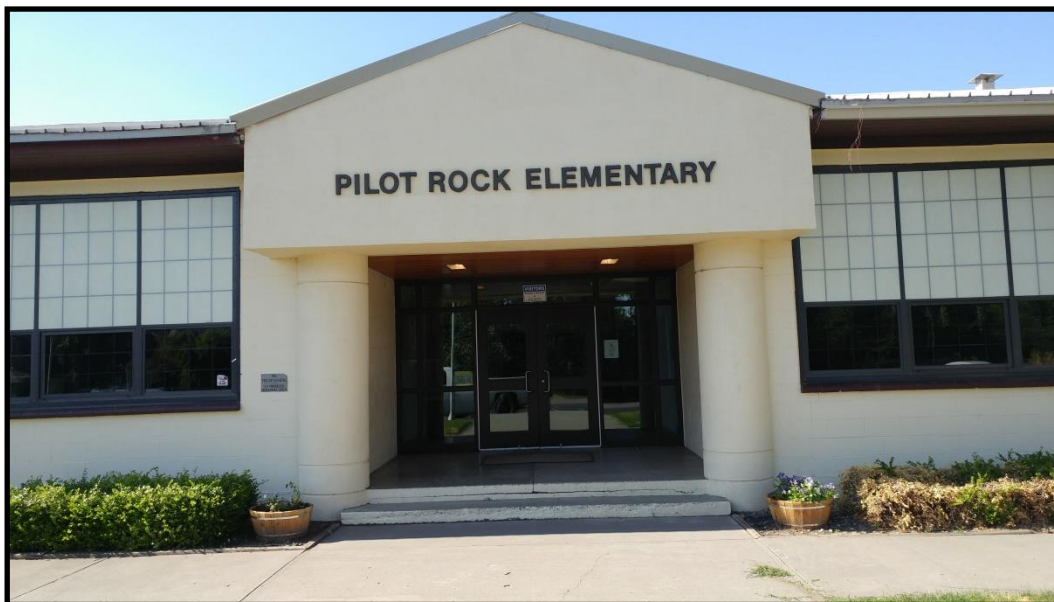
Figure 1: Pilot Rock Elementary School

- **1948 Original [RM1]:** The original single story classroom structure consists of CMU walls with a flexible wood roof diaphragm. The roof consists of straight sheathing over wood joists bearing on wood pony walls and CMU walls. The foundation consists of slab-on-grade with cast-in-place concrete footings. This structure houses multiple classrooms, and an office with an approximate footprint of 23,300-square-feet.

- **1948 Gym [C2A]:** The original Gymnasium structure consists of concrete walls and areas of CMU infill walls with a flexible wood roof diaphragm. The roof consists of straight or diagonal sheathing over wood joists on glulam beams bearing on concrete walls. The foundation consists of cast-in-place concrete stem walls and footings. This structure has an approximate footprint of 6,000-square-feet.
- **1962 Addition [RM1]:** This addition consists of cast-in-place reinforced concrete exterior walls and wood framed interior walls with a flexible wood roof diaphragm. The roof consists of plywood sheathing over wood joists bearing on beams and exterior walls. The foundation consists of concrete slab-on-grade with cast-in-place concrete stem walls and footings. The approximate footprint of this structure is 7,400-square-feet.

<b>Building</b>	<b>Deficiency</b>
<b>1948 Original [RM1]</b>  <b>Seismic Hazard: High</b>	<ul style="list-style-type: none"> <li>• WALL ANCHORAGE: Out-of-plane connections at the top of wall are not present.</li> <li>• DIAPHRAGM ATTACHMENT: The diaphragms are not properly attached to shear walls below.</li> <li>• STRAIGHT SHEATHING: The straight sheathed diaphragm does not have adequate in-plane shear capacity.</li> <li>• DIAPHRAGM SPAN: The unblocked diaphragm spans greater than 40-feet.</li> <li>• WOOD STRUCTURAL SHEAR WALLS: The wood sheathed shear walls do not have adequate capacity.</li> <li>• LARGE WINDOW LENGTHS: The glazing package along the longitudinal walls reduces the available shear wall lengths and do not have adequate capacity.</li> <li>• HOLDOWNS: Holdown devices are not present to transfer overturning forces to foundation elements.</li> <li>• INCIDENTAL NON-STRUCTURAL ITEMS: There are typically many non-structural items found in similar buildings. These consist of HVAC equipment, heavy tall cabinetry, unbraced suspended ceiling, hot water piping, etc.</li> </ul>

<b>1948 Gym [C2A]</b>  <b>Seismic Hazard: High</b>	<ul style="list-style-type: none"> <li>• WALL ANCHORAGE: Out-of-plane connections at the top of wall are not present.</li> <li>• DIAPHRAGM ATTACHMENT: The diaphragms are not properly attached to shear walls below.</li> <li>• STRAIGHT SHEATHING: The straight</li> </ul>

<p>sheathed diaphragm does not have adequate in-plane shear capacity.</p> <ul style="list-style-type: none"> <li>INCIDENTAL NON-STRUCTURAL ITEMS: There are typically many non-structural items found in similar buildings. These consist of HVAC equipment, heavy tall cabinetry, unbraced suspended ceiling, hot water piping, etc.</li> </ul>
<p><b>1962 Addition [C2A]</b></p> <p><b>Seismic Hazard: High</b></p>	<ul style="list-style-type: none"> <li>WALL ANCHORAGE: Out-of-plane connections at the top of wall are not present.</li> <li>DIAPHRAGM ATTACHMENT: The diaphragms are not properly attached to shear walls below.</li> <li>DIAPHRAGM SPAN: The unblocked diaphragm spans greater than 40-feet.</li> <li>LARGE WINDOW LENGTHS: The glazing package along the longitudinal walls reduces the available shear wall lengths and do not have adequate capacity.</li> <li>GYP SUM SHEAR WALLS: The gypsum sheathed shear walls do not have adequate capacity.</li> <li>HOLD DOWNS: Hold down devices are not present to transfer overturning forces to foundation elements.</li> <li>INCIDENTAL NON-STRUCTURAL ITEMS: There are typically many non-structural items found in similar buildings. These consist of HVAC equipment, heavy tall cabinetry, unbraced suspended ceiling, hot water piping, etc.</li> </ul>

Building	Deficiency
<p><b>1948 Original [RM1]</b></p> <p><b>Seismic Hazard: High</b></p>	<ul style="list-style-type: none"> <li>WALL ANCHORAGE: Provide out-of-plane attachment between walls and roof diaphragms</li> <li>DIAPHRAGM ATTACHMENT: Provide new in-plane hardware directly attaching the diaphragms to the shear walls below.</li> <li>STRAIGHT SHEATHING: Remove the existing roofing and install a new layer of plywood over the existing straight sheathing providing an adequate diaphragm.</li> <li>WOOD STRUCTURAL SHEAR WALLS: Provide additional nailing or sheathing as necessary to</li> </ul>

<p>increase the available shear walls capacity to acceptable levels.</p> <ul style="list-style-type: none"> <li>• <b>LARGE WINDOW LENGTHS:</b> Remove and replace existing window packages in strategic locations and infill.</li> <li>• <b>HOLDOWNS:</b> Provide new foundation elements as necessary and new holdowns to properly.</li> <li>• <b>INCIDENTAL NON-STRUCTURAL ITEMS:</b> There are typically many non-structural items found in similar buildings. These consist of HVAC equipment, heavy tall cabinetry, unbraced suspended ceiling, hot water piping, etc.</li> </ul>
<p><b>1948 Gym [C2A]</b></p> <p><b>Seismic Hazard: High</b></p>	<ul style="list-style-type: none"> <li>• <b>WALL ANCHORAGE:</b> Provide out-of-plane attachment between walls and roof diaphragms</li> <li>• <b>DIAPHRAGM ATTACHMENT:</b> Provide new in-plane hardware directly attaching the diaphragms to the shear walls below.</li> <li>• <b>STRAIGHT SHEATHING:</b> Remove the existing roofing and install a new layer of plywood over the existing straight sheathing providing an adequate diaphragm.</li> <li>• <b>INCIDENTAL NON-STRUCTURAL ITEMS:</b> There are typically many non-structural items found in similar buildings. These consist of HVAC equipment, heavy tall cabinetry, unbraced suspended ceiling, hot water piping, etc.</li> </ul>

<p><b>1962 Addition [C2A]</b></p> <p><b>Seismic Hazard: High</b></p>	<ul style="list-style-type: none"> <li>• <b>WALL ANCHORAGE:</b> Provide out-of-plane attachment between walls and roof diaphragms</li> <li>• <b>DIAPHRAGM ATTACHMENT:</b> Provide new in-plane hardware directly attaching the diaphragms to the shear walls below.</li> <li>• <b>DIAPHRAGM SPAN:</b> Provide new blocking at over spanned diaphragms.</li> <li>• <b>LARGE WINDOW LENGTHS:</b> Remove and replace existing window packages in strategic locations and infill.</li> <li>• <b>GYPSUM SHEAR WALLS:</b> Provide plywood sheathing and nailing as necessary to increase the available shear walls capacity to acceptable levels.</li> <li>• <b>HOLDOWNS:</b> Provide new foundation elements as necessary and new holdowns to properly.</li> <li>• <b>INCIDENTAL NON-STRUCTURAL ITEMS:</b> There are typically many non-structural items found in similar buildings. These consist of HVAC equipment, heavy tall cabinetry, unbraced suspended ceiling, hot water piping, etc.</li> </ul>

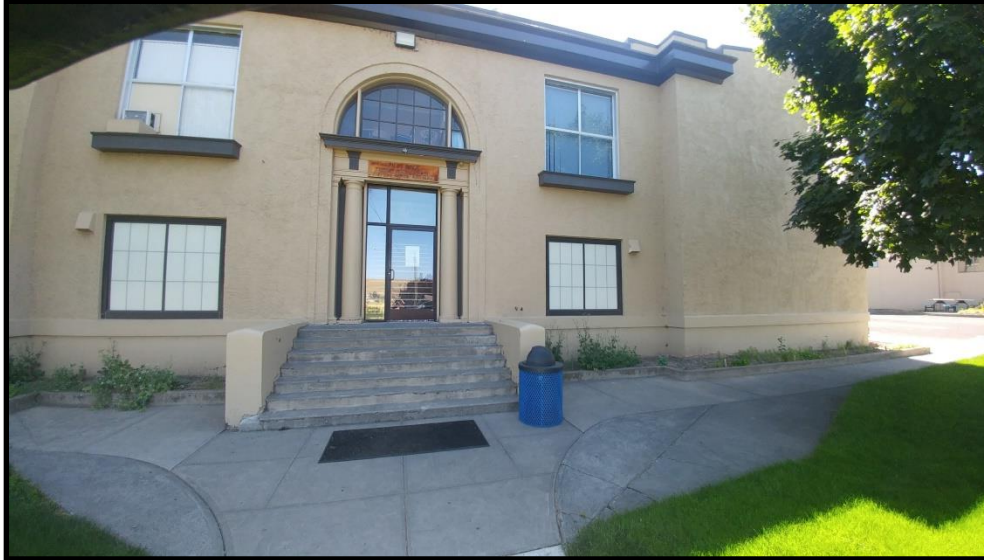
Figure 2: Pilot Rock Middle School

- **1919 Original [URM]:** The original two story structure consists of unreinforced clay brick walls with flexible wood second floor and roof diaphragms. The second floor consists of diagonal sheathing over wood joists bearing on interior wood walls and exterior URM walls. The roof consists of straight sheathing over wood joists bearing on timber beams, interior wood walls, and exterior URM walls. The foundation consists of slab-on-grade with cast-in-place concrete footings. This structure houses multiple classrooms, and an office with an approximate footprint of 11,300-square-feet.

- **Mid 1900s Additions [URM]:** The single and two story additions consist of unreinforced clay brick walls with flexible wood second floor and roof diaphragms. The second floor consists of diagonal sheathing over wood joists bearing on interior wood walls and exterior URM walls. The roof consists of straight sheathing over wood joists bearing on timber beams, interior wood walls, and exterior URM walls. The foundation consists of slab-on-grade with cast-in-place concrete footings. This structure houses multiple classrooms, music room, a stage, and a multipurpose room with an approximate footprint of 11,900-square-feet.

<b>Building</b>	<b>Deficiency</b>
<b>1919 Original</b> <b>[URM]</b>  <b>Seismic Hazard:</b> <b>High</b>	<ul style="list-style-type: none"> <li>• WALL ANCHORAGE: Out-of-plane connections at the top of wall are not present.</li> <li>• DIAPHRAGM ATTACHMENT: The diaphragms are not properly attached to shear walls below.</li> <li>• STRAIGHT SHEATHING: The straight sheathed diaphragm does not have adequate in-plane shear capacity.</li> <li>• DIAPHRAGM SPAN: The unblocked diaphragm spans greater than 40-feet.</li> <li>• WOOD STRUCTURAL SHEAR WALLS: The wood walls in the attic are not sheathed for transfer of in-plane shear forces.</li> <li>• LARGE WINDOW LENGTHS: The glazing package along the longitudinal walls reduces the available shear wall lengths and do not have adequate capacity.</li> <li>• HOLDOWNS: Holdown devices are not present to transfer overturning forces to foundation elements.</li> <li>• INCIDENTAL NON-STRUCTURAL ITEMS: There are typically many non-structural items found in similar buildings. These consist of HVAC equipment, heavy tall cabinetry, unbraced suspended ceiling, hot water piping, etc.</li> </ul>

<b>Mid 1900s</b> <b>Additions</b> <b>[URM]</b>  <b>Seismic Hazard:</b> <b>High</b>	<ul style="list-style-type: none"> <li>• WALL ANCHORAGE: Out-of-plane connections at the top of wall are not present.</li> <li>• DIAPHRAGM ATTACHMENT: The diaphragms are not properly attached to shear walls below.</li> <li>• STRAIGHT SHEATHING: The straight sheathed diaphragm does not have adequate in-plane shear capacity.</li> <li>• DIAPHRAGM SPAN: The unblocked diaphragm spans greater than 40-feet.</li> <li>• WOOD STRUCTURAL SHEAR WALLS: The wood walls in the attic are not sheathed for transfer of in-plane shear forces.</li> <li>• LARGE WINDOW LENGTHS: The glazing package along the longitudinal walls reduces the available shear wall lengths and do not have adequate capacity.</li> <li>• HOLDOWNS: Holdown devices are not present</li> </ul>

- 
- to transfer overturning forces to foundation elements.
  - INCIDENTAL NON-STRUCTURAL ITEMS: There are typically many non-structural items found in similar buildings. These consist of HVAC equipment, heavy tall cabinetry, unbraced suspended ceiling, hot water piping, etc.
-

<b>Building</b>	<b>Deficiency</b>
<b>1919 Original [URM]</b>  <b>Seismic Hazard: High</b>	<ul style="list-style-type: none"> <li>• WALL ANCHORAGE: Provide out-of-plane attachment between walls and roof diaphragms</li> <li>• DIAPHRAGM ATTACHMENT: Provide new in-plane hardware directly attaching the diaphragms to the shear walls below.</li> <li>• STRAIGHT SHEATHING: Remove the existing roofing and install a new layer of plywood over the existing straight sheathing providing an adequate diaphragm.</li> <li>• WOOD STRUCTURAL SHEAR WALLS: Provide additional nailing or sheathing as necessary to increase the available shear walls capacity to acceptable levels.</li> <li>• LARGE WINDOW LENGTHS: Remove and replace existing window packages in strategic locations and infill.</li> <li>• HOLDOWNS: Provide new foundation elements as necessary and new holdowns to properly.</li> <li>• INCIDENTAL NON-STRUCTURAL ITEMS: There are typically many non-structural items found in similar buildings. These consist of HVAC equipment, heavy tall cabinetry, unbraced suspended ceiling, hot water piping, etc.</li> </ul>

<b>Mid 1900s Additions [RM1]</b>  <b>Seismic Hazard: High</b>	<ul style="list-style-type: none"> <li>• WALL ANCHORAGE: Provide out-of-plane attachment between walls and roof diaphragms</li> <li>• DIAPHRAGM ATTACHMENT: Provide new in-plane hardware directly attaching the diaphragms to the shear walls below.</li> <li>• STRAIGHT SHEATHING: Remove the existing roofing and install a new layer of plywood over the existing straight sheathing providing an adequate diaphragm.</li> <li>• WOOD STRUCTURAL SHEAR WALLS: Provide</li> </ul>

- **LARGE WINDOW LENGTHS:** Remove and replace existing window packages in strategic locations and infill.
  - **HOLDOWNS:** Provide new foundation elements as necessary and new holdowns to properly.
  - **INCIDENTAL NON-STRUCTURAL ITEMS:** There are typically many non-structural items found in similar buildings. These consist of HVAC equipment, heavy tall cabinetry, unbraced suspended ceiling, hot water piping, etc.
-

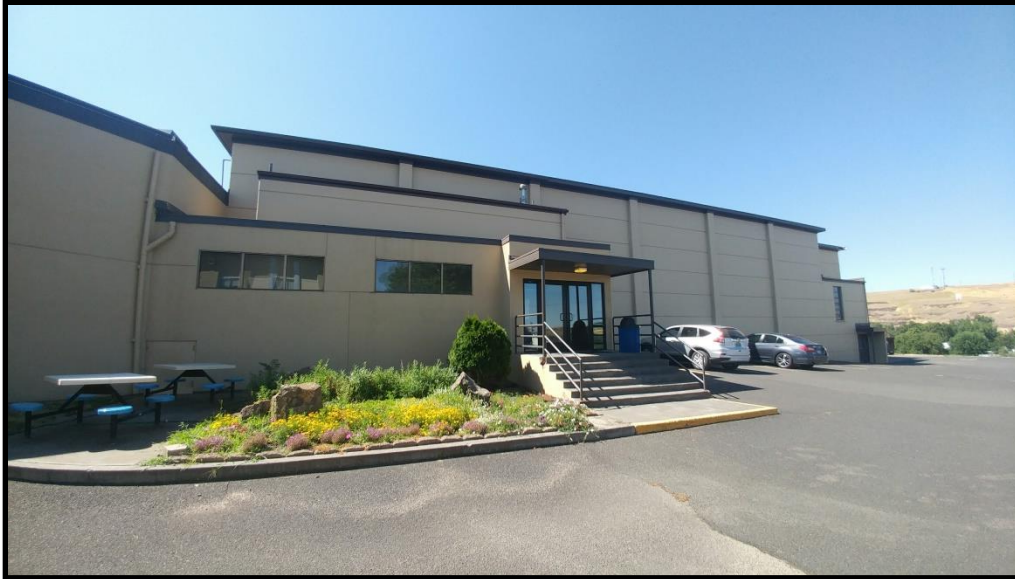
Figure 3: Pilot Rock High School

- **1955 Original [C2A] [RM1]:** The original single story classroom structure consists of concrete exterior walls, interior CMU and wood framed walls with a flexible wood roof diaphragm. The roof consists of plywood sheathing over wood joists bearing on timber beams, interior wood walls and concrete walls. The foundation consists of slab-on-grade with cast-in-place concrete footings. This structure houses multiple classrooms, and an office with an approximate footprint of 9,500-square-feet.

The original gymnasium consists of concrete walls with concrete pilasters, and interior CMU walls with a flexible wood roof diaphragm. The roof consists of straight sheathing over wood joists bearing on large bowstring trusses. There is a wood framed mezzanine with locker rooms below. The floor consists of wood joists bearing on beams and exterior walls. The foundation consists of cast-in-place concrete walls and footings. The approximate footprint of the gymnasium is 18,500-square-feet.

- **1962 Addition [RM1]:** This addition houses the current library and consists of reinforced concrete walls with a flexible wood roof diaphragm. The roof consists of plywood sheathing over wood joists bearing on beams and exterior walls. The foundation consists of concrete slab-on-grade with cast-in-place concrete stem walls and footings. The approximate footprint of this structure is 2,200-square-feet.

<b>Building</b>	<b>Deficiency</b>
<b>1955 Original [C2A] [RM1]</b>  <b>Seismic Hazard: High</b>	<ul style="list-style-type: none"> <li>• WALL ANCHORAGE: Out-of-plane connections at the top of wall and mezzanine to wall are not present.</li> <li>• DIAPHRAGM ATTACHMENT: The diaphragms are not properly attached to shear walls below.</li> <li>• STRAIGHT SHEATHING: The straight sheathed diaphragm does not have adequate in-plane shear capacity.</li> <li>• DIAPHRAGM SPAN: The unblocked diaphragm spans greater than 40-feet.</li> <li>• WOOD STRUCTURAL SHEAR WALLS: The wood walls in the attic are not sheathed for transfer of in-plane shear forces.</li> <li>• LARGE WINDOW LENGTHS: The glazing package along the longitudinal walls reduces the available shear wall lengths and do not have adequate capacity.</li> <li>• HOLDOWNS: Holdown devices are not present to transfer overturning forces to foundation elements.</li> <li>• INCIDENTAL NON-STRUCTURAL ITEMS: There are typically many non-structural items found in similar buildings. These consist of HVAC equipment, heavy tall cabinetry, unbraced suspended ceiling, hot water piping, etc.</li> </ul>

<b>1962 Addition [RM1]</b>  <b>Seismic Hazard: High</b>	<ul style="list-style-type: none"> <li>• WALL ANCHORAGE: Out-of-plane connections at the top of wall are not present.</li> <li>• DIAPHRAGM ATTACHMENT: The diaphragms are not properly attached to shear walls below.</li> <li>• DIAPHRAGM SPAN: The unblocked diaphragm spans greater than 40-feet.</li> <li>• WOOD STRUCTURAL SHEAR WALLS: The wood walls in the attic are not sheathed for transfer of in-plane shear forces.</li> <li>• LARGE WINDOW LENGTHS: The glazing package along the longitudinal walls reduces the available shear wall lengths and do not have adequate capacity.</li> <li>• HOLDOWNS: Holdown devices are not present to transfer overturning forces to foundation elements.</li> <li>• INCIDENTAL NON-STRUCTURAL ITEMS:</li> </ul>

There are typically many non-structural items found in similar buildings. These consist of HVAC equipment, heavy tall cabinetry, unbraced suspended ceiling, hot water piping, etc.

<b>Building</b>	<b>Deficiency</b>
<b>1956 Original</b> <b>[C2A] [RM1]</b>  <b>Seismic Hazard:</b> <b>High</b>	<ul style="list-style-type: none"> <li>• <b>WALL ANCHORAGE:</b> Provide out-of-plane attachment between walls and roof diaphragms and walls and mezzanine floor.</li> <li>• <b>DIAPHRAGM ATTACHMENT:</b> Provide new in-plane hardware directly attaching the diaphragms to the shear walls below.</li> <li>• <b>STRAIGHT SHEATHING:</b> Remove the existing roofing and install a new layer of plywood over the existing straight sheathing providing an adequate diaphragm.</li> <li>• <b>WOOD STRUCTURAL SHEAR WALLS:</b> Provide additional nailing or sheathing as necessary to increase the available shear walls capacity to acceptable levels.</li> <li>• <b>LARGE WINDOW LENGTHS:</b> Remove and replace existing window packages in strategic locations and infill.</li> <li>• <b>HOLDOWNS:</b> Provide new foundation elements as necessary and new holdowns to properly.</li> <li>• <b>INCIDENTAL NON-STRUCTURAL ITEMS:</b> There are typically many non-structural items found in similar buildings. These consist of HVAC equipment, heavy tall cabinetry, unbraced suspended ceiling, hot water piping, etc.</li> </ul>

<b>1950s Addition</b> <b>[RM1]</b>  <b>Seismic Hazard:</b> <b>High</b>	<ul style="list-style-type: none"> <li>• <b>WALL ANCHORAGE:</b> Provide out-of-plane attachment between walls and roof diaphragms</li> <li>• <b>DIAPHRAGM ATTACHMENT:</b> Provide new in-plane hardware directly attaching the diaphragms to the shear walls below.</li> <li>• <b>WOOD STRUCTURAL SHEAR WALLS:</b> Provide additional nailing or sheathing as necessary to increase the available shear walls capacity to acceptable levels.</li> <li>• <b>LARGE WINDOW LENGTHS:</b> Remove and replace existing window packages in strategic locations and infill.</li> </ul>

- 
- **HOLDOWNS:** Provide new foundation elements as necessary and new holdowns to properly.
  - **INCIDENTAL NON-STRUCTURAL ITEMS:** There are typically many non-structural items found in similar buildings. These consist of HVAC equipment, heavy tall cabinetry, unbraced suspended ceiling, hot water piping, etc.
-
