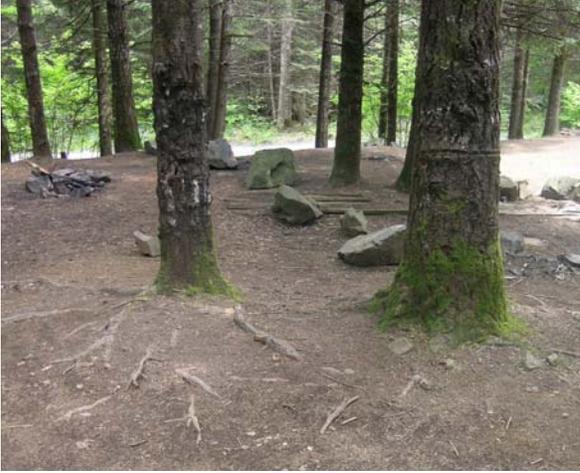
Impact Type	Photographic Example
Tree damage (firewood cutting, vehicle impacts, bark removal, ring barking and nailing)

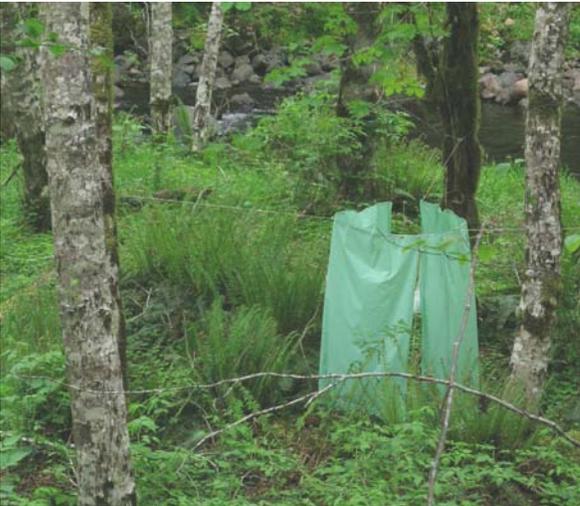
Human waste

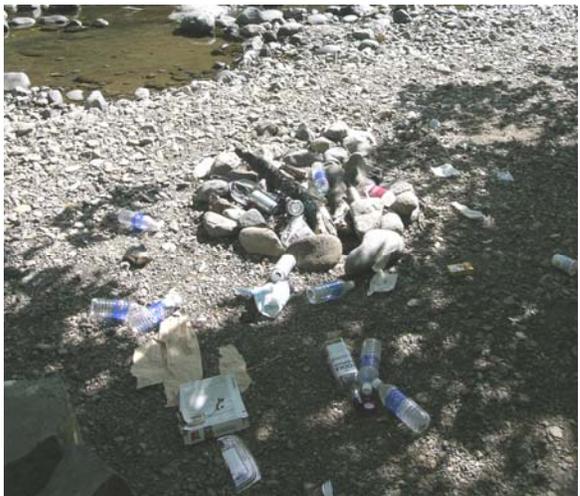
Garbage

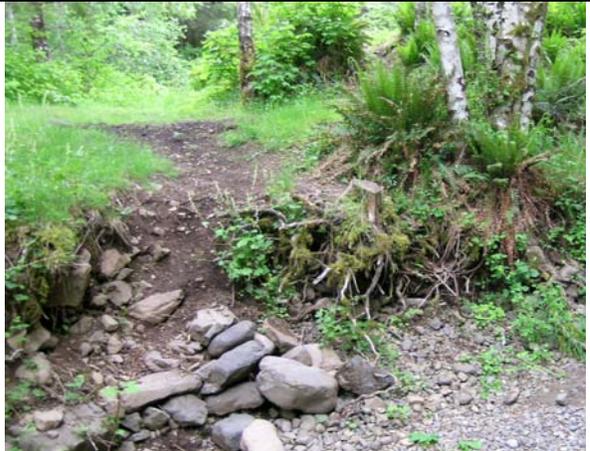
Impact Type	Photographic Example
Erosion from social trails leading directly to the waters edge

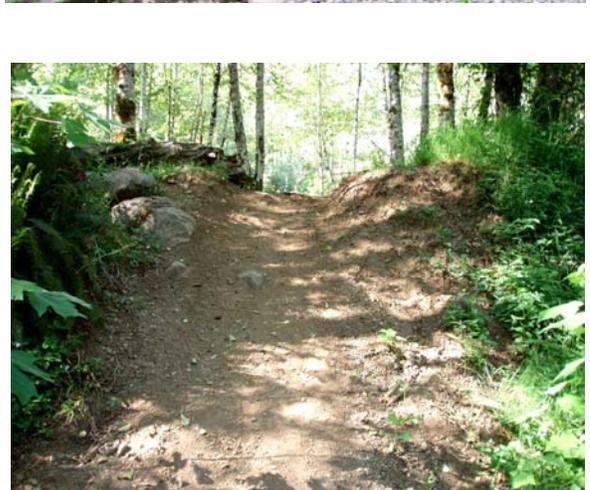
Erosion from motorized recreation using riparian areas for circuit riding

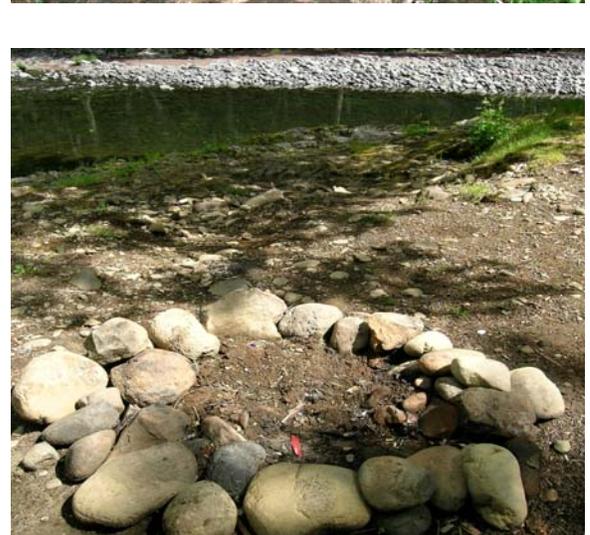
Fire rings, burnt garbage and ash within and scattered.

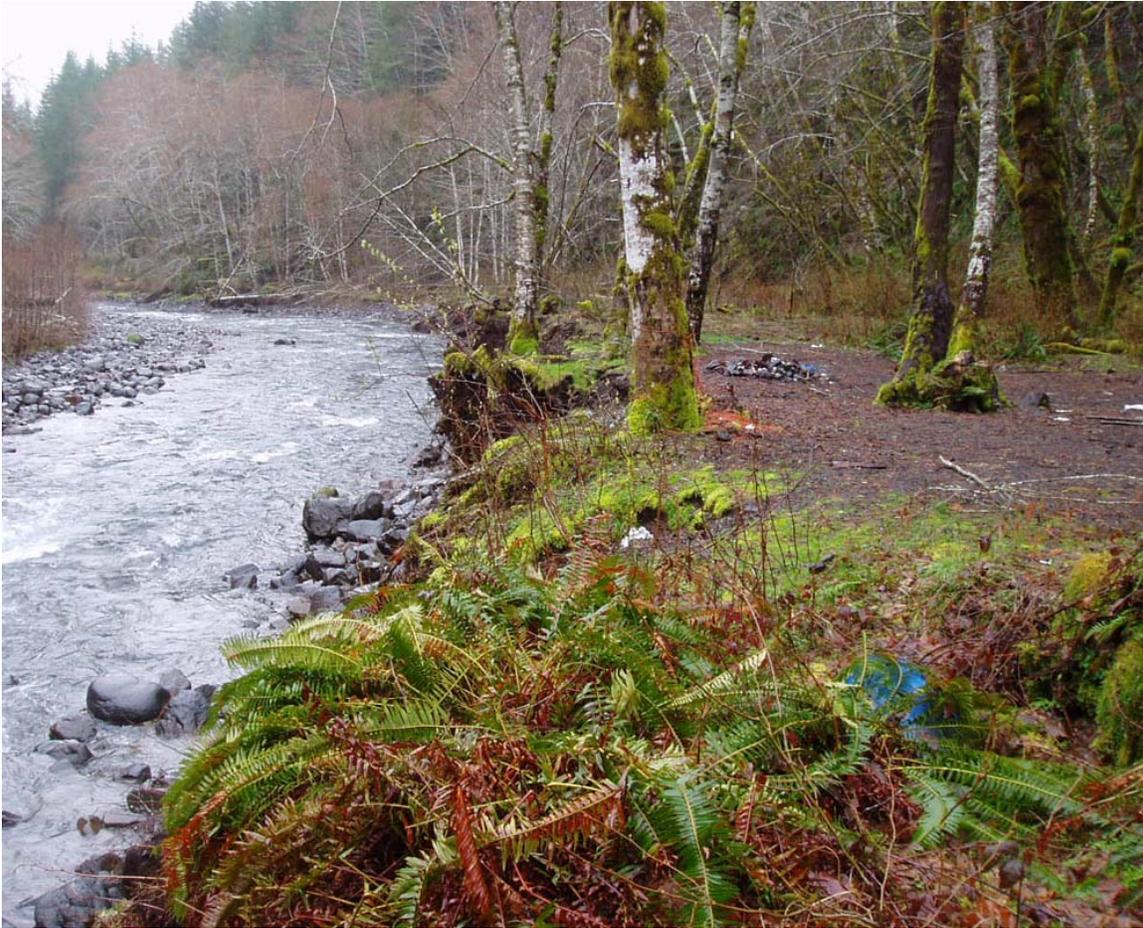
**Photographic Plate 10.** Example of a Dispersed Campsite. A relatively small disturbance area produces a local sediment source to the stream (see erosion in the center of the photo) and disruptions in canopy cover.

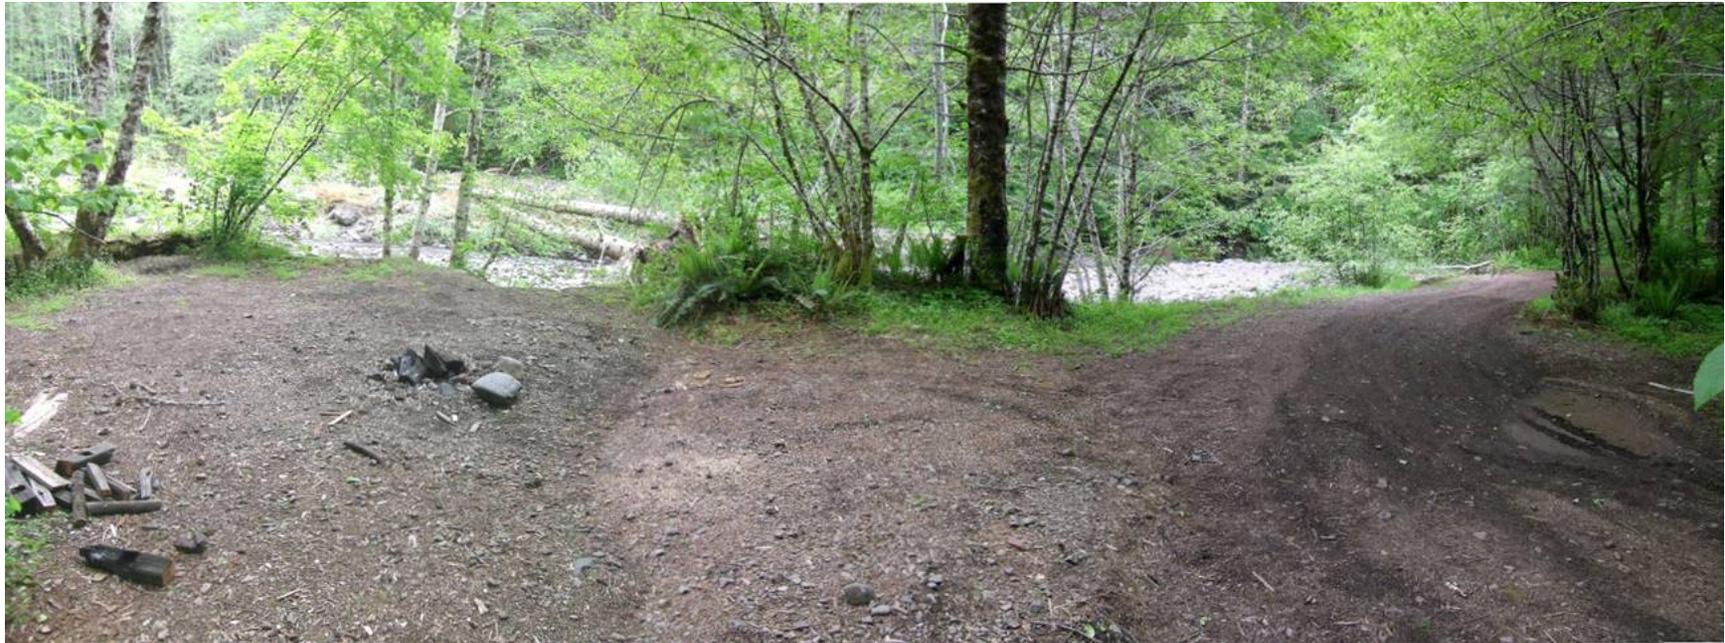
**Photographic Plate 11.** Example of a Ground Cover Disturbance in a Dispersed Campsite. A disturbance area of ~1200 square feet with bare mineral soil widespread and the potential to deliver erosional materials directly into the North Fork of the Wilson River.

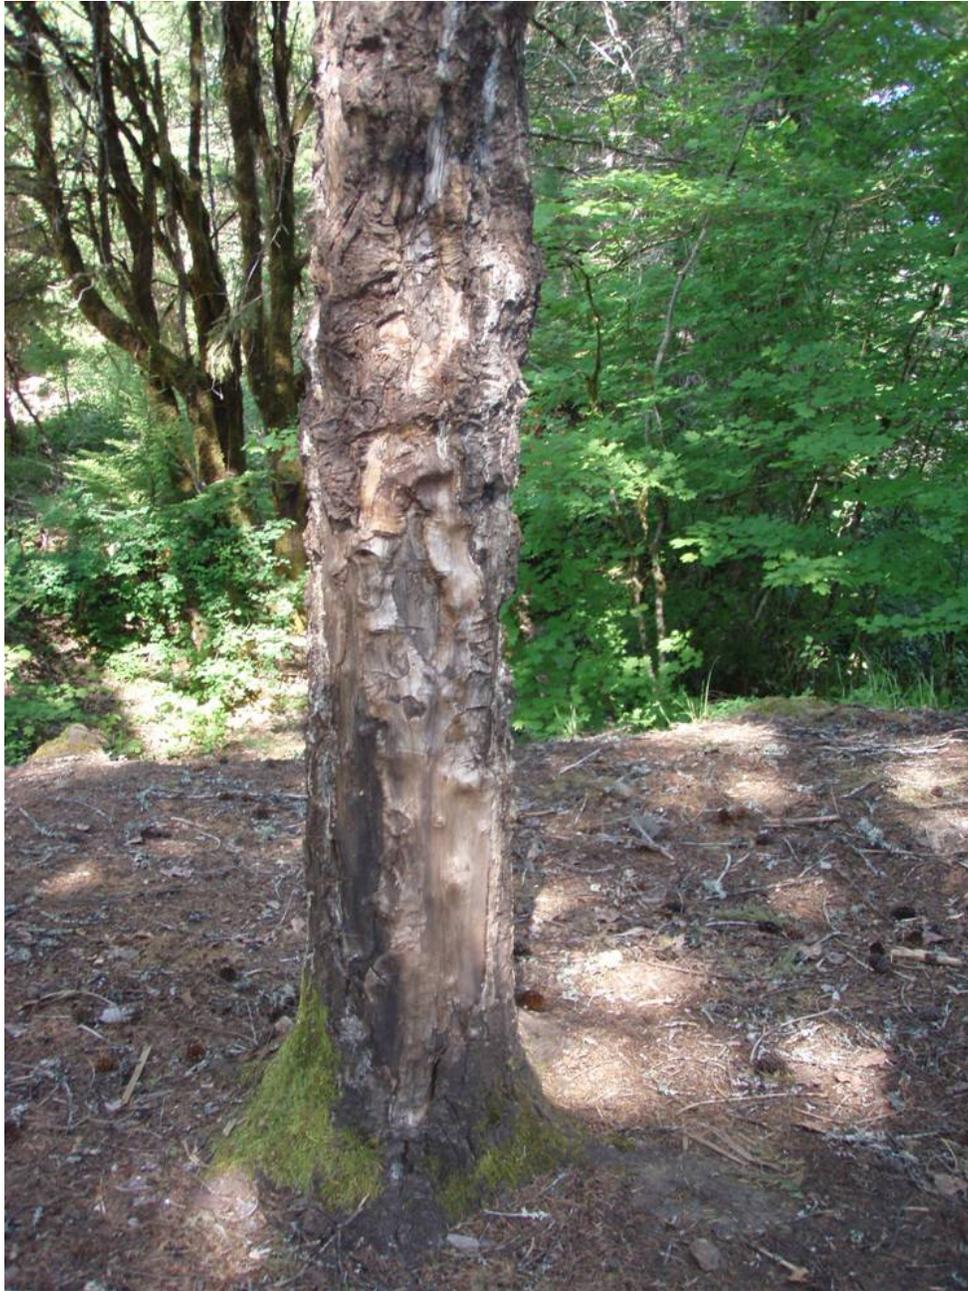
**Photographic Plate 12.** Example of Tree Damage in a Dispersed Campsite. A 30-40 year old Douglas-fir showing severe damage and loss of vigor within 15 feet of the stream.

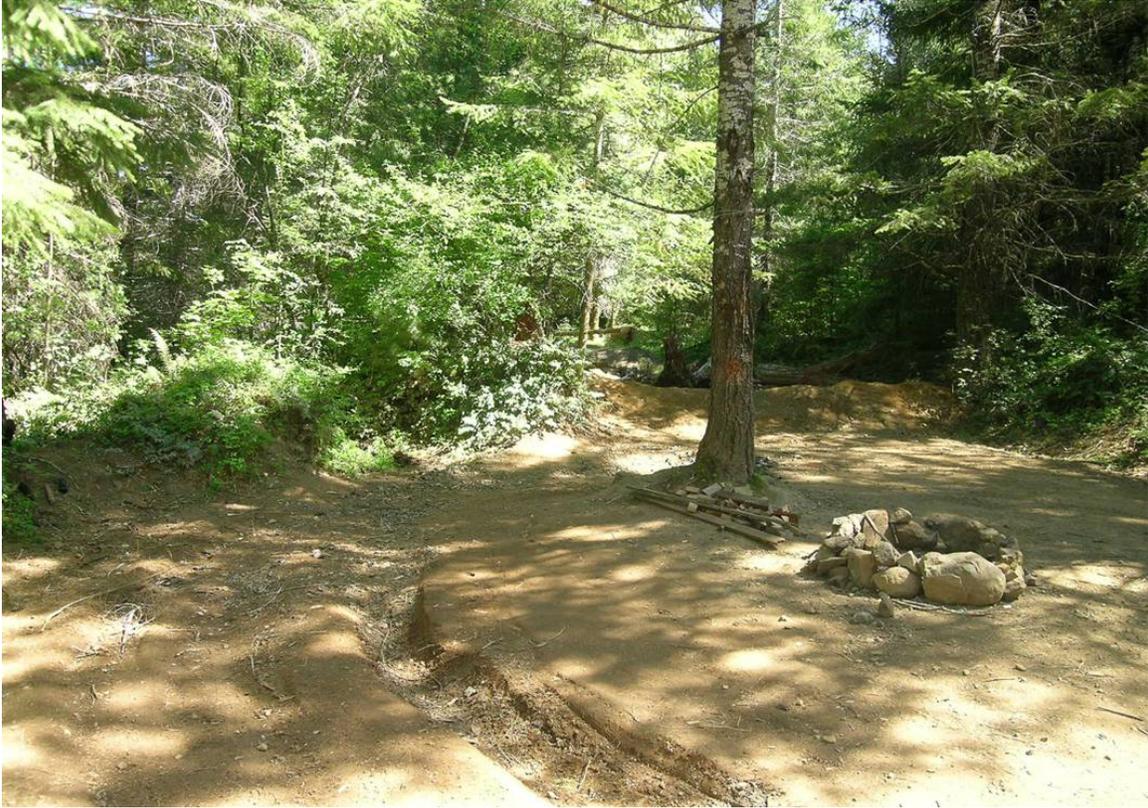
**Photographic Plate 13.** Example of OHV Use Associated with a Dispersed Campsite. Vehicle parking and OHV use of the riparian areas exacerbates vegetation loss, soil compaction, and erosion.

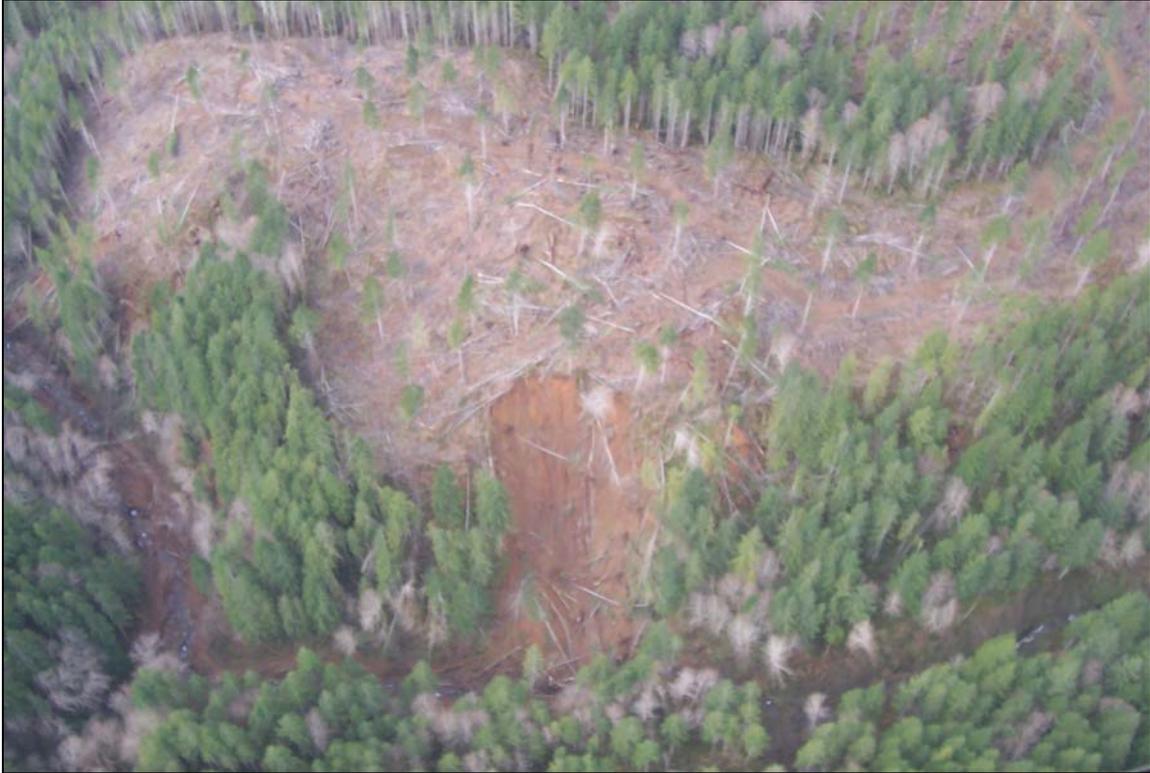
**Photographic Plate 16.** Aerial view of one of many small, deep-seated landslides seen from the Partenavia flight in March of 2007.
