PROJECT PROSPECTUS

Section: 38th Street (Franklin Ave.) Bridge No. 07T03		Key Number:		Jurisdiction:	
Region: 2		Area: North West Oregon Act		District: 1	
State Highway No.:	Highway Name:	Mile Point From:	To:	Length: (mi) (km)	
<input checked="" type="checkbox"/> Urban <input type="checkbox"/> Rural	City:	MPO:	Within UGB <input checked="" type="checkbox"/> Yes <input type="checkbox"/> No	County: Clatsop	Road/Street Name: Franklin Ave.
Route No.:	NHS <input type="checkbox"/> YES <input type="checkbox"/> NO	HPMS:	FC:	Applicant (if other than State): City of Astoria	
US Congressional District: 1		State Senate District: 15		State Representative District: 31	
Cost Estimates (x \$ 1,000)		Project Components		Right Of Way	
Preliminary Engineering	\$476	Grading	<input checked="" type="checkbox"/>	Files	(#) 8
Right Of Way	\$24	Paving	<input checked="" type="checkbox"/>	Hectares	(#) 4
Utility Reimbursement		Structures	<input checked="" type="checkbox"/>	Relocations	(#) 0

Re Bridge with Serious Structural Deficiencies
Bridge #07T03 Carrying Franklin Avenue
over 38th Street, City of Astoria

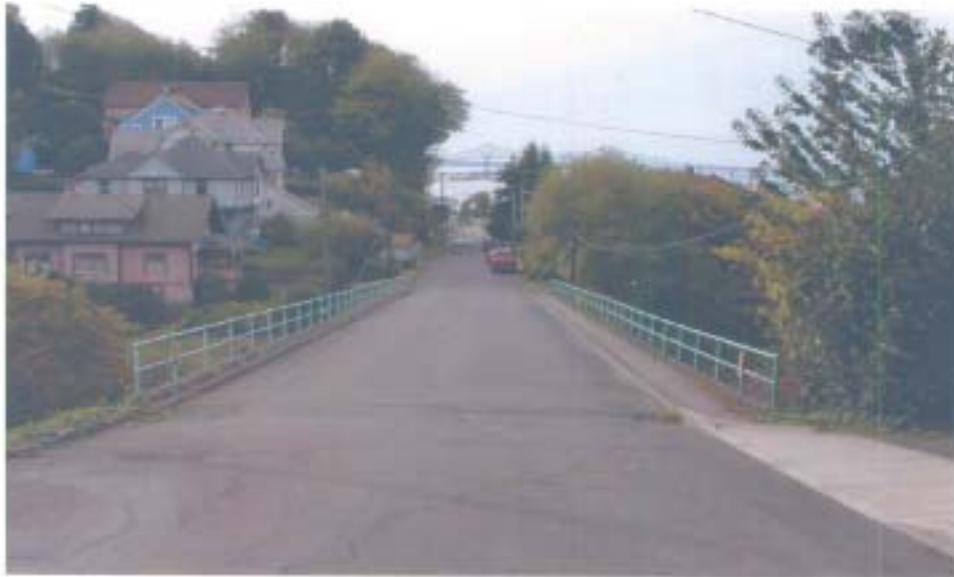
Photograph No. 1 — Approach looking west.

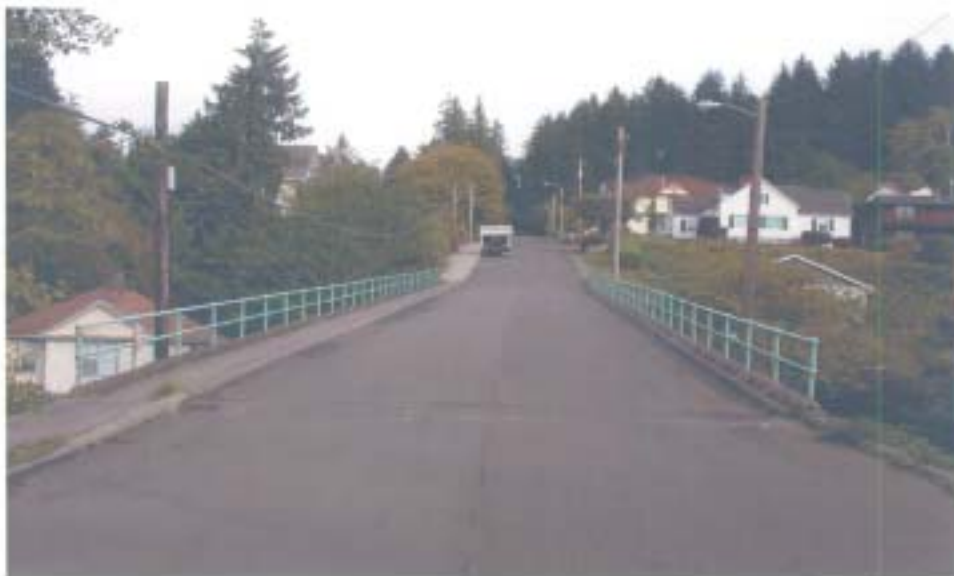
Photograph No. 2 — Approach looking east.

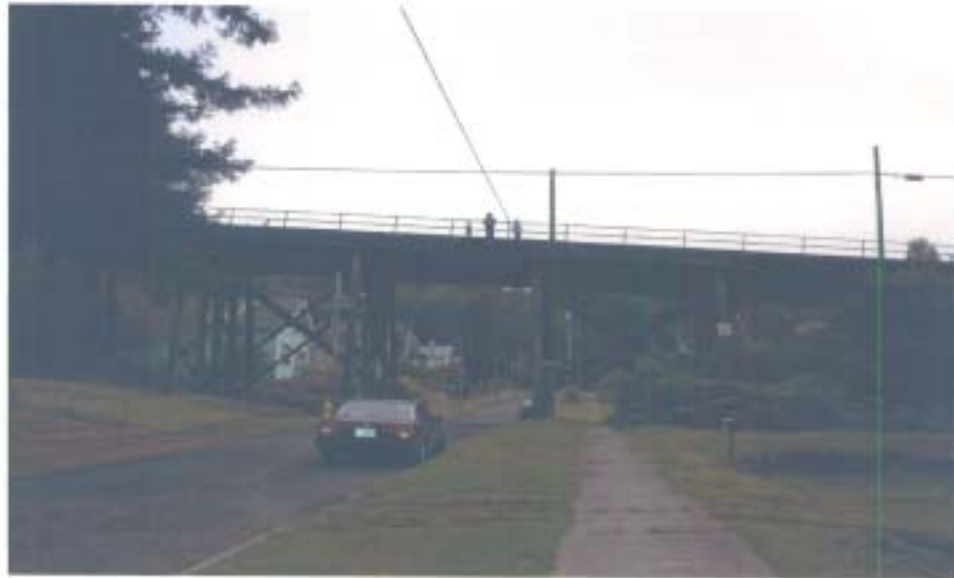
Photograph No. 3 — Elevation looking north.

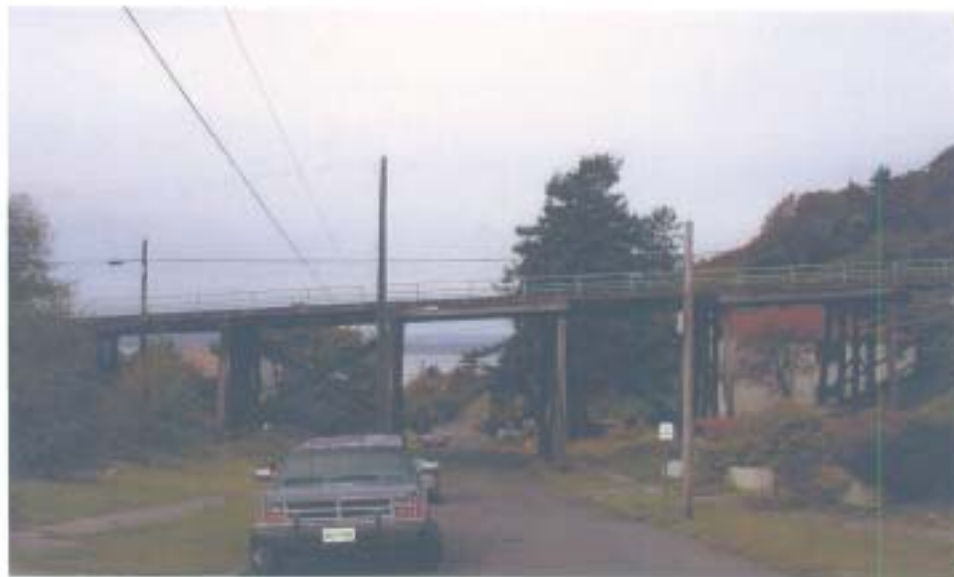
Photograph No. 4 — Elevation looking south.
