OREGON DEPARTMENT OF TRANSPORTATION

AGGREGATE SITES

DISTRICT 4

JUNE 2002

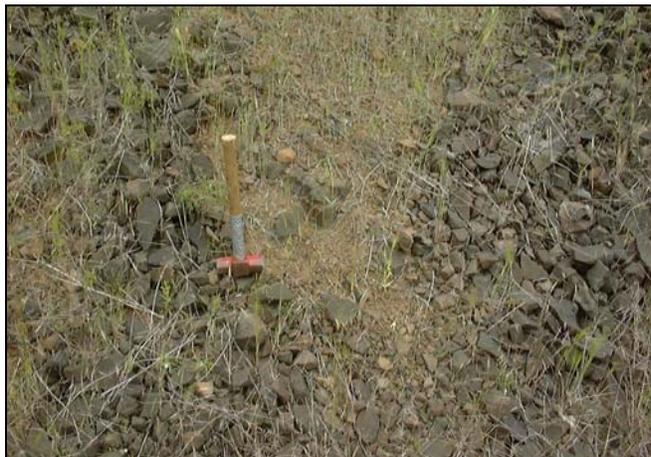
Close-up view of the basalt rock and the fracture pattern.

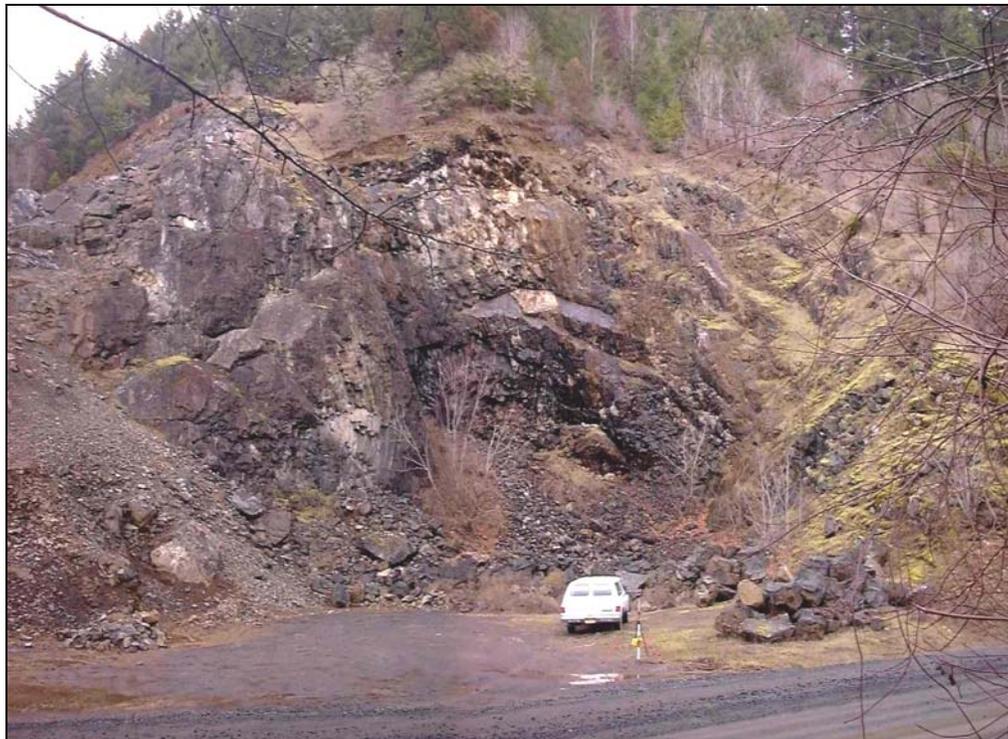
Adjacent Land Use										
Forest										
Remarks										
This site is adjacent to and north of South Fork County Road. The rock here is a medium-grain basalt with moderate mineral alteration along joint boundaries to zeolites. There is limited room to work due to the steep nature of the terrain. This site has some screening from the county road if you remove rock from the upper pit. There are large rip rap boulders from this site that could be used in the future. The bench cut or small pit adjacent to the county road is too tall (up to 55 feet) and should be cut down to a safer height. The upper pit appears to have been used the last time rock was removed from this location and it is well screened from the road. This site is categorized in the Right of Way data base as RW and should be changed to SQ. This area has very steep terrain and could pose problems in removing rock safely next to the county road. All work should be from the top down to maximize this site and make it a safe work place. You would definitely need to drill and blast the rock. This site needs a good survey and development plan for future work. With the steep terrain a site plan should have most of the work proceed from the top down.

View to the northeast, looking at the lower pit along the county road

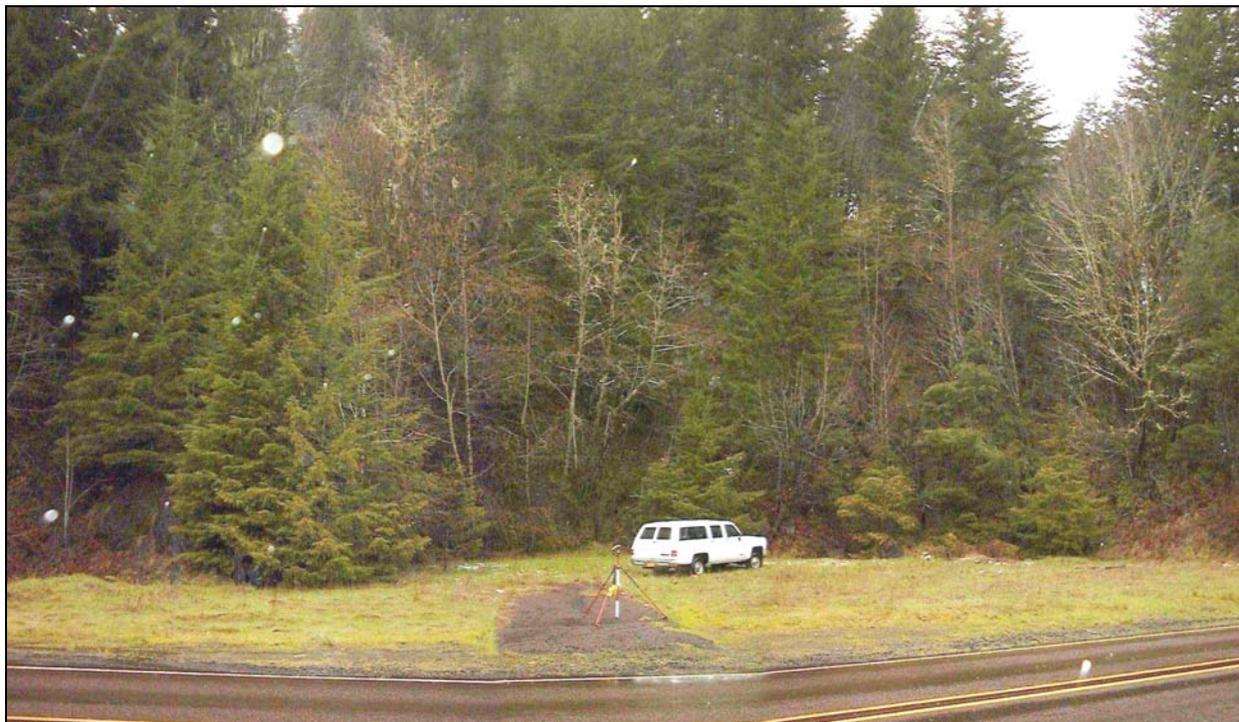
Remarks										
This site is located adjacent to and northwest of Highway 34. The rock here is a coarse-grain massive gabbro. The exposures are very blocky and massive. This rock can be soft due to the weathering. There is no screening from the highway and very limited room to work. The terrain is steep and could pose some access problems. There is little to no disturbance at this site. You would need to drill and blast this rock which could produce some good rip rap. The GPS is suspect and a current boundary survey is advised to locate the exact boundaries. This site has been worked from the bottom up and makes it more difficult to come in and work safely here. If we come back to this site, it should be worked from the top down.										
202B	203B	211	206 Fine	206 Coarse	208 F	208 F Ht.	208 C	208 C Ht.

View to the northwest of the area along Highway 34.

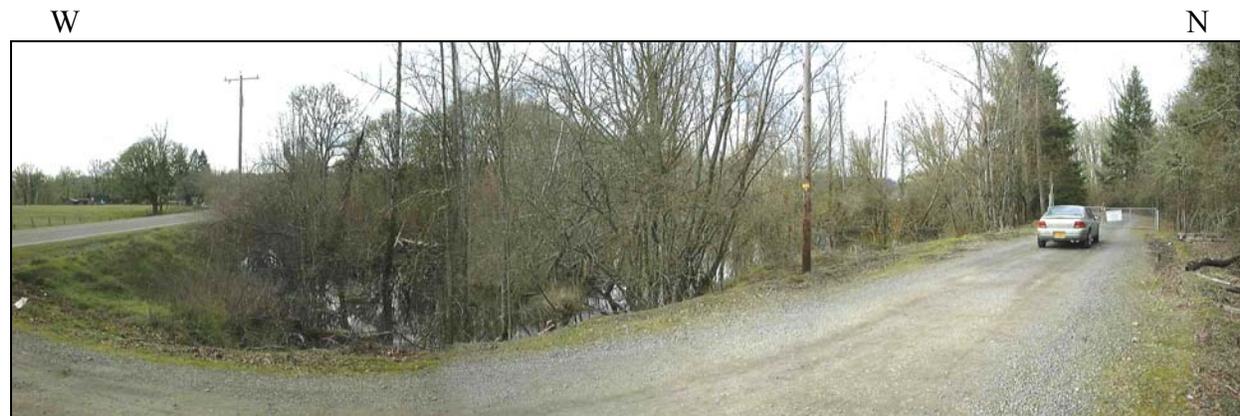
County	Site Name				Dist	Hwy	Mile Pt	TWP	RGE	Sect
Benton	Monroe Pit Quarry				04	0001	0	14S	05.0W	33
File ID		Source #	Date Visited	Map #			Type of Site			
04523		02-902-2	4/20/1999	1R-1-1710			Gravel			
Latitude	Longitude	Elev. (m)	Acreage	Pit Size	DOGAMI Permit #					
44 18'44.68000"	123 17'25.43000"	90	12.52	NA						
Comments										
Lat. and Long. acquired using Terrain Navigator Software										
Rock Type	Unit	Color		Weathering			Jointing			
Alluvium	NA	NA		NA			NA			
Quality			Hardness	lbs./cu ft.	Reserve (cy)	Reserve (Tons)				
Depleted			NA	120						
Potentially Significant Site	Why			Open/Closed	Direction					
No	It appears the site might depleted			Closed	Adjacent to the Long Tom River.					
Adjacent Land Use										
Commercial/Residential										
Remarks										
This site is just south of Monroe on Highway 99. We are co-owners with the town of Monroe and Benton County. This site appears to be the transfer station now. The gravel here is depleted. The river was in flood stage and it appears that the site is depleted.

View looking northwest at the access point into the transfer station south of Monroe, OR. The site is the brushy area on the other side of the road.

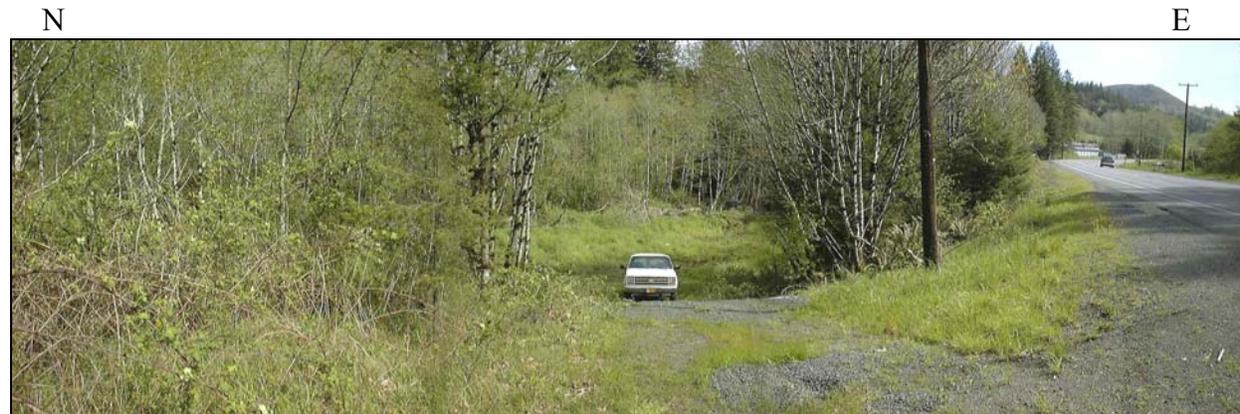
County	Site Name				Dist	Hwy	Mile Pt	TWP	RGE	Sect
Lincoln	Widow Creek Quarry				04	0039	6.4	06S	10.0W	25
File ID		Source #	Date Visited	Map #			Type of Site			
02241		21-015-2	3/04/1999	1R-2-2534			Gravel			
Latitude	Longitude	Elev. (m)	Acreage	Pit Size	DOGAMI Permit #					
45 01'13.99000"	123 51'47.95000"	111	5	<5						
Comments										
Lat. and Long. acquired using Terrain Navigator Software										
Rock Type	Unit	Color		Weathering			Jointing			
Volcanic Gravel	NA	NA		NA			NA			
Quality			Hardness	lbs./cu ft.	Reserve (cy)	Reserve (Tons)				
NA			NA	120						
Potentially Significant Site	Why			Open/Closed	Direction					
No	Depleted gravel			Closed	Adjacent to Widow Creek					
Adjacent Land Use										
Rural residential										
Remarks										
This site is adjacent to and north of Highway 18 about one half of a mile east of the Rose Lodge Maintenance Yard. It is adjacent to Widow Creek. All of the gravel is depleted and the property is used as a waste site now. Possible stock pile site or a waste site for maintenance.

Looking northeast at the depleted gravel site along Widow Creek. The creek is to the left out of view. Highway 18 is along the right side of the image.

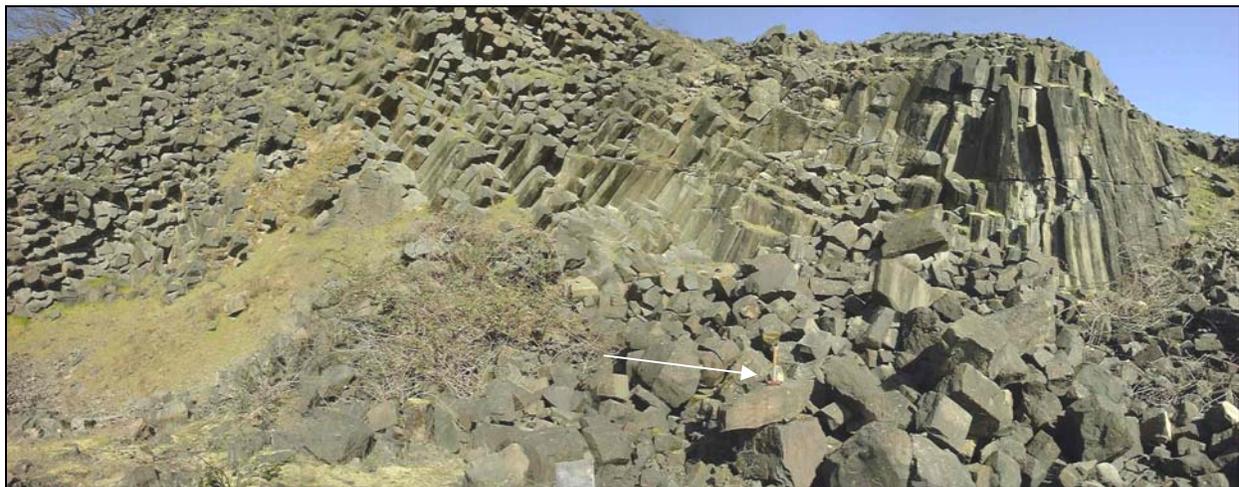
Close-up view of the columnar jointing within the pit. Hammer for scale.

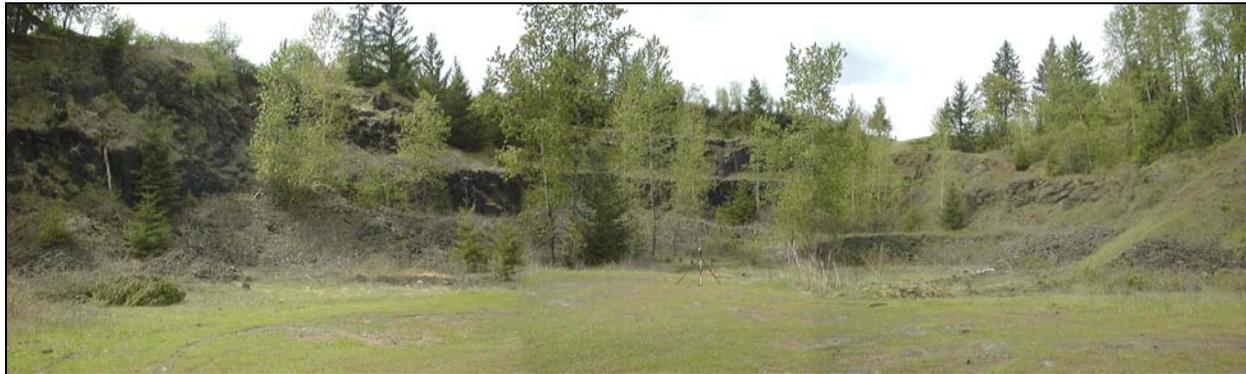
View to the west of the pit floor and the bench cuts. Total height of the pit wall is approximately 35 feet.

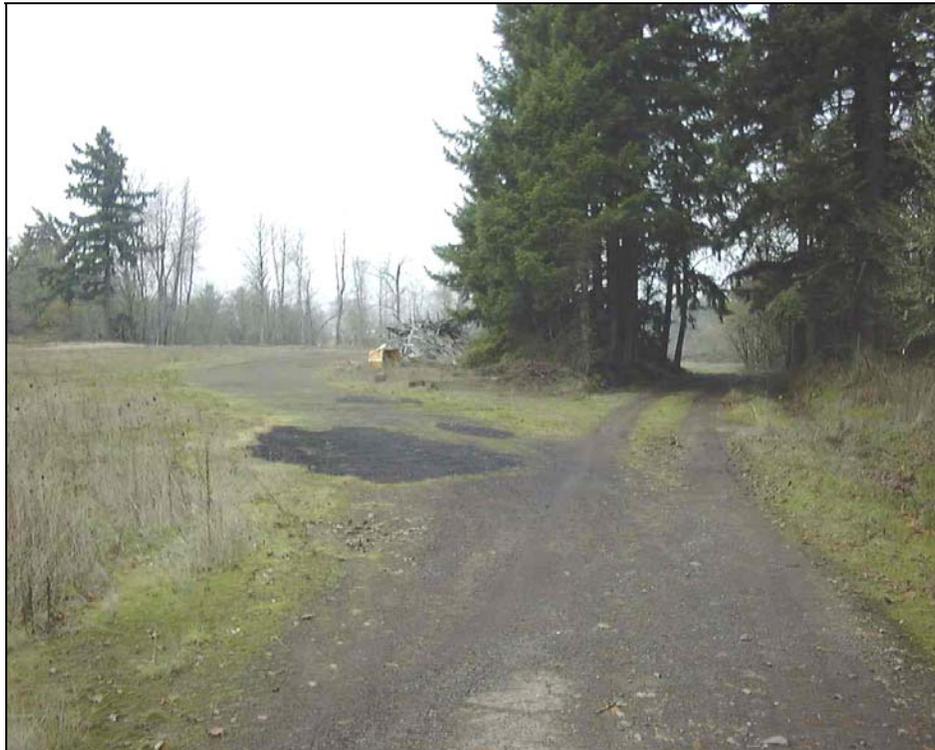
County	Site Name				Dist	Hwy	Mile Pt	TWP	RGE	Sect
Linn	McTimmonds Gravel Pit				04	0016	17.6	12S	01.0W	30
File ID		Source #	Date Visited	Map #			Type of Site			
10258		22-036-2	12/17/1999	1R-2-1281			Stock Pile Site			
Latitude	Longitude	Elev. (m)	Acreage	Pit Size	DOGAMI Permit #					
44 29'58.22449"	122 50'56.66303"	124.003	15.4	NA						
Comments										
GPS acquired at gate.										
Rock Type	Unit	Color	Weathering			Jointing				
Volcanic Gravel	NA	NA	NA			NA				
Quality			Hardness	lbs./cu ft.	Reserve (cy)	Reserve (Tons)				
NA			NA	0						
Potentially Significant Site	Why			Open/Closed	Direction					
No	Waste rock site now			Closed	Vail Creek is to the north.					
Adjacent Land Use										
Residential										
Remarks										
This site is located southeast of Lebanon on the north side of Highway 20. The property is being used as a waste site/stock pile site and appears to be depleted of gravel.

Looking north at the Maintenance stockpile site.

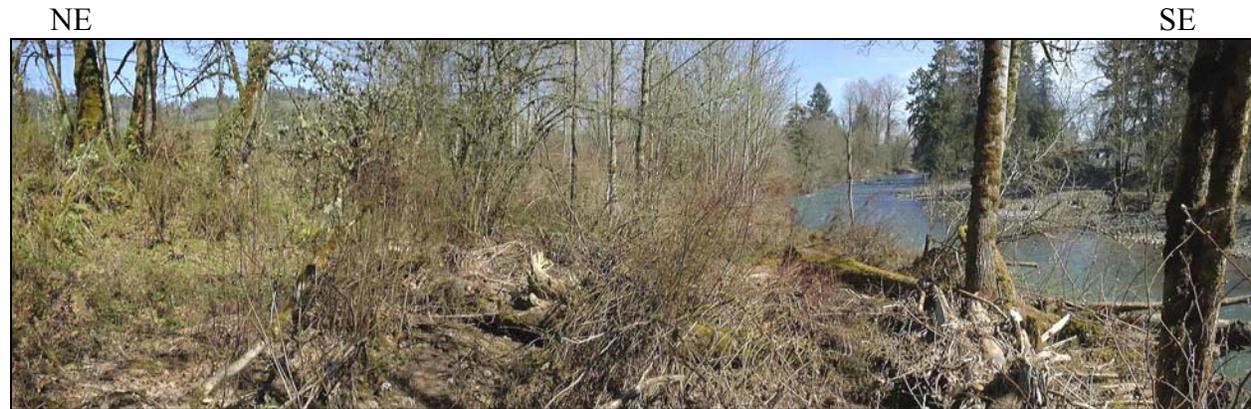
County	Site Name			Dist	Hwy	Mile Pt	TWP	RGE	Sect
Linn	Myers Pit			04	0211	0	10S	01.0W	12
File ID		Source #	Date Visited	Map #			Type of Site		
04532, 03991		22-900-2	1/21/1999	1R-1-1711			Gravel		
Latitude	Longitude	Elev. (m)	Acreage	Pit Size		DOGAMI Permit #			
44 42'50.42828"	122 45'41.96279"	126.95	3.6	NA					
Comments									
GPS acquired at the eastside of property.									
Rock Type	Unit	Color	Weathering			Jointing			
Alluvium	NA	NA	NA			NA			
Quality			Hardness	lbs./cu ft.	Reserve (cy)	Reserve (Tons)			
Poor			NA	120					
Potentially Significant Site	Why			Open/Closed	Direction				
No	Small acreage, with no rock.			Closed	Adjacent to Thomas Creek				
Adjacent Land Use									
Residential/Farming									
Remarks									
This site is along Highway 226 about 5 miles east of Scio. The property is on the outside of the stream radius along Thomas Creek. The site is narrow and has no gravel just sand size particles. This site is in the flood plane of Thomas Creek. There is no access to this site off of the highway and no screening. That means there is no room to work either. We might at some time in the future need to put rip rap along this site to protect our highway.

Looking east at the site along Thomas Creek.
