APPENDIX A: BEAM DESIGNATION LEGEND

APPENDIX B: TYPICAL FAILURE MODES

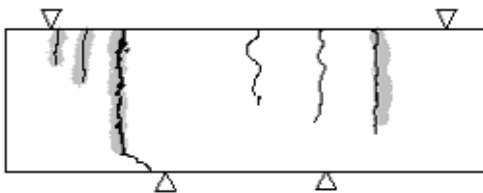
1 Layer - flexure and shear:

Obvious flexural cracking combined with transverse failure of shear laminate and eventually flexural failure of the laminate as well. Transverse failure occurs in shaded areas.

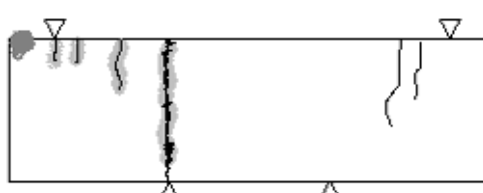
2 Layer - flexure and shear:

Flexural cracks appear outside of center of span. Beam fails in flexure with transverse shear laminate failure and eventual failure of the longitudinal laminate. Debonding occurs at end of laminate at which the failure occurs.

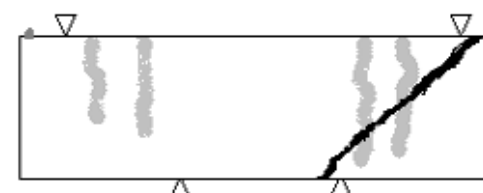
3 Layer - flexure and shear:

Little or no flexural cracking. Beam fails in shear with transverse failure of shear laminate. Debonding occurs at both ends of flexural laminate.

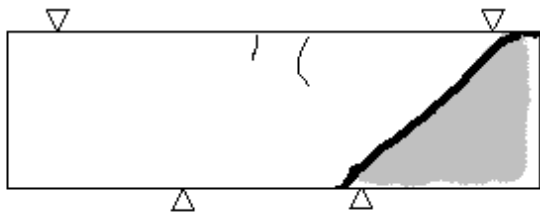
45° shear reinforced:

Laminate pulls off or debonds (shaded area) and beam fails in shear. In the one and two layer beams flexural cracks exist, but do not propagate out from under the composite.

Figure B.3.3.3: Typical crack pattern and failure mode for beams reinforced at 45° for shear with Replark.

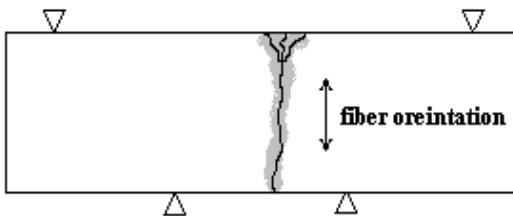
1 Layer - 90° shear reinforced:

Beam fails in classic flexure. Laminate splits transversely at point of cracking (shaded area).

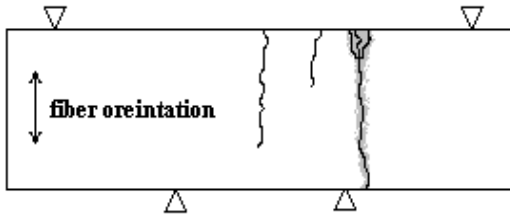
2 Layer - 90° shear reinforced:

Beam fails in flexure, but not in middle third of beam. Laminate again splits at points where cracks occur in concrete.

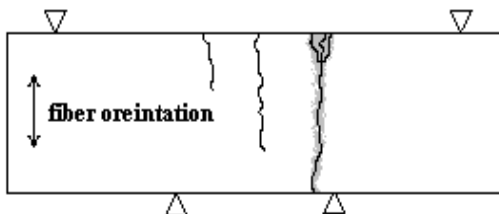
3 Layer - 90° shear reinforced:

Beam fails in flexure in middle third, but closer to loading points than 1 layer beams. Again laminate fails transversely at points where cracks occur.

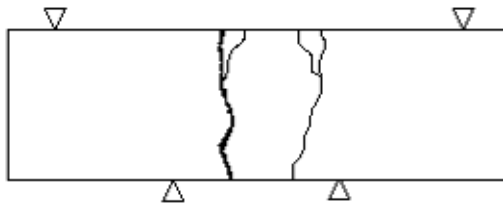
1 Layer - SHCFS:

Flexural cracking originating along edge of shear laminate. Eventual flexural failure of concrete and laminate.

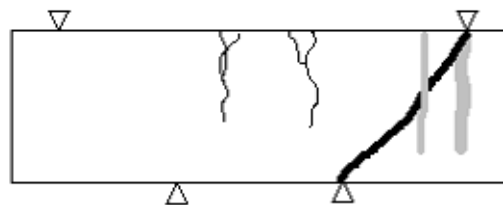
2 Layer - SHCFS:

Flexural cracking starts very similar to one layer beams (along shear lam. edge). Shear laminate splits parallel to fiber orientation (shaded) and beam fails in shear.

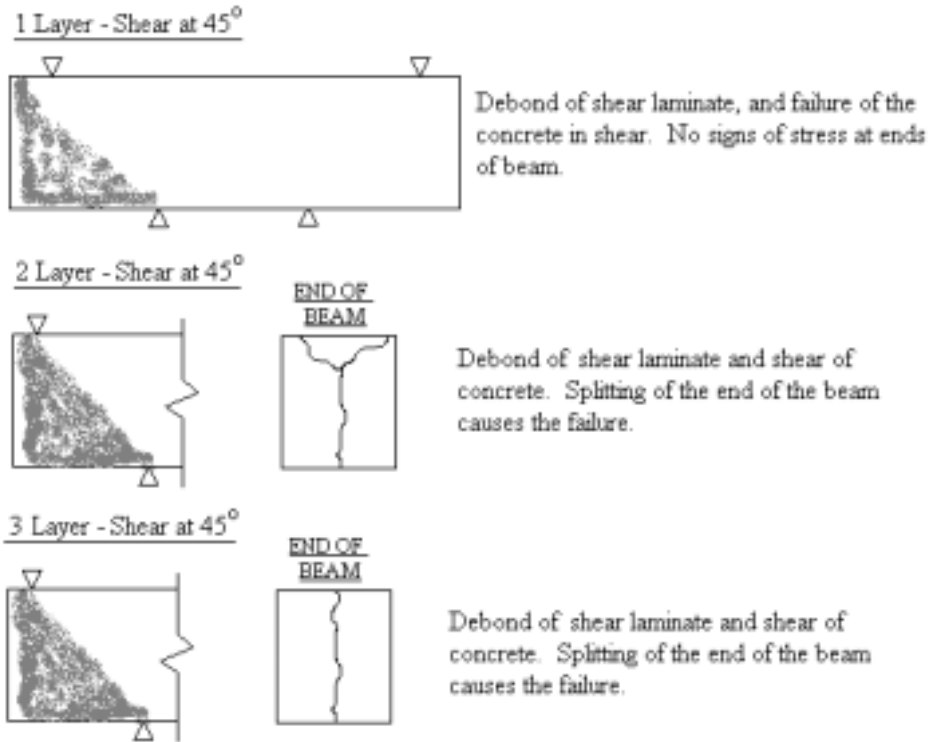
Figure B.5.3.4: Typical cracking and failure modes of beams reinforced with Tyfo® carbon for shear at 45°.

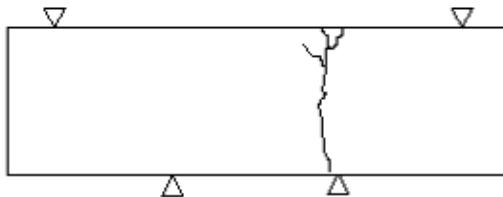
1 LAYER REINFORCED FOR FLEXURE:

Shear cracking occurs but the beam fails in flexure. The failure is within the middle third of the beam.

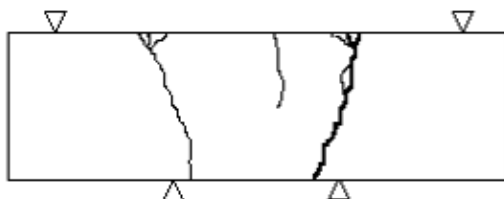
2 LAYER REINFORCED FOR FLEXURE:

Flexural cracking followed by flexural failure of the concrete and debonding of the laminate at ends of beam.

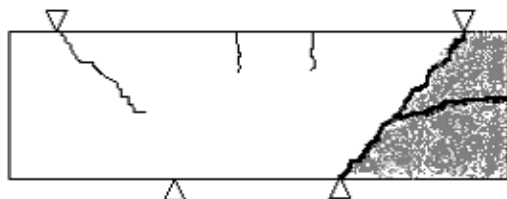
3 LAYER REINFORCED FOR FLEXURE:

Beam fails in shear with little presence of flexural cracking. Beam is clearly over reinforced.

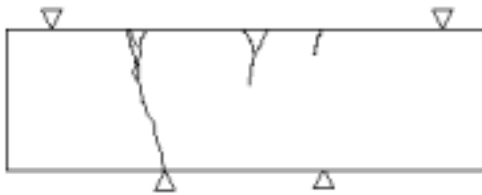
1 LAYER REINFORCED FOR FLEXURE AND SHEAR AT 90 DEGREES

Shear cracks form but beam fails predominantly in flexure. Laminate is failed across tensile (top) face of beam.

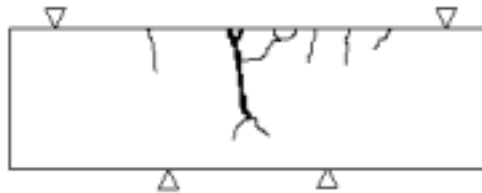
2 LAYERS REINFORCED FOR FLEXURE AND SHEAR AT 90 DEGREES

Flexural failure occurs with the failure of the laminate in the middle third of the beam. Limited shear cracking is observed.

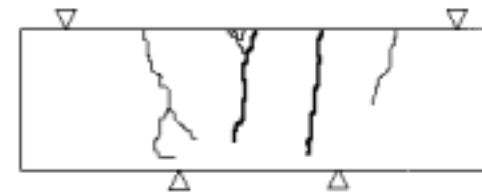
3 LAYERS REINFORCED FOR FLEXURE AND SHEAR AT 90 DEGREES

Flexural and shear cracks develop with the ultimate failure of the flexural laminate in the middle third of the beam.

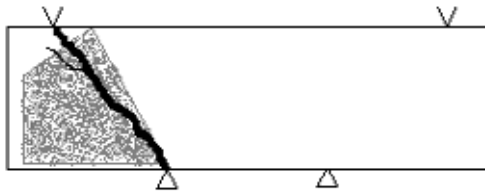
1 LAYER REINFORCED FOR FLEXURE AND SHEAR AT 45 DEGREES

Little flexural cracking is observed. Beam fails ultimately in shear with debonding of shear laminate and fracture of flexural laminate near the support. Some fracturing of shear laminate is observed but not typical.

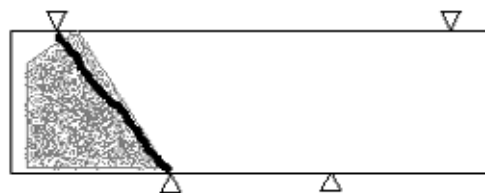
2 LAYERS REINFORCED FOR FLEXURE AND SHEAR AT 45 DEGREES

Beam fails in shear with little presence of flexural cracking. Shear laminate debonds while flexural laminate fractures near the support.

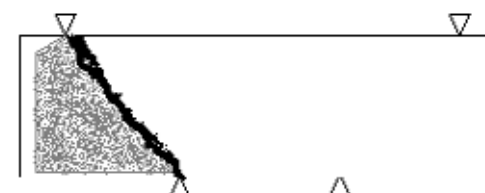
3 LAYERS REINFORCED FOR FLEXURE AND SHEAR AT 45 DEGREES

Beam fails in shear with little presence of flexural cracking. Shear laminate debonds while flexural laminate fractures near the support.

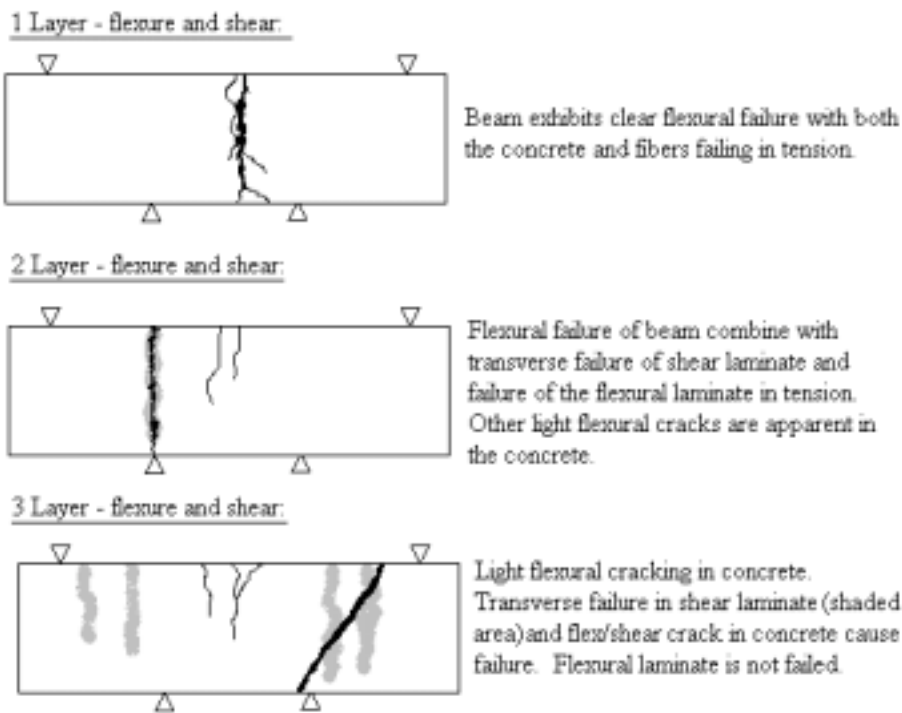
Figure B.7.2.3: Typical cracking and failure modes for beams strengthened with the MBrace™ glass system for shear and flexure.

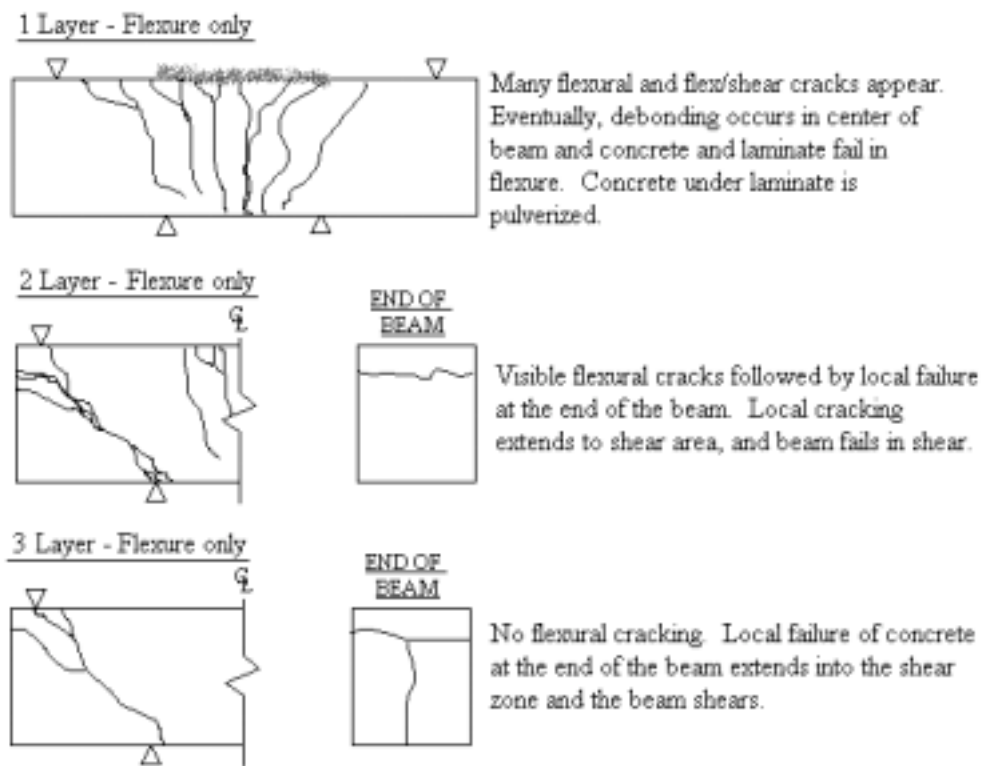
Figure B.8.1.3: Typical cracking and failure modes for beams reinforced with the Tyfo® glass system for flexure only.

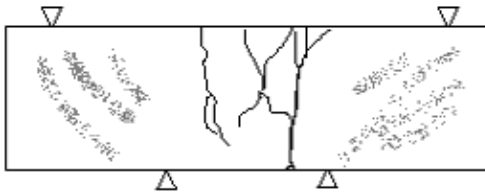
1 Layer - flexure and shear:

Flexural cracking originating along edge of shear laminate. Eventual flexural failure of concrete and laminate. Visible cracking of resin over shear laminate (showing signs of stress in shear laminate - shaded area).

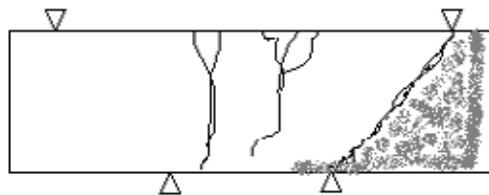
2 Layer - flexure and shear:

Obvious flexural cracking. Eventually shear laminate debonds (shaded area) and concrete fails in shear. Local cracking develops as it does with carbon at the ends of the beams.

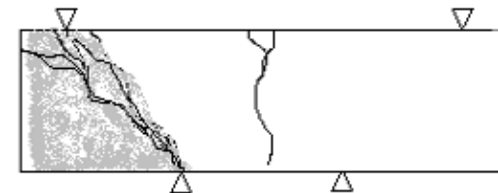
3 Layer - flexure and shear:

Light flexural cracking. Debond of shear laminate. Local stresses cause cracking at end of beam. Failure caused by debond of shear laminate (shaded area) and shear cracking.

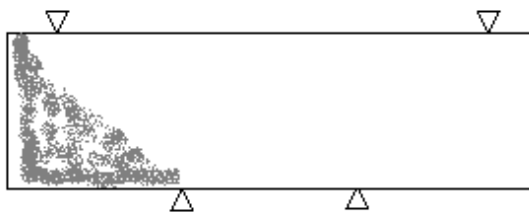
1 Layer, 2 layers, and 3 layers- Shear at 45°

Debond of shear laminate, and failure of the concrete in shear. No signs of stress at ends of beam.

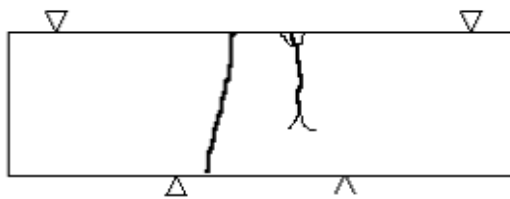
1 LAYER REINFORCED FOR FLEXURE AND SHEAR AT 90 DEGREES

Flexural cracking is observed followed by flexural failure in middle third of beam. Flexural laminate fractures across tensile face of the beam.

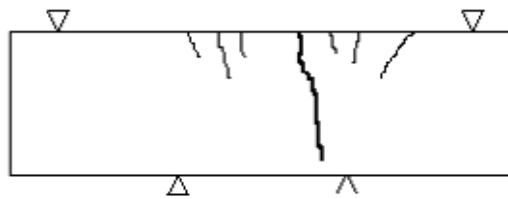
2 LAYERS REINFORCED FOR FLEXURE AND SHEAR AT 90 DEGREES

Some shear cracking occurs followed by flexural failure in the middle third of the beam. Flexural laminate fractures across tensile face of the beam.

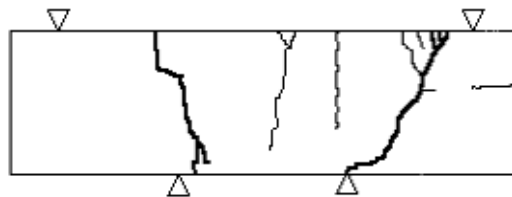
3 LAYERS REINFORCED FOR FLEXURE AND SHEAR AT 90 DEGREES

Beam exhibits substantial shear and flexural cracking. Beam fails in combined flexure and shear. Flexural laminate fractures across tensile face outside the middle third of the beam.

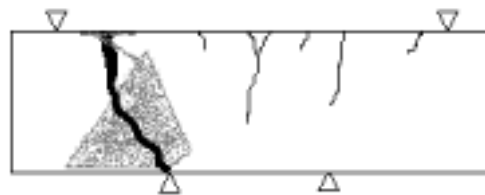
1 LAYER REINFORCED FOR FLEXURE AND SHEAR AT 45 DEGREES

Flexural and shear cracking is observed. Beam fails in a combined flexural/shear mode. Some of the shear laminate is fractured while the majority debonds. Flexural laminate fractures outside the middle third of the beam.

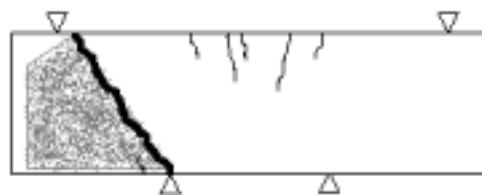
2 LAYERS REINFORCED FOR FLEXURE AND SHEAR AT 45 DEGREES

Flexural cracks form but beam fails in shear followed by debonding of the shear laminate. Flexural laminate fails near the support.

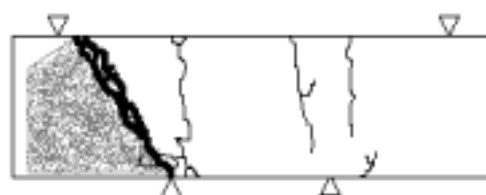
3 LAYERS REINFORCED FOR FLEXURE AND SHEAR AT 45 DEGREES

Flexural cracking is observed but ultimate failure is in shear. Shear laminate debonds followed by fracture of flexural laminate near the support.

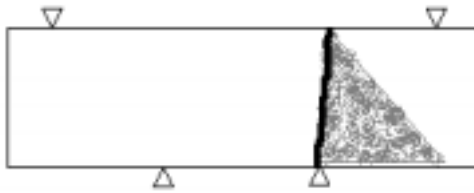
1 LAYER REINFORCED FOR SHEAR AT 45 DEGREES*

Flexural cracking in the middle third of the beam is not observed. Shear laminate debonds while the flexural laminate fractures across the tensile face just outside the middle third of the beam.

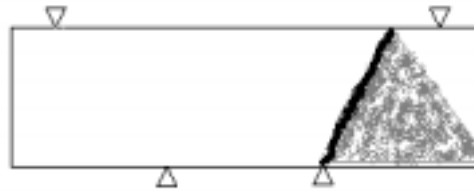
2 LAYERS REINFORCED FOR SHEAR AT 45 DEGREES*

Flexural cracking in the middle third of the beam is not observed. Major cracks are angled toward the support but fall intermediate to a pure flexural or shear crack. Shear laminate debonds while the flexural laminate fractures between the load point and the support.

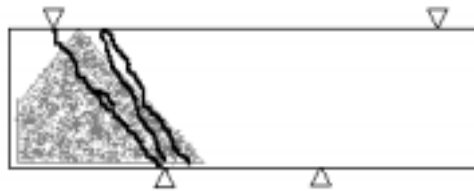
3 LAYERS REINFORCED FOR SHEAR AT 45 DEGREES*

Shear cracking occurs along with some cracking that is skewed vertically. Shear laminate debonds while the flexural laminate fails near the support.
