OREGON STATE HISTORIC PRESERVATION OFFICE
SPECIAL ASSESSMENT OF HISTORIC PROPERTY PROGRAM
Application Form/Affidavit and Preservation/Renovation Plan

EXAMPLE OF APPLICATION FOR RESIDENTIAL PROPERTY

Historic Name of Property: Charles and Twila Samson House

Preservation/Renovation Plan

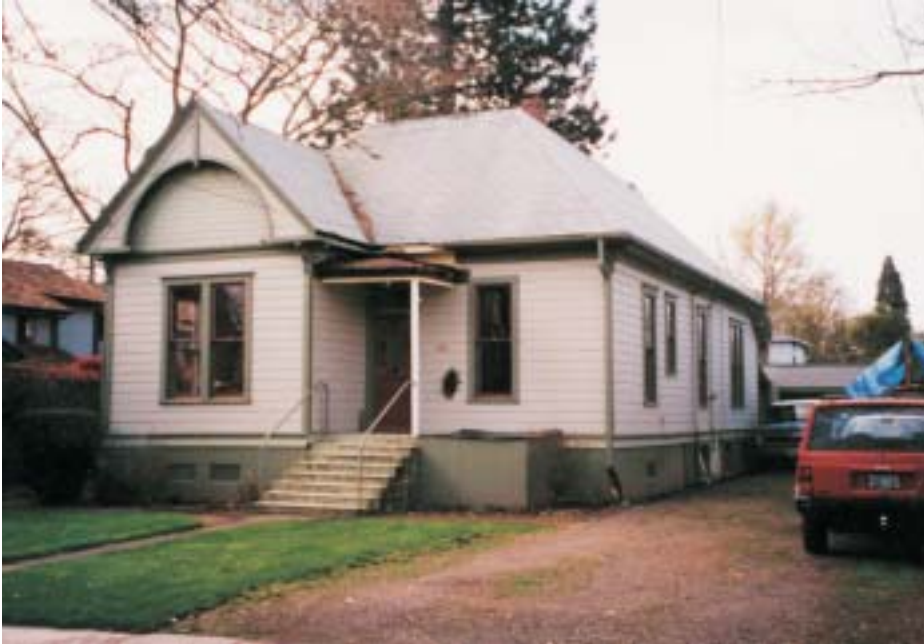
Charles and Twilla Samson House
1590 Broad St NW
Broad Street Historic District
Anywhere, What'sis County OR 97000
Photo 1 of 7
North (front) and West Elevations

Describe existing feature and its condition: The existing porch is not the historic one, but replaced a second porch in 1974. The existing porch falls outside the period of significance of the historic district, 1879 - 1940, and is jarringly out of character with this Queen Anne style house. The porch is of wood frame construction, except for the steps and stoop, which are poured-in-place concrete. The porch roof leaks badly and the concrete steps have tilted significantly. The only railing is a 2" galvanized pipe about 30" above the porch floor.		
Photo no.: <u>1</u>		Drawing no.: <u>N and W Elevations</u>

1	Architectural feature: <u>Front Porch</u> Approximate date of feature: <u>1890 c1950</u>	Describe work and impact on existing feature: Although I have not been able to find any historic photographs of the house, there is good evidence, in the form of Sanborn Insurance maps (1890-1935), paint shadows, nail holes, and impressions in the concrete walkway to show the general configuration of the porch. It was a flat-roofed, two-bay structure with sawn face brackets on turned columns supporting perimeter beams. There was a short soffit, about 9" deep, and the two exposed sides of the roof were finished in shingles at a 12/12 pitch. The steps were wide, taking up almost half the width of the porch (one bay). I propose to remove the concrete stoop and restore the porch as revealed by this physical and documentary evidence. There are also several extant porches of this general type in the neighborhood, from which I am taking cues about those aspects I have been unable to document.

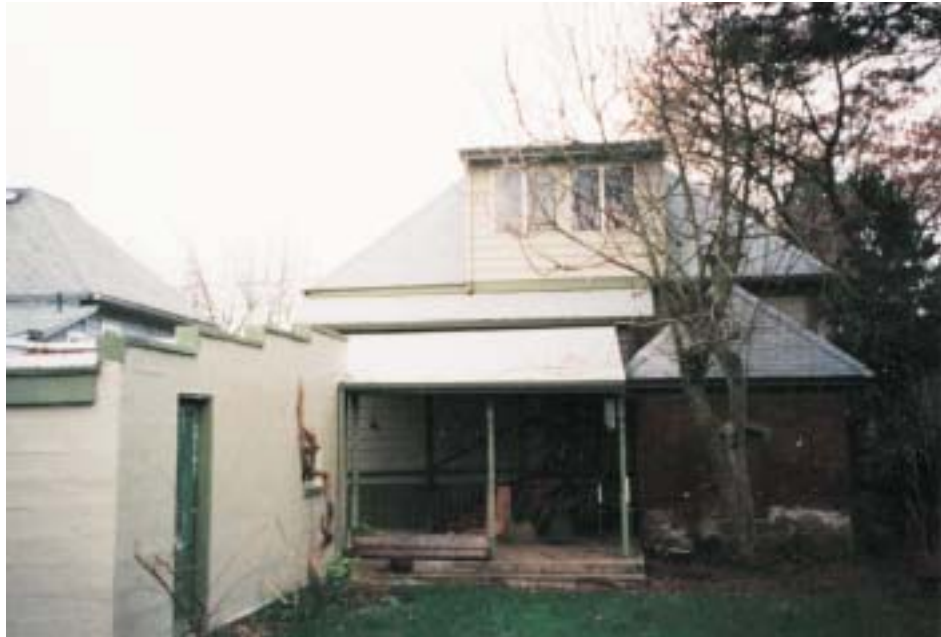
Charles and Twilla Samion House
1590 Broad St NW
Broad Street Historic District
Anywhere, Whatis County, OR 97000
Photo 2 of 7
South (rear) Elevation

6	Architectural feature: <u>Cooler House</u> Approximate date of feature: <u>1895</u>	Describe work and impact on existing feature: I plan to rehabilitate the cooling house into a garden shed during the second five years of the benefit. I will consult with the SHPO in this process.
Describe existing feature and its condition: On the earliest Sanborn maps, 1890-1918, this small one story brick structure is shown as detached from the house. On the 1923 and subsequent maps its footprint becomes part of the house because of an addition. The structure was at first thought to be a smokehouse, but further investigation revealed that it was a cooling house. It has one original opening, a boarded up window on the south side, an internal door opening to the house, and an aluminum window cut into the east side in 1974. The brick is in good to fair condition, the mortar is in fair to poor condition, and the roof is in good to fair condition.

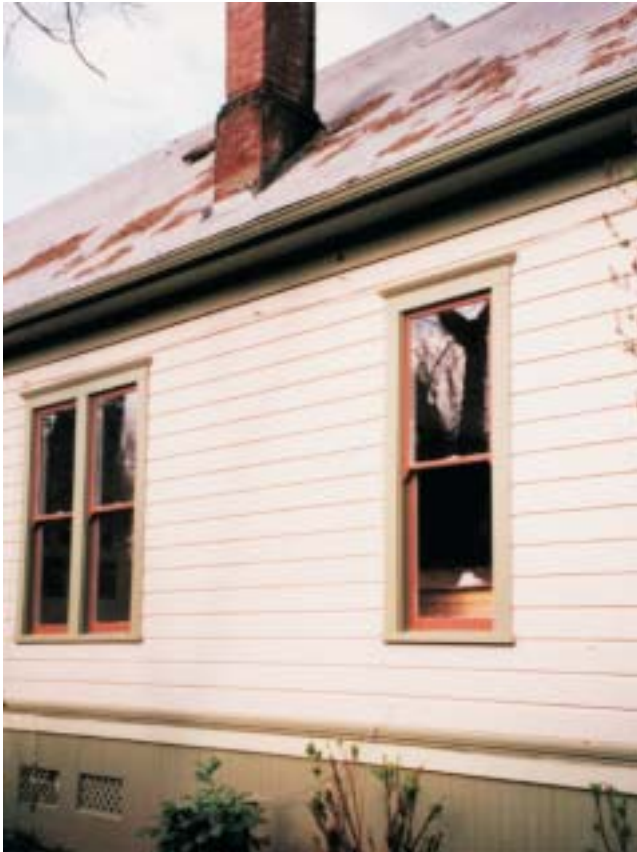
Charles and Twila Samson House
1590 Broad St NW
Broad Street Historic District
Anywhere, What's County, OR 97000
Photo 3 of 7
East Elevation (partial)

3	Architectural feature: <u>Fireplace and Stove Flue</u> Approximate date of feature: <u>1890</u>	Describe work and impact on existing feature: I propose to restore the fireplace and hearth, and perhaps the stove flue, in consultation with the SHPO, during the second five years of the benefit. For the time being I would like to install a flexible metal liner in the remaining chimney flue to serve a freestanding gas burning stove that looks like a traditional woodstove. This unit will be installed on the hearth, which I have stabilized with temporary shoring in the crawlspace.
Describe existing feature and its condition: As originally configured there was a stove to heat the parlor and a fireplace in the dining room, both served by the same chimney and occupying spaces on either side of the wall common to these rooms. The flue opening for the parlor stove is still in the wall, but has been bricked up and papered over. The mantelpiece and firebox of the fireplace, which faced diagonally into the dining room from a corner, have been removed and the opening closed with framing and sheetrock. The configuration of the firebox is discernable in the surviving fireplace floor and the throat of the chimney. The cantilevered brick hearth is intact but failing, and it has been plastered over with an unknown and highly adhesive material to bring the surface level with the floor. Above the roof line the original chimney has been removed and replaced with a smaller single flue that rises only four feet above the roof surface.

Photo no.: <u>3, 7</u>		Drawing no.: <u>floor plan</u>
4	Architectural feature: <u>Windows</u> Approximate date of feature: <u>1890, c1920, 1974</u>	Describe work and impact on existing feature: All windows except the garden window in the kitchen and the aluminum sliders in the rear dormer will be fully rehabilitated. New wooden window screens and storm windows, based closely on a few surviving screens will be built and used in alternation to provide a measure of climate control. The garden window will be removed and two appropriate replacement windows will be installed to replicate the original configuration. See Item 5 for discussion of the dormer and its windows.
Describe existing feature and its condition: There are nine tall (2'-6" x 6'-0") and one short (2'-0" x 4'-6") original one-over-one, double-hung wooden windows on the front and sides of the house. Toward the rear, on both sides, where the house was expanded in c1920, there are four similar but not identical tall windows that appear to have been salvaged from another property. In the kitchen there is a large protruding "garden window" that replaced two short windows, like the one surviving from the extinct toilet room, in 1974. There are two 4'-0" x 4'-0" aluminum horizontal sliding windows in the dormer added to the attic in 1974, see Item 5. All the windows are in fair to poor condition, some painted or nailed shut, many with broken sash cords, some with cracked glass and failing glazing putty, etc.

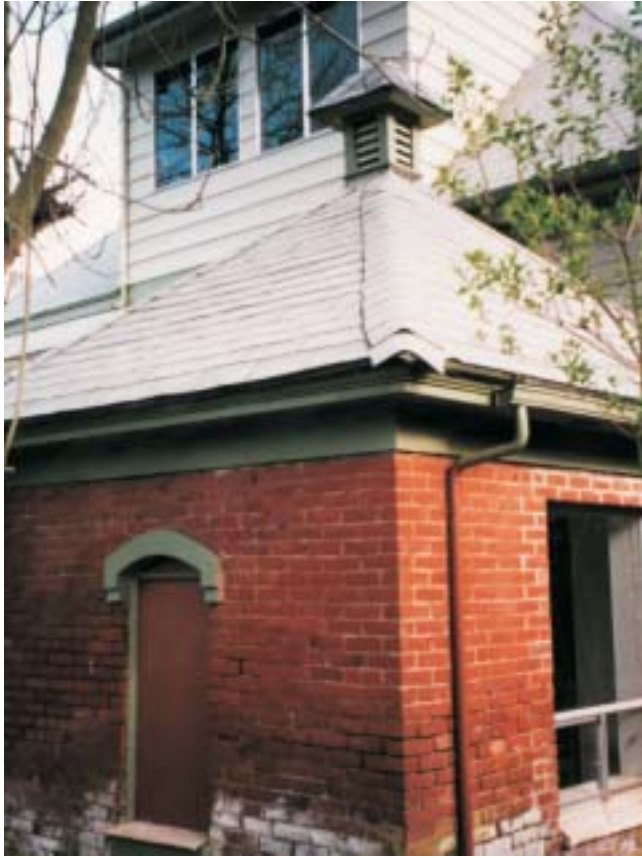
Charles and Twila Samson House
1590 Broad St NW
Broad Street Historic District
Anywhere, Whatis County, OR 97000
Photo 4 of 7
Cool House (foreground) Dormer (beyond)

5	Architectural feature: <u>Attic Dormer</u> Approximate date of feature: <u>1974</u>	Describe work and impact on existing feature: I will develop plans in consultation with the SHPO and the local building official for a more compatible dormer, and possibly for finishing the attic as living space. Because the existing dormer gives daylight to the attic, is on the rear of the house, and is in sound condition, I propose to leave these changes until the second five years of the benefit.
Describe existing feature and its condition: In 1974 the previous owners "bootlegged" a sizable shed-roofed dormer onto the rear slope of the roof in anticipation of finishing the large attic as living space. The local building inspector was informed of the work and ordered it stopped, but the project was never reversed or made code compliant. It is distinctly out of character with the house but well built.		
Photo no.: <u>3, 4</u>		Drawing no.: _____

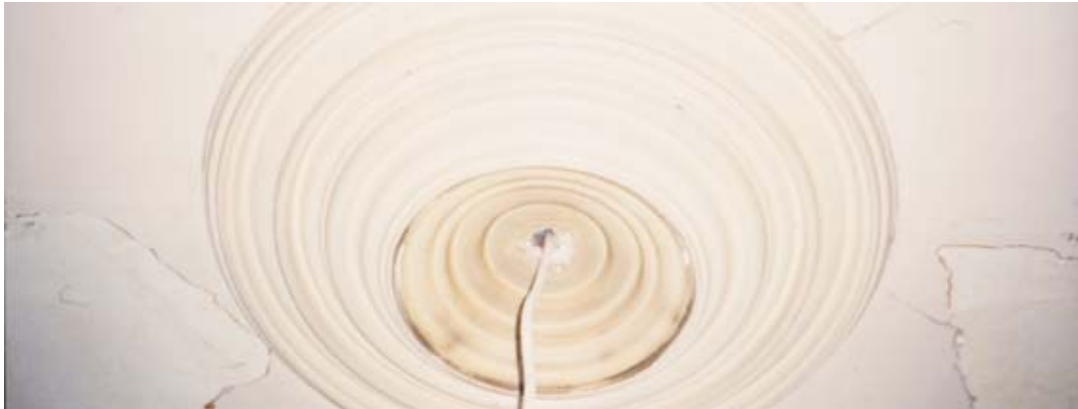
Charles and Twila Samson House
1590 Broad St NW
Broad Street Historic District
Anywhere, Whatsis County, OR 97000
Photo 5 of 7
Plaster Ceiling Medallion (living room)

Describe existing feature and its condition: This house was expanded by a sizable addition at the rear in about 1920, and the interior configuration was changed at that time. Further significant interior changes were undertaken in 1974 by the owners from whom I purchased the house, including the installation of lowered ceilings in all rooms at the height of the window heads, 8'-1". The parlor and dining room originally had pocket doors between them. This appears to have been followed by a widening of the opening and the addition of framing columns on raised pedestals. (Shadows of the capitals and the pedestals are faintly visible in the header and the flooring.) The pedestals and columns were removed in the "modernization" of 1974. One surviving door surround, from the inside of what was once a small toilet room, shows that the original trim system had bullseye corner blocks. These were replaced by cornice type heads in the c1920 remodeling which were in turn cut down in the 1974 lowering of the ceilings.

2	Architectural feature: <u>Parlor/Dining Room</u> Approximate date of feature: <u>1890 and c1920</u>	Describe work and impact on existing feature: I propose to restore the earliest configuration of these two most public rooms as accurately as possible. I have already removed the dropped ceiling, revealing a circular plaster medallion in the middle of the room, the center of which matches a late nineteenth century lighting fixture found in the attic. There are also some remnants of many layers of wallpaper. The built-in truss that supported the pocket doors is in place in the wall, as are some broken pieces of the track system. There is good physical evidence in the floor, paint shadows and patched door guide mounting holes, to guide the restoration. The doors are gone. I plan to have new, compatible doors made, and will install new hardware to carry and close them. Appropriate finishes and flooring for both rooms will be determined in consultation with the Historic Preservation Office. See item 3 for discussion of the fireplace and stove flue.
