## U.S. Bureau of Reclamation Underwater Investigation of Conduits and Inaccessible Features

Ryan Hedrick

PN Regional Diving Officer

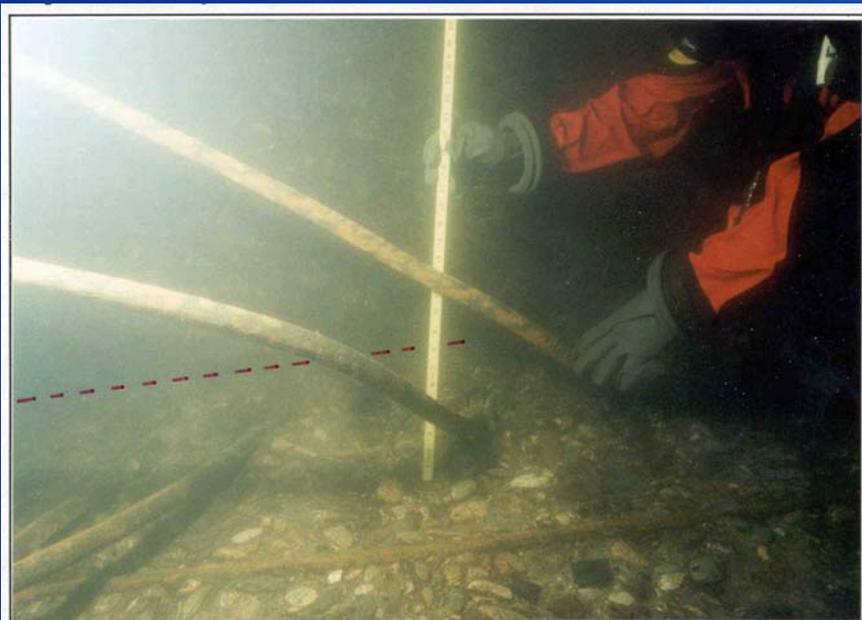
**Photograph No. 40.** Wall anchoring rebar is eroded out and bent downstream. The dashed line is the original wall/floor contact at spillway stilling basin (left side) at approximately Station 2+45. Note roundness of the originally square rebar and the lack of rust. PN Regional Underwater Inspection Team - Canyon Ferry Dam Spillway Stilling Basin, Canyon Ferry Unit, Pick-Sloan Missouri Basin Program, Montana, April 1999.

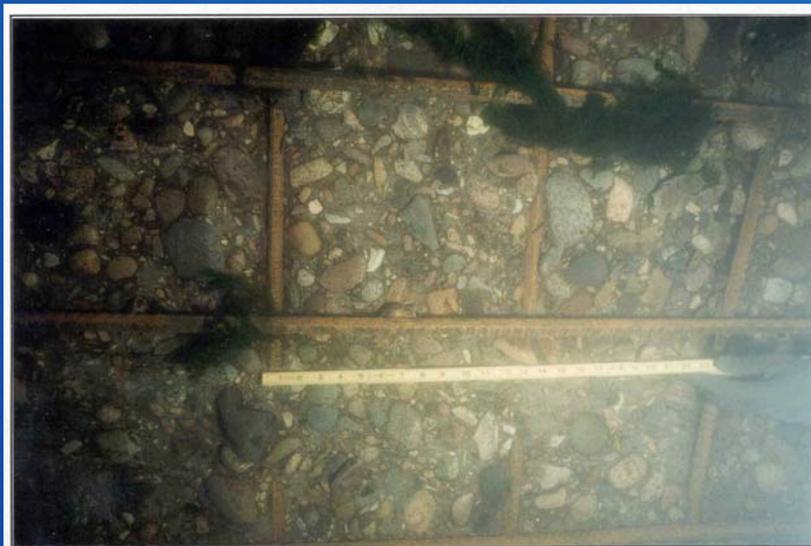
**Photograph No. 34.** Exposed rebar mat at spillway stilling basin (left side) at approximately Station 2+50. PN Regional Underwater Inspection Team - Canyon Ferry Dam Spillway Stilling Basin, Canyon Ferry Unit, Pick-Sloan Missouri Basin Program, Montana, April 1999.

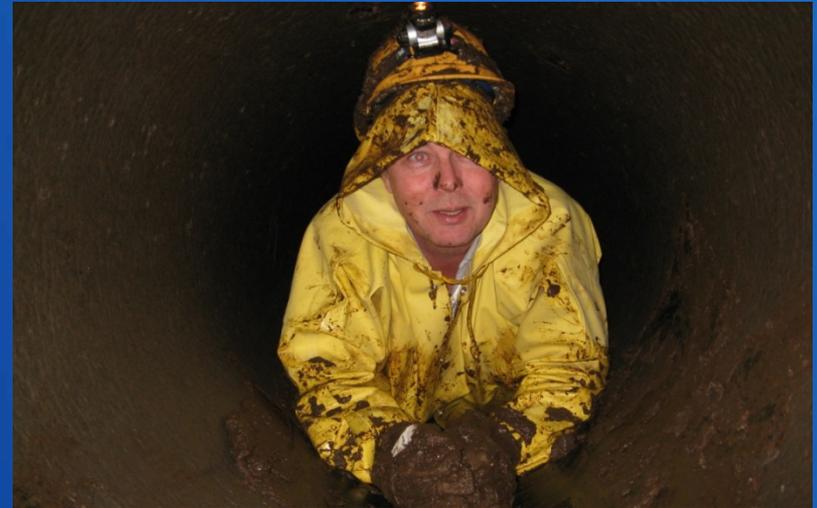
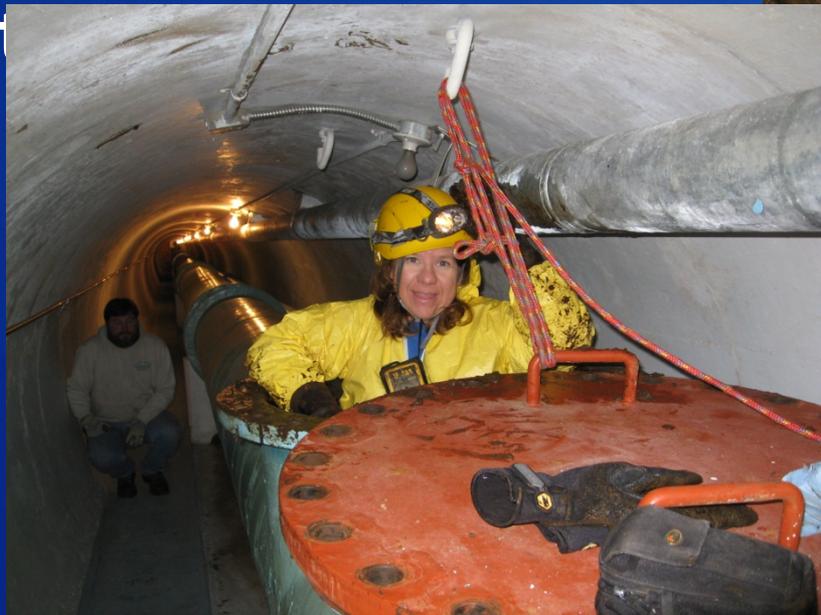
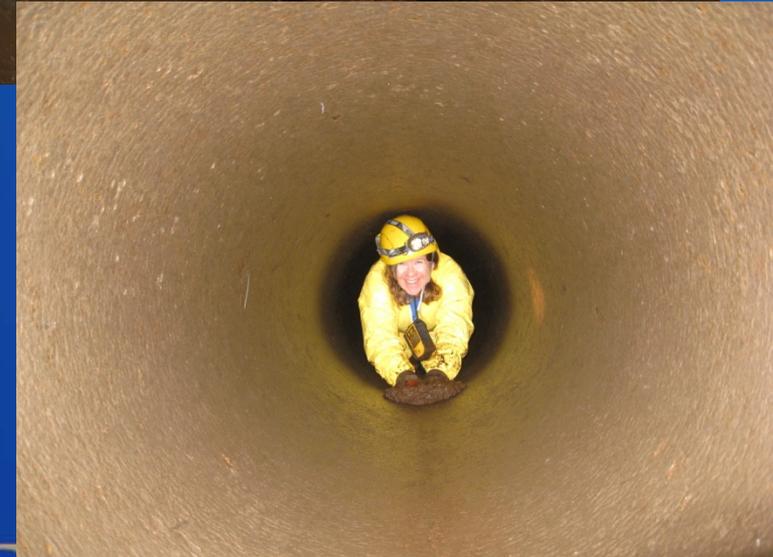
# Inspection of Conduit interior Agate Dam

Inspection of 27”  
conduit interior

Difficult to see rust  
nodules due to silt in  
conduit

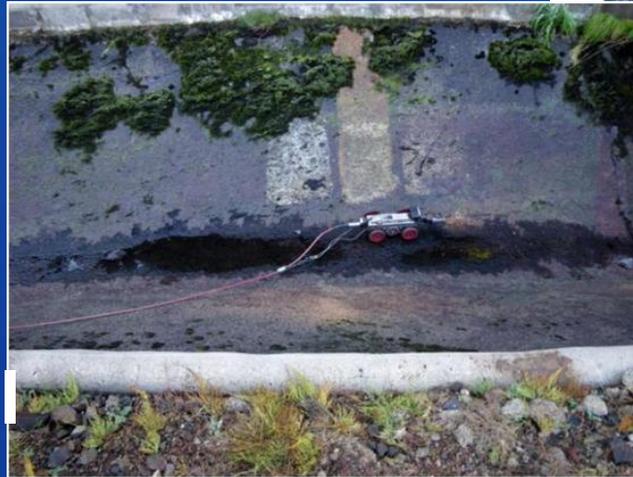
# Inspection of outlet works Howard Prairie Dam

Inspection of 30”  
pipe interior  
performed by ROV  
Fin in the pipe  
prevented  
acceptable retrieval  
method for person  
in conduit

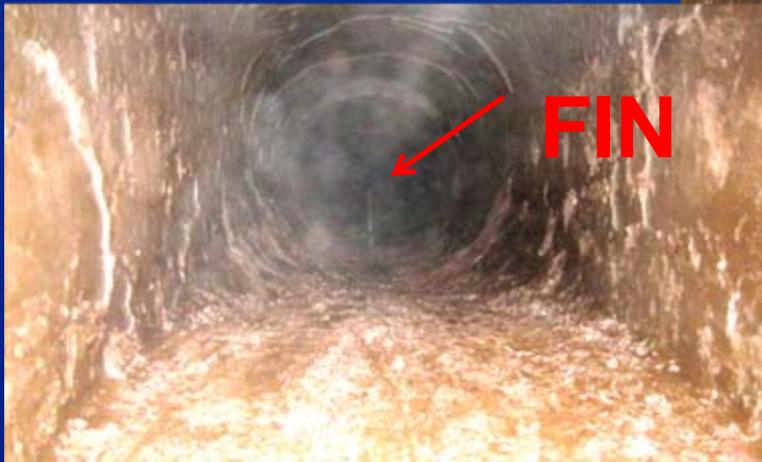
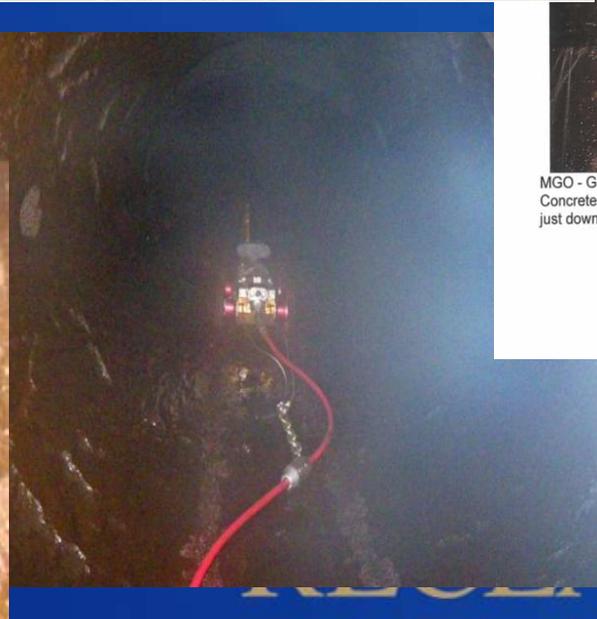
General Observation @ 168.6 ft.  
looking downstream

MGO - General Observation @ 169.5 ft.  
downstream face of emergency gate

MGO - General Observation @ 169.5 ft.  
Concrete conduit ceiling in gate chamber  
just downstream of emergency gate
