Dieback and mortality of ponderosa pine along Highway 20 associated with herbicide applications near Sisters, Oregon –

Spring 2018 Update

Brent Oblinger

Plant Pathologist, USDA Forest Service, Forest Health Protection, Central OR Forest Insect & Disease Service Area

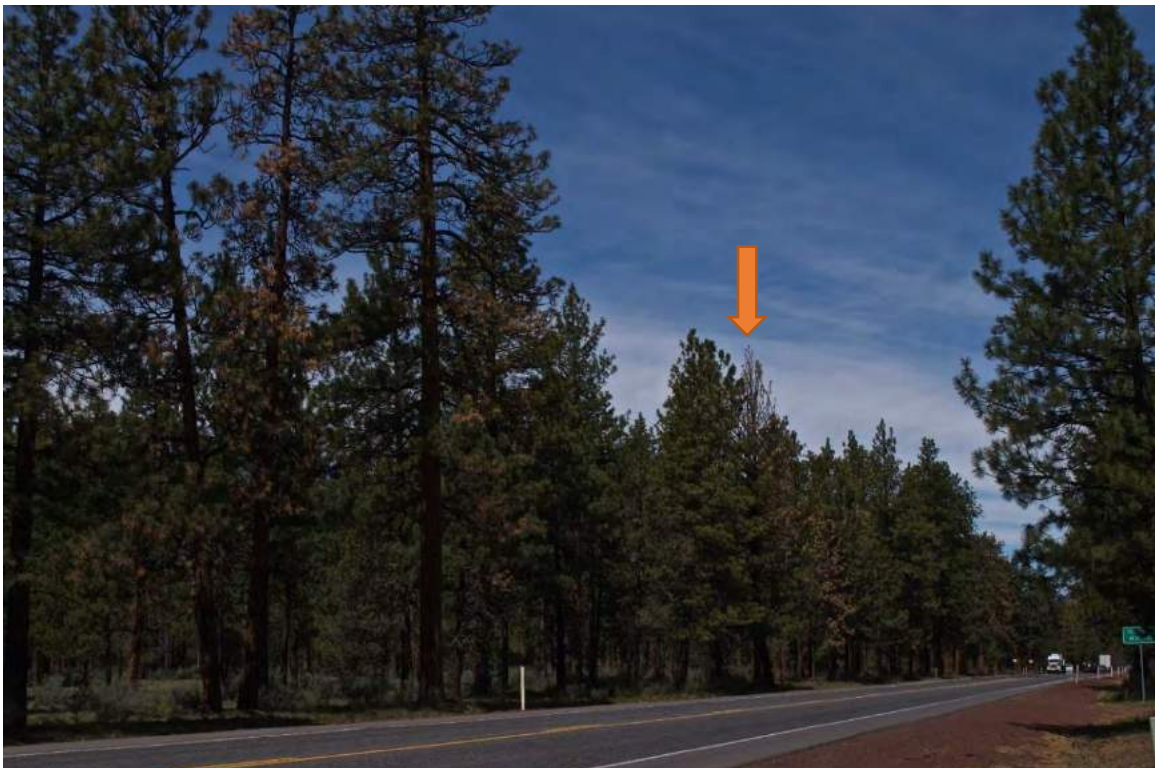
Figure 1a. Crown dieback and mortality in ponderosa pine along Highway 20 - taken southeast of the intersection between Highway 20 and the Tollgate Rd on April 28, 2015 (Oregon Department of Agriculture). Arrow for reference in Figure 1b.

The mature, live tree in 2015 on the left-hand side of Figures 1a-b (left of the roadside reflector) is now dead in 2018 (left of roadside reflector) in Figures 2a-b, along with others that were still living in 2015 in these figures.

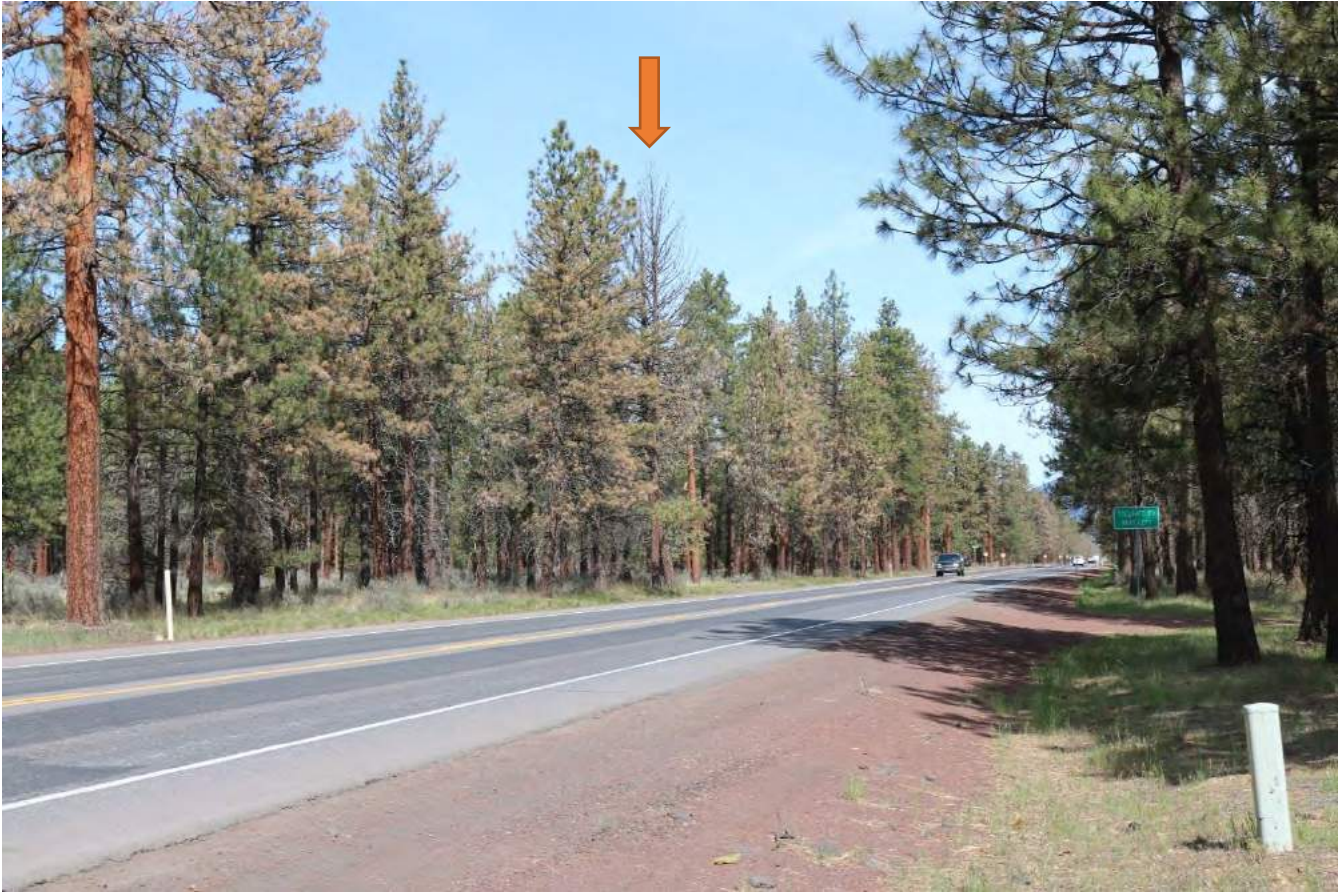
Figure 1b. Increased damage in ponderosa pine along Highway 20 three years later– taken at the same location as the photo in Figure 1a on May 3, 2018. Arrow for reference in Figure 1a.

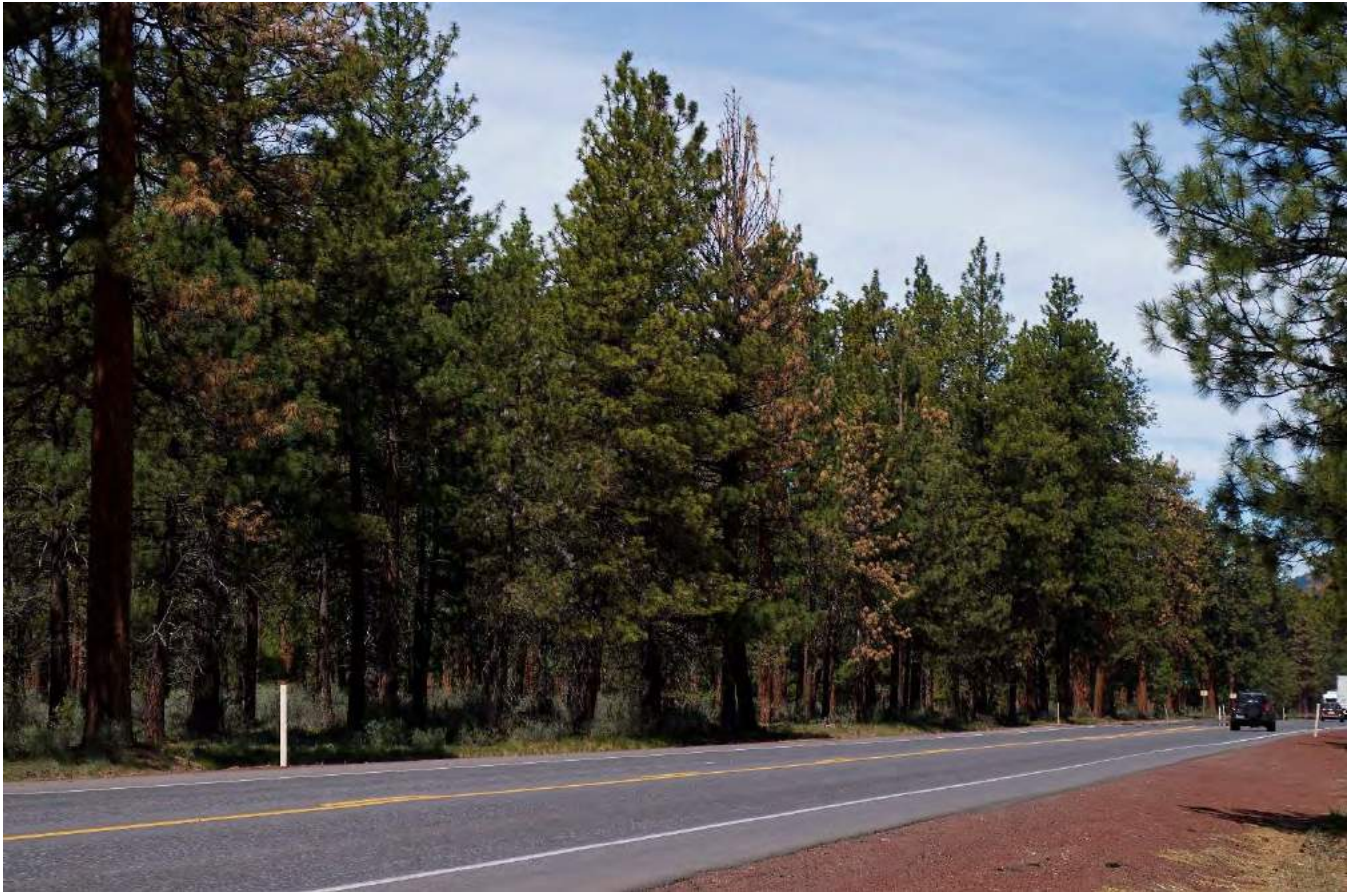
Figure 2a. Crown dieback and mortality in ponderosa pine along Highway 20 - taken near the same photos in Figures 1a-b on April 28, 2015 (photo: Oregon Department of Agriculture).

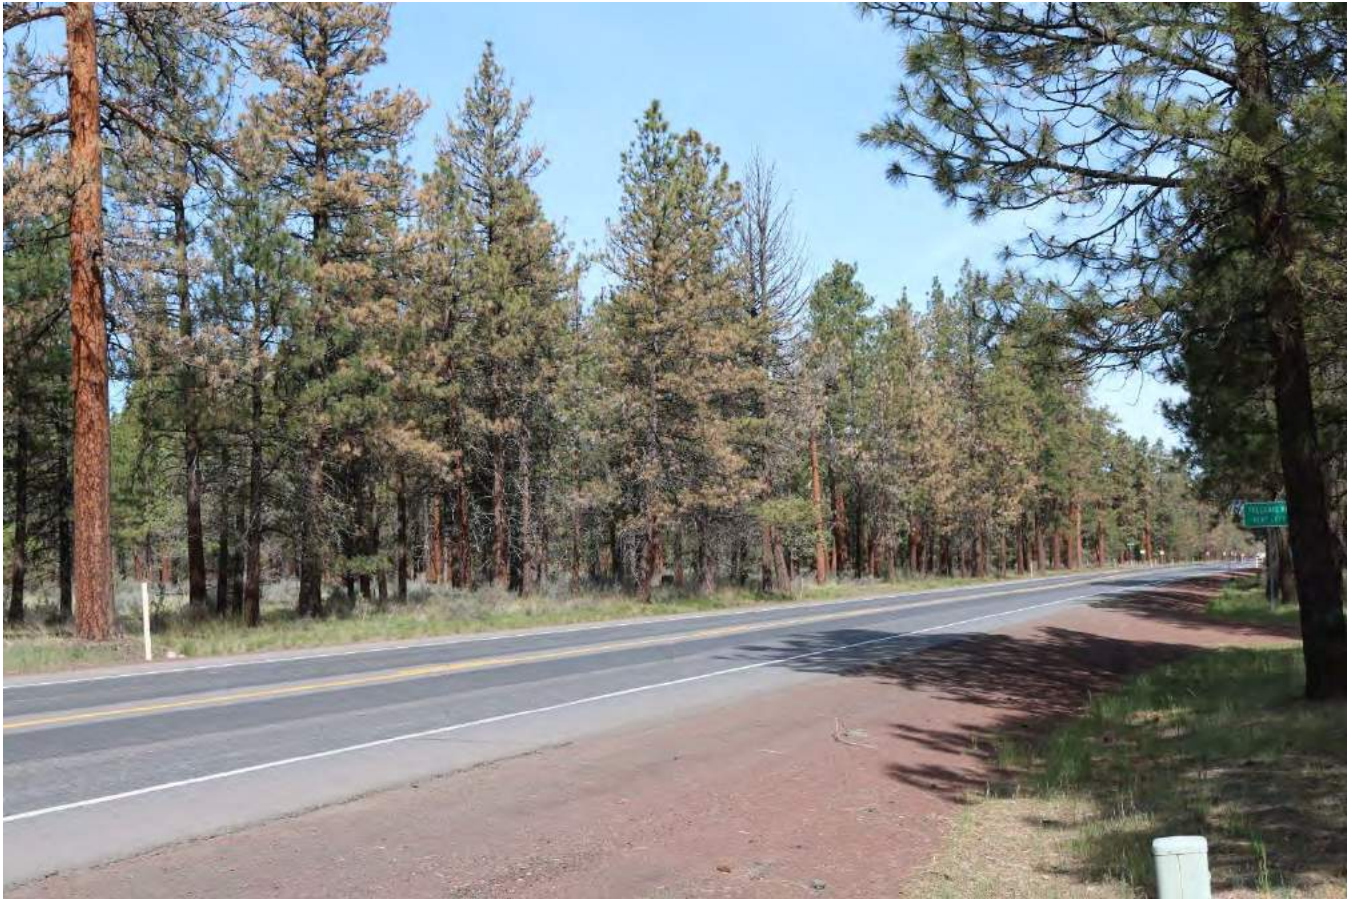
Figure 2b. Increased damage in ponderosa pine along Highway 20 three years later– taken at the same location as the photo in Figure 2a on May 3, 2018. These photos were taken near those shown in Figures 1a-b.

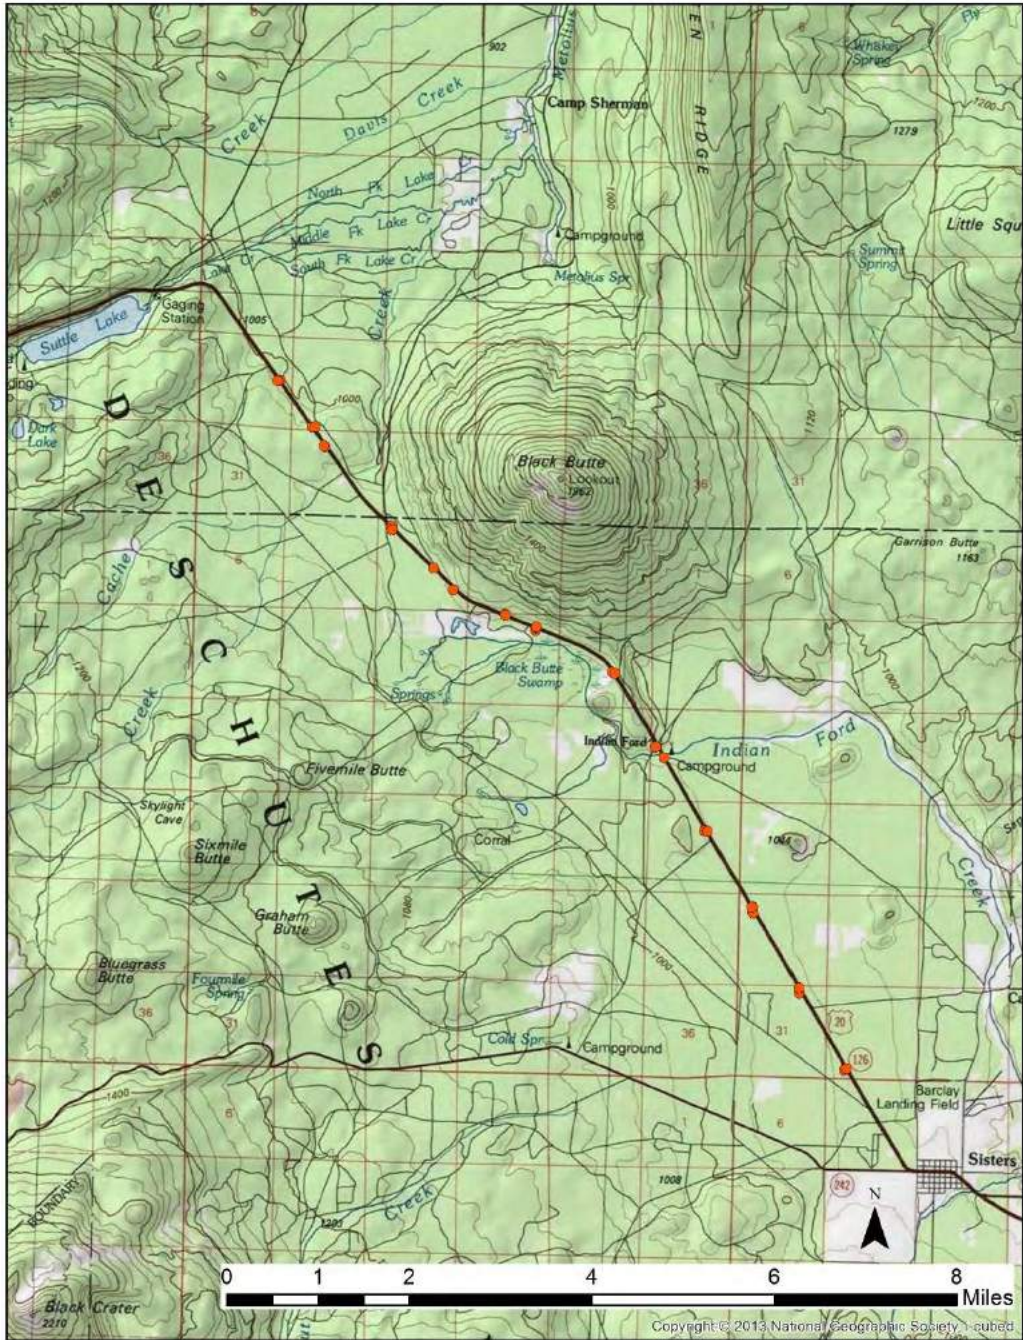
Figure 4. Locations (orange points) of trees sampled on May 3-4, 2018 to examine branches for the presence of symptoms of herbicide injury in live ponderosa pine along Highway 20.

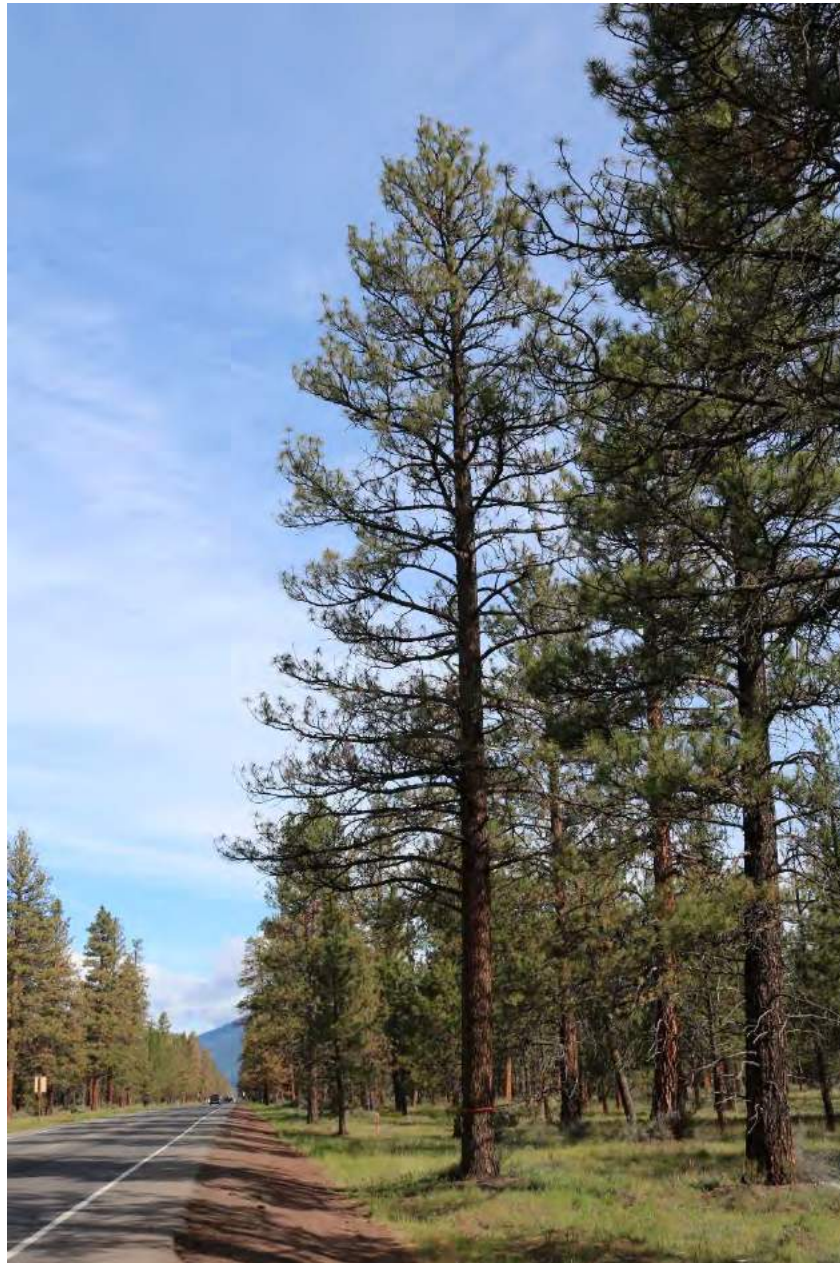
Figure 5. Live ponderosa pine (E99S in Appendices A-B) with crown symptoms associated with herbicide injury (abnormal swellings in stems of shoots, killed shoots, chlorosis) along the eastside of Highway 20 flagged in orange from which a symptomatic branch sample was collected.

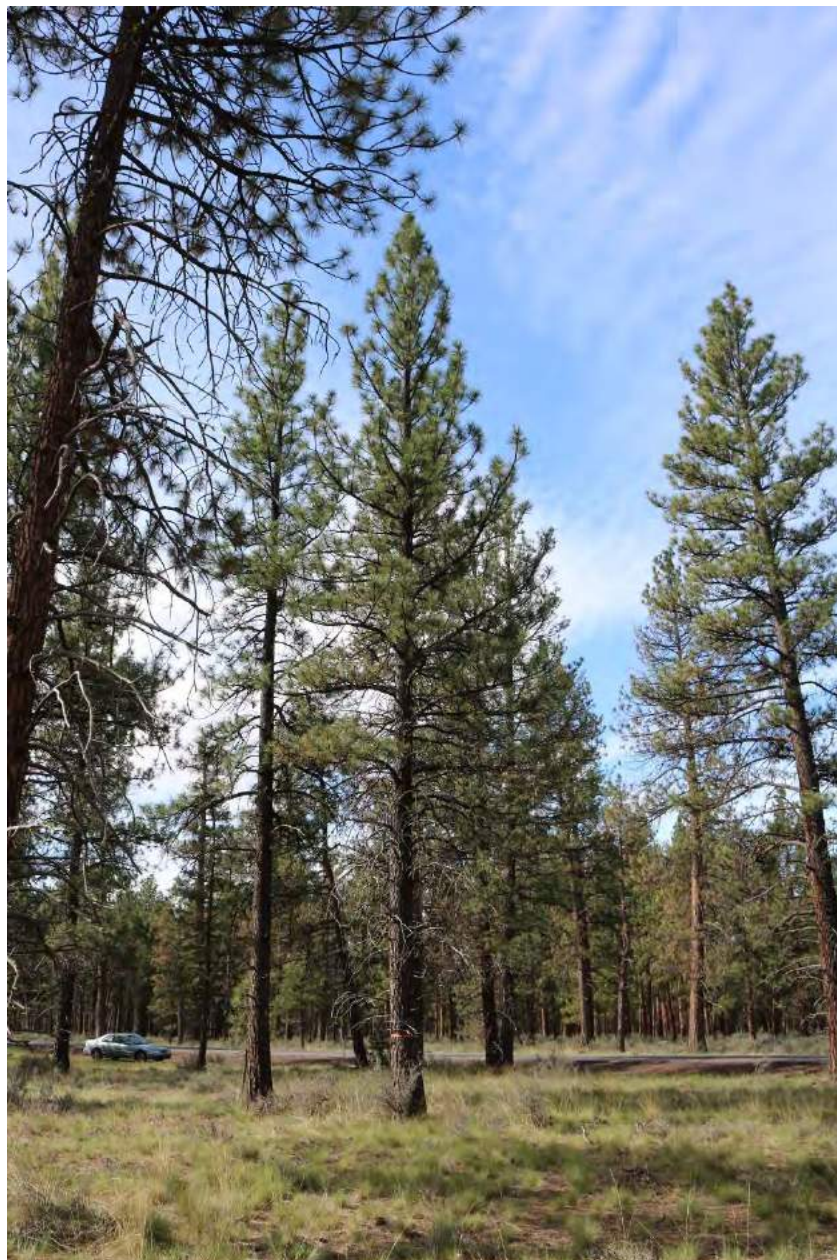
Figure 7. Live ponderosa pine (E99A in Appendix A) without crown symptoms along the eastside of Highway 20 flagged in orange from which an asymptomatic branch sample was collected.

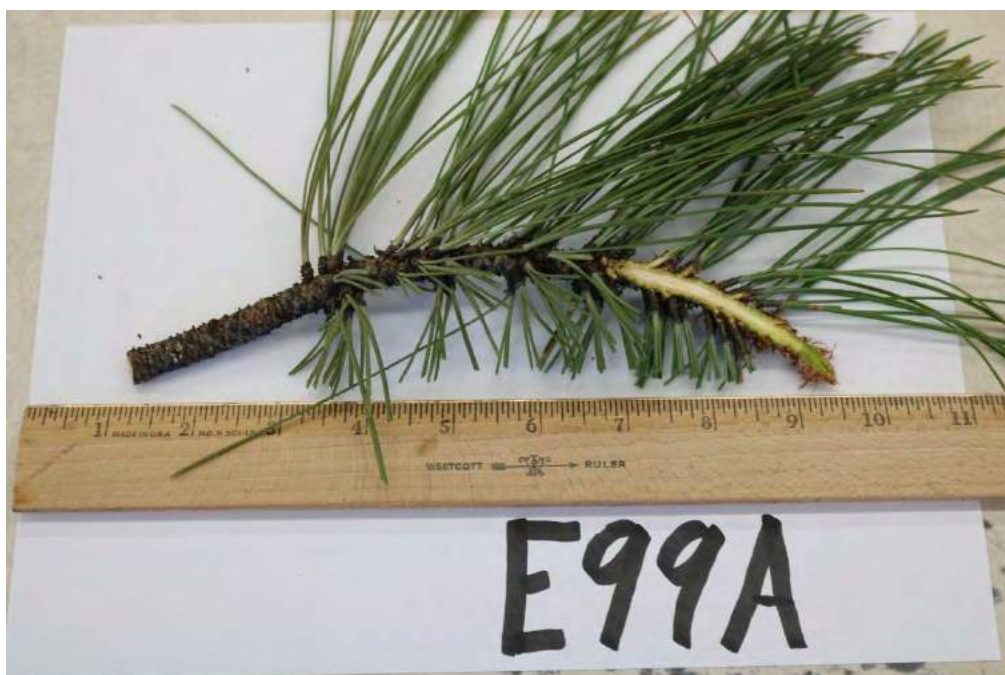
Figure 8b. Dissected branch showing healthy-appearing shoot and healthy-appearing meristematic tissue on the right without symptoms of herbicide injury from the same shown in Figure 8b.
