I-5: BRIDGE OVER NE HASSALO STREET AND NE HOLLADAY STREET

MULTNOMAH COUNTY

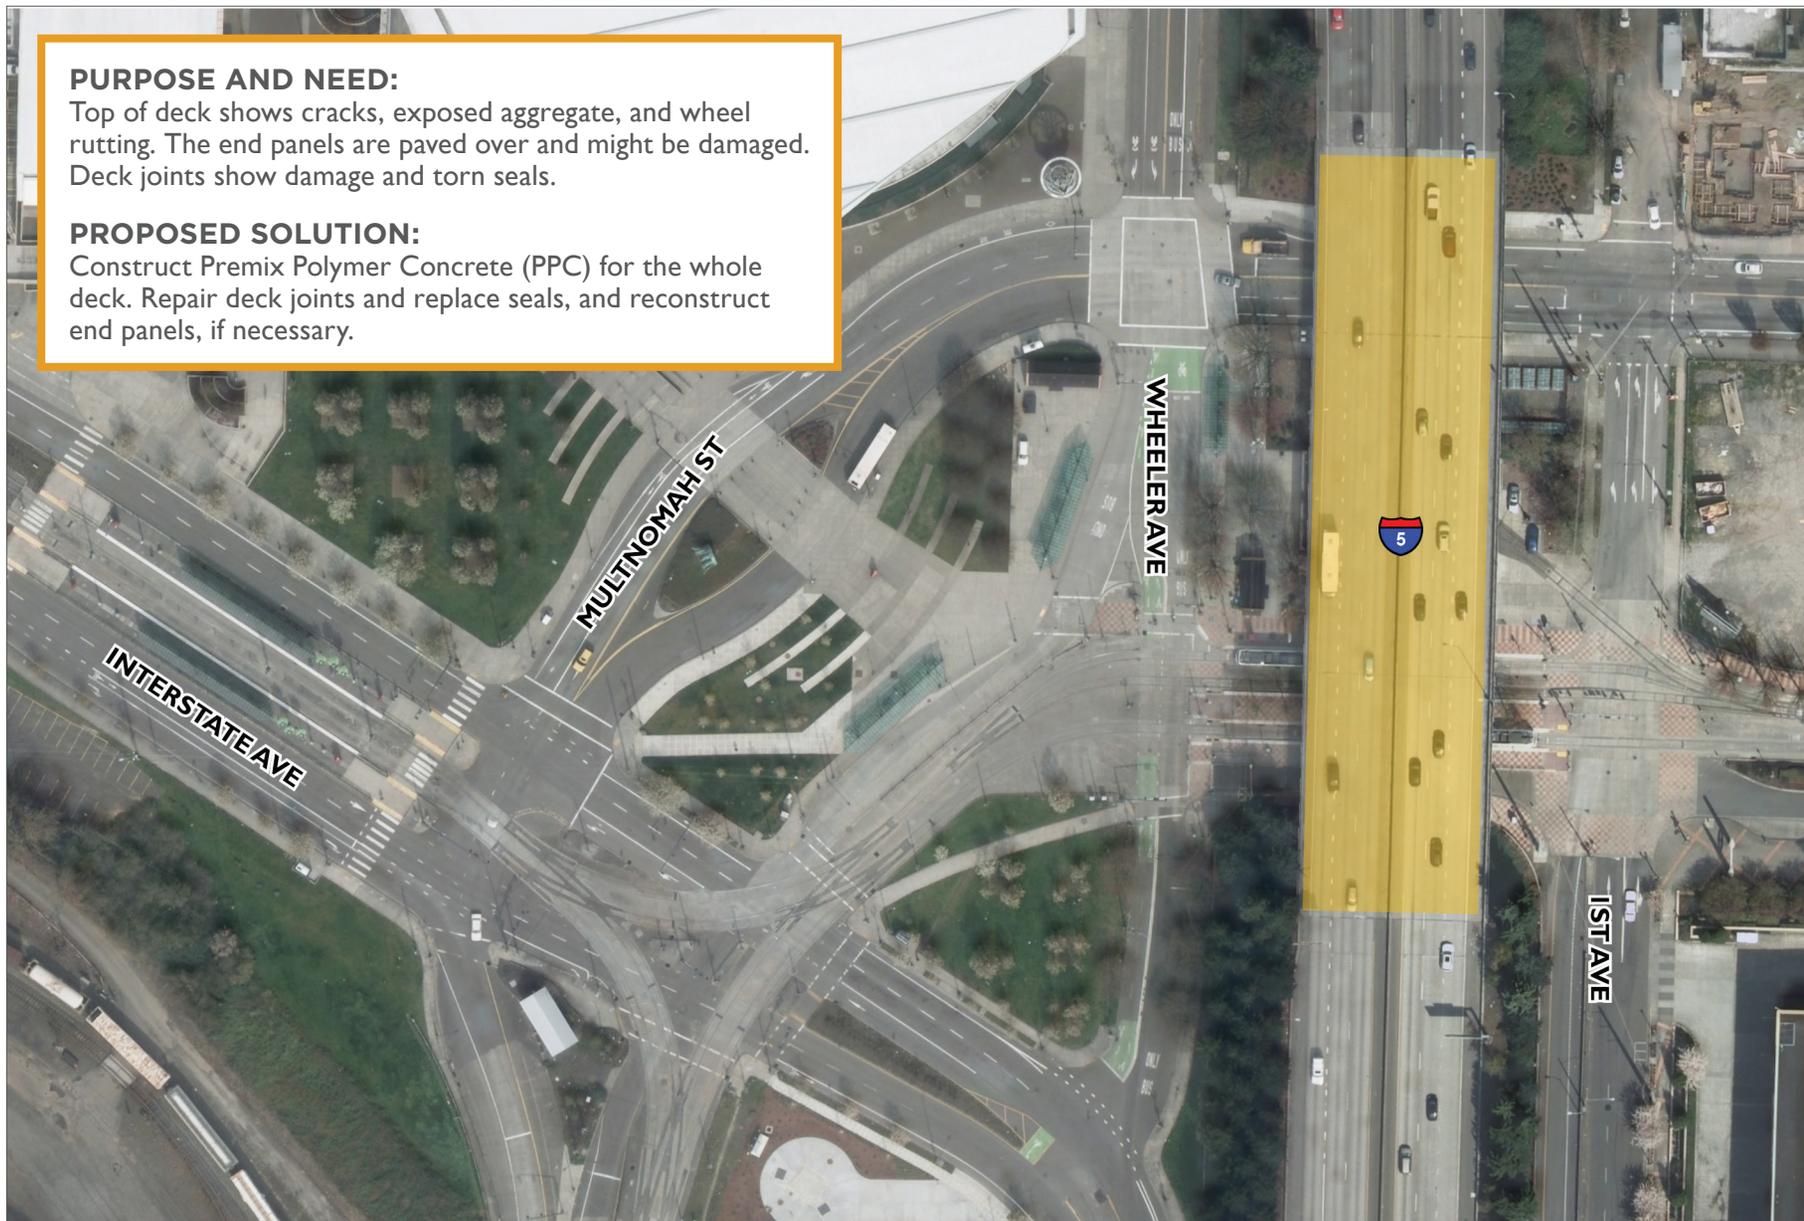
Top of deck shows cracks, exposed aggregate, and wheel rutting. The end panels are paved over and might be damaged. Deck joints show damage and torn seals.

Construct Premix Polymer Concrete (PPC) for the whole deck. Repair deck joints and replace seals, and reconstruct end panels, if necessary.

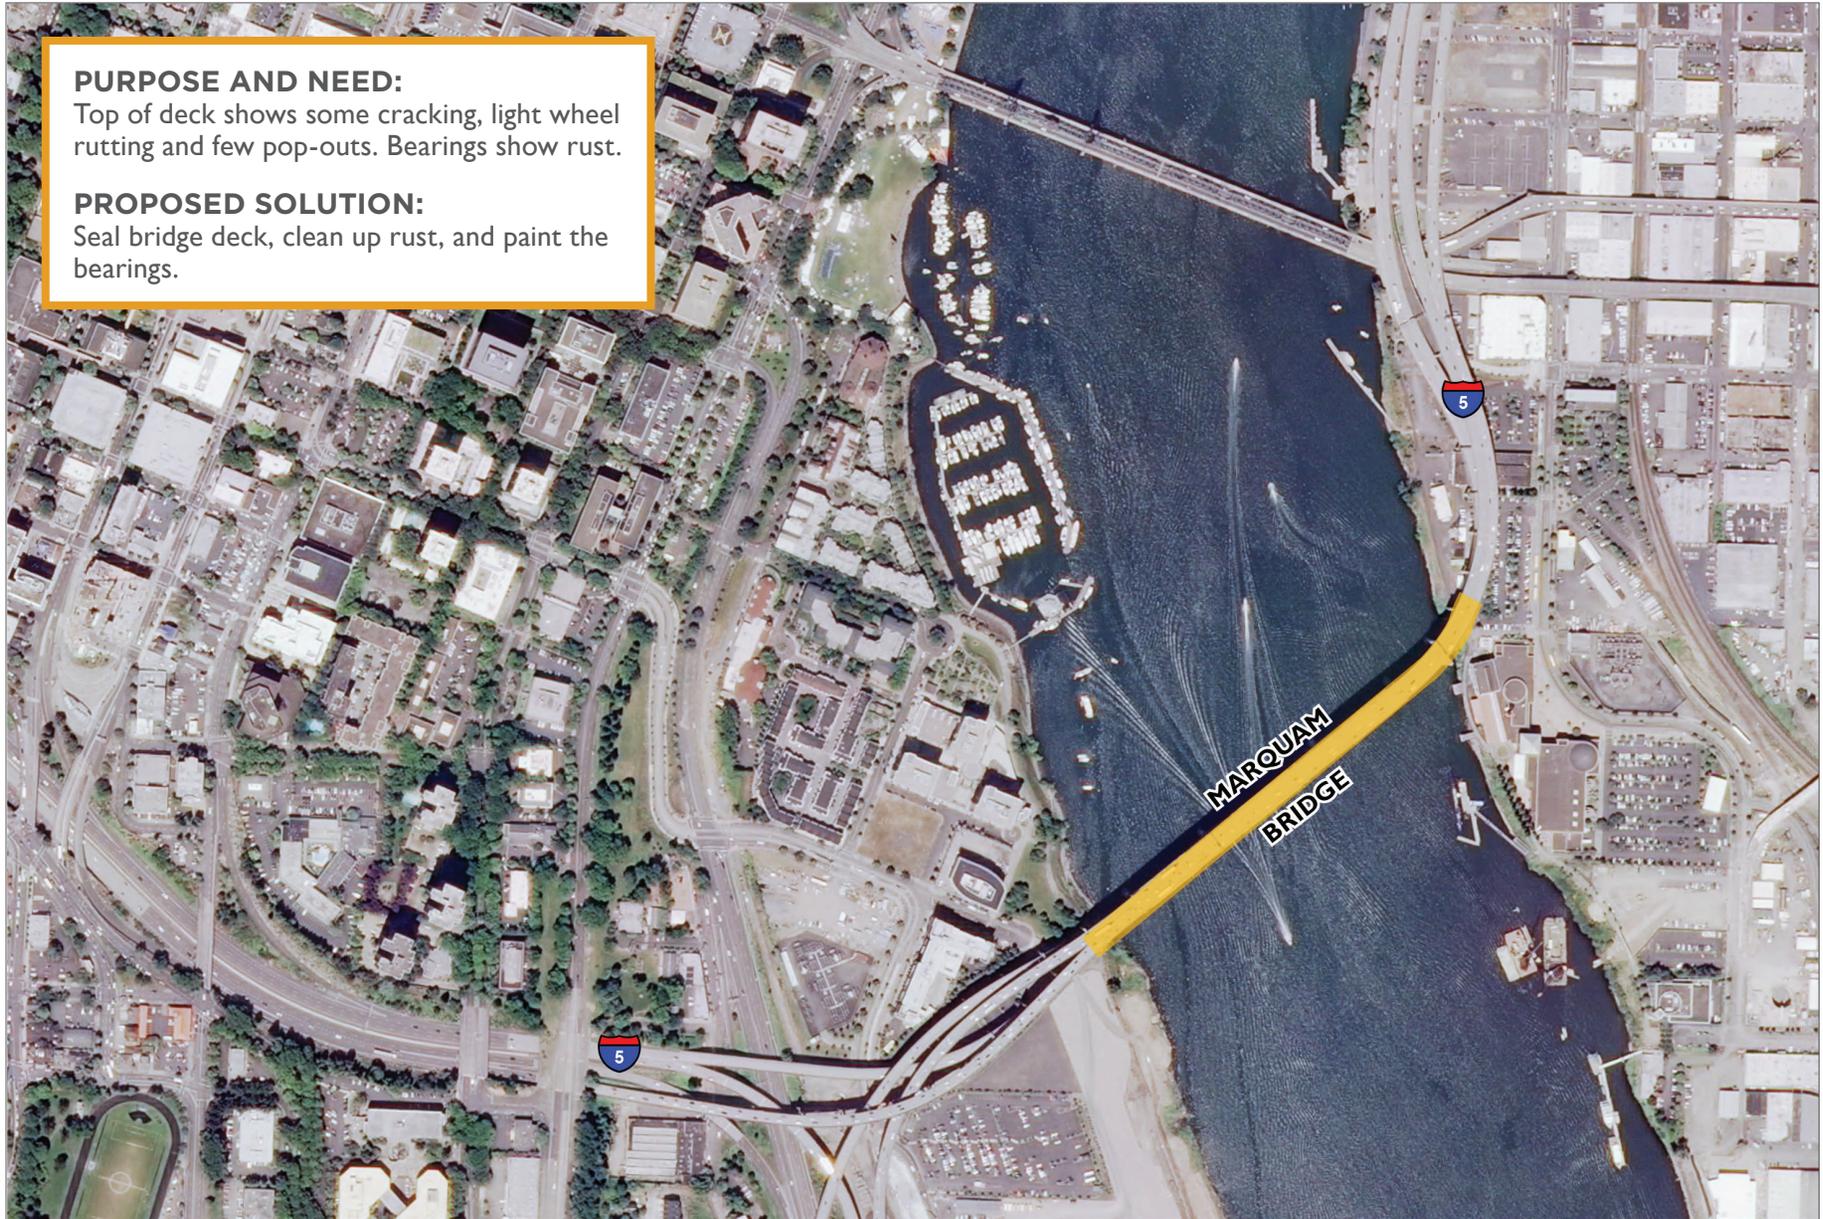
I-5: MARQUAM BRIDGE

Top of deck shows some cracking, light wheel rutting and few pop-outs. Bearings show rust.

Seal bridge deck, clean up rust, and paint the bearings.

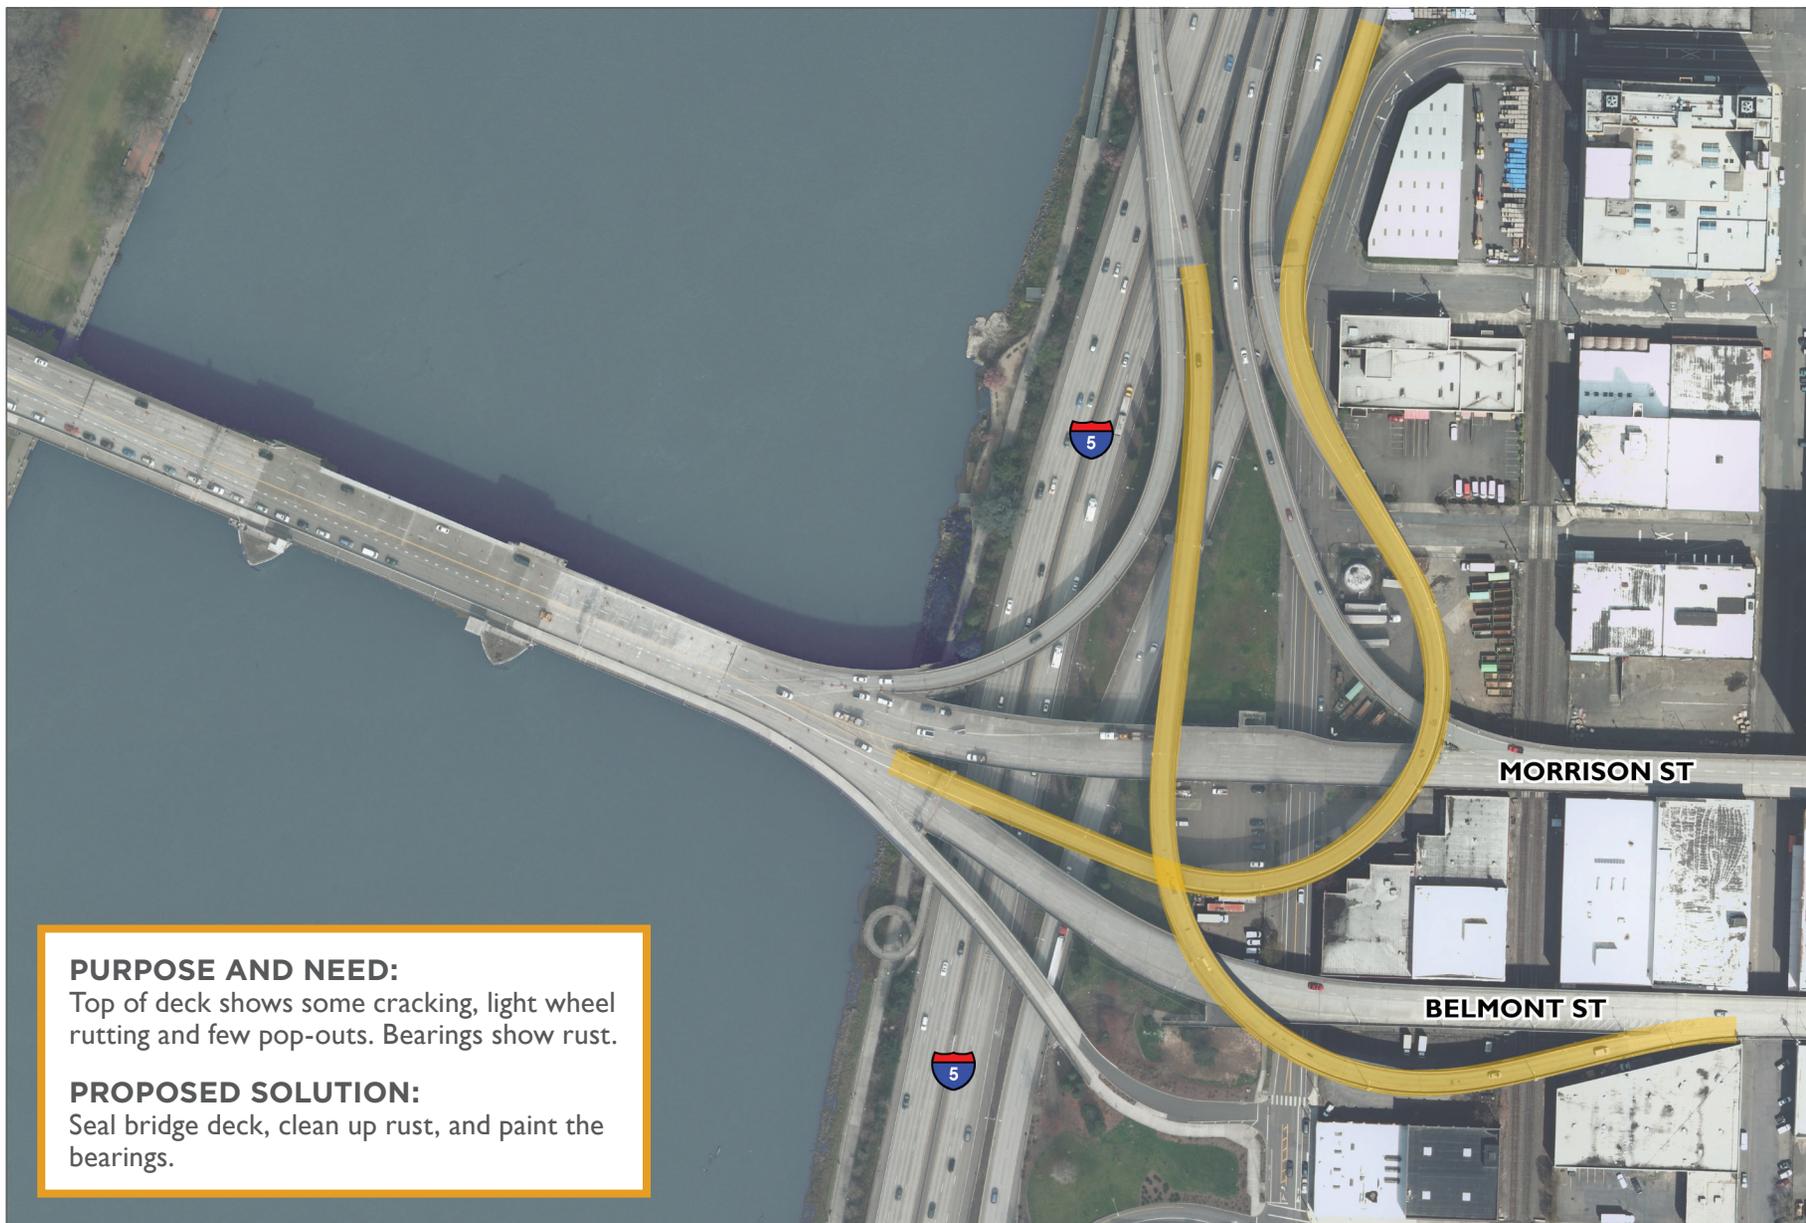
I-5: MORRISON INTERCHANGE RAMP BRIDGES

Top of deck shows some cracking, light wheel rutting and few pop-outs. Bearings show rust.

Seal bridge deck, clean up rust, and paint the bearings.

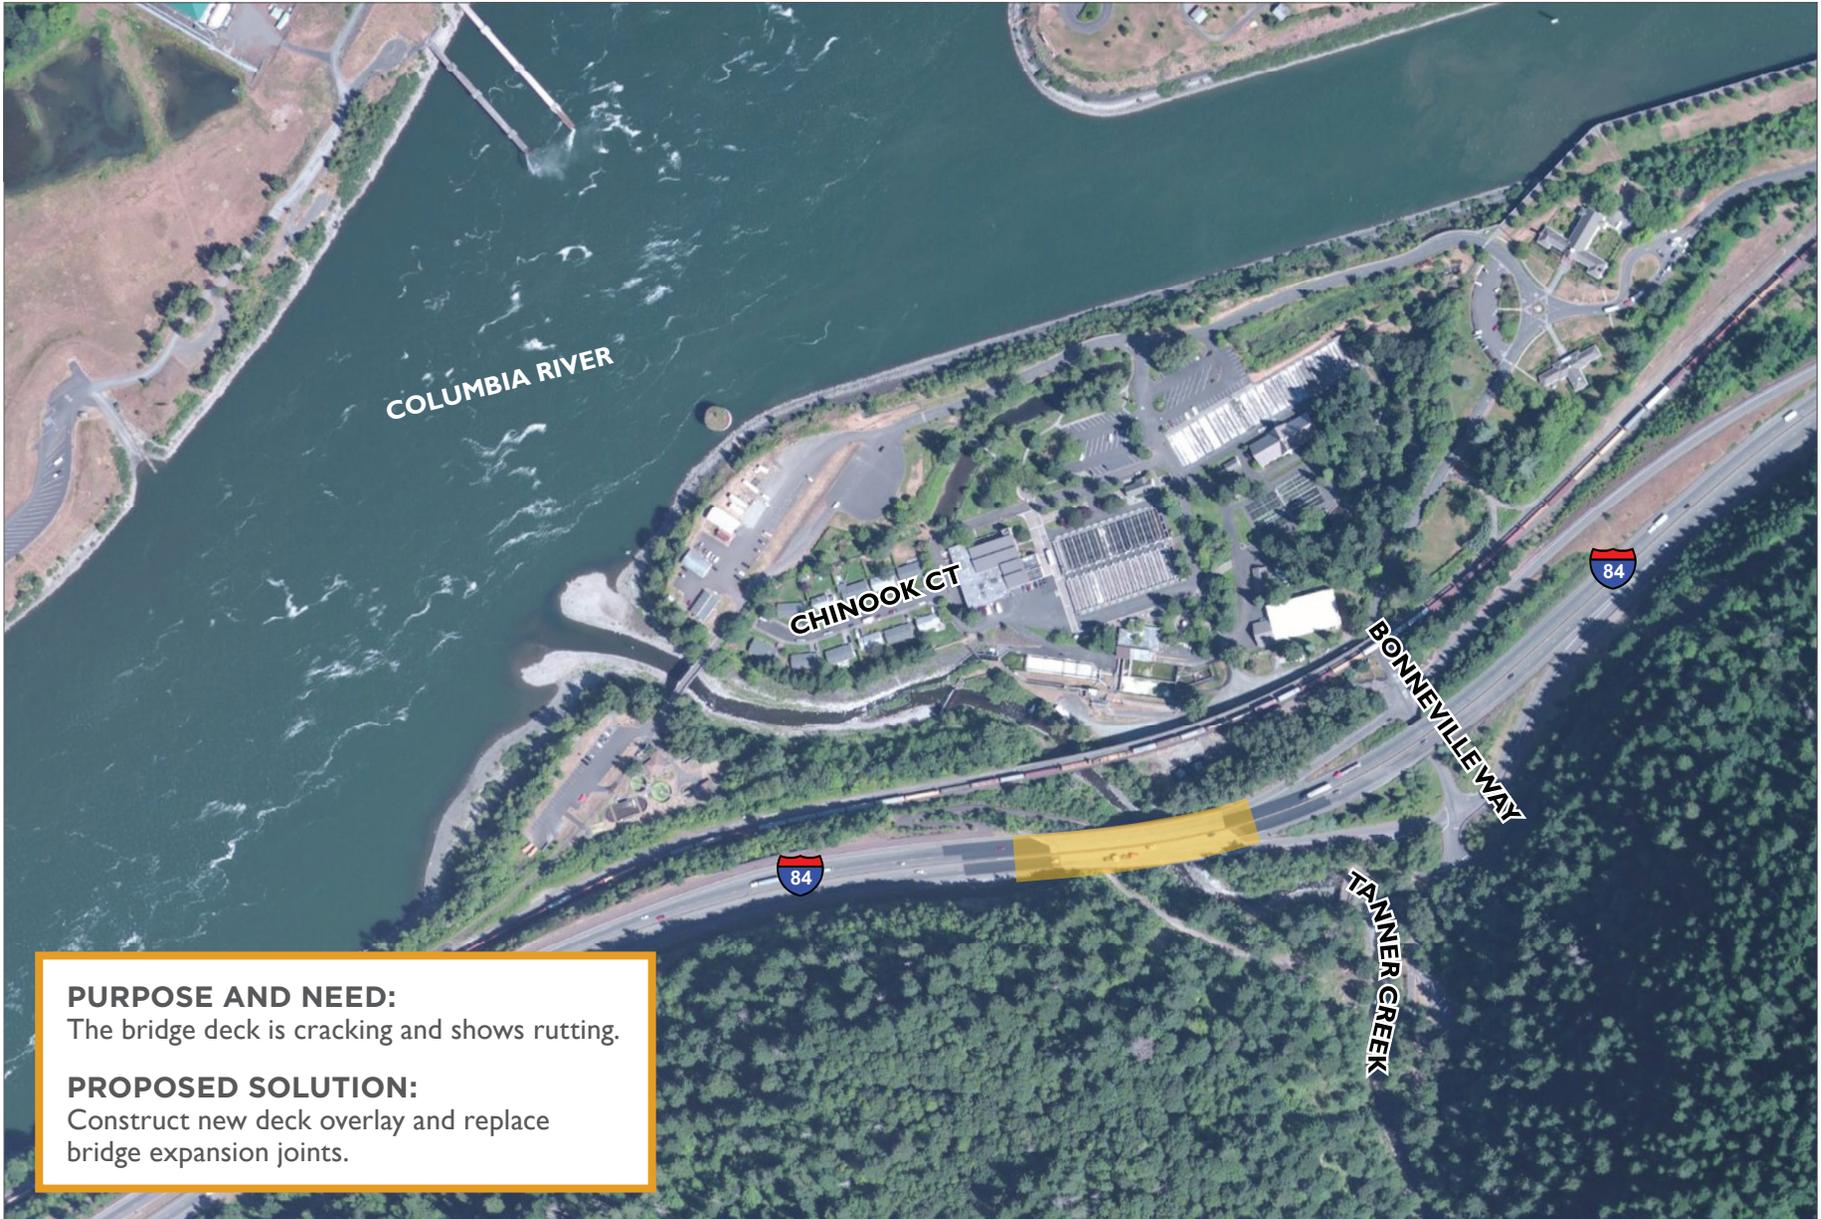
I-84: TANNER CREEK BRIDGE

PURPOSE AND NEED:
The bridge deck is cracking and shows rutting.

PROPOSED SOLUTION:
Construct new deck overlay and replace bridge expansion joints.

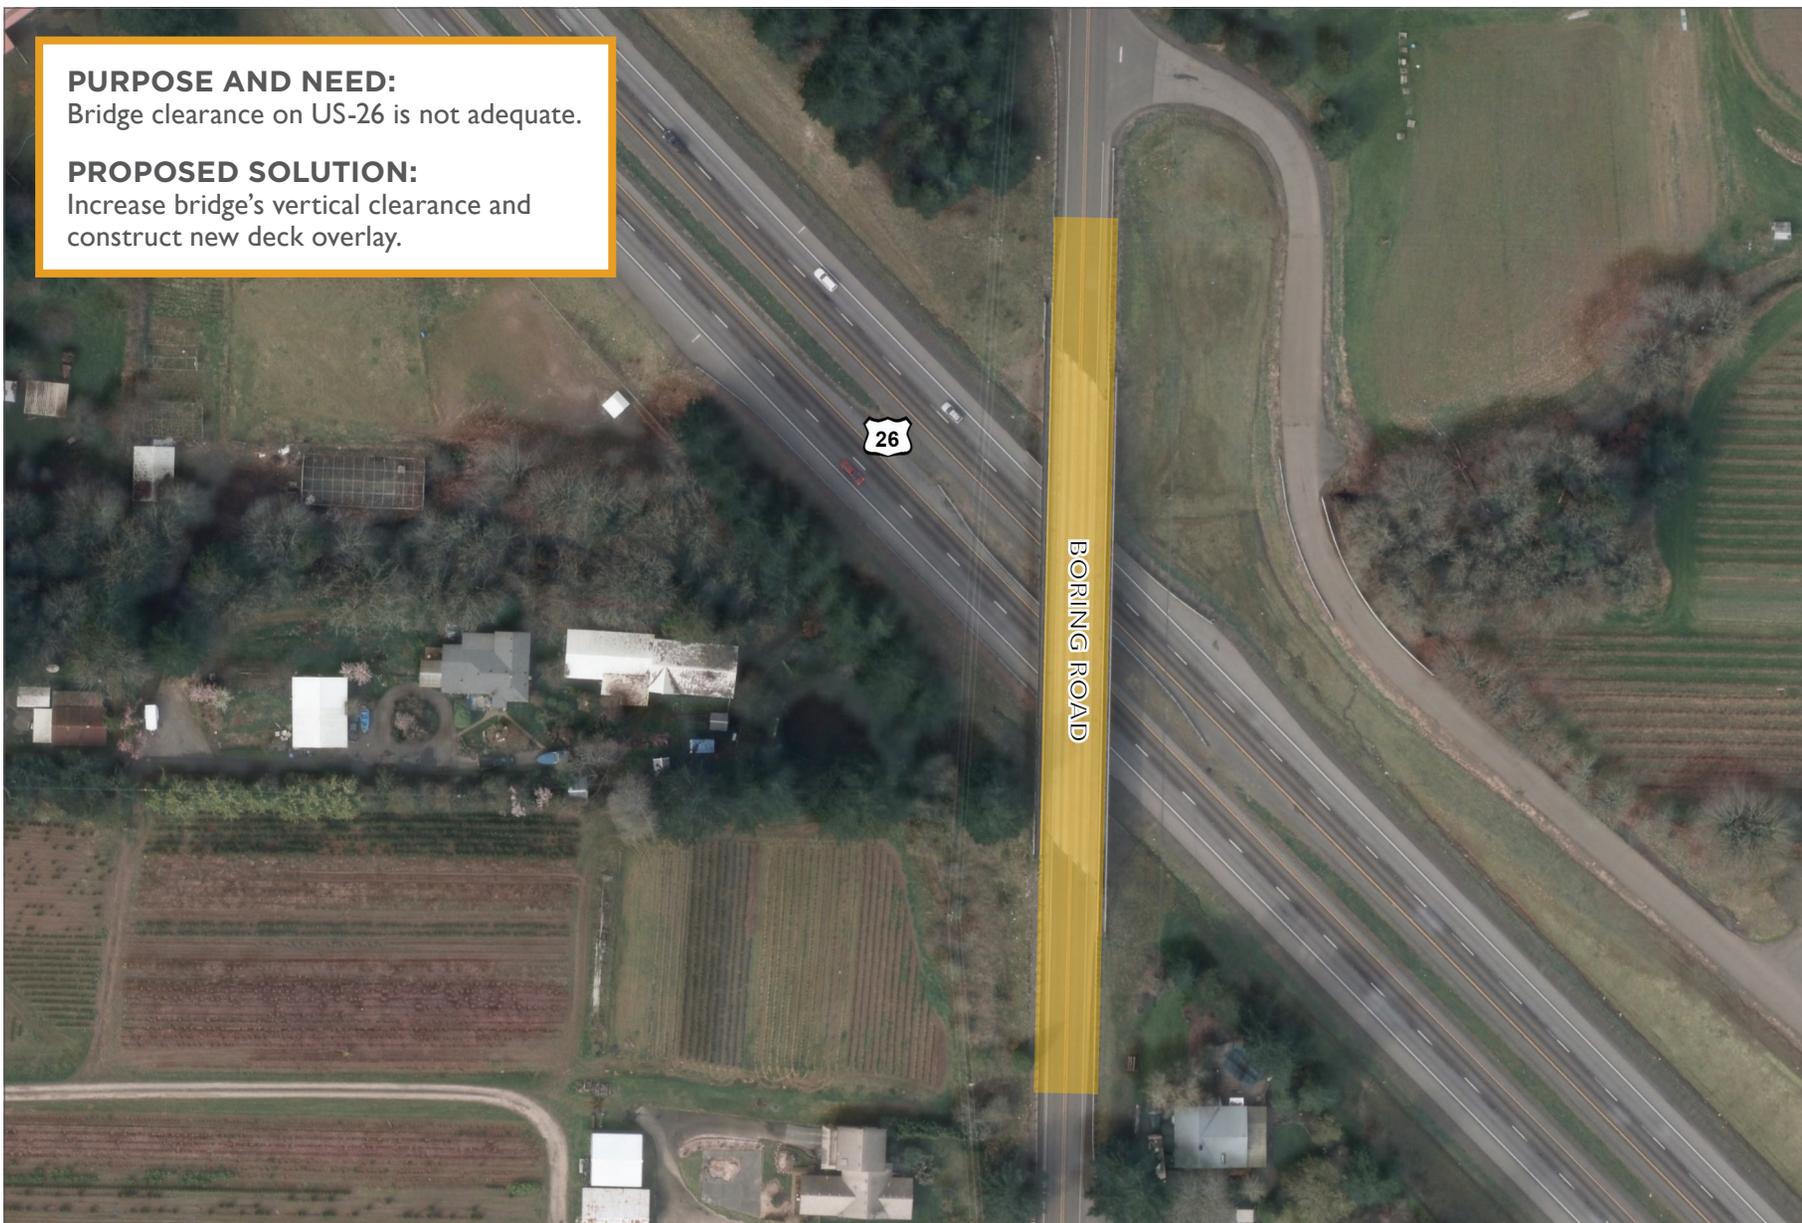
US-26: BORING ROAD BRIDGE OVERCROSSING

Bridge clearance on US-26 is not adequate.

Increase bridge's vertical clearance and construct new deck overlay.

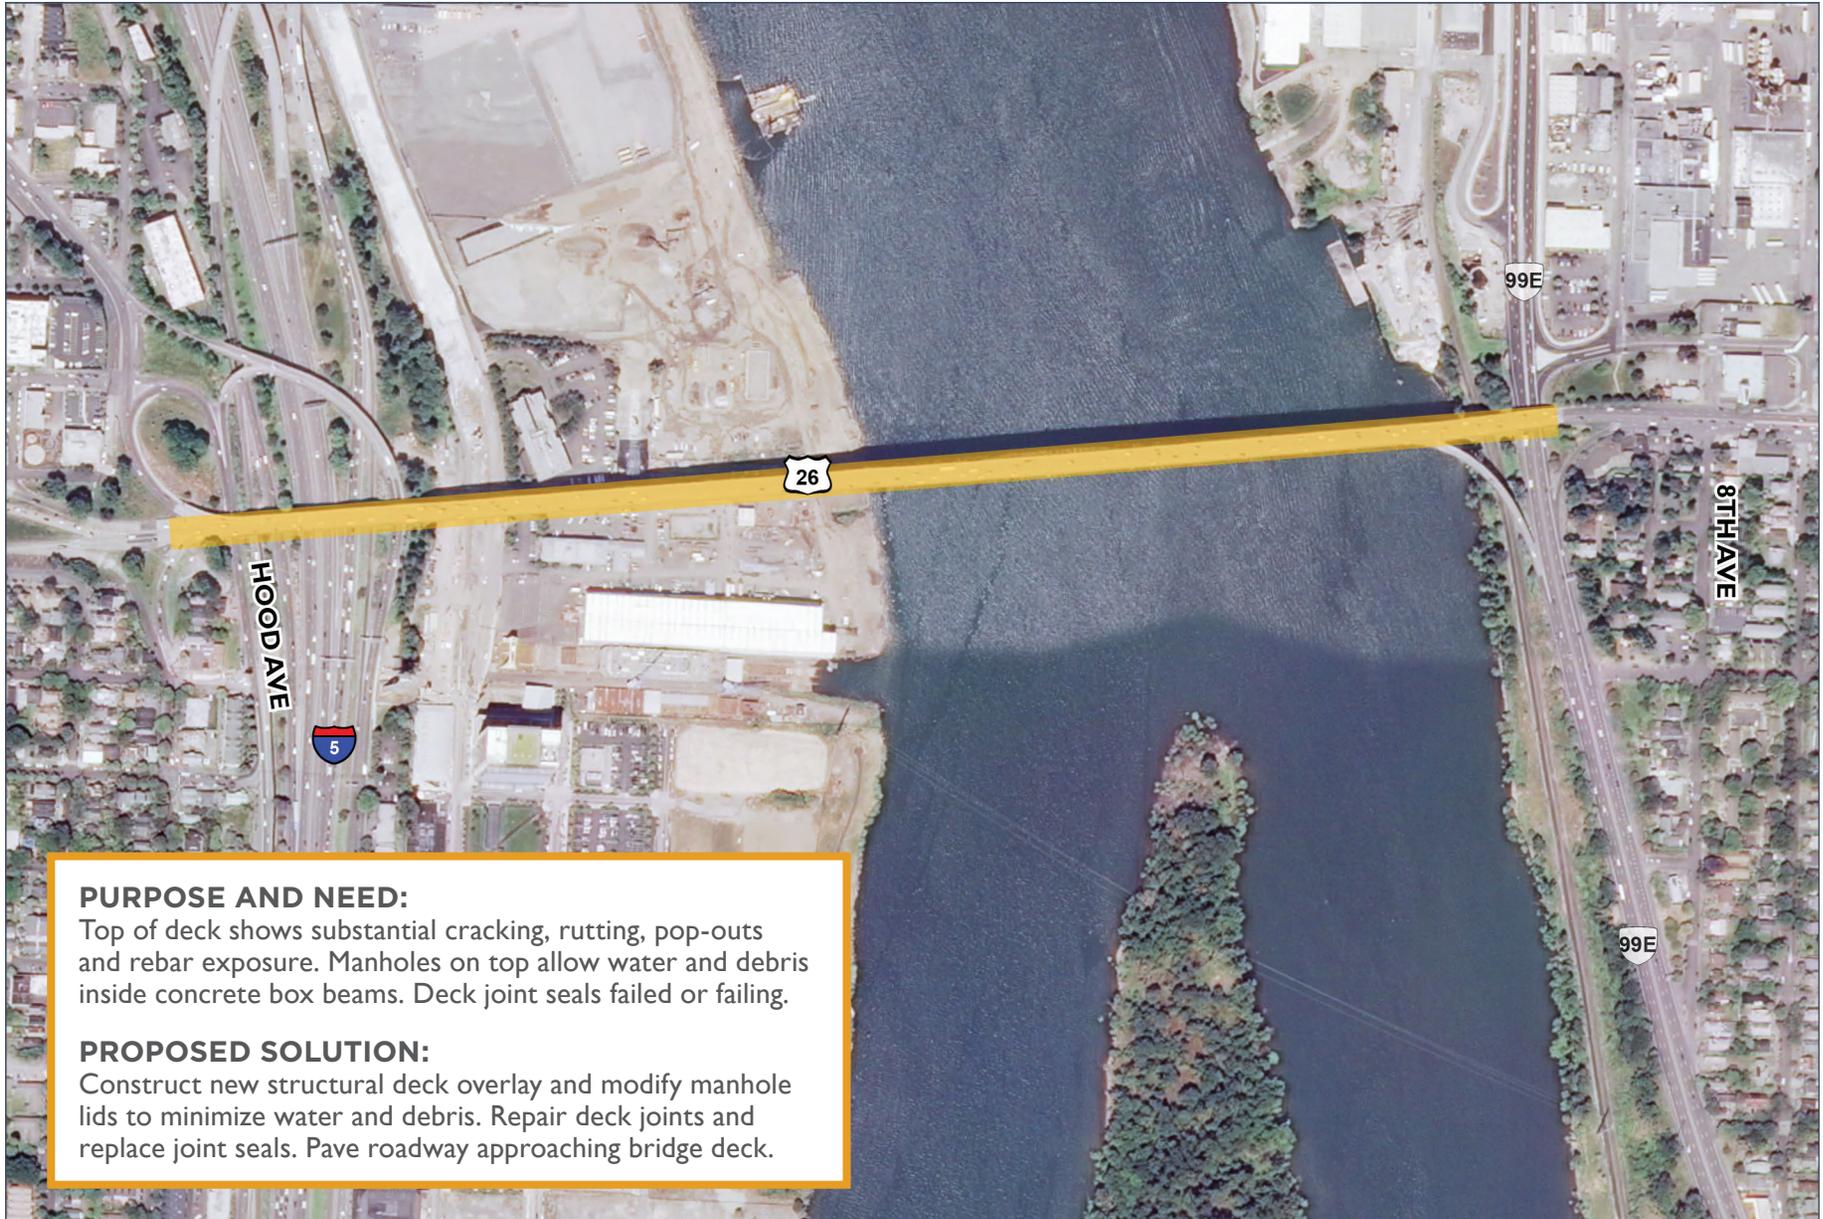
US-26: ROSS ISLAND INTERCHANGE BRIDGE

Top of deck shows substantial cracking, rutting, pop-outs and rebar exposure. Manholes on top allow water and debris inside concrete box beams. Deck joint seals failed or failing.

Construct new structural deck overlay and modify manhole lids to minimize water and debris. Repair deck joints and replace joint seals. Pave roadway approaching bridge deck.
