State of Oregon  
Department of  
Environmental  
Quality

DEQ Solid Waste Program

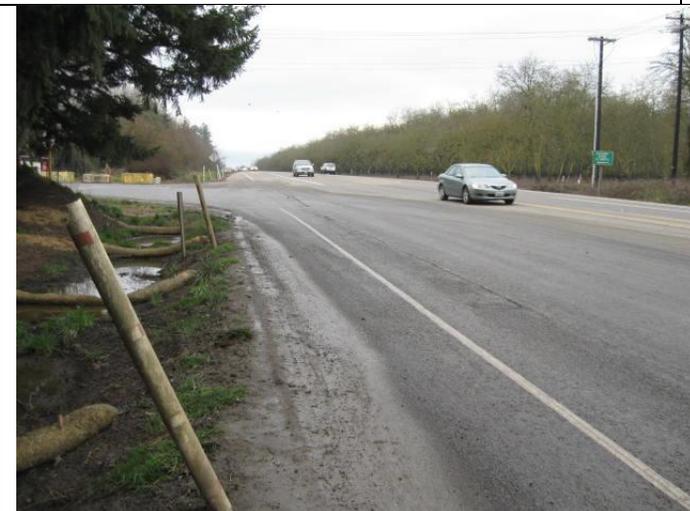
3. Highway 19, looking south. Photo was taken as cars pass, to assess whether dust is kicked up from road. No dust was noted. Some staining of the road was observed.

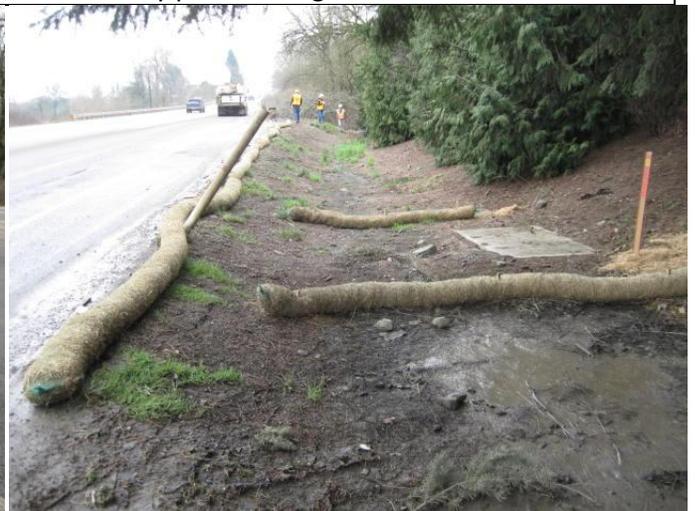
4. Hwy 18, looking north. Sweeper is seen in acceleration lane. Wattles parallel to road are trapping sediment along the edge of the road.

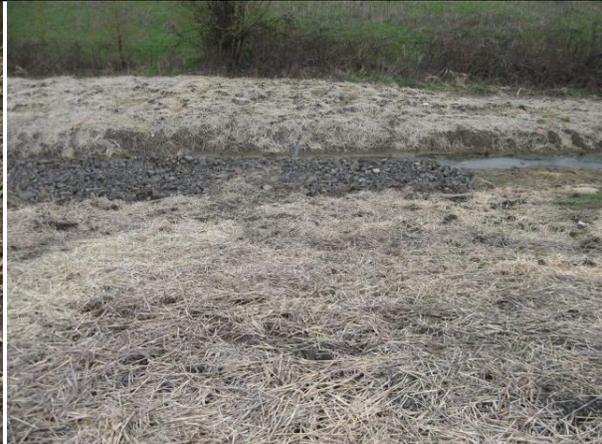
16. Eastern of two areas where soil sloughing was repaired. (North side of landfill.) A rip rap buttress is visible at the bottom of the slope.

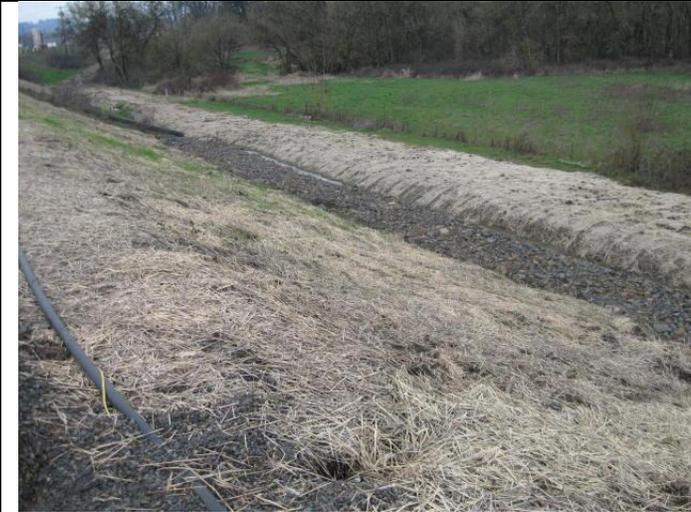
17. Western of two areas where soil sloughing was repaired.

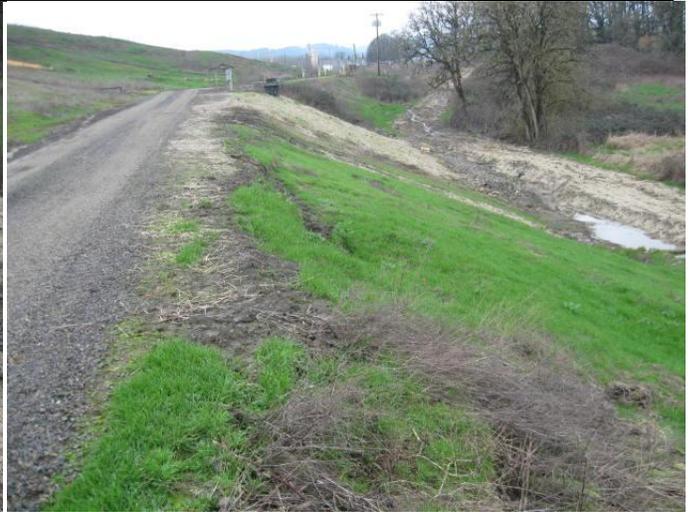
18. Soil sloughing was recently observed in the area between the two repaired areas.

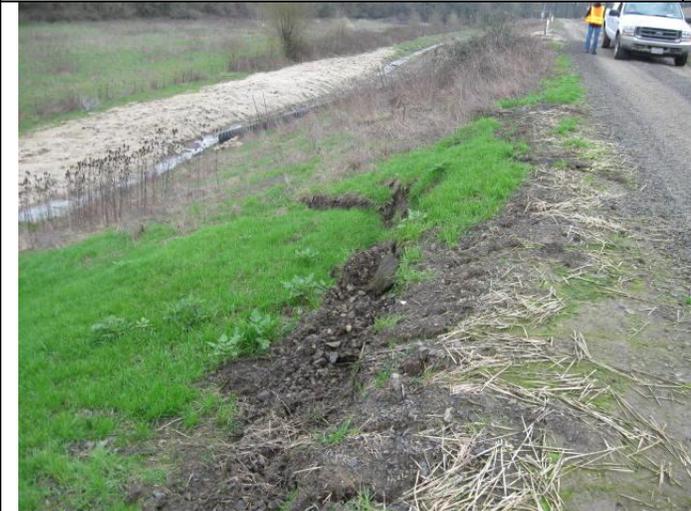
19. Another view of the recent soil sloughing.
