# ATTACHMENT A LPCS AIR CASTING EMISSIONS MEMO

To:	Kenzie Billings	Date:	December 14, 2021
From:	Brian Eagle	Project No.:	8006.58.01
RE:	PCC Structurals LPC Steel Air Casting Emissi	ons

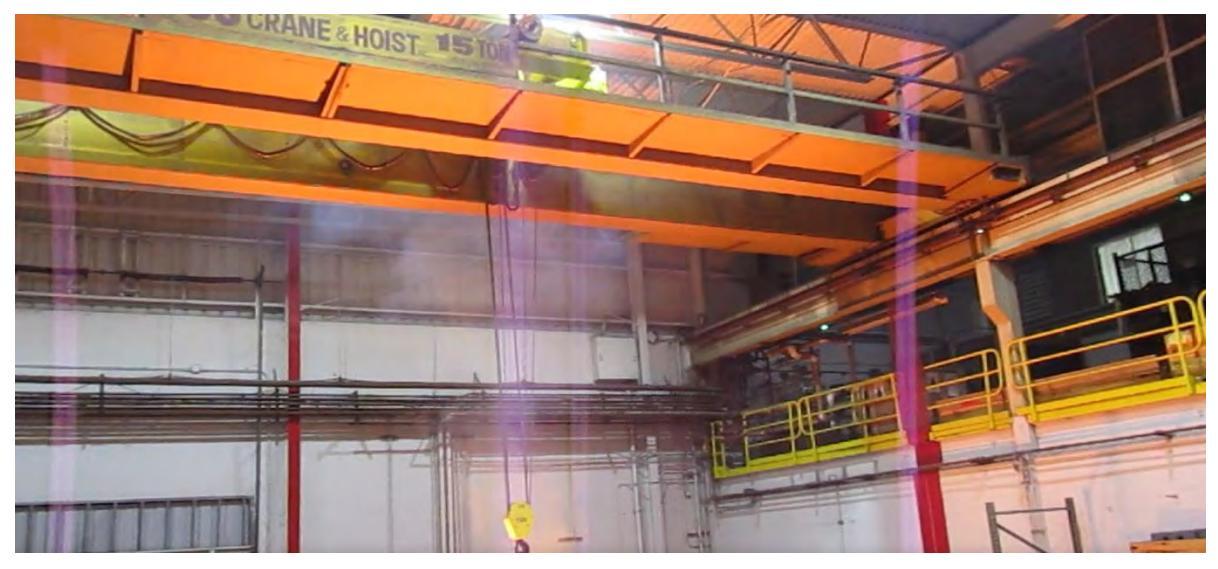
Image 1: Smoke rising, southwestern-facing view.

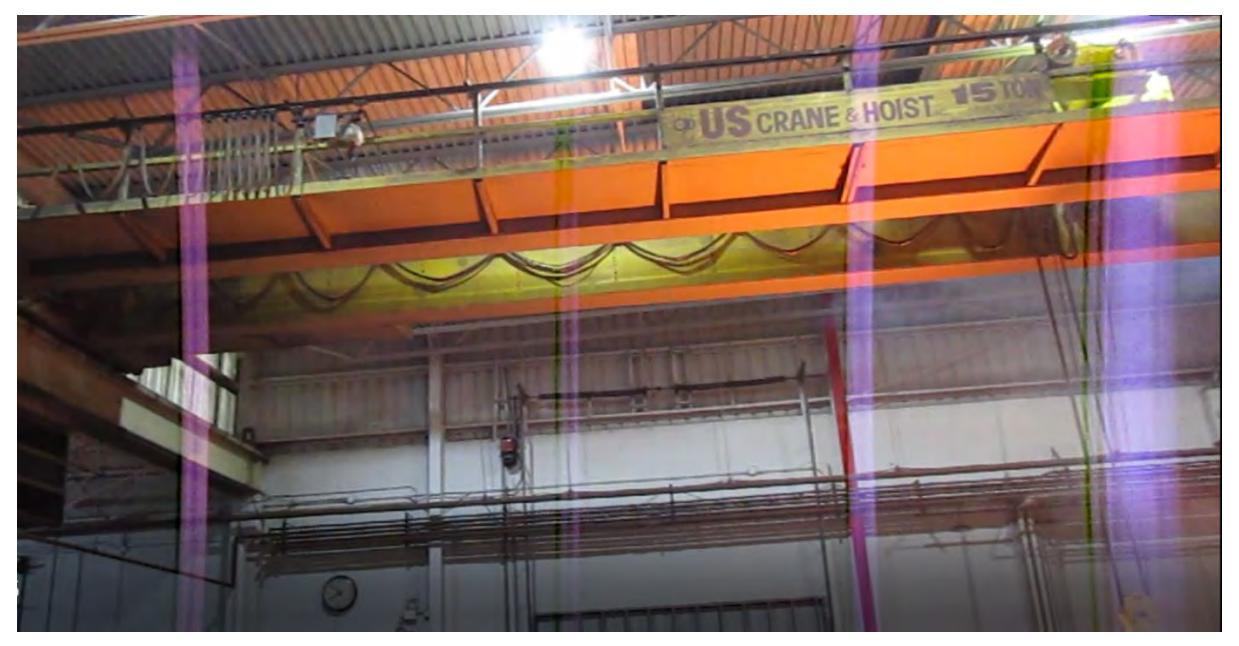
Image 2: Southeastern-facing view.

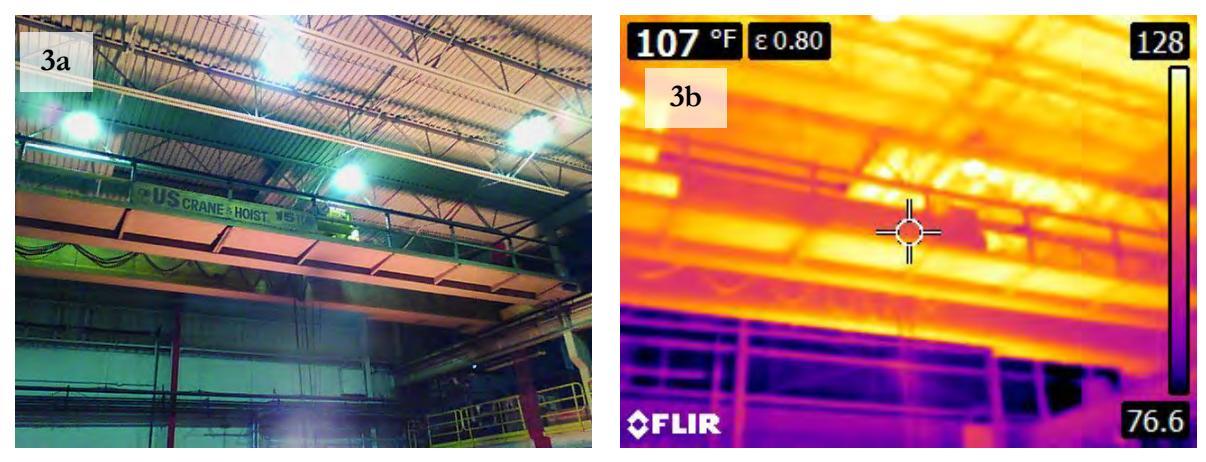
**Image 3:** Smoke rising, southwestern-facing view. (a) photograph and (b) thermogram.

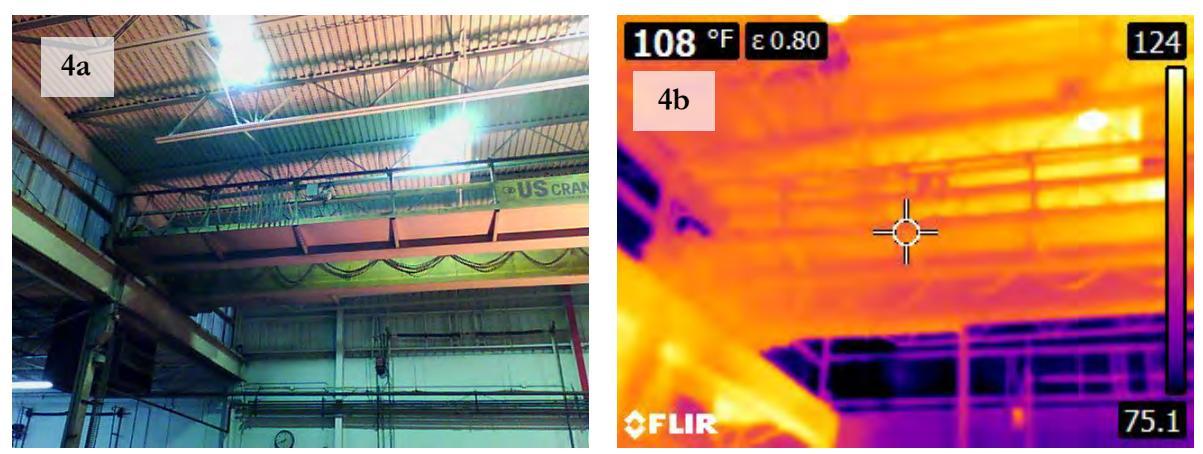
**Image 4:** Southeastern-facing view. (a) photograph and (b) thermogram.

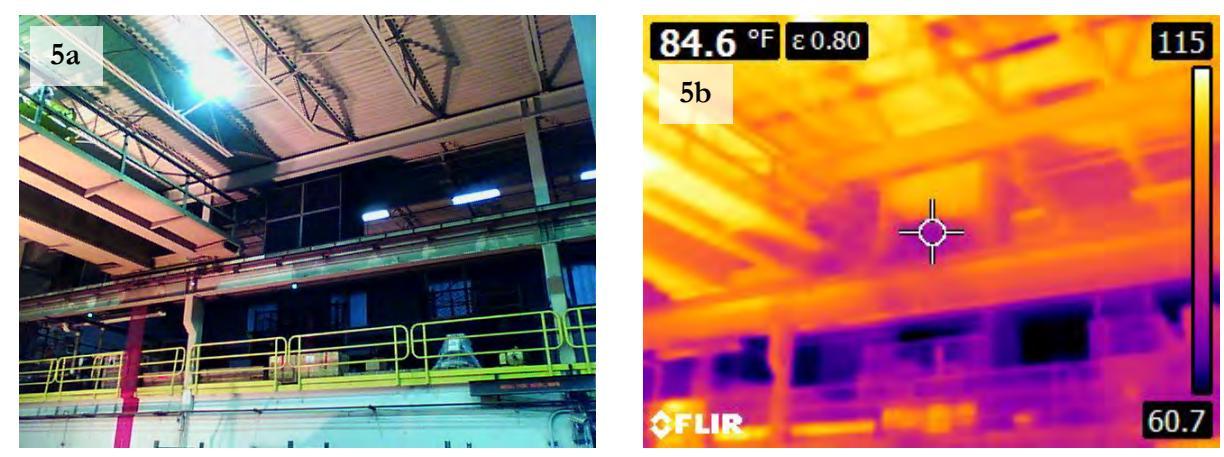
Thermograms taken of the western vents connected to the baghouse show elevated temperature on the inside walls of the vents compared to the nearby temperatures (see Images 5b and 6b in the photograph log). This is consistent with the high temperature emissions being exhausted to the baghouse. Conversely, only one of the vents on the eastern wall appears to have elevated temperatures on the exterior walls of the vent (see Image 7b in the photograph log). This vent is close to the high temperature exhaust stacks of the burnout ovens, which could account for the elevated temperature on the exterior surface of the vent. The eastern vent in Image 8b of the photograph log shows no signs of elevated temperature relative to nearby surfaces. These observations are consistent with heated air exhausting through the baghouse vents only, and not the general building vents. To corroborate this assumption, PCC personnel performed a qualitative assessment of the eastern vents using thin plastic strips attached to a pole. The strips were placed in front of each eastern vent face from the inside of the building. The strips were either not impacted by the vents (i.e., the strips did not move), or an inward airflow through the vent was observed (i.e., the strips moved away from the vent). At the time of this assessment, the axial fans in the eastern vents were configured to move air Kenzie Billings December 14, 2021 Page 3

**Image 5:** Northwestern vent. Routed to Baghouse 9256. (a) photograph and (b) thermogram.

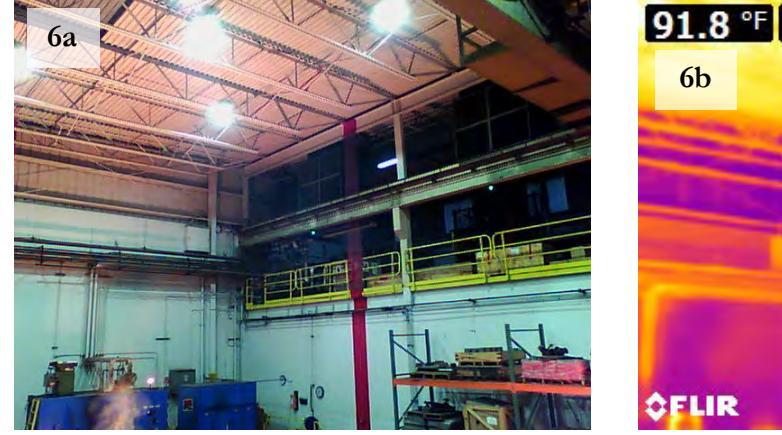
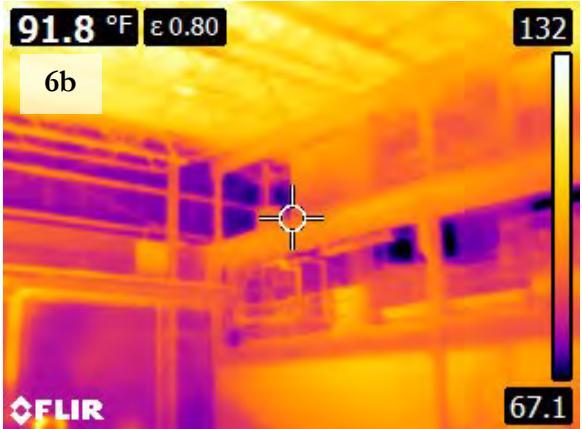
**Image 6:** Southwestern vents. Routed to Baghouse 9256. (a) photograph and (b) thermogram.

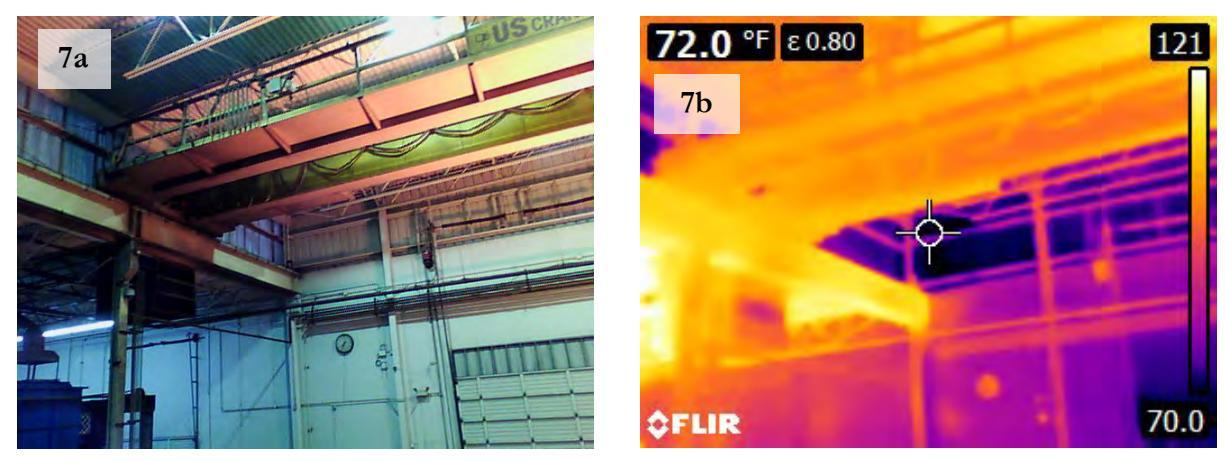
**Image 7:** Southeastern exhaust vent. (a) photograph and (b) thermogram.

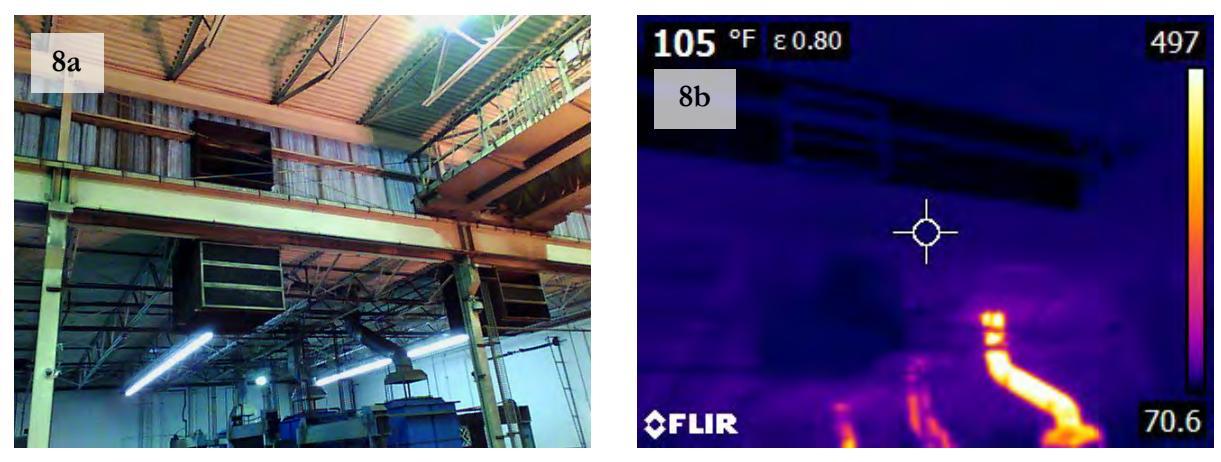
**Image 8:** Northeastern exhaust vents. Burnout oven exhaust stacks in background. (a) photograph and (b) thermogram.
