STATE DEPARTMENT OF GEOLOGY AND MINERAL INDUSTRIES

CATLOW VALLEY CREVICE

N. S. Wagner*

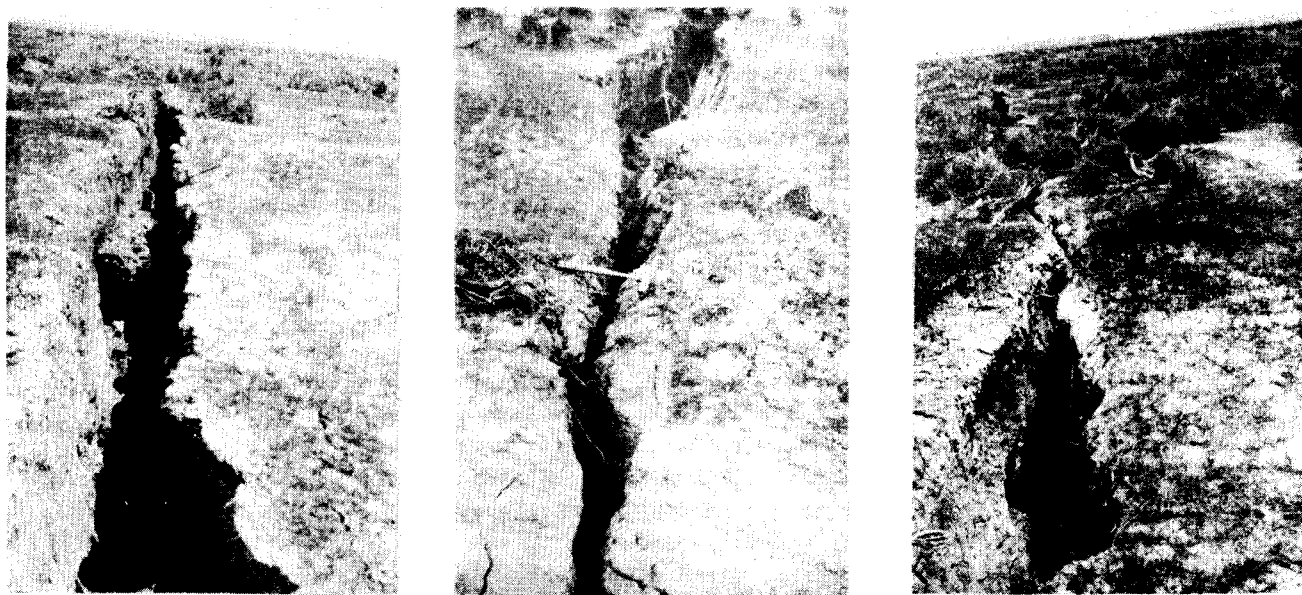
Typical views of the narrow (eastern) portion of the crevice.
Note geologist's pick in center picture. (Photos by N. S. Wagner)

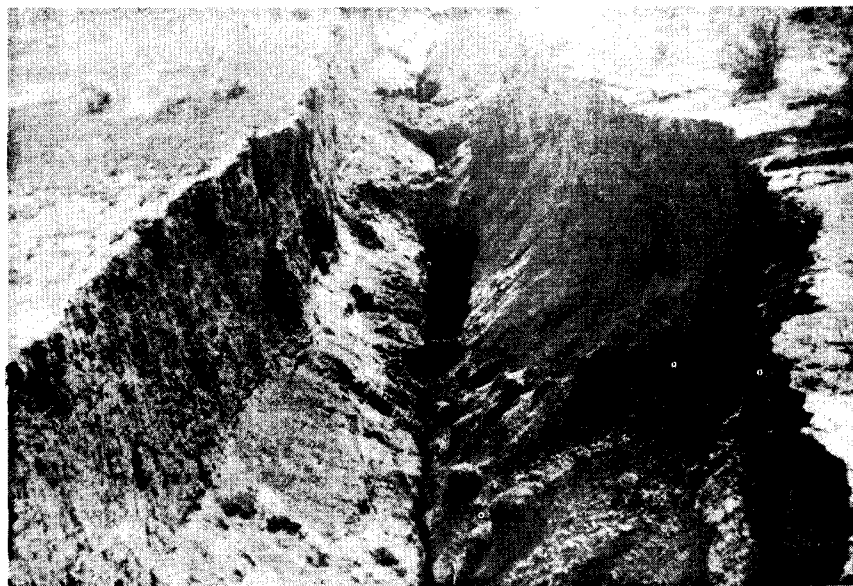
Wide phase of fissure between well and fence with narrow crevice
at bottom of V-shaped section. (Photo by Eleanor McCormick)

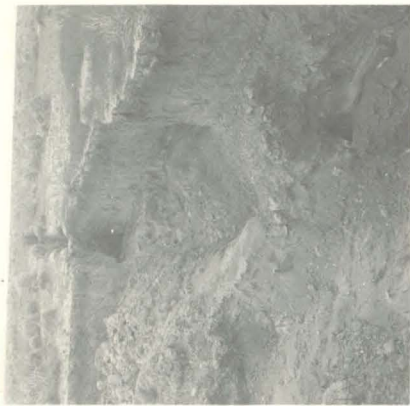
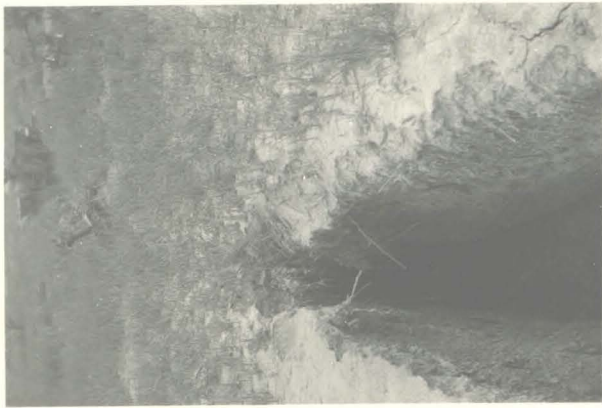
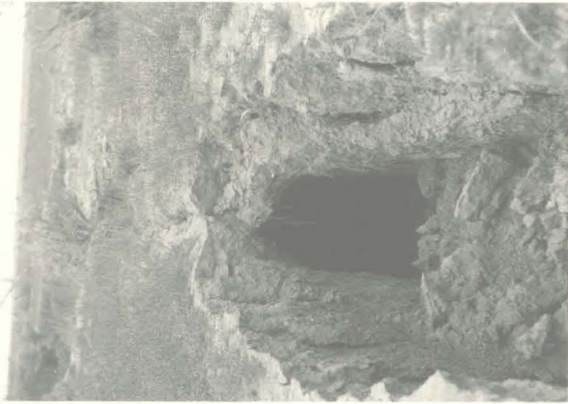
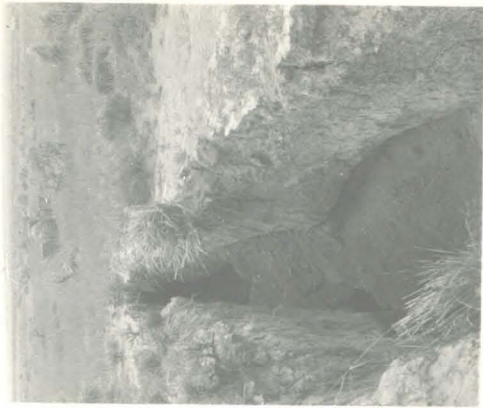
These pictures were all taken east of the well. They illustrate various instances of crevice enlargement with depth. The picture on the left also shows a washed-out enlargement representing a floodwater intake area. These local enlargements were always situated on the northwest side of the crevice, or on the side from which the floodwaters came. The bridge capping the narrow crevice at the end of the wash-out represented a remnant of completely undisturbed soil which had been undercut and left standing.

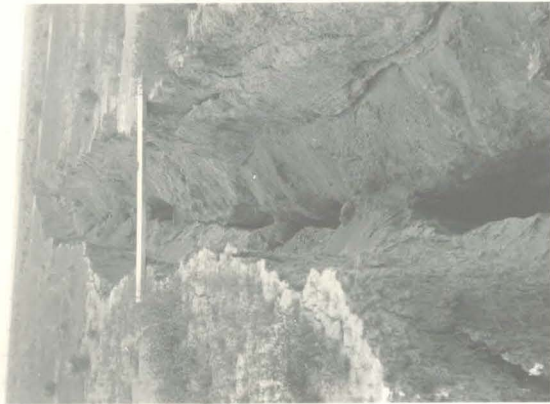
View looking southwest from the well. Surface exposure here 8 to 10 feet in width. Deeper main crevice ranges from 10 to 15 or more inches. Distance to road and fence line shown at the far side of the bare area is approximately 220 feet.

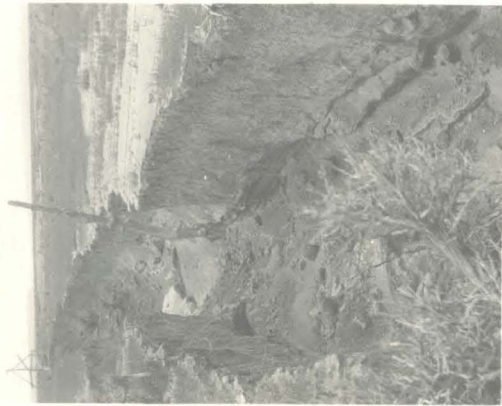
View looking back to the northeast showing fence and road in foreground and well in distance.

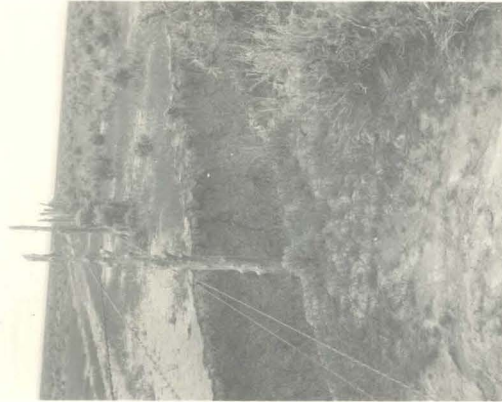
Close-up of fence line which shows no evidence of displacement, vertical, lateral or tensional.

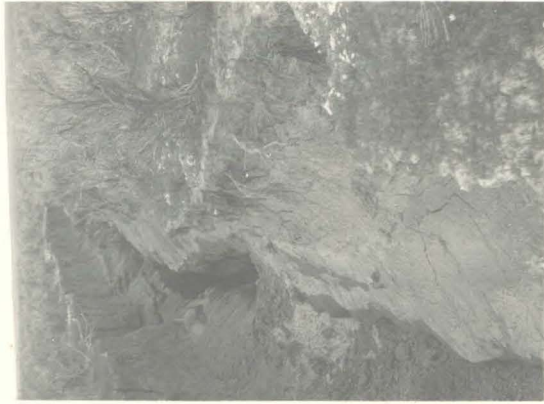
Westward extension of crevice. This was taken from the fence location so view represents a direct, uninterrupted continuation of the crevice as shown in the foregoing pictures.

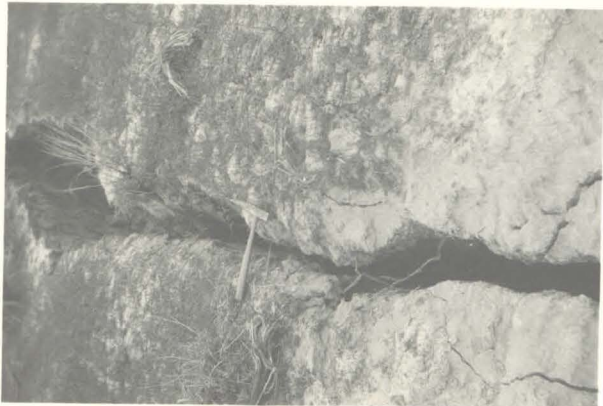
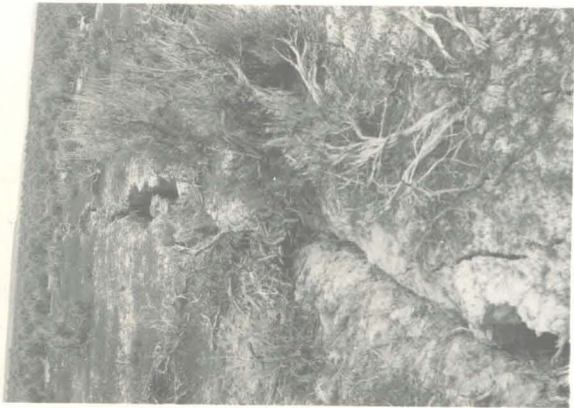
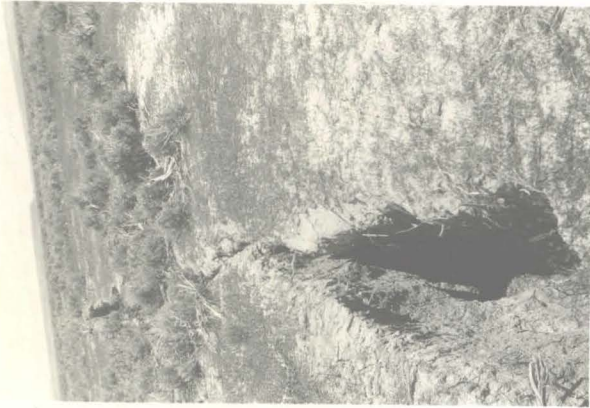
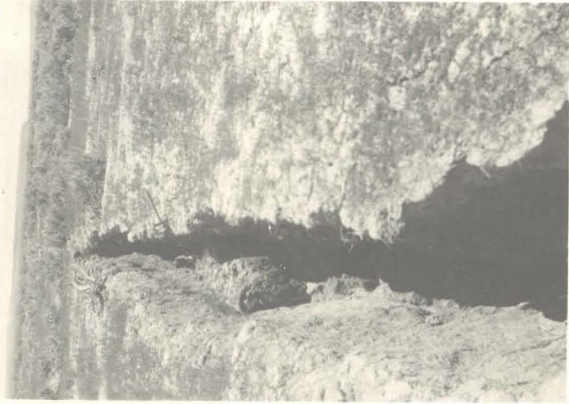
Typical views illustrating how crevice narrows in the section of higher ground extending northeastward from the well. Stretches such as these alternate with wider areas in the vicinity of the well, but the wider areas become progressively narrower and less frequent with distance from the well to the extent that the above type of surface exposure characterizes the crevice throughout the eastern half of its extension as contrasted with the wide variety of exposure prevailing to the westward.

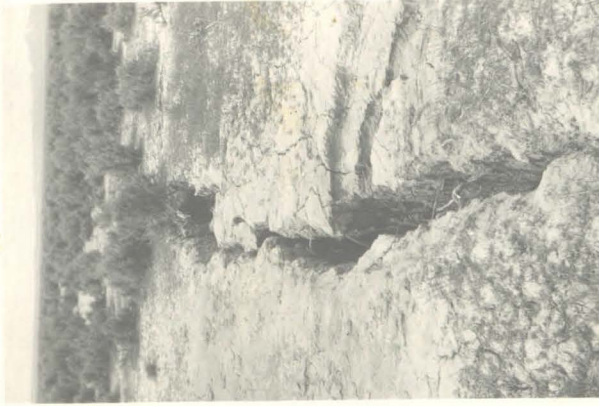
Remains of small water channels extending to crevice on northwest side, but not crossing it.

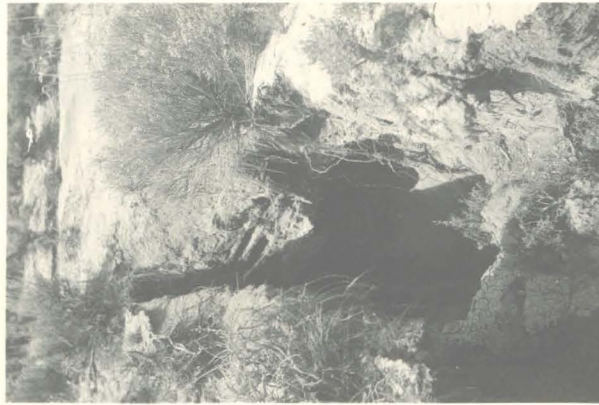
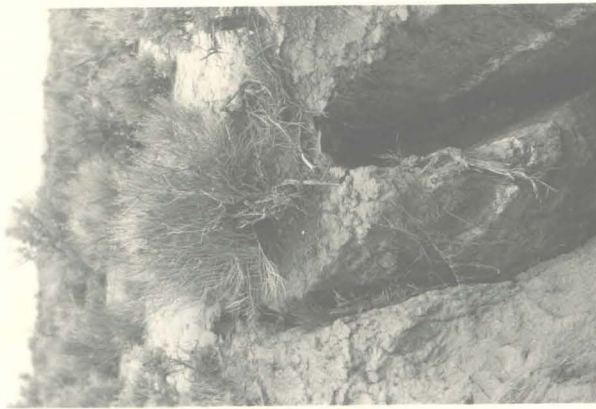
Views showing crevice where it crosses the eastern most creek channel shown on map. The left picture is looking eastward and the right picture westward along the fracture. Note lack of evidence of fracture on surface. This is present in both instances but most evident only in the left one.

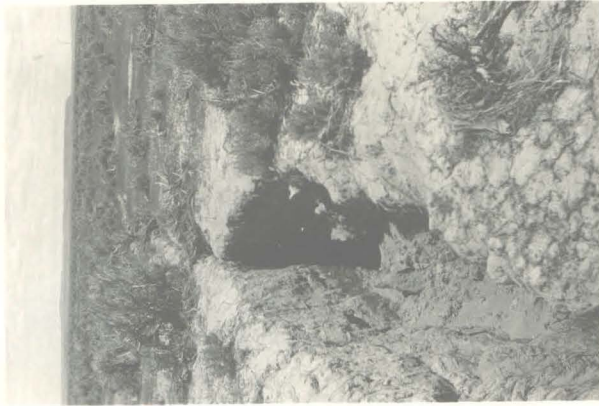
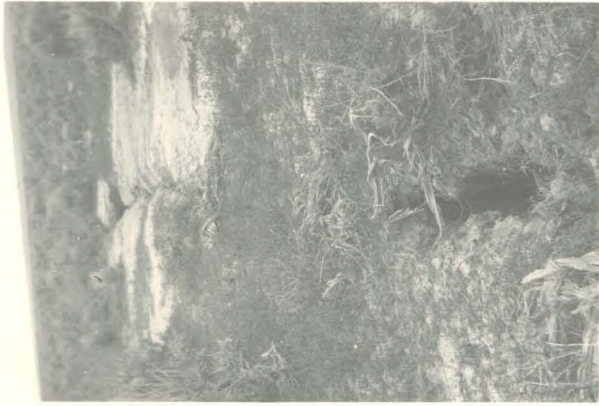
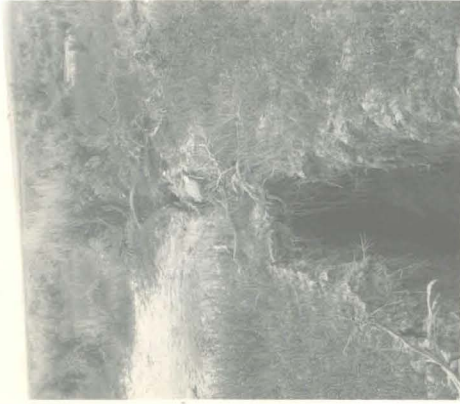
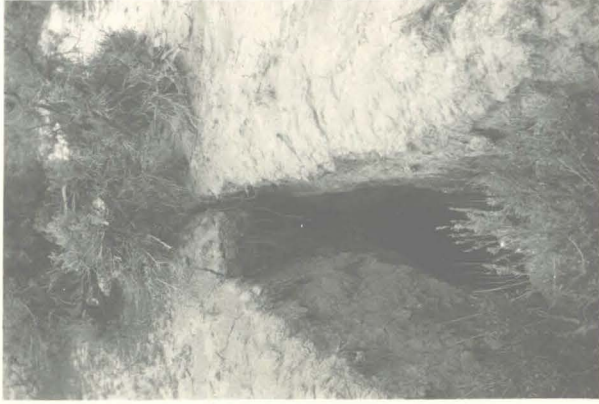
Miscellaneous views. Most were taken to illustrate examples of undisturbed surface conditions as evidenced by lack of visible cracking or pulling of vegetation roots etc. While said evidence is present in these pictures it isn't apparent in a conclusive or striking manner.

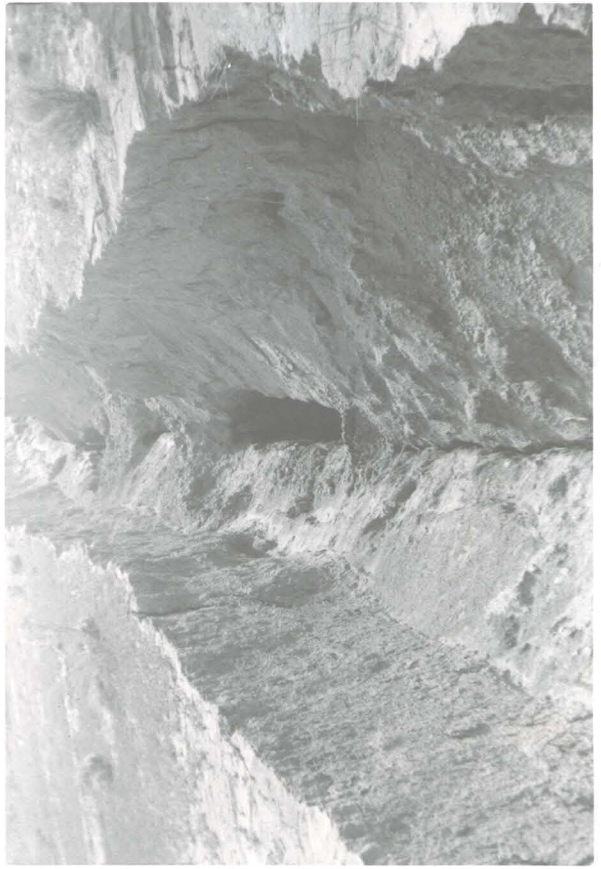
The following pictures were taken by Eleanor McCormick, Frenchglen, about mid May, or a week earlier than the foregoing shots. The one below illustrates both the wide surface and narrow lower phases of the crevice in the area between the well and the fence. Also the V-shaped cross-section sometimes developed along the bottom of the upper surface phase of the crevice.

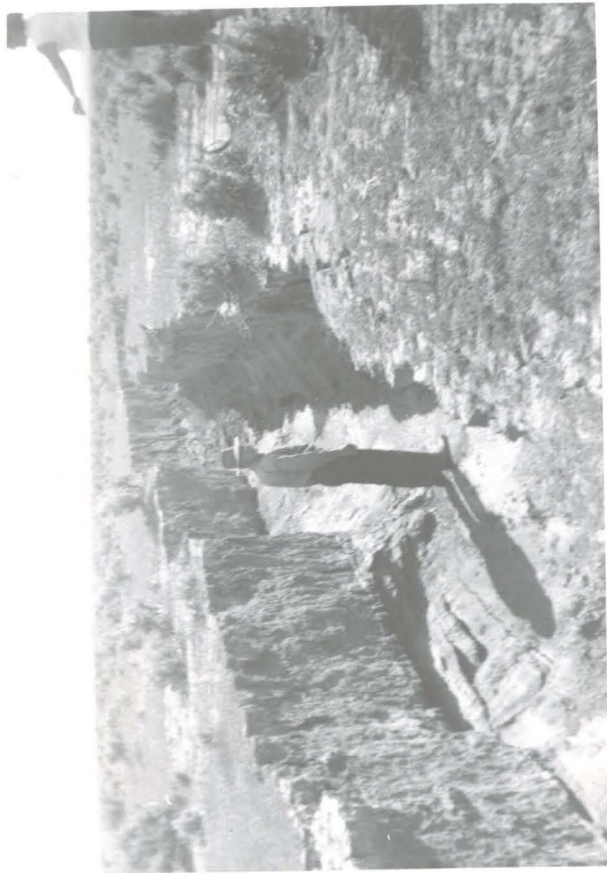
Differential erosion along the lower portion of the surface phase of the crevice. The location is west of the fence a short distance.

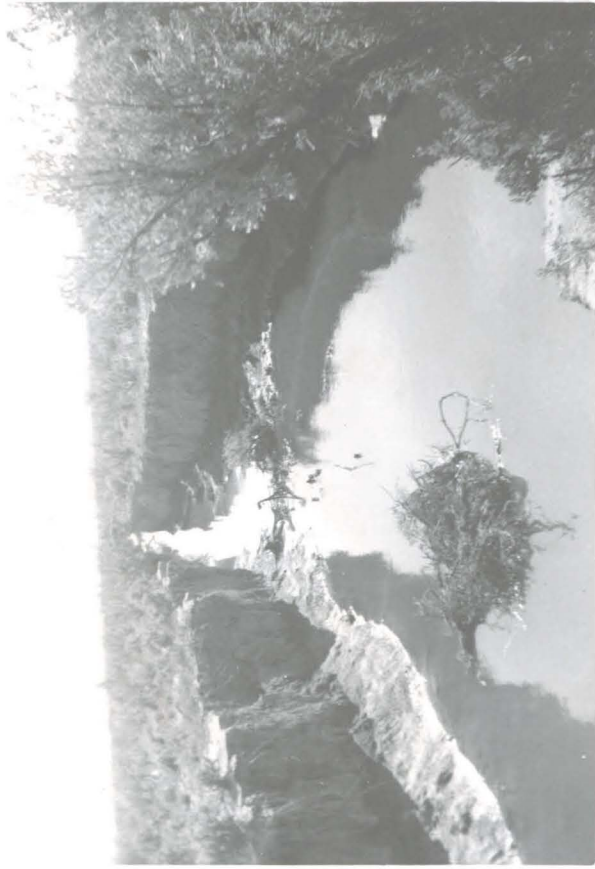
Irrigation water backed up in the crevice in the area adjoining the meadow due to attempted and only partially successful filling of the crevice in meadow to stop water loss.
