State Department of Geology and Mineral Industries

Iceland Spar Claims, Malheur County, Page 5.

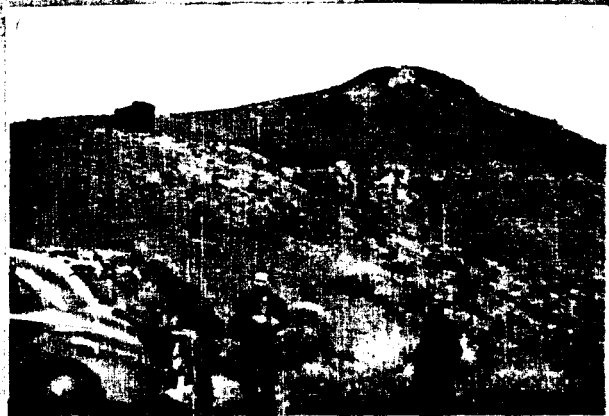
View showing main vein which follows the crest of the hill from the left of the picture to a point on the skyline about halfway across the picture at which point it swings along the side of the hill and can be seen outcropping in large blocks against the crest of the highest part.

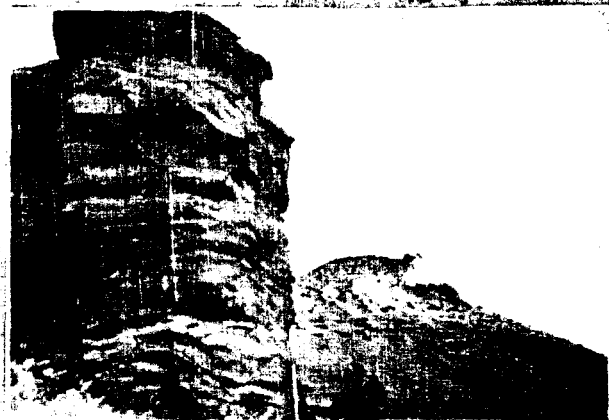
Another view from the pillar seen in the picture above. This shows more clearly the manner in which the veins outcrop and the extent to which they have been exposed to weather.
