STRUCTURAL EVALUATION OF CENTRAL ELEMENTARY SCHOOL

Albany, Oregon

STRUCTURAL EVALUATION

Central Elementary School
Albany, Oregon

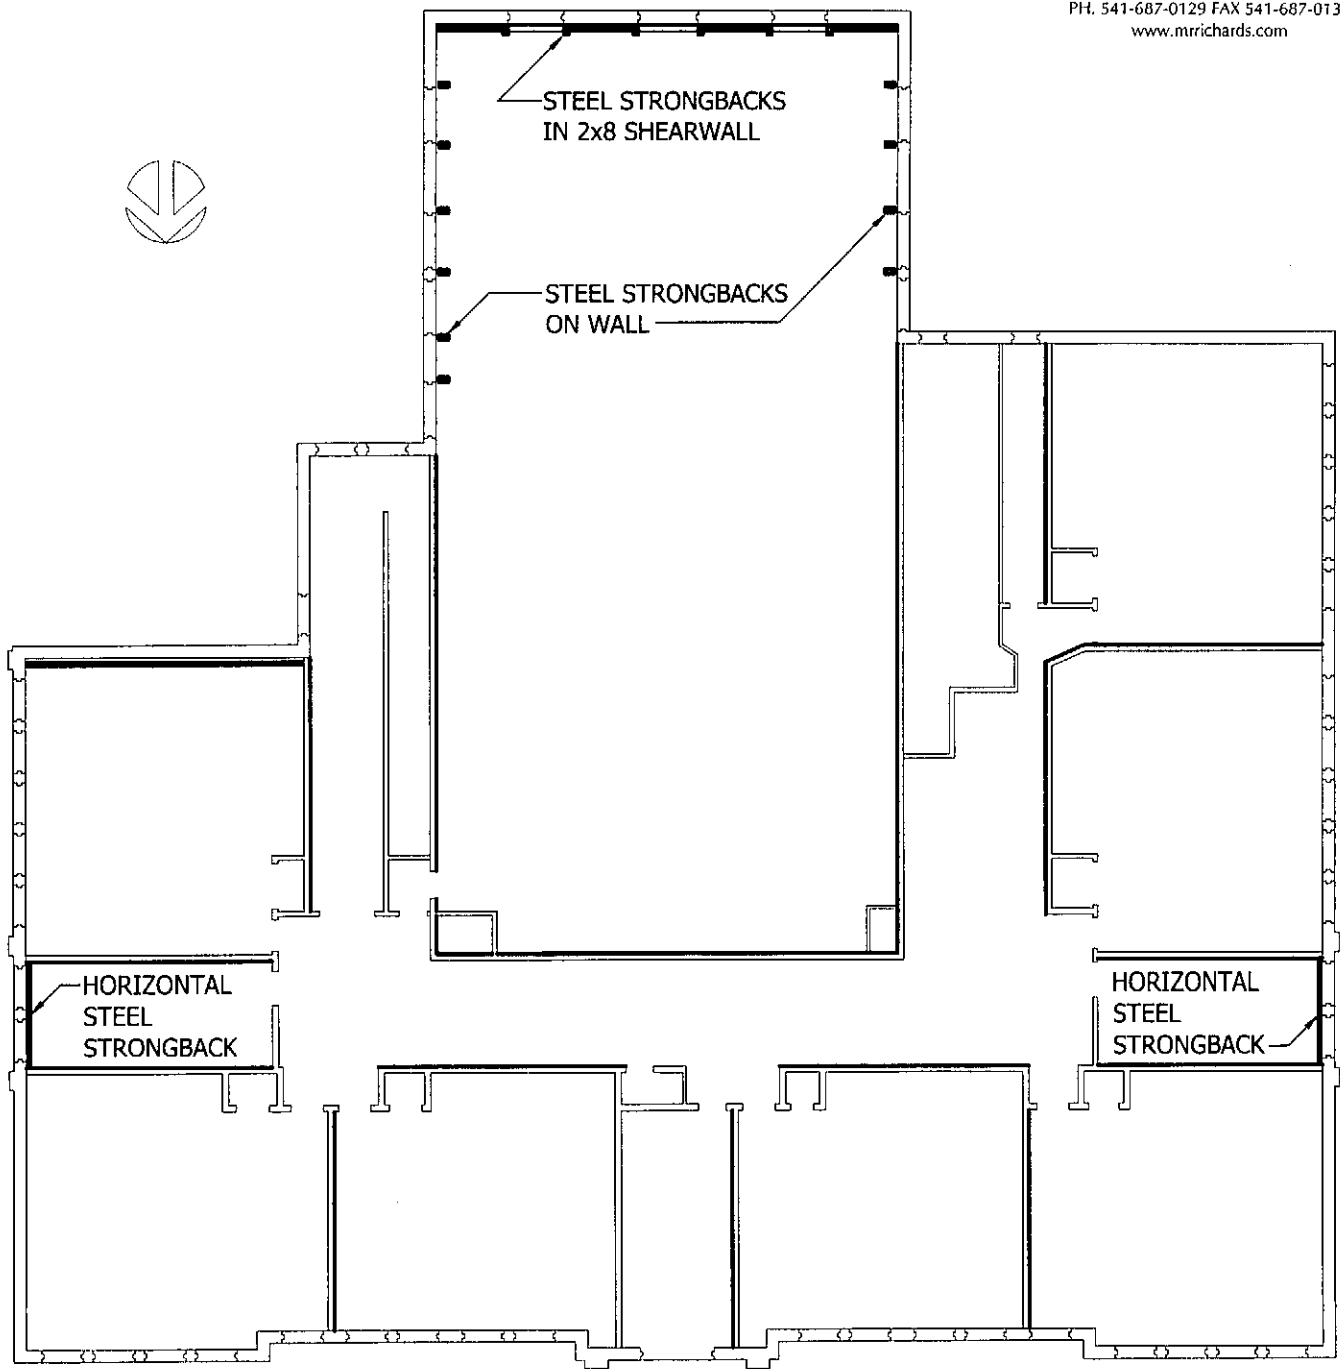
PLAN: SECOND FLOOR SEISMIC UPGRADES

The existing wood shear walls, if new sheathing were applied, are adequate for the majority of potential seismic loads. Additions of new wood shear walls in selected locations at the perimeter of the building, as shown in the attached structural plans, would result in a complete structural system. Using this method of seismic rehabilitation, some cracking is expected to occur in the masonry exterior walls if a major earthquake were to occur, but the masonry would stay intact and continue to carry gravity loads.

— STRUCTURAL SHEATHING APPLIED TO ONE SIDE OF EXISTING STUDWALL

— NEW WOOD SHEARWALL
